Queen Victoria Building Condition Assessment

23 July 2018

Document reference: 399302 | 1 | A

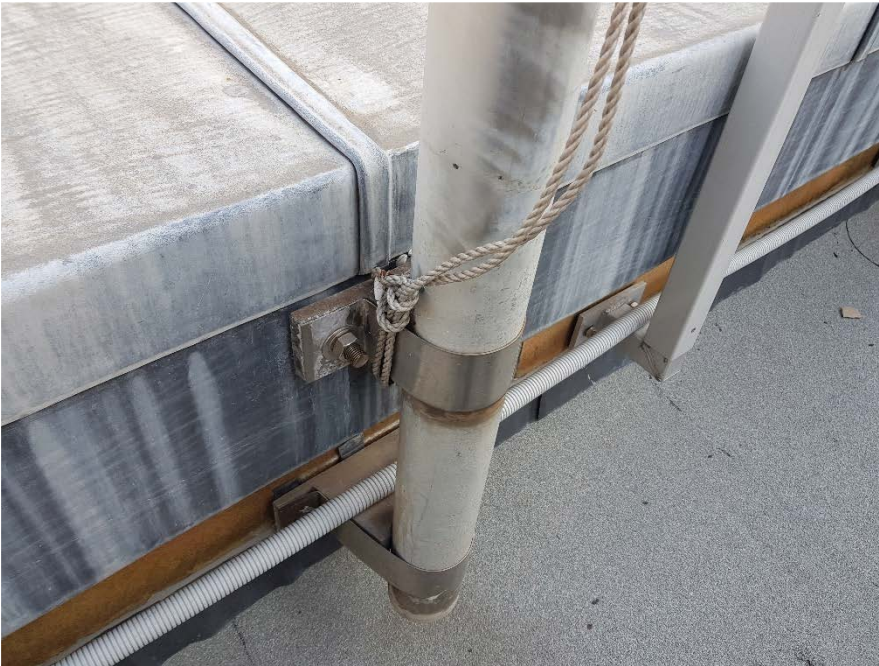
- The side connection to the flag pole in Figure 1 was found to be loose.
- The flag poles at the southern end looked to have potentially corroded bolts with insufficient threads.

Figure 1: Typical Connection for East and West Flag Poles

- All flag poles to be inspected and checked on a regular basis.
- Where defective fixings are identified they should be rectified as soon as possible.

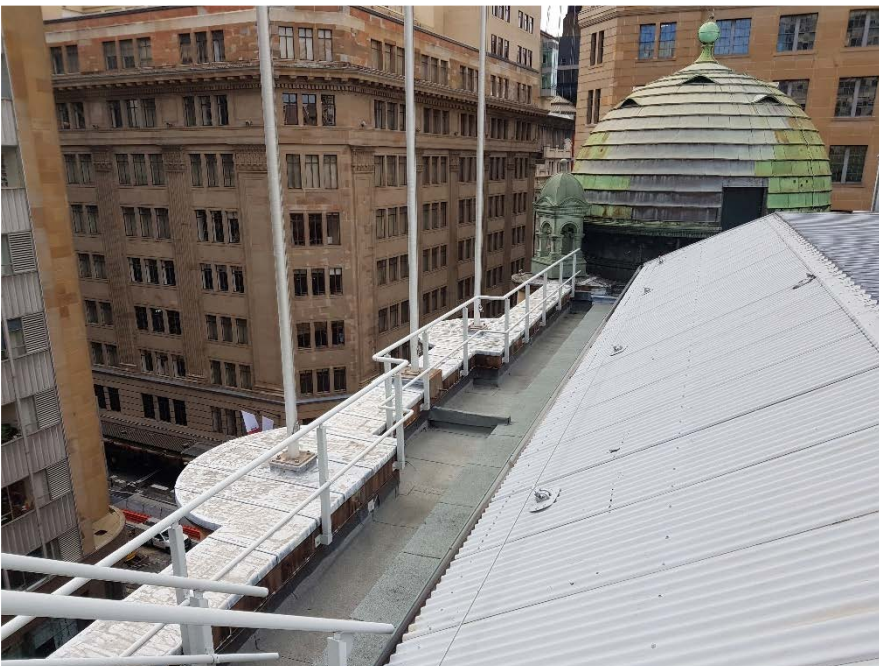
Figure 2: Flag Poles North End

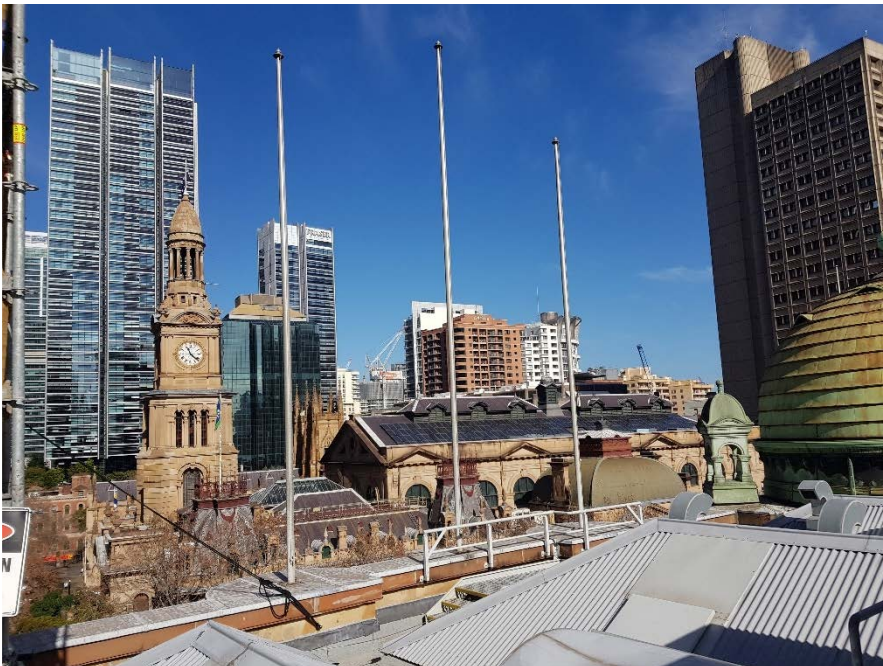
Figure 3: Flag Poles South End

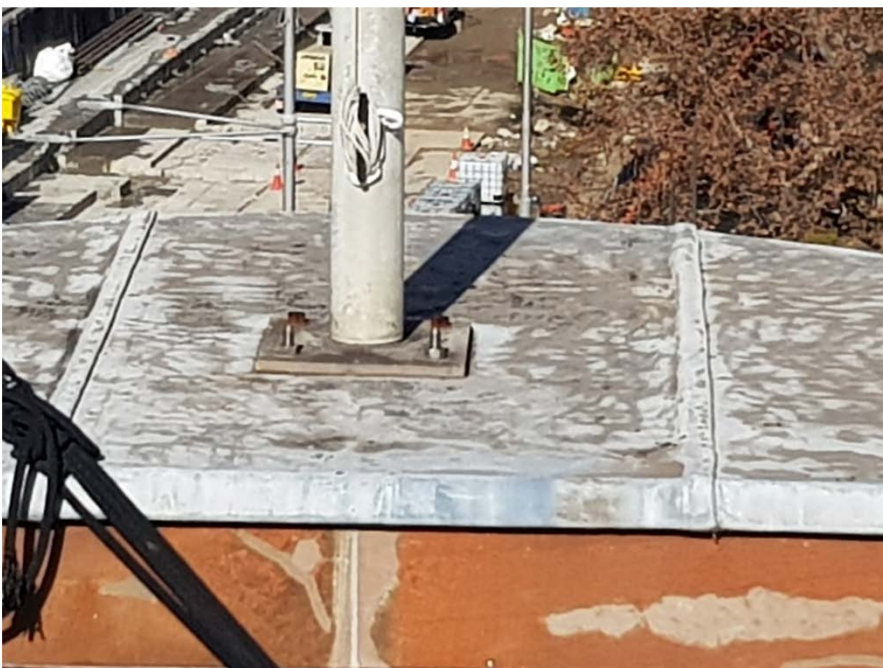
Figure 4: Corroded Flag Pole Connections South End

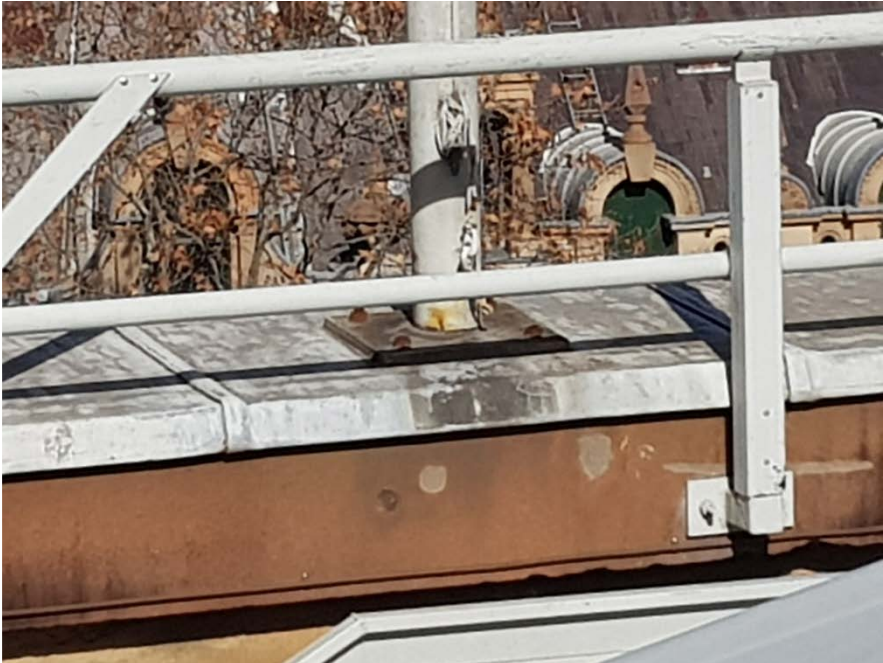
Figure 5: Corroded Flag Pole Connections South End

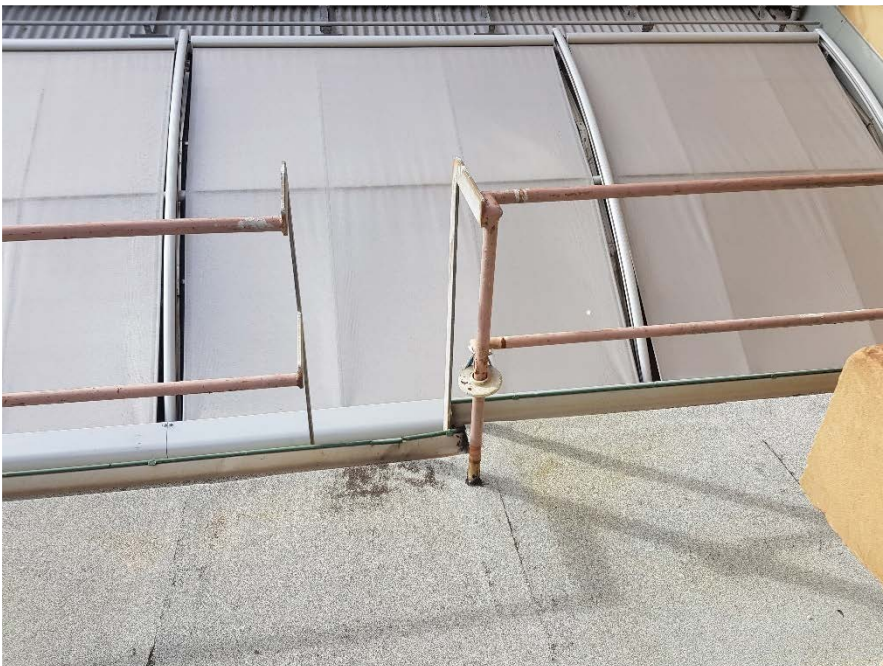
Figure 6: Balustrade North West

- A survey of roof access structures be made and a risk assessment carried out. And where necessary access should be upgraded to meet new codes.
- All fixings be checked during routine maintenance and replaced if necessary.

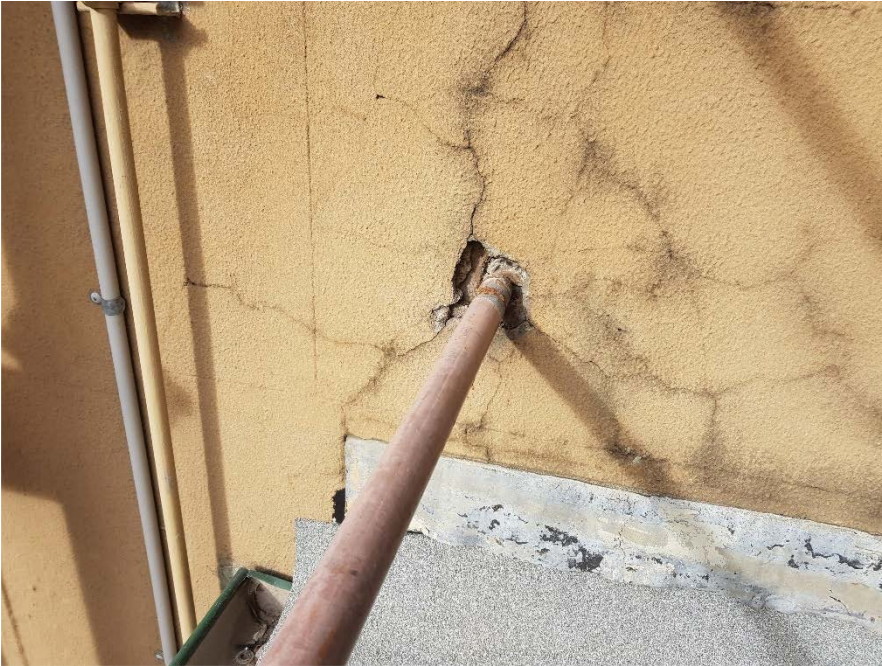
Figures 6-12 show example photos of the access structures found on the building's roof. Figures 7 and 8 show an original railing having broken off from the embedded end. Figure 12 shows an unbolted end to a railing on one of the new lightweight walkways.

Figure 7: North West Balustrade Closest to Central Dome Fixing

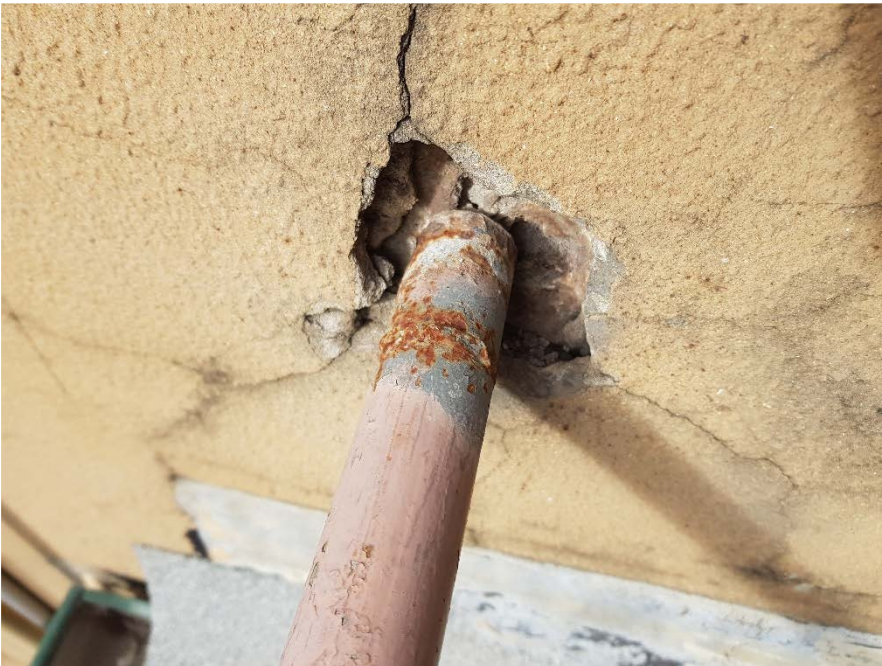
Figure 8: Original Railing Broken Off from Wall

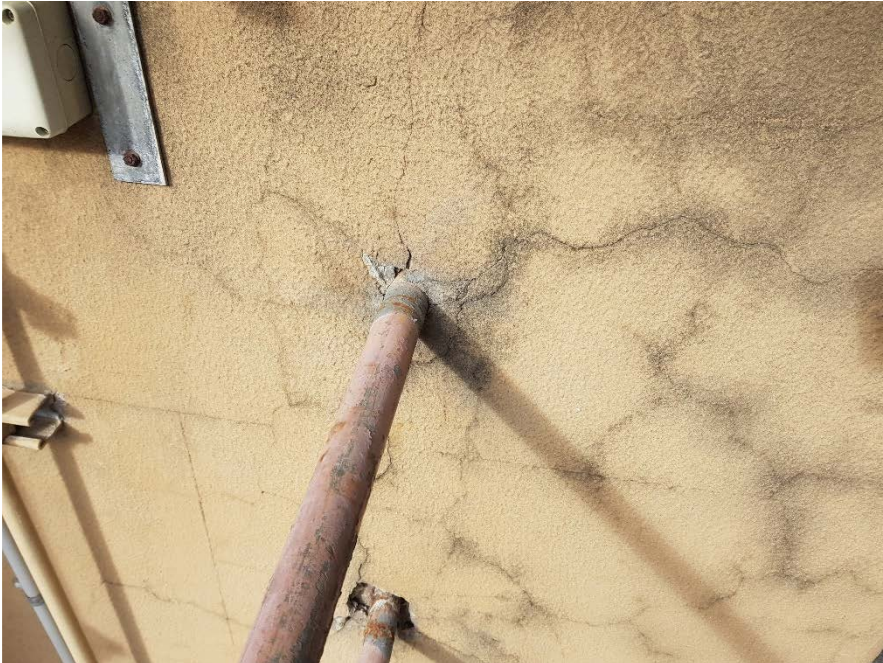
Figure 9: Cracking Around Embedded Railing

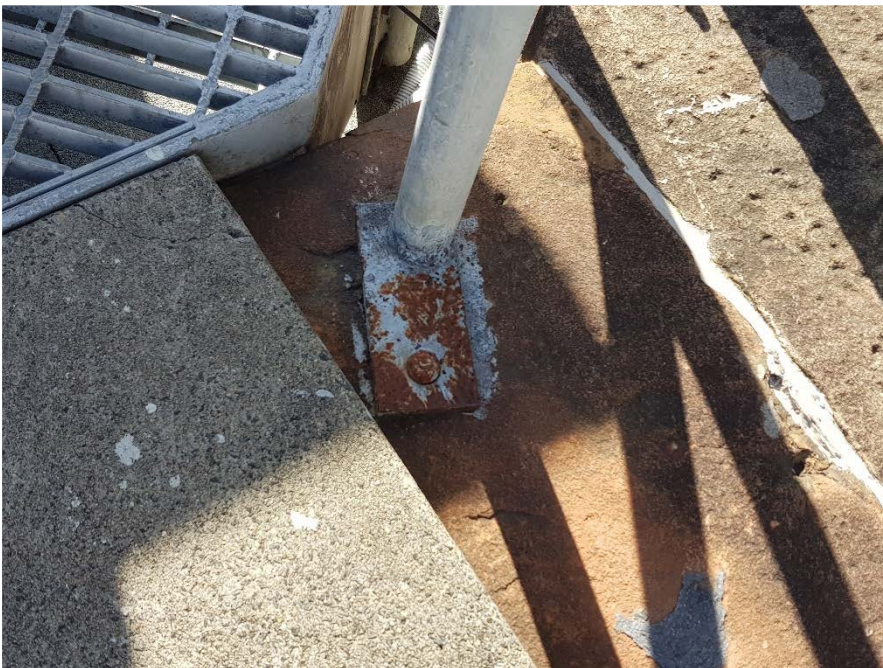
Figure 10: Corroded Connection of Access Structure South End

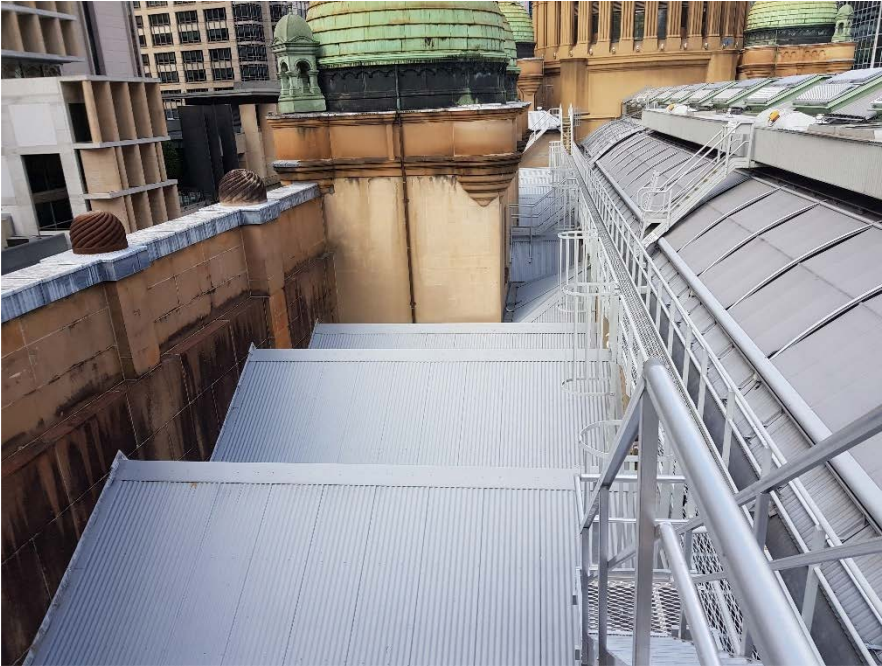
Figure 11: Typical New Access Walkways

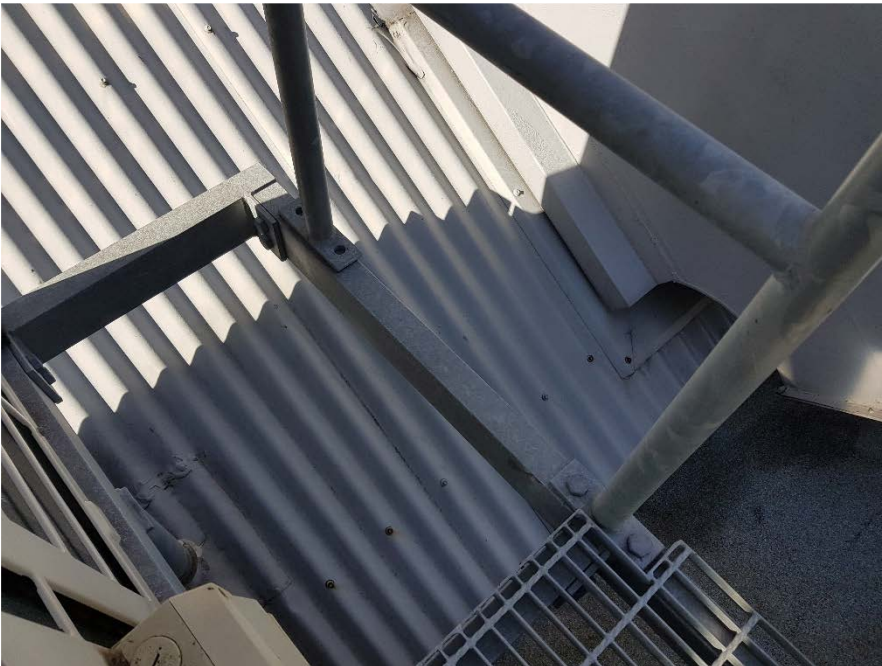
Figure 12: Missing Bolts on Balustrade South End

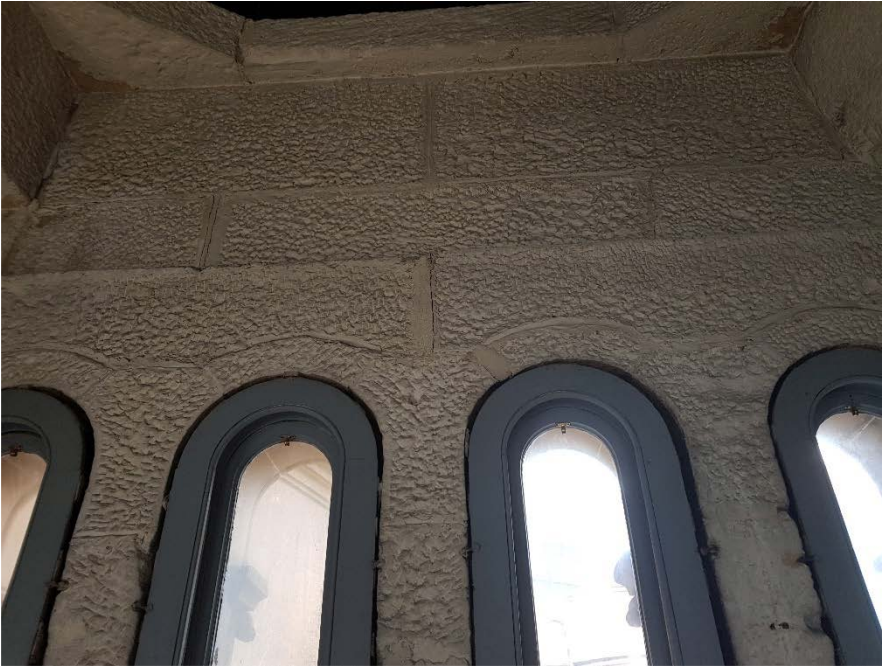
Minor cracking was evident between the joints of the sandstone. Diagonal cracks running from the concrete lintels above the thin windows were common among the small dome structures. Examples photos are shown in Figures 13 to 16.

The crack patterns suggest movement has occurred in the life of the structure, this is not uncommon in buildings of this age and size. The size and pattern of cracking seen does not pose a risk to the structure at this time.

Figure 13: Diagonal Cracking Through Bed Joints Above Windows

- Cracks in the stone walls below the small domes should be documented and monitored to determine whether or not further movement is occurring.
- Repair may be necessary if the stone itself starts cracking or the existing cracks continue to creep or widen.

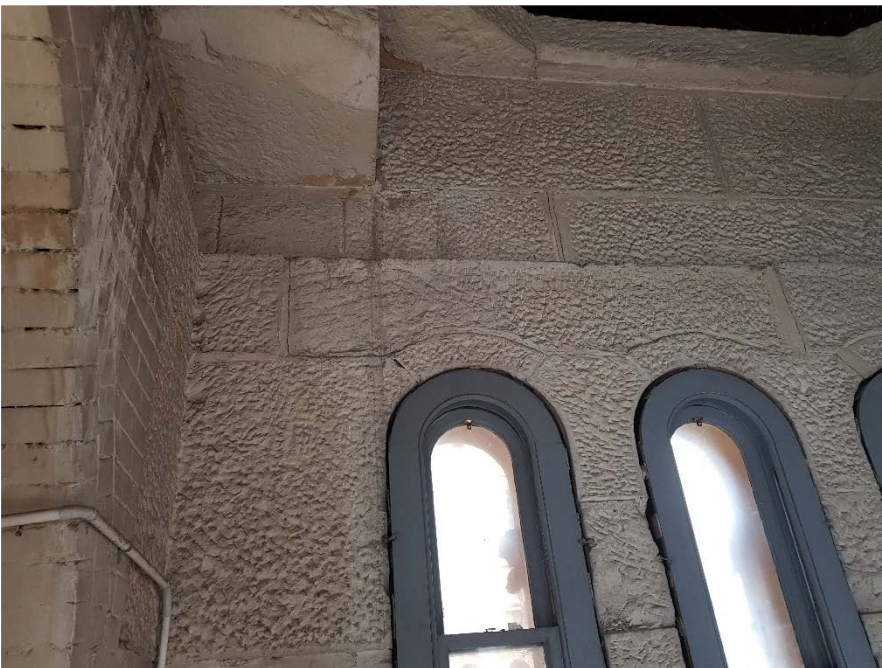
Figure 14: Diagonal Cracking Through Bed Joints Above Windows

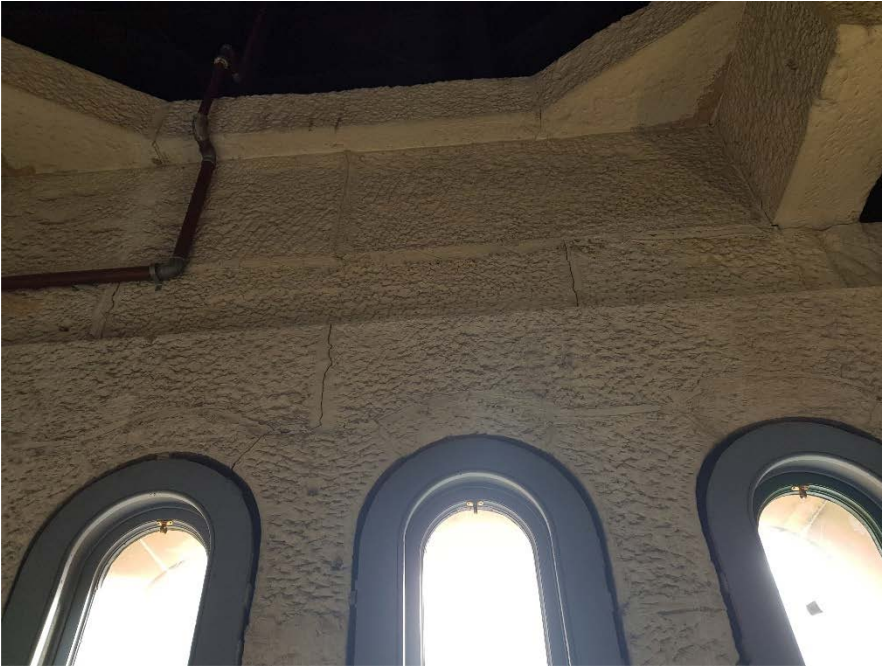
Figure 15: Diagonal Cracking Through Bed Joints Above Windows

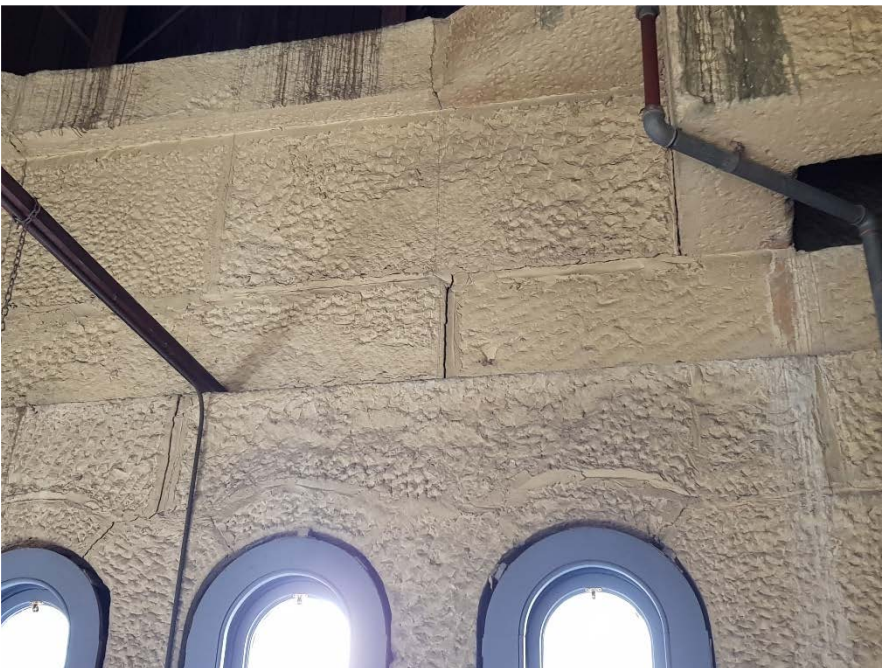
Figure 16: Diagonal Cracking Through Bed Joints Above Windows

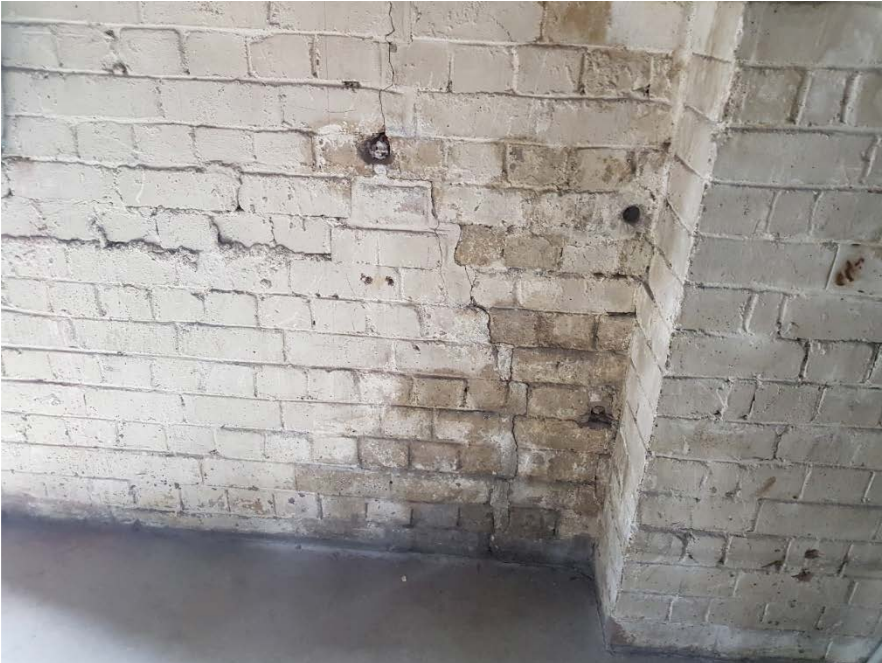
- Redundant fixings in to masonry walls appear to have led to cracks such as those shown in Figures 17 and 20.
- Other cracks appear to be due to minor building movement as the sandstone in Figure 18.
- Several concrete elements suffering spalling and cracking were noted in the roof access area on the west side of the building (just north of the main dome). Refer Figures 21, 24, 25, and 28.

Figure 17: Cracking Around Old Embedded Fixings

- As with the sandstone cracking in Section 2.3, cracks throughout the building should be documented and monitored to determine if further movement is occurring. Cracks continuing to grow should be assessed and repaired if necessary.
- The crack in the column in the roof access area on the west side of the building, just north of the main dome (Figure 24) should be assessed by a structural engineer
- Spalling concrete elements in this area (including figure 25) should be repaired and the area should be assessed for leaks which may be causing damage to structure.

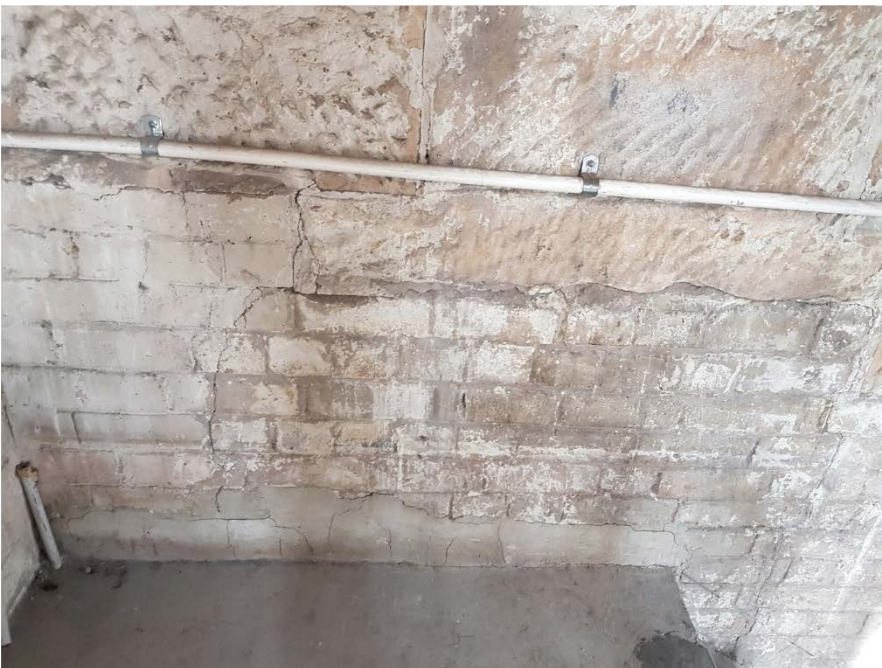
Figure 18: Vertical Cracking at Sandstone Brick Interface

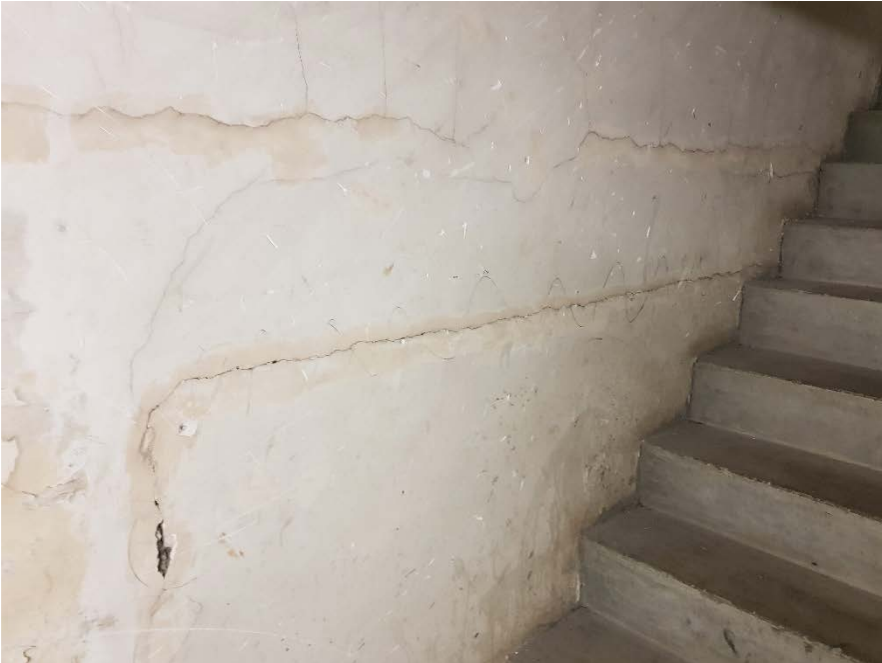
Figure 19: Cracking in Northern Fire Escape Walls

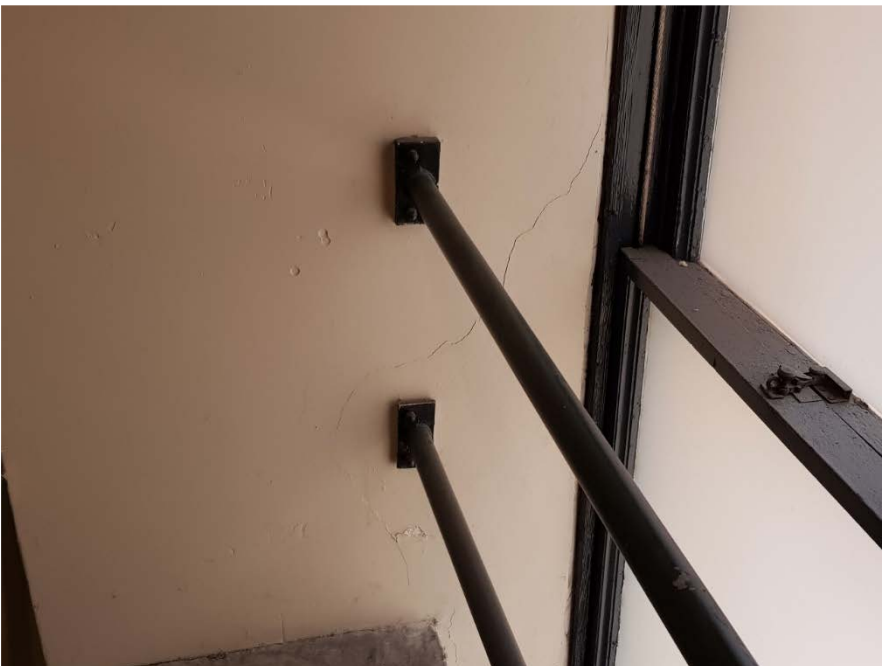
Figure 20: Cracking Around Railing Fixings

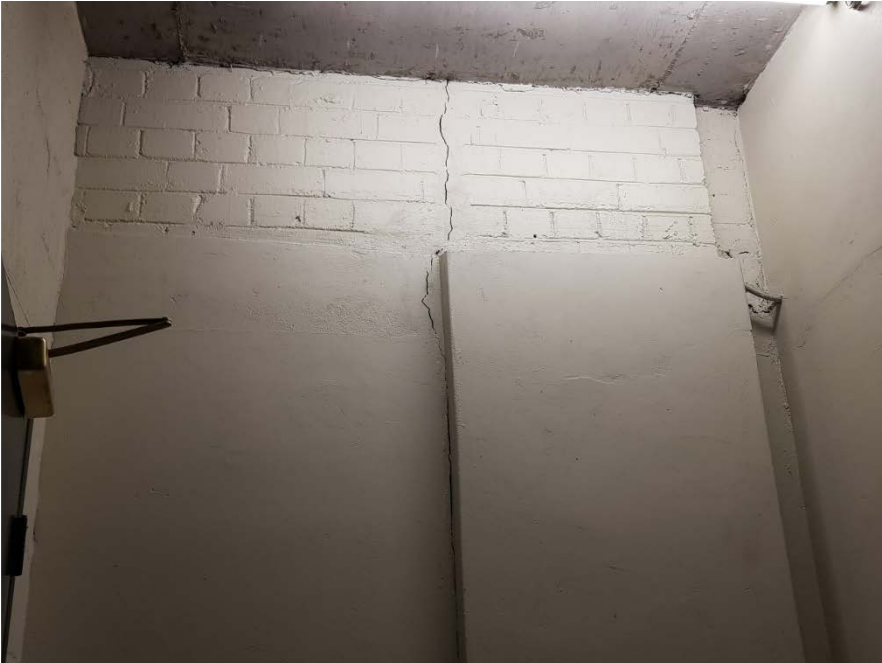
Figure 21: Vertical Cracking in Masonry

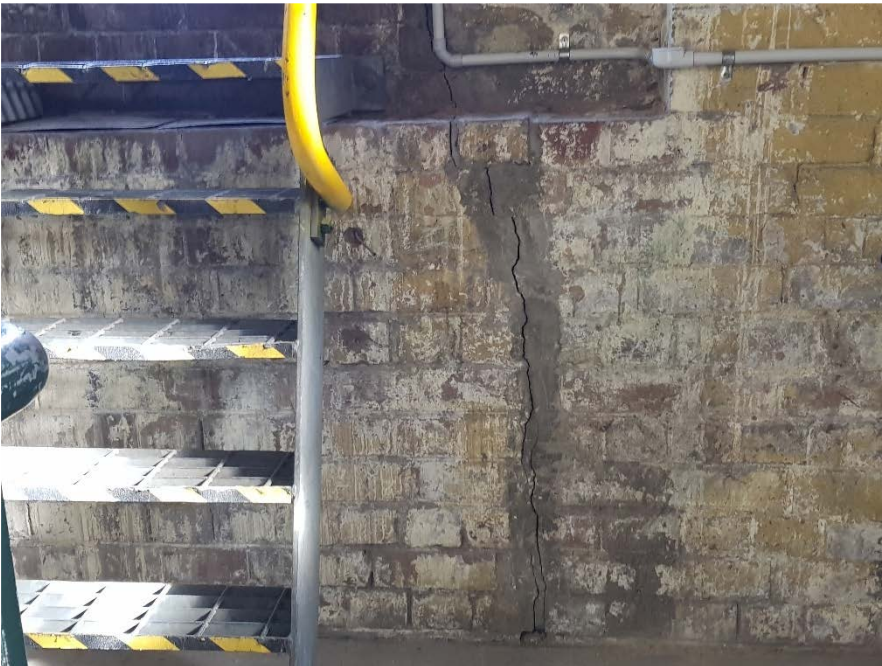
Figure 22: Vertical Cracking in Masonry

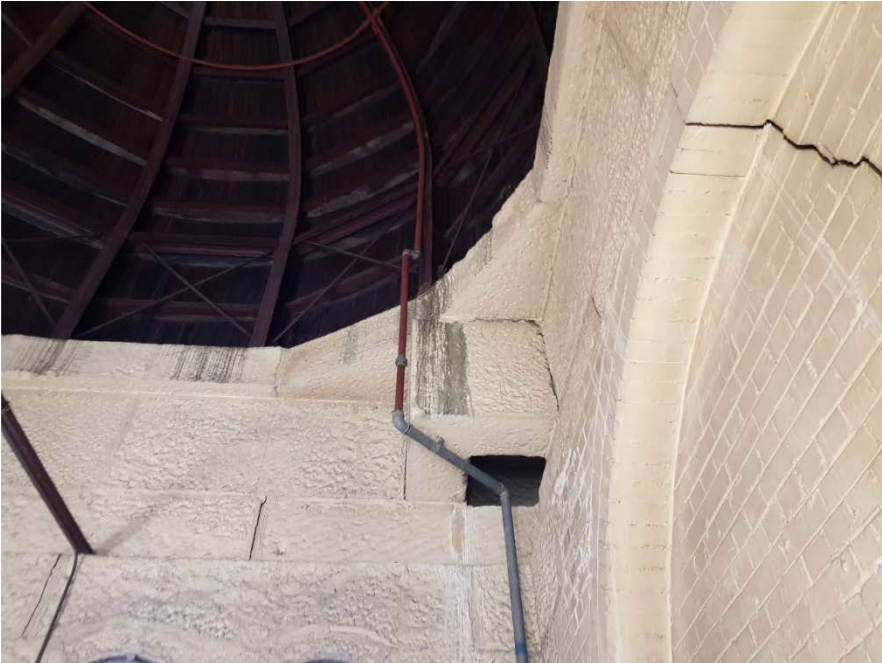
Figure 23: Vertical Cracking in Dome Masonry

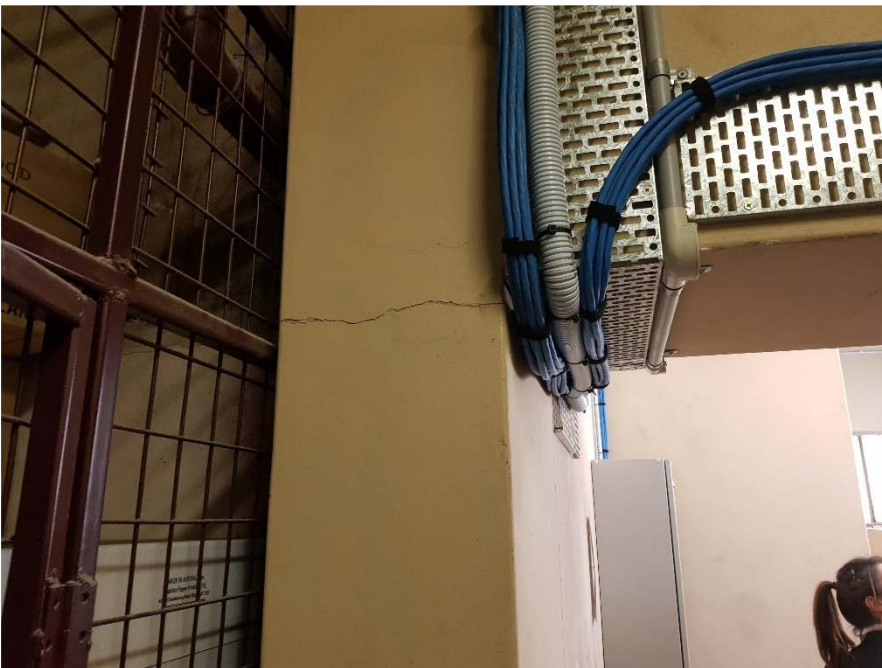
Figure 24: Horizontal Crack in Column

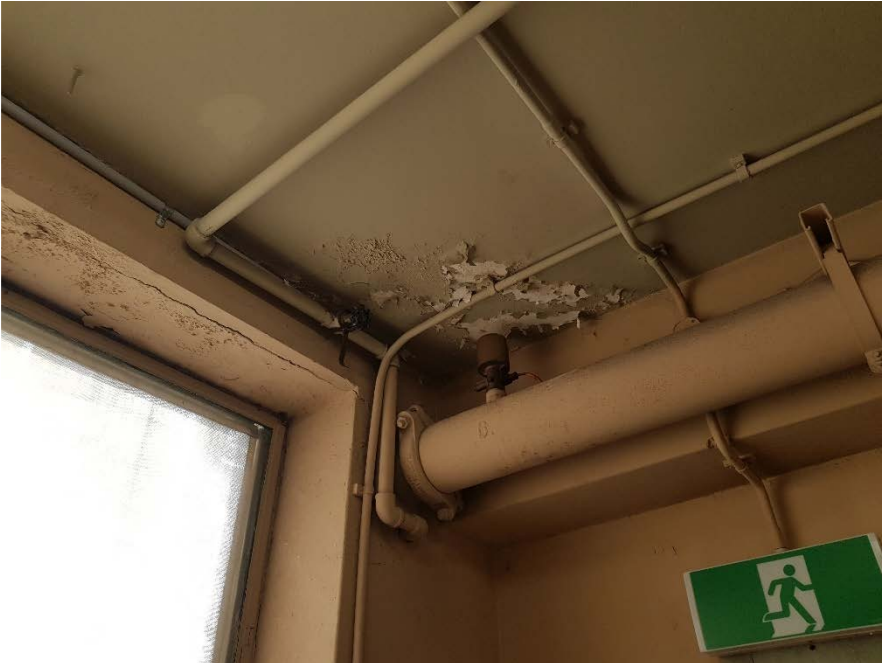
Figure 25: Cracking in Lintel

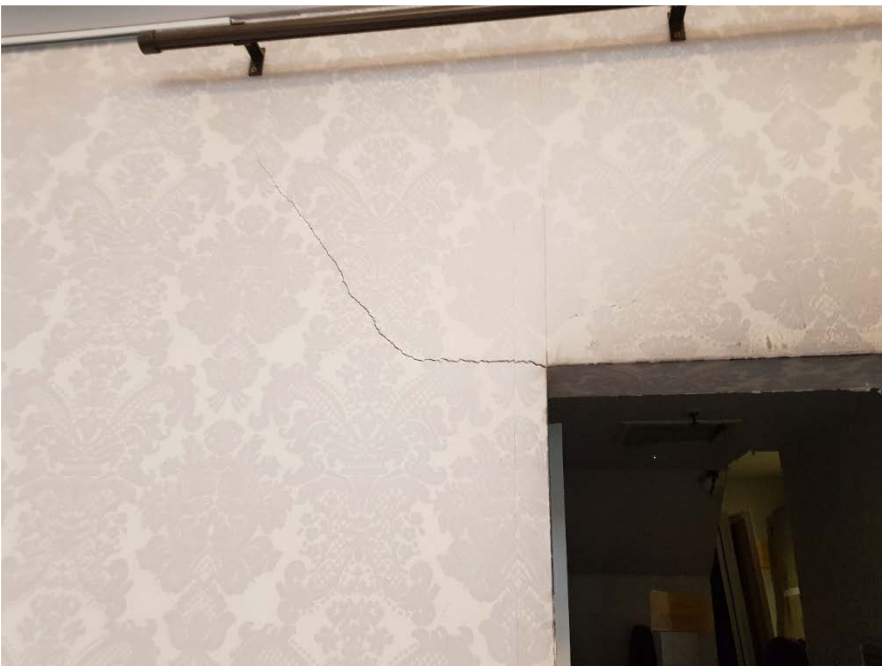
Figure 26: Diagonal Cracking in Tea Room Lintel

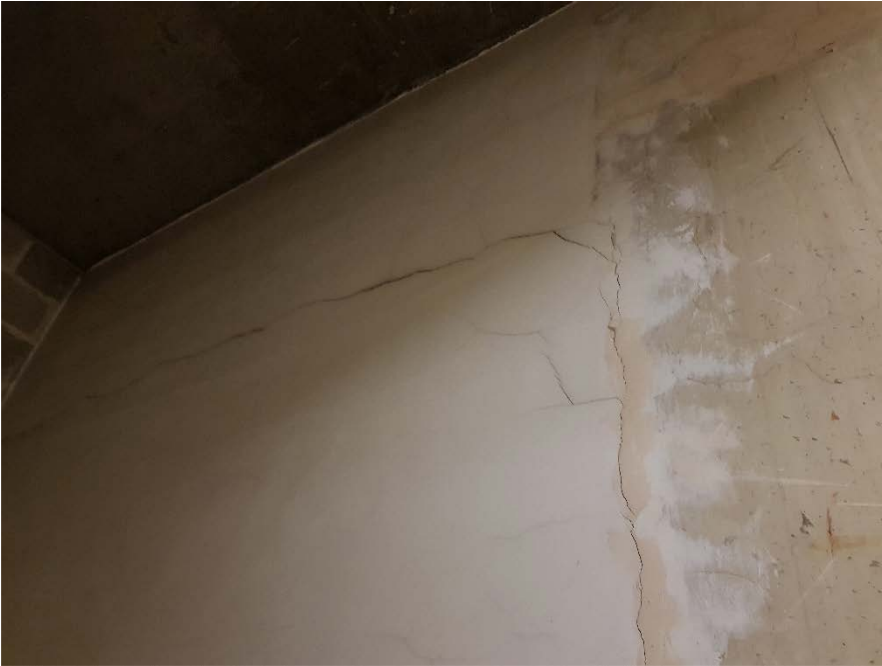
Figure 27: Fire Escape Cracking

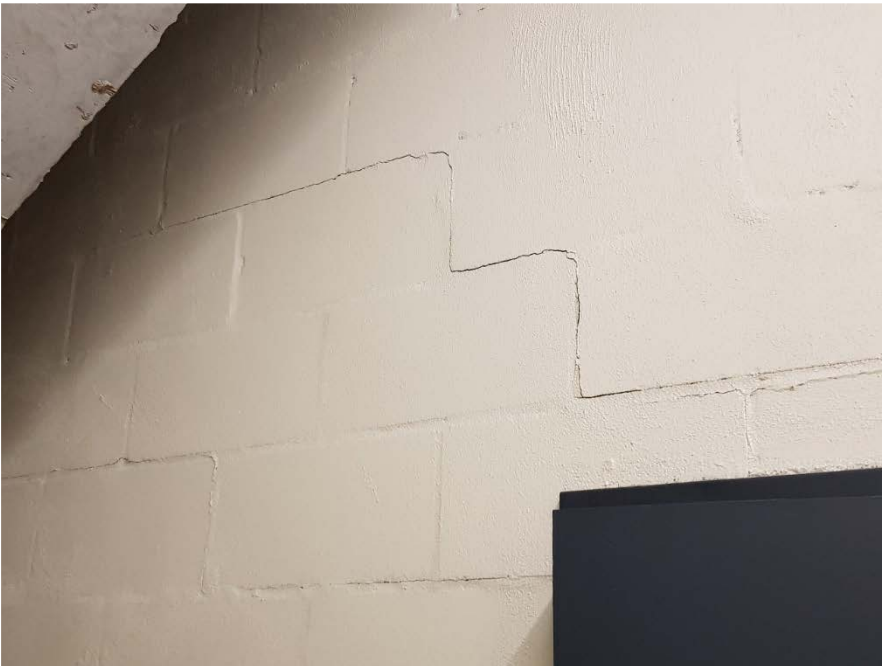
Figure 28: Diagonal Cracking Above Fire Escape Door Opening

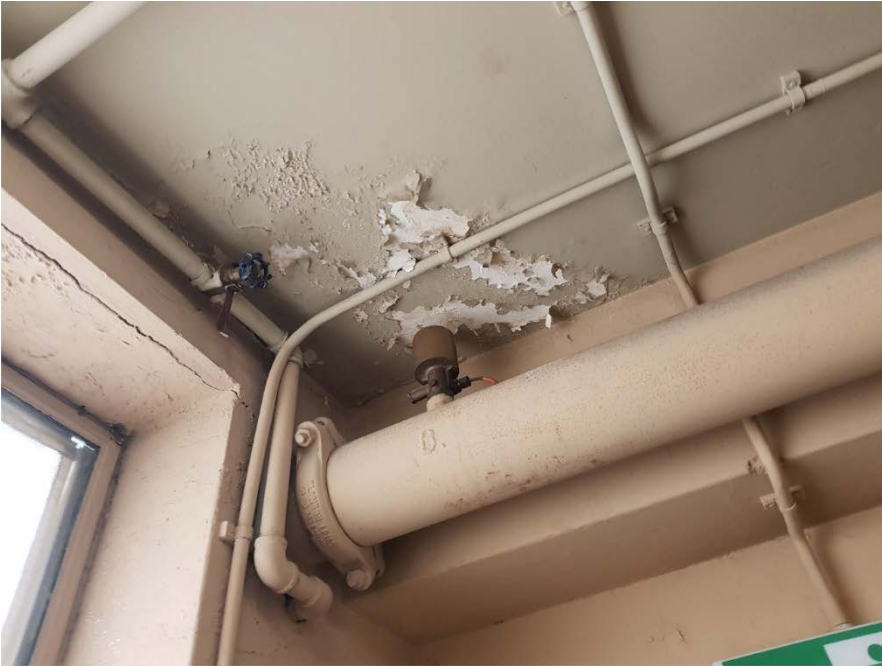
Figure 29: Spalling Concrete

- If left unchecked leaks can lead to damp, corrosion, and spalling. Regular building maintenance should be carried out to prevent leaking.
- Checking the drainage in the area of the flat roof at the southern end of the building for leaks (Figure 33).

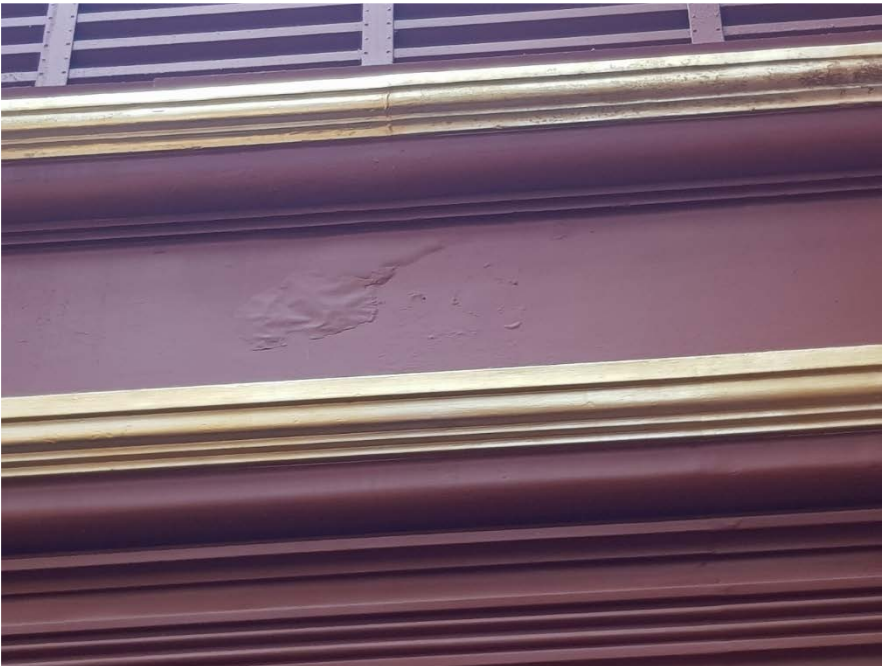
Figure 30: Signs of Water Ingress On Tea Room Entrance Roof

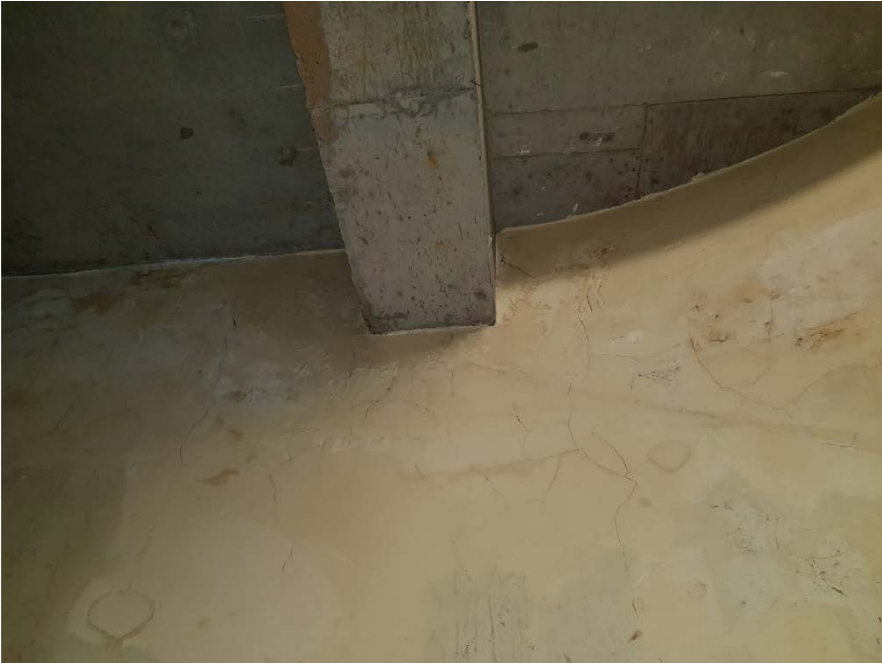
Figure 31: Damp Walls in Fire Escape

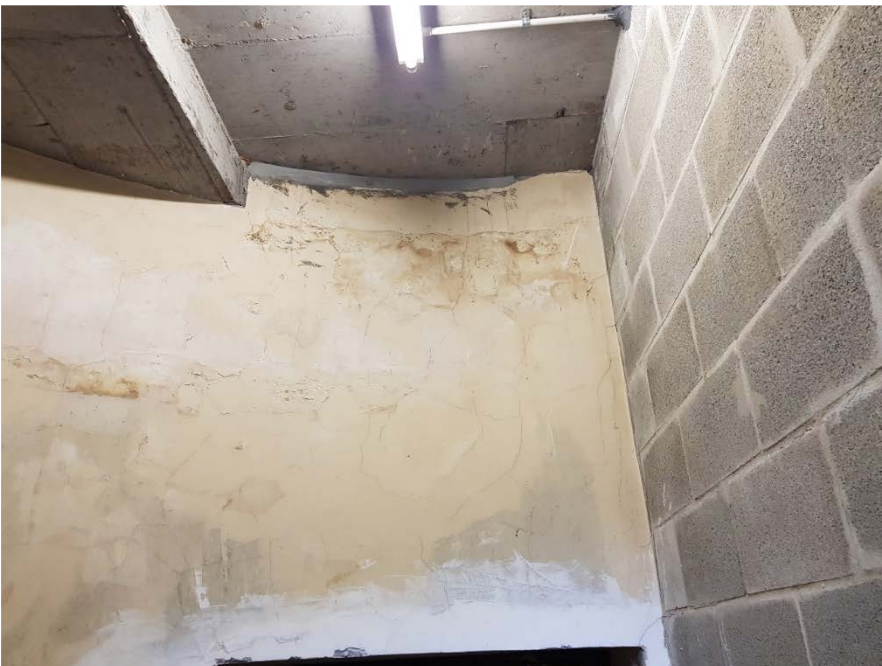
Figure 33 shows ponding in a section of flat roof on the Southern end of the building. It is likely this has led to the damp walls shown in Figures 32 and 34 which lie directly below the roof.

Figure 32: Damp Fire Escape Walls Under North West Flat Roof

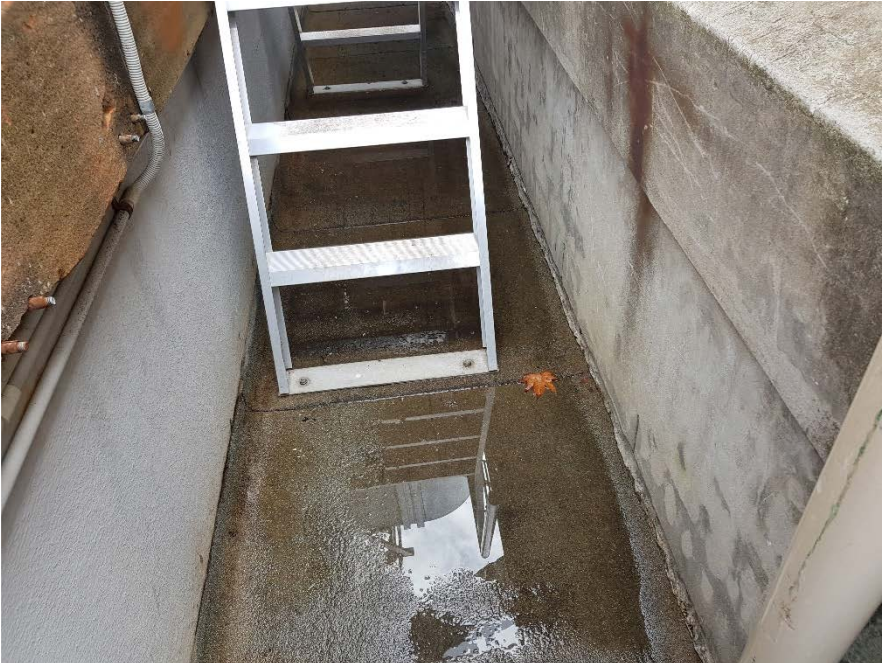
Figure 33: Ponding Water on North East Flat Roof

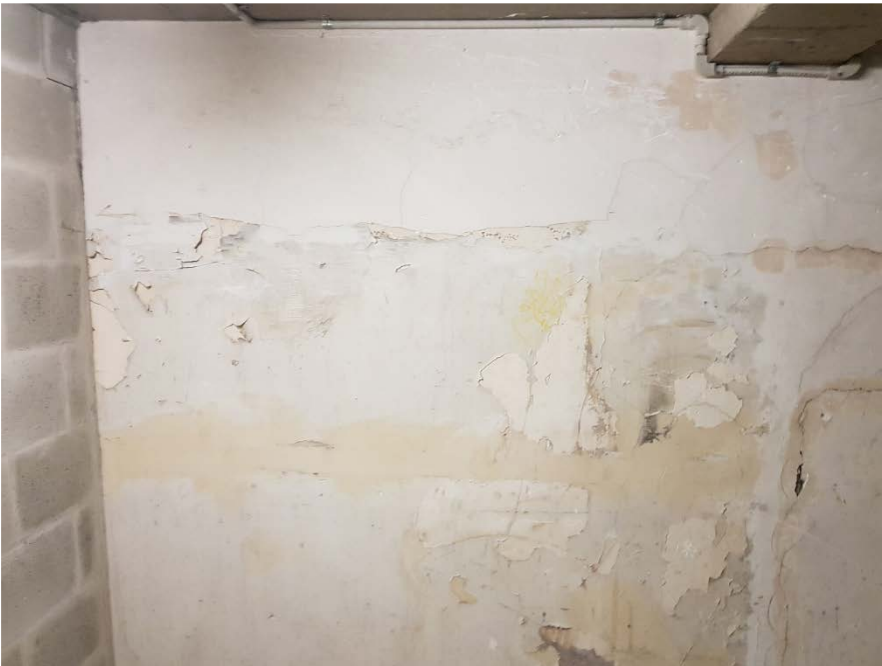
Figure 34: Damp Fire Escape Walls Under North West Flat Roof

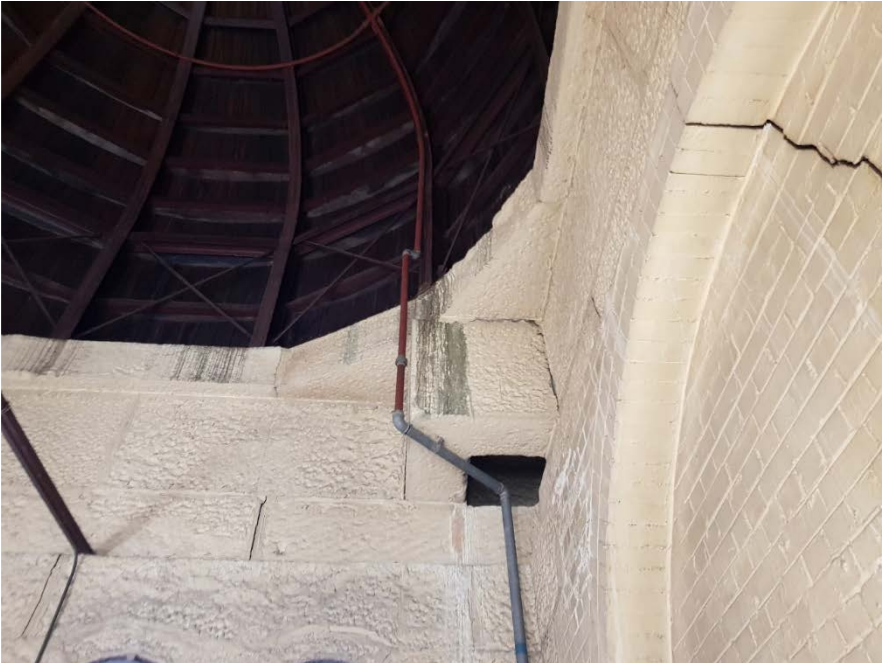
Figure 35: Water Staining From Dome Roof

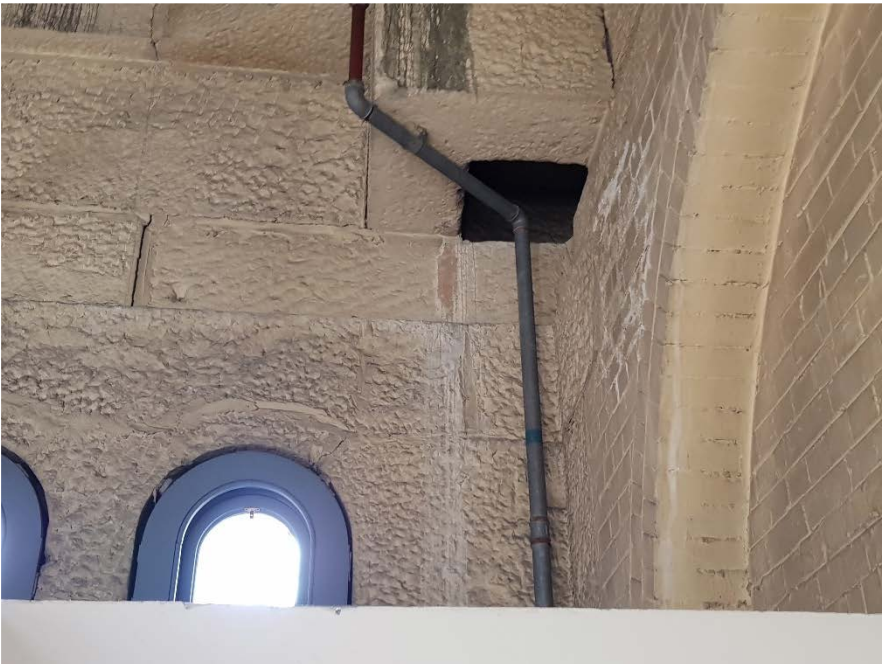
Figure 36: Water Staining From Dome Roof

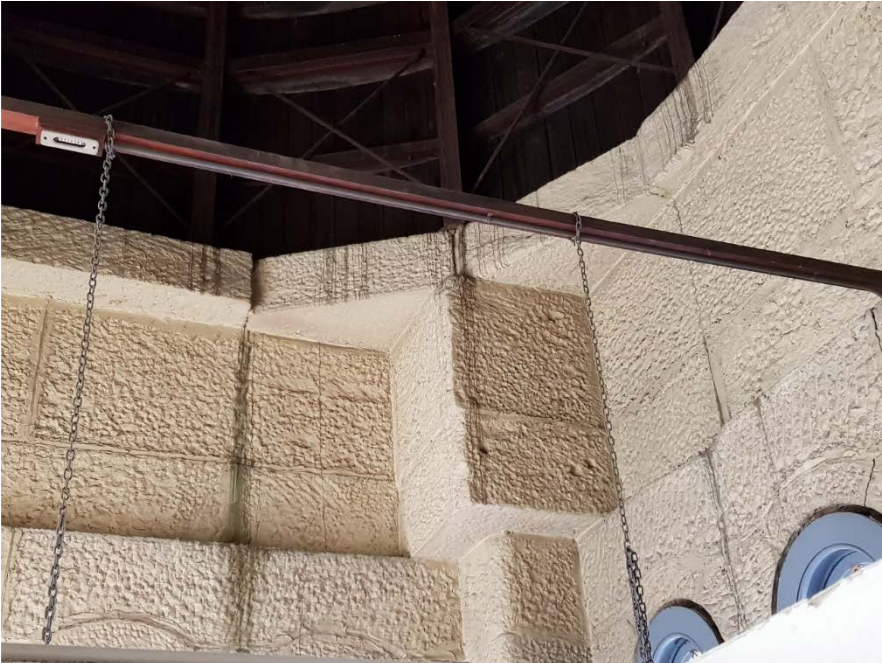
Figure 37: Water Staining From Dome Roof
