Queen Victoria Building Condition Assessment

23 July 2018

Document reference: 399302 | 1 | A

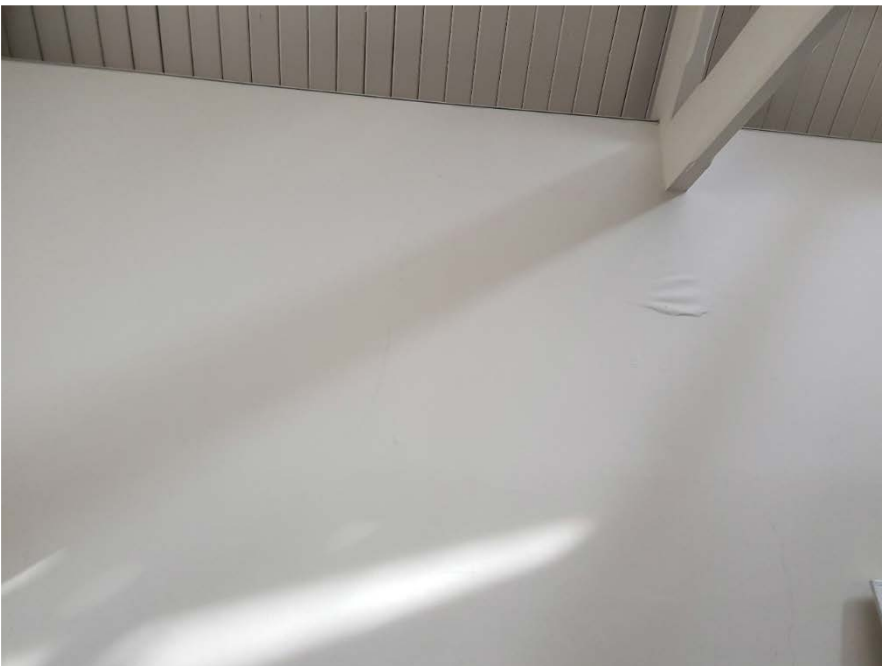
Figure 38: Signs of Water Ingress From The Victoria Room Roof

- If left unchecked leaks can lead to damp, corrosion, and spalling. Regular building maintenance should be carried out to prevent leaking.
- Checking the drainage in the area of the flat roof at the southern end of the building for leaks (Figure 33).

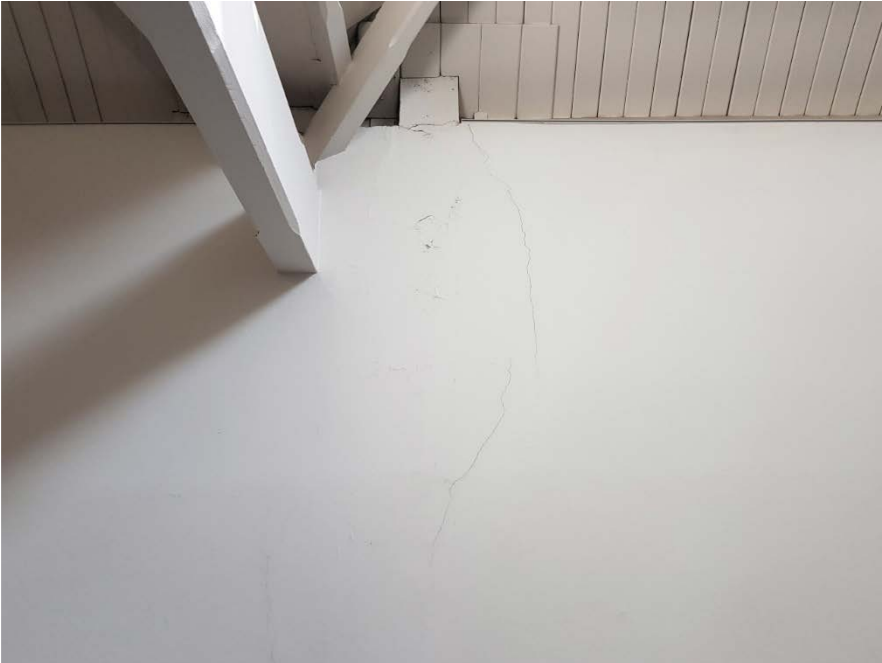
Figure 39: Signs of Water Ingress From The Victoria Room Roof

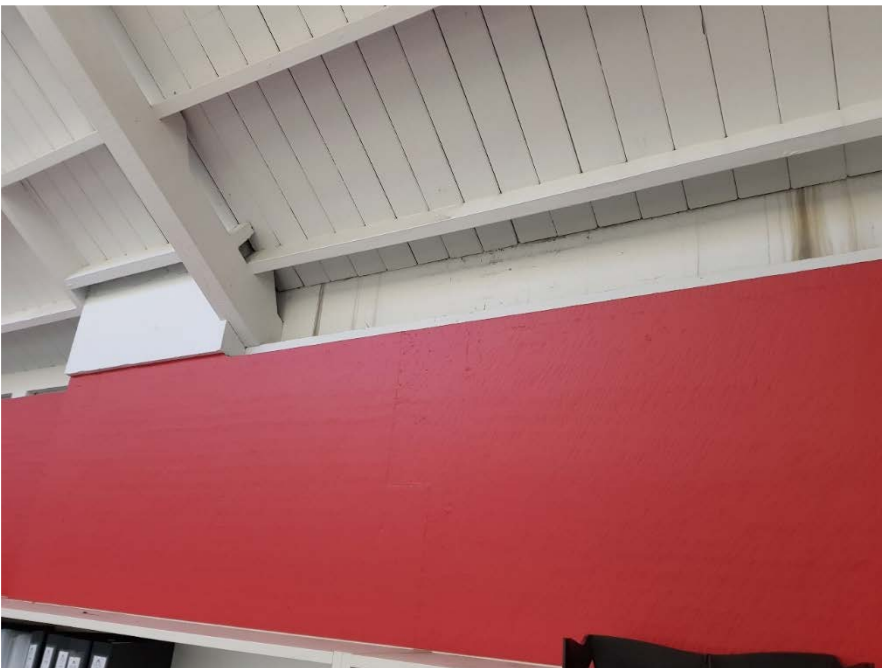
Figure 40: South East Meeting Room Water Staining

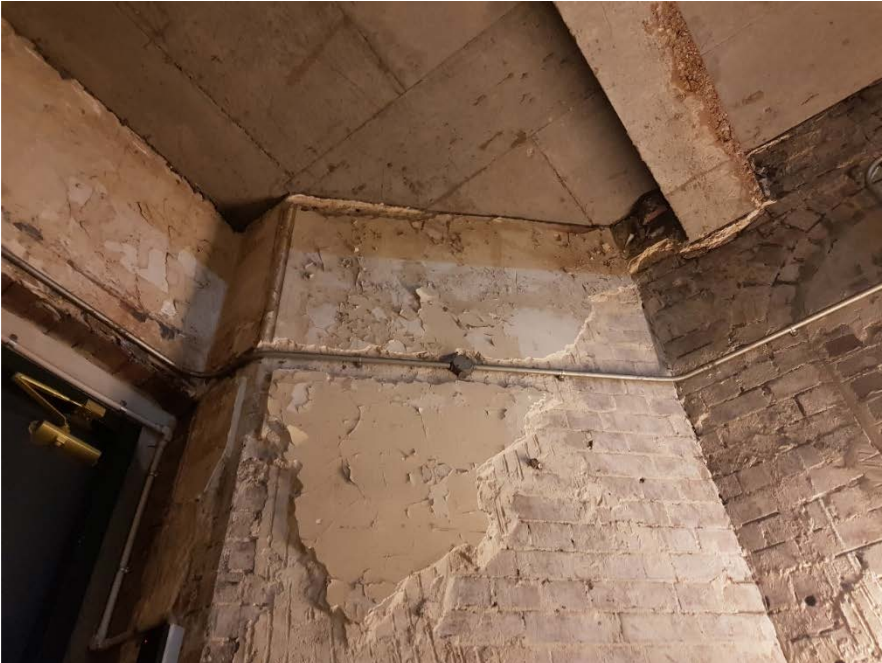
Figure 41: South Fire Escape Damp and Spalling Concrete

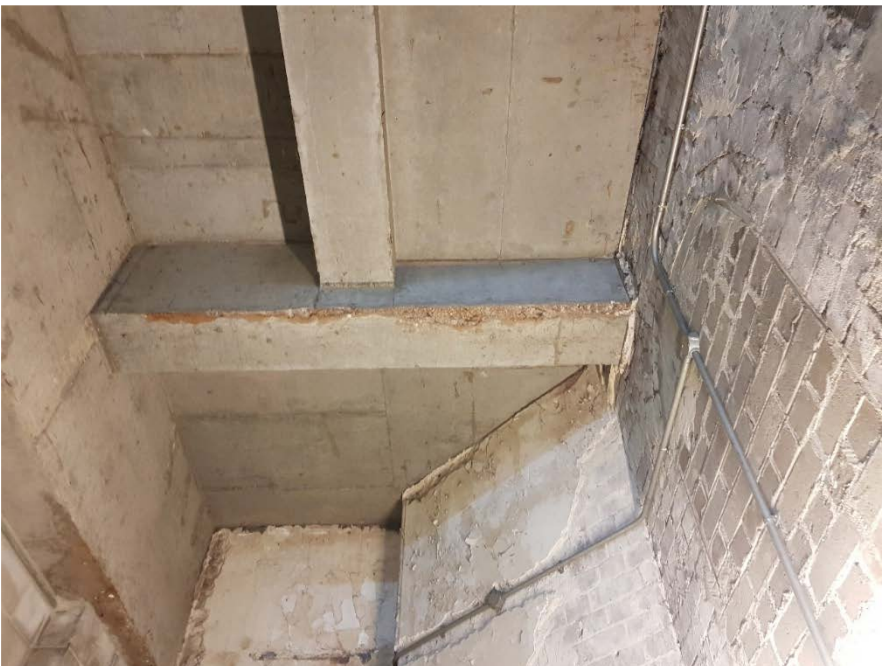
Figure 42: South Fire Escape Damp and Spalling Concrete

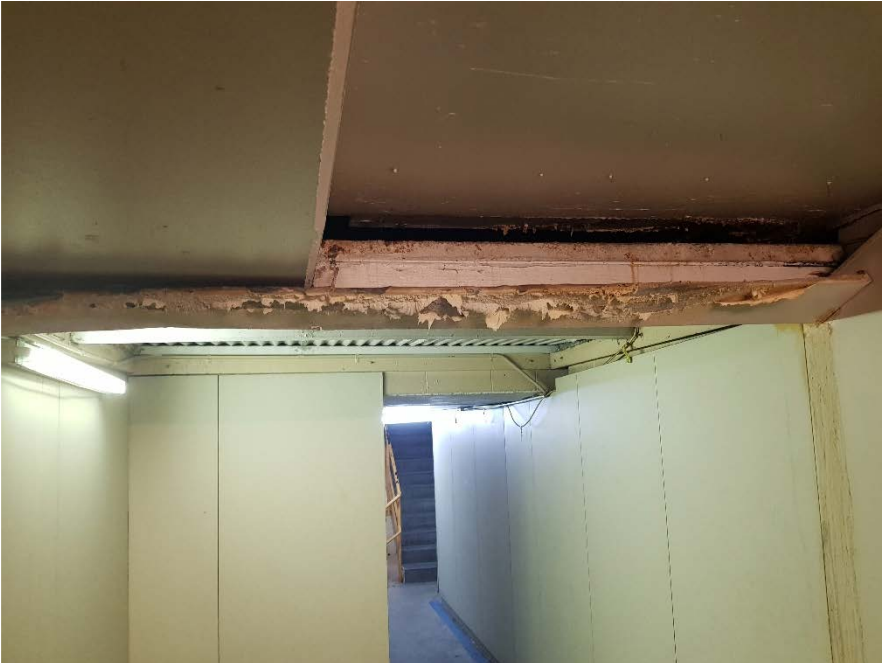
Evidence of water entering through the rock in basement areas was noted. Water can easily move through porous rock such as sandstone. Any contact with the ground without seamless waterproofing can cause leaking. Areas where sub-ground leaking is occurring is shown in Figures 43-46.

Figure 43: Water Staining Around Lower Ground Gutter in Service Corridor

- A survey of basement areas be carried out by building maintenance to identify areas of water ingress and areas where such ingress poses a risk to structure (damp, corrosion etc)

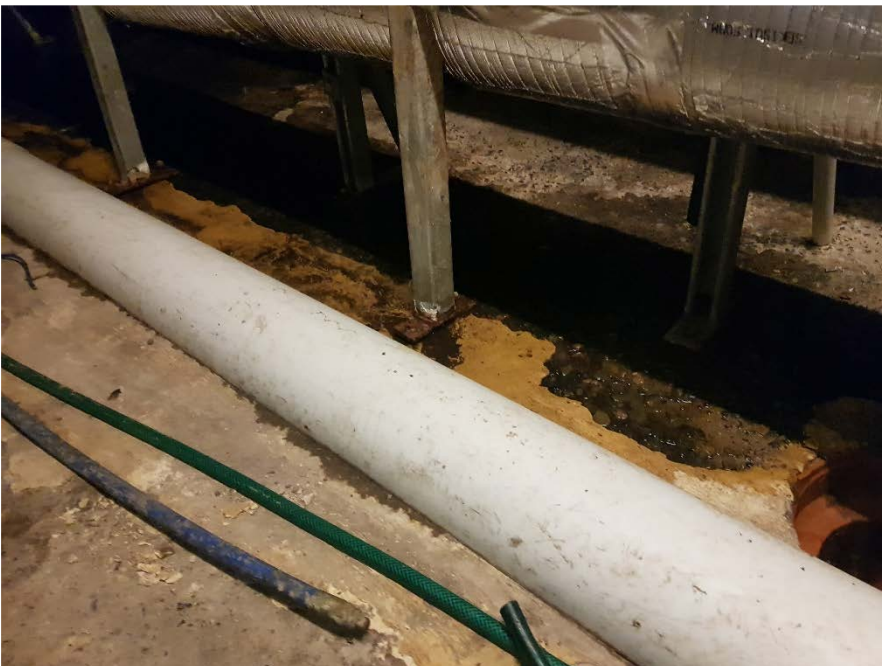
Figure 44: Ponding Water in Lower Ground Service Corridor

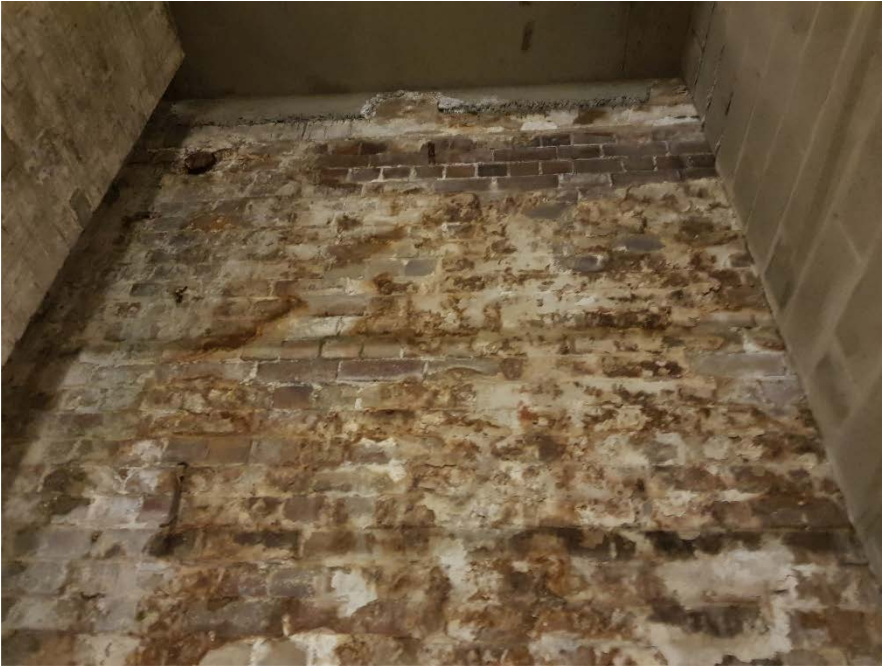
Figure 45: Damp Wall in Lower Ground Fire Escape

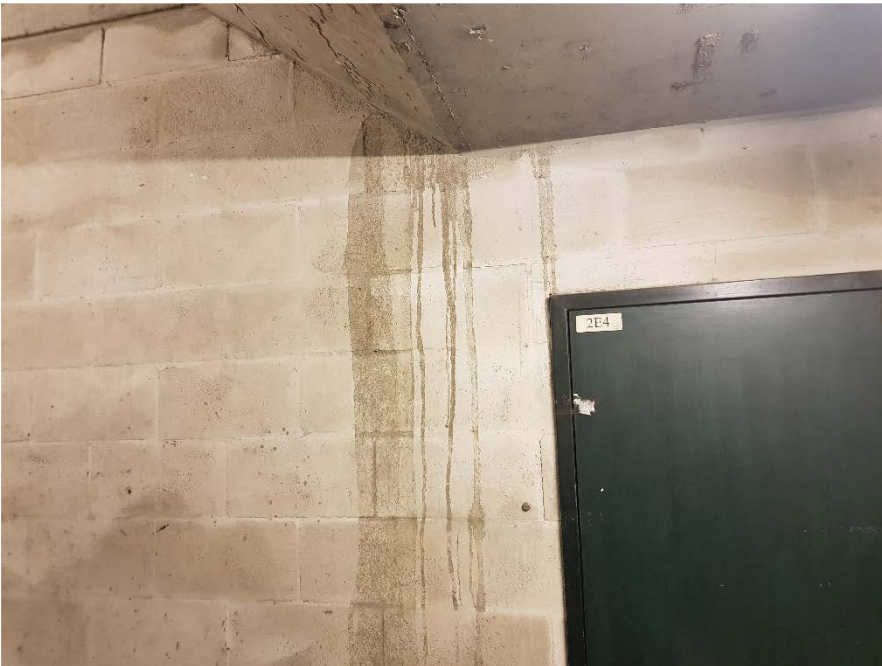
Figure 46: Signs of Water Ingress in Lower Ground Fire Escape

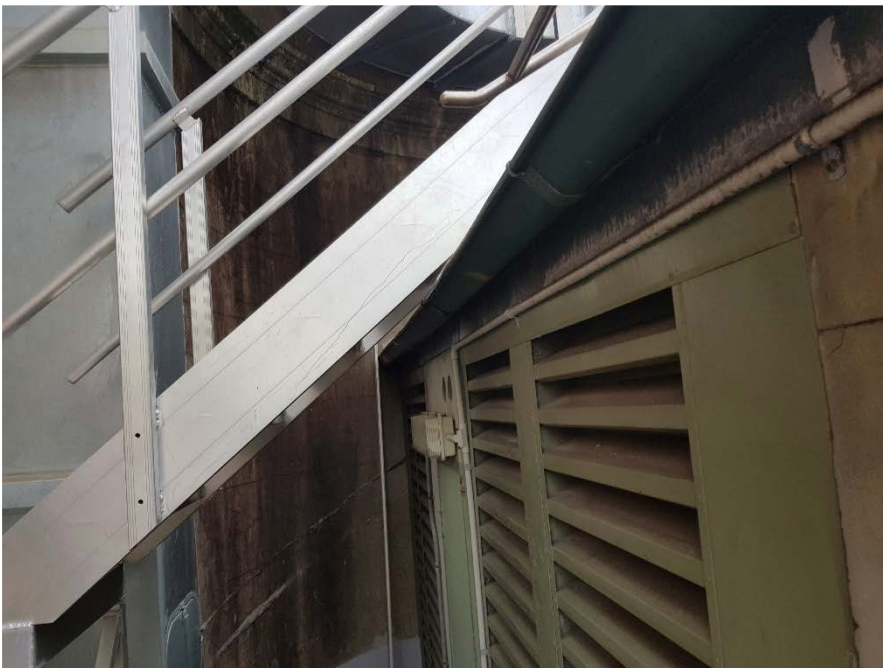
Figure 50: Bowing Gutter Above North West Flat Roof

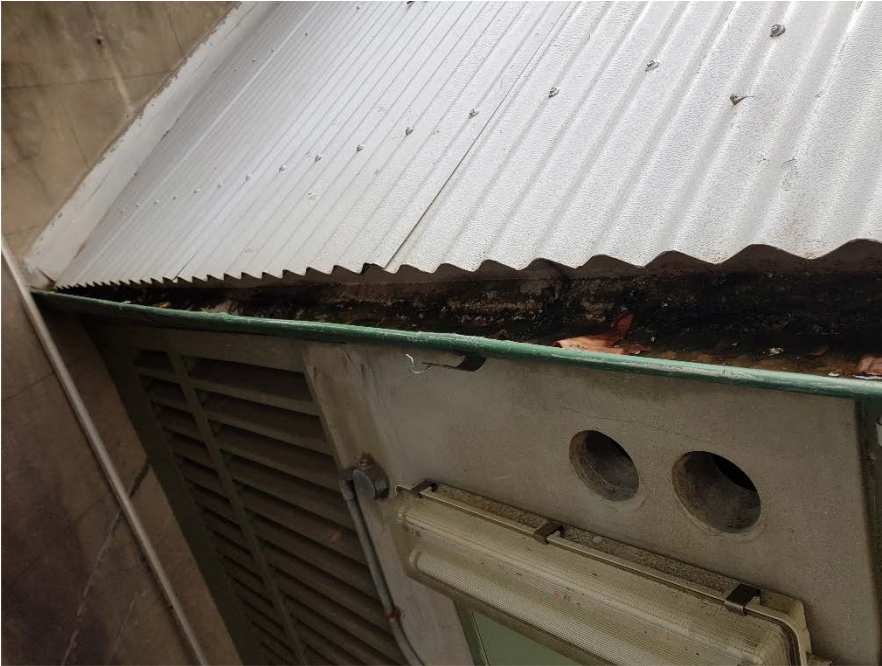
Figure 51: Broken Fixing on Gutter Above North West Flat Roof
