Hazardous Materials Management Plan

Harry Jensen Activity Centre
2 Watson Road, Millers Point, 2000
10th March 2020

Hazardous Building Materials Survey

Report Title: Hazardous Building Materials Survey
Prepared for: Ventia Pty Ltd
Project Address: 2 Watson Road, Millers Point NSW 2000
File Reference: VEN-01-17187
Report Reference: ADE-17187-Harry Jensen Centre
Date: 05.05.2020

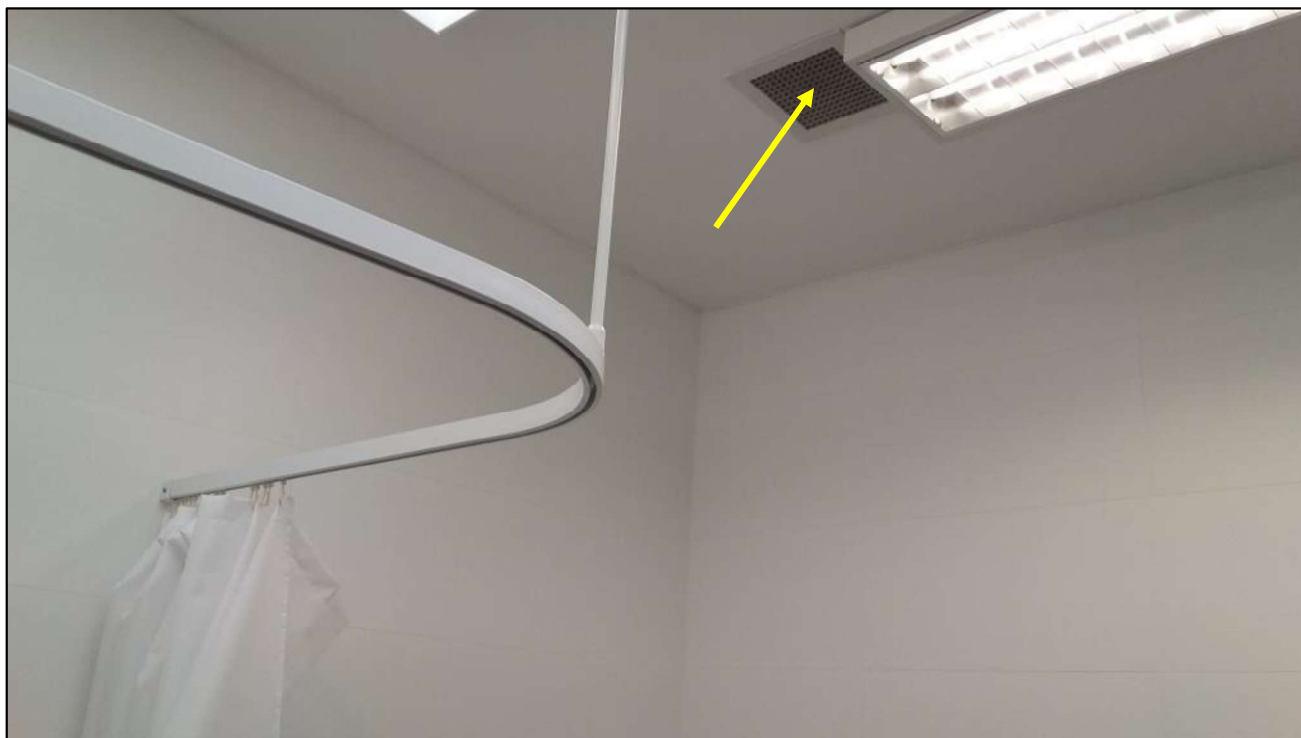
Photo 1: Interior, male bathroom, ceiling space, air conditioning ducting presumed to contain SMF insulation

Location	Material	Risk Score	Recommendation
Interior, male bathroom, ceiling space	Ac ducting	Low	Leave and maintain in current condition, remove prior to refurbishment or demolition. For further information refer to Section 4.

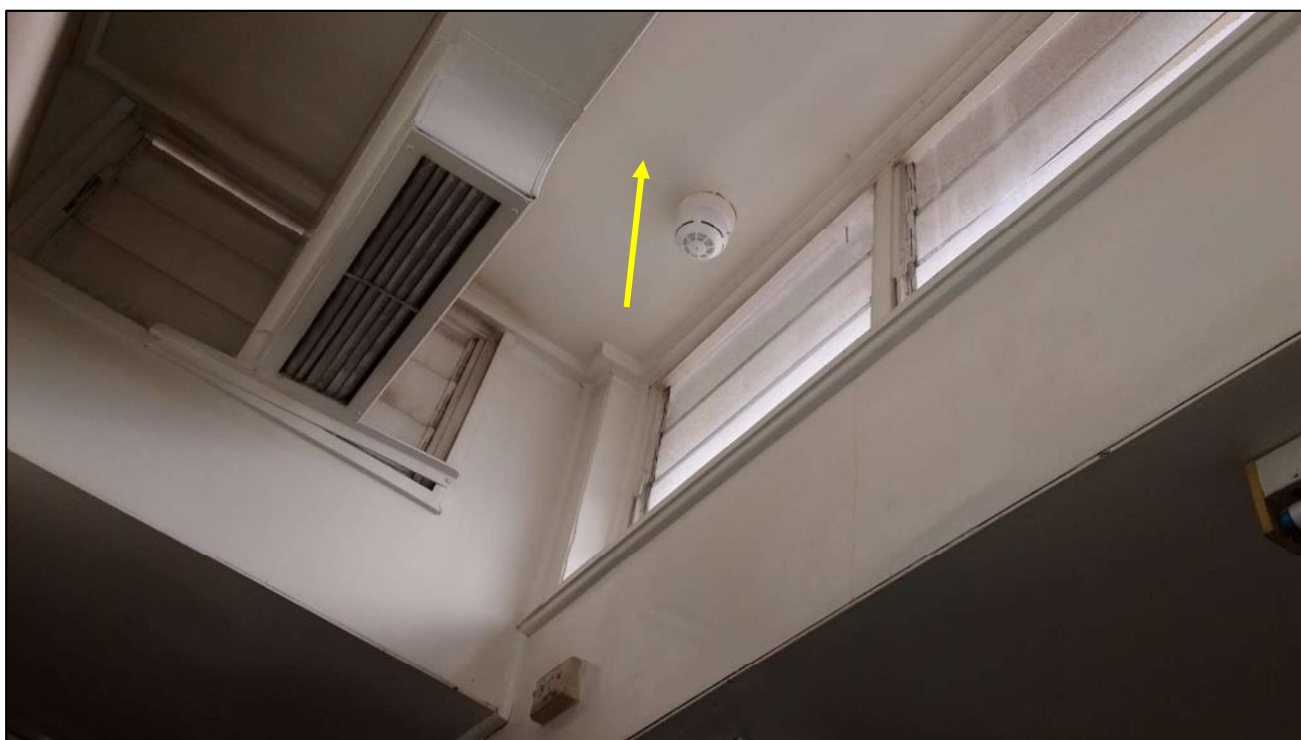
Photo 2: Interior, kitchen, ceiling panels, lead based white paint system

Location	Material	Risk Score	Recommendation
Interior, kitchen, ceiling panels	White paint system	Low	Leave and maintain in current condition. For further information refer to Section 4.
Interior, sink area adjacent kitchen, walls	Light purple paint system	Low	Leave and maintain in current condition. For further information refer to Section 4.
Laundry and bathroom building, walls	White paint system	Low	Leave and maintain in current condition. For further information refer to Section 4.

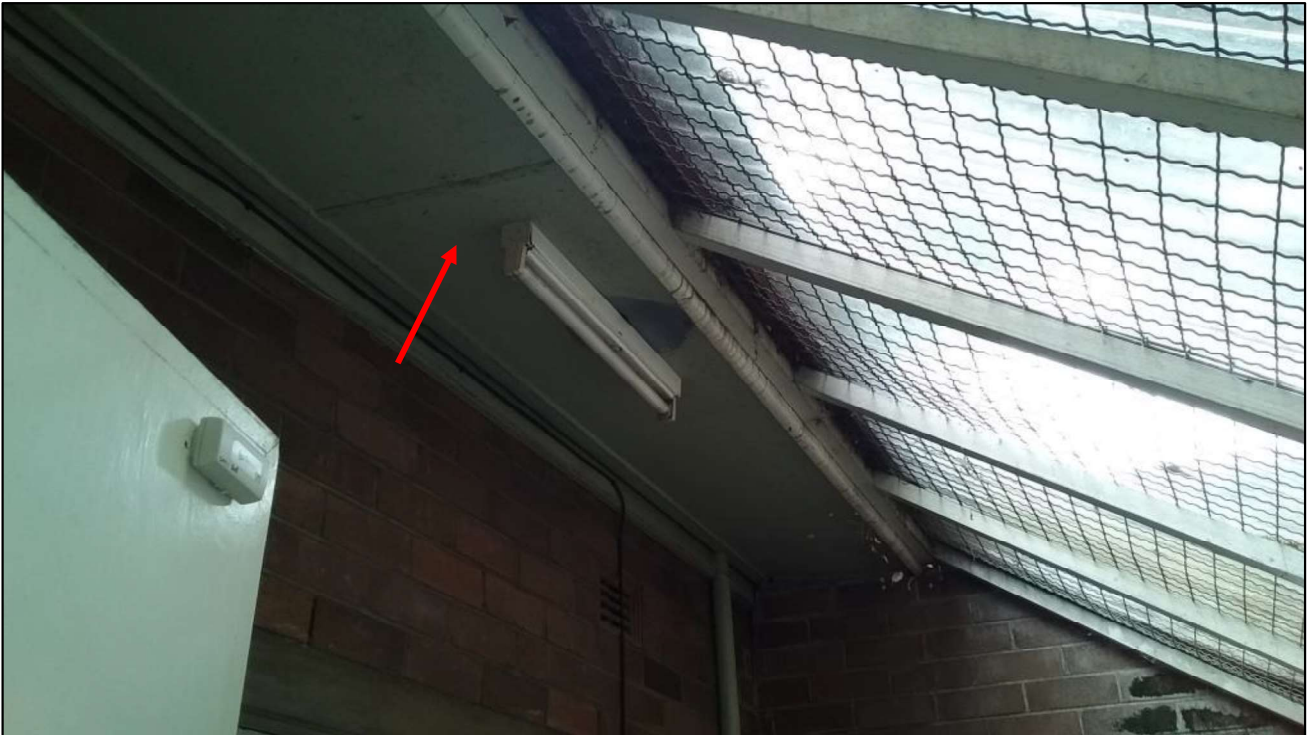
Photo 3: Interior, kitchen, eaves exterior panels (extends through kitchen above cupboards) containing asbestos

Location	Material	Risk Score	Recommendation
Kitchen, eaves exterior panels (extends through kitchen above cupboards)	Asbestos cement eaves	Low	Leave, label and maintain in the current condition. For further information, refer to Section 4.
Laundry and bathroom building, ceiling	Fibre cement sheeting	Low	Leave, label and maintain in the current condition. For further information, refer to Section 4.
Interior, kitchen, vents, electrical duct heating	Electrical duct heating	Low	Leave, label and maintain in the current condition. For further information, refer to Section 4.

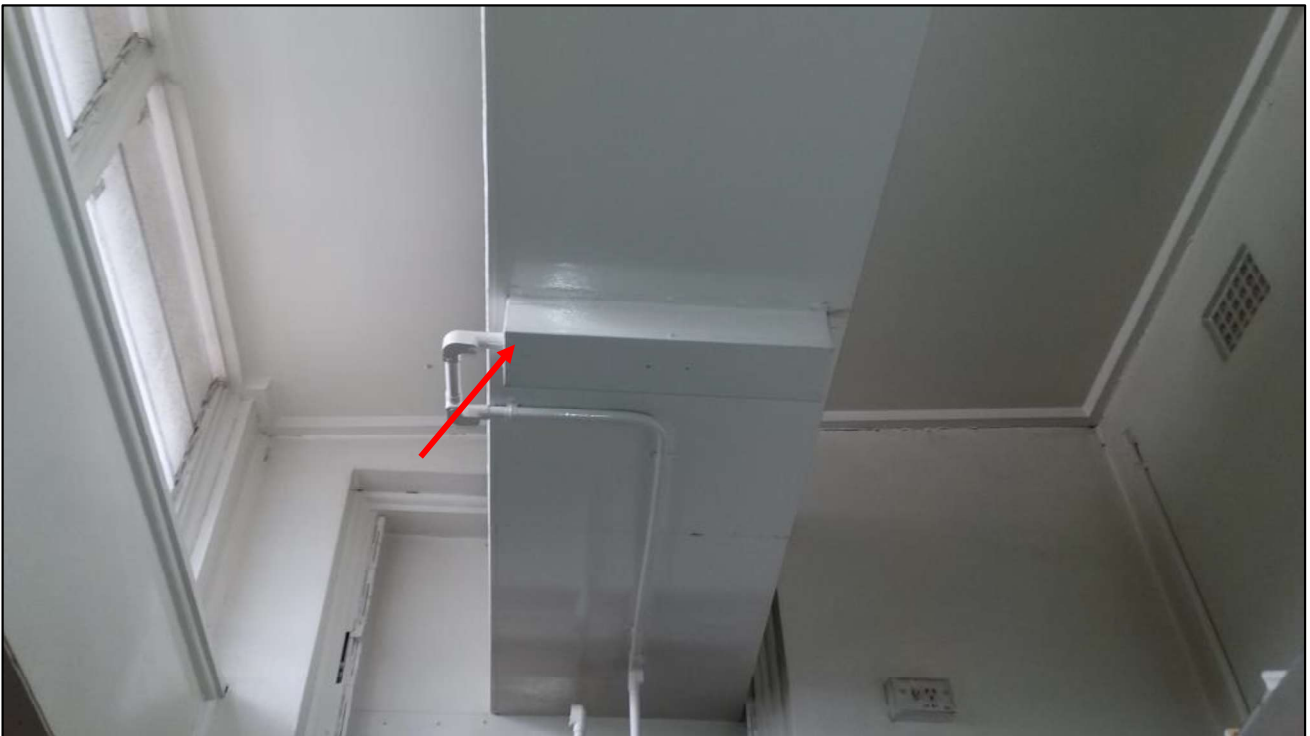
Photo 4: Interior, kitchen, vents, electrical duct heating with asbestos presumed present

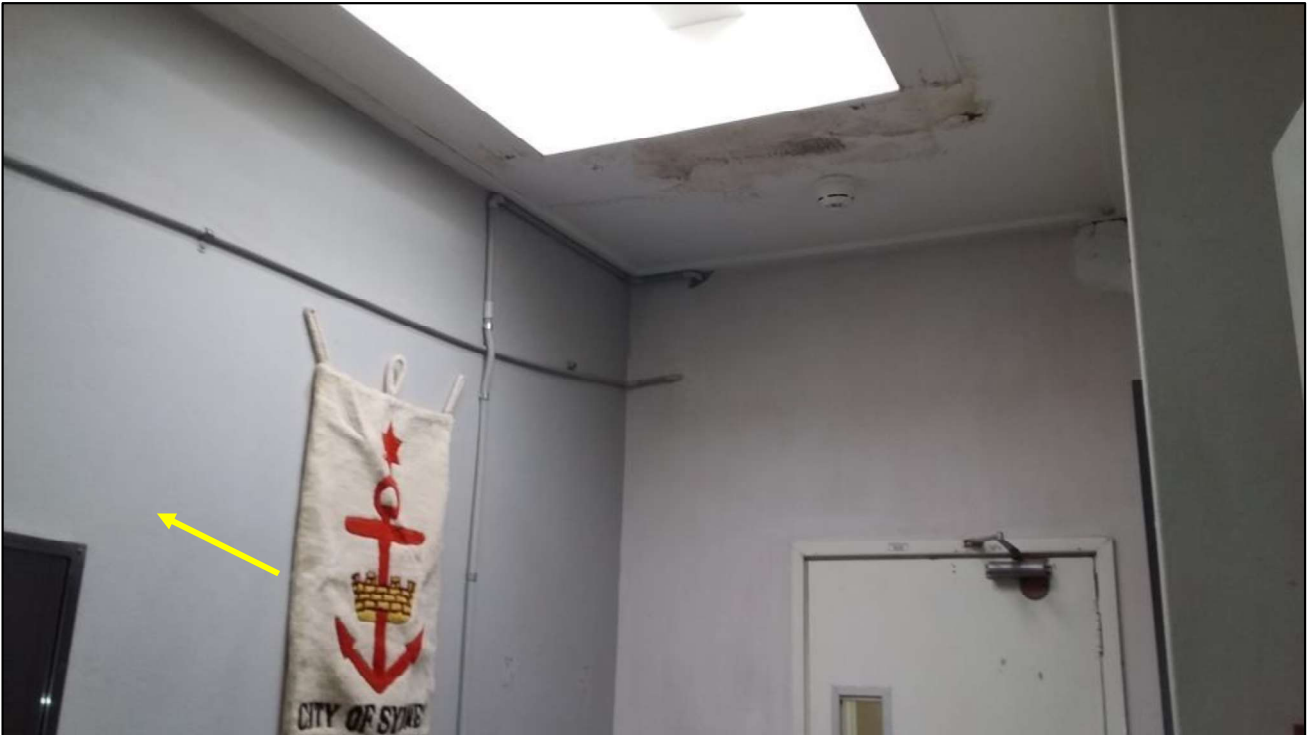
Photo 5: Interior, sink area adjacent kitchen, walls, light purple paint system containing lead

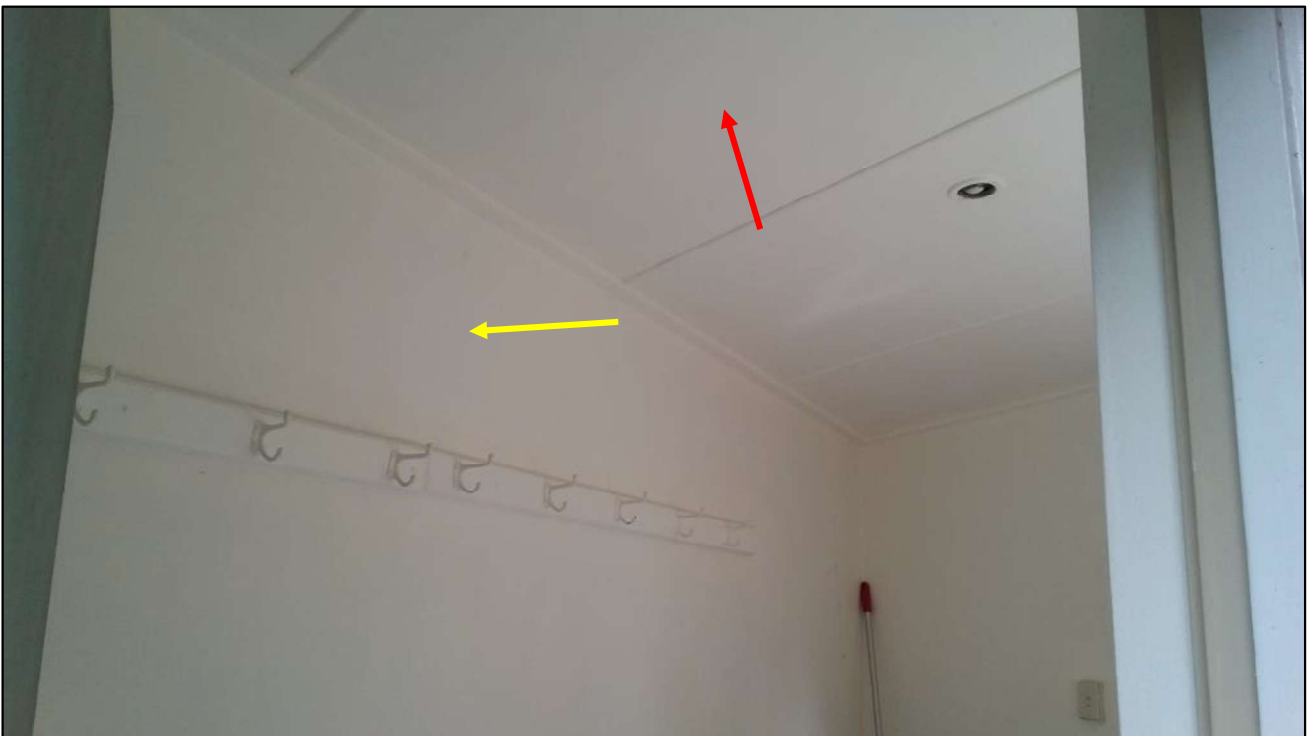
Photo 6: Interior, laundry and bathroom building, ceiling, fibre cement sheeting containing asbestos and walls with white paint system containing lead
