Hazardous Materials Management Plan

William Street Holding 1
101-111 William Street, Darlinghurst, 2010
13th March 2020

Hazardous Building Materials Survey

Report Title: Hazardous Building Materials Survey
Prepared for: Ventia Pty Ltd
Project Address: 101-111 William St Darlinghurst
File Reference: VEN-01-17187
Report Reference: ADE-17187- 101-111 William Street holding 1
Date: 07.05.2020

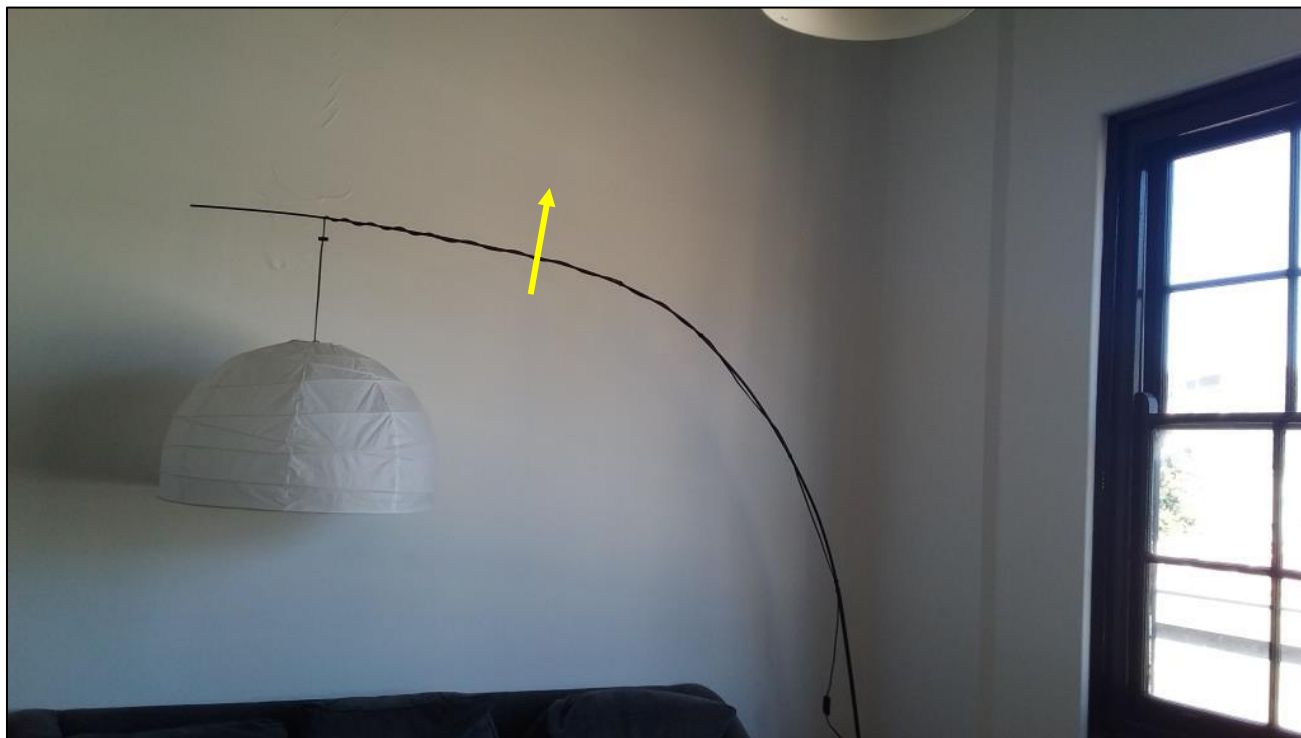
Location	Material	Risk Score	Recommendation
Interior, level 4, rooftop, eaves, walls and fascia	Cream paint system	Low	Paint removal is not required. Maintain in current condition if to remain in situ. Re-inspect periodically. For further information, refer to Section 4.

Photo 1: Representative photo of interior, rooftop, eaves, walls, and fascia with cream paint system containing lead

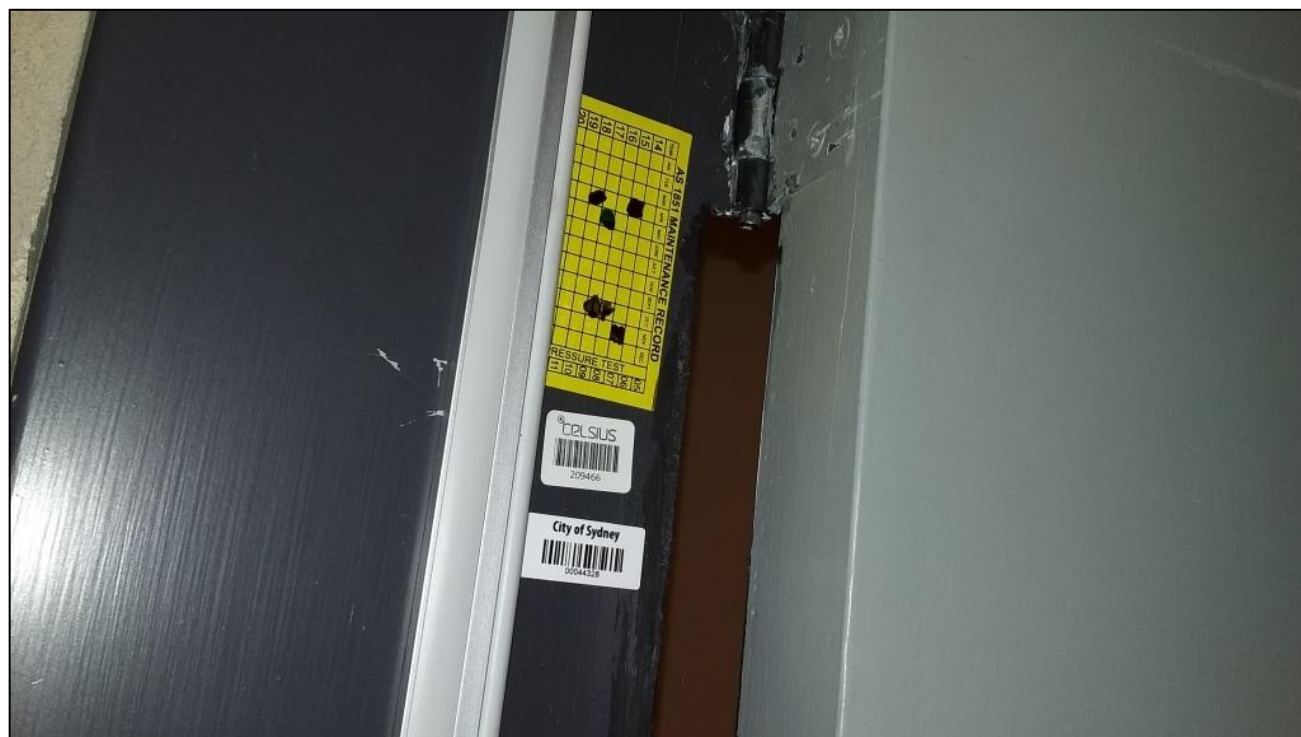
Location	Material	Risk Score	Recommendation
Interior, throughout, electrical cupboards, fire doors	Fire door core	Low	Maintain in current condition if to remain in situ. Re-inspect periodically. For further information, refer to Section 4.

Photo 2: Interior, electrical cupboards, fire doors presumed to containing SMF (inaccessible).
