# **Great Synagogue**

Condition Assessment

June 2020

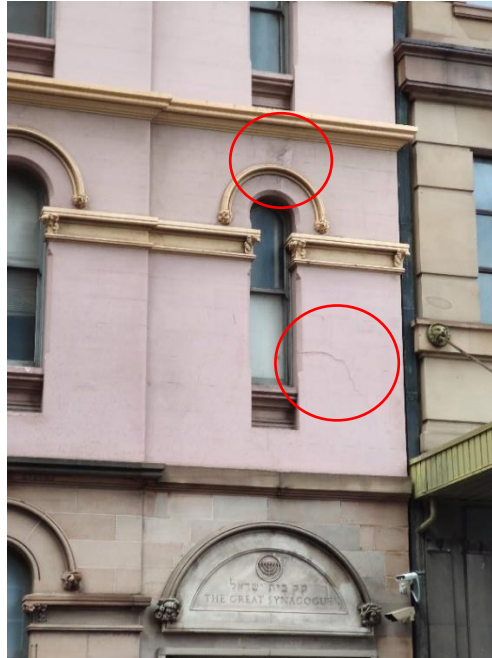
### Defect 1

Defect No.	Location	Defect Description	Discussion	Action Required
1	Castlereagh Street façade, second storey southern window	Minor cracking beside and above window opening	<ul style="list-style-type: none"> <li>Cracks do not appear to be active, and have been there for quite some time</li> </ul>	Monitor
2	Castlereagh Street façade, third storey southern window	Minor cracking above window arch		Monitor
3	Castlereagh Street façade, second and third storey northern windows	Minor cracking above window arches		Monitor
4	Elizabeth Street façade stone arch entrance	Minor spalling of stone at top of arch	<ul style="list-style-type: none"> <li>Spalling seems to have been there for quite some time and offers no imminent threat to the structural integrity of the arch.</li> </ul>	N/A
5 Typical photo provided	Synagogue Men's Floor south side	Paint bubbling above archways	<ul style="list-style-type: none"> <li>Paint bubbling is very minor and appears to have formed over a long period of time.</li> <li>Mostly likely a result of water ingress from blockages in the box gutters above.</li> <li>Ground movement and/or general ageing of the building could also have formed cracks which would have increased water ingress.</li> </ul>	Monitor, ensure box gutters cleared regularly

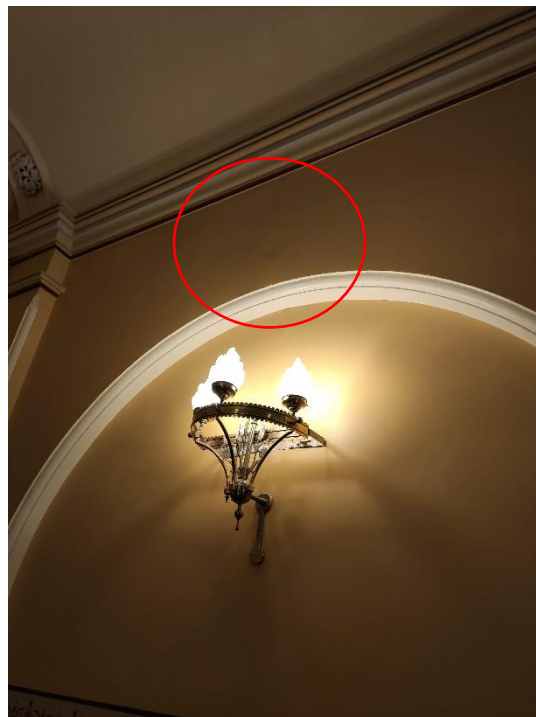
**Defect 6**

6 Typical photo provided	Synagogue Men's Floor north side	Paint bubbling above archways	<ul style="list-style-type: none"> <li>Discussions with the building manager indicate the gutters are regularly cleared and maintained.</li> </ul>	Monitor, ensure box gutters cleared regularly

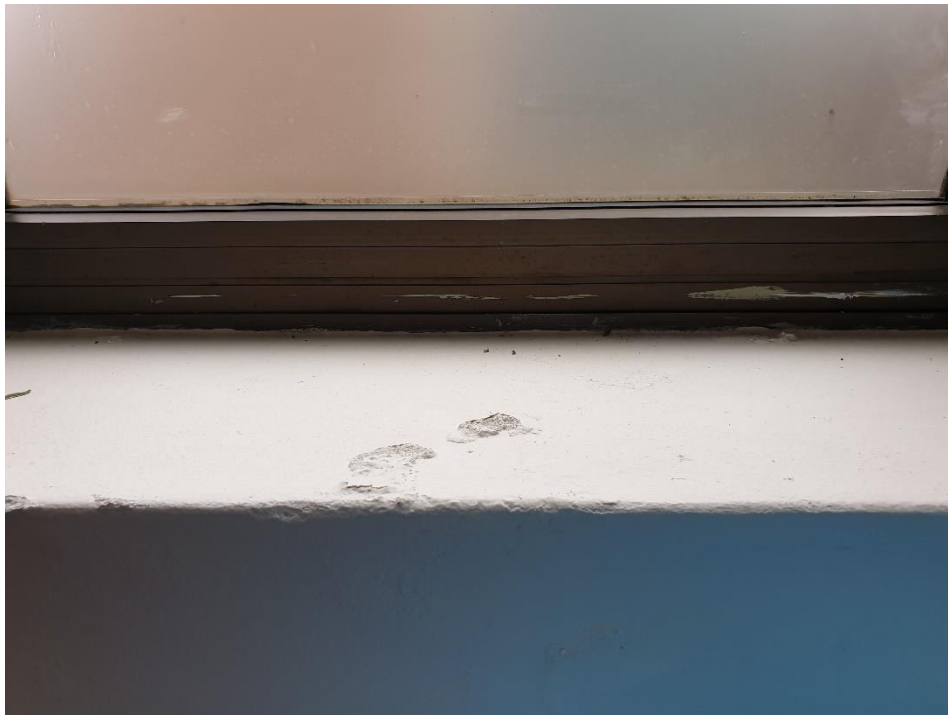
**Defect 10**

10	Along windowsill in the Succah	Minor spalling of render	<ul style="list-style-type: none"> <li>Spalling is very localised. Most likely caused by water tracking under the sills</li> <li>Does not pose a threat to the structural integrity of the building</li> </ul>	N/A
11	Along windowsill in the Succah	Minor spalling of render		N/A
12	Ladies Gallery Southern wall between first and second arch	Bubbling of paint and minor decay of timber	<ul style="list-style-type: none"> <li>Most likely a result of water ingress. This may be caused from blockages in the box gutters above.</li> <li>Does not pose a threat to the structural integrity of the building</li> </ul>	Monitor, ensure box gutters cleared regularly
13	Ladies Gallery Western wall	Bubbling of paint and minor decay of timber		Monitor, ensure box gutters cleared regularly

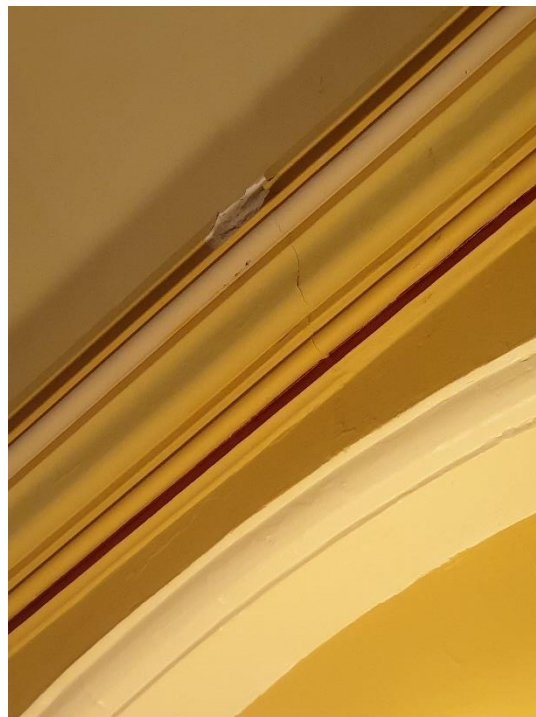
**Defect 14**

Defect No.	Location	Defect Description	Discussion	Action Required
14	Ladies Gallery Southern Wall third archway	Minor spalling of cornice	<ul style="list-style-type: none"> <li>Spalling seems to be fairly recent but is quite localised.</li> <li>Does not pose a threat to the structural integrity of the cornice.</li> </ul>	N/A
15	Ladies Gallery corner of Southern and Eastern walls	Minor cracking	<ul style="list-style-type: none"> <li>Most likely a result of water ingress. This may be caused from blockages in the box gutters above.</li> <li>Cracks may also relate to the junction between main building and towers.</li> <li>Cracks appear to have formed over a long period of time, and do not pose a threat to the structural integrity of the building</li> </ul>	Monitor
16	Ladies Gallery Northern Wall	Hairline cracks from air vent to ceiling rose	<ul style="list-style-type: none"> <li>Cracks appear to be active, but have formed over a long period of time, and do not pose a threat to the structural integrity of the building</li> <li>Cracks may be formed from differential settlement between the northern brick wall and the timber framing of the gallery</li> </ul>	Monitor

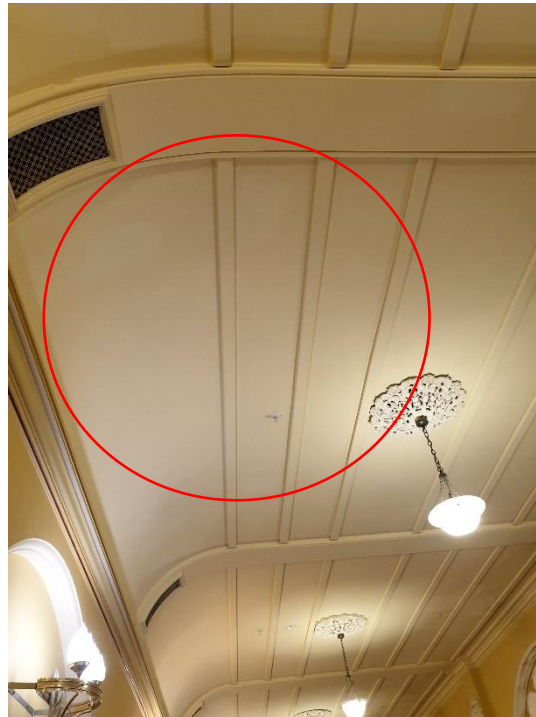
**Defect 17**

17	Ladies Gallery Northern Wall	Hairline cracks from air vent to ceiling rose		Monitor
18	Ladies Gallery Northern Wall	Hairline cracks from air vent to ceiling rose		Monitor
19	Ladies Gallery northern side, western door	Minor cracking at top of doorway arch	<ul style="list-style-type: none"> <li>Cracks do not appear to be active, and have been there for quite some time</li> <li>Does not pose a threat to the structural integrity of the building</li> </ul>	Monitor

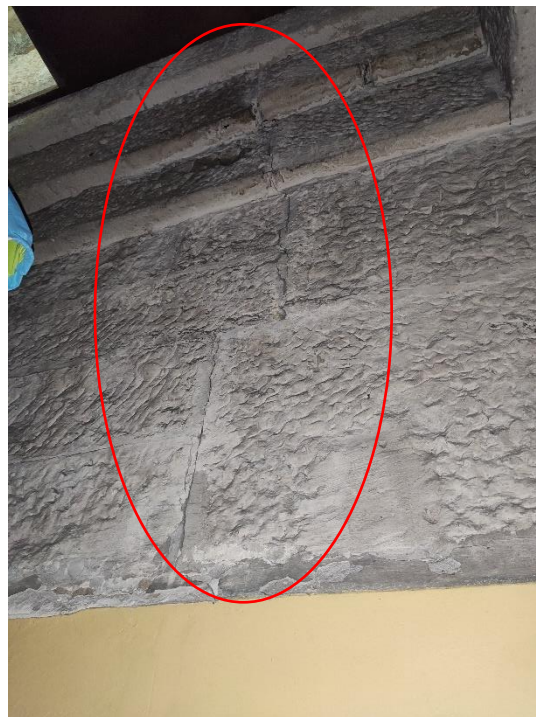
**Defect 20**

Defect No.	Location	Defect Description	Discussion	Action Required
20	Stairway up to Tower Platform, Southern side	Moderate cracking in exposed stone wall	<ul style="list-style-type: none"> <li>• Cracks appear to be active, but have been growing slowly over quite a prolonged period of time</li> <li>• Possibly due to localised settlement as a result of ground movement and/or the weight of the towers</li> <li>• The cracks do not pose a threat to the structural integrity of the building</li> </ul>	Monitor
21	End of first flight of stairs down from the Ladies Gallery, Southern tower	Moderate cracking in rendered stone wall, crack extends from the Ladies Gallery level up to the tower platform (over 3m long)	<ul style="list-style-type: none"> <li>• Cracks appear to be active, as they appear to have worsened since it was last painted</li> <li>• Possibly due to localised settlement or as a result of ground movement and/or the weight of the towers</li> <li>• The cracks do not pose a threat to the structural integrity of the building, but should be monitored</li> </ul>	Monitor

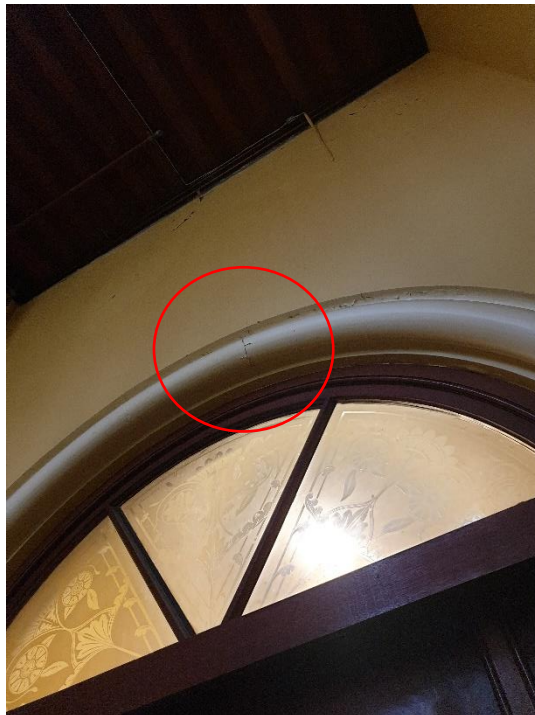
**Defect 22**

22	Southern tower, Ladies Gallery	Minor cracking in top of archway above door	<ul style="list-style-type: none"> <li>• Cracks do not appear to be active, and have been there for quite some time</li> <li>• Possibly a result of ground movement and/or localised settlement or as a result of ground movement and/or the weight of the towers</li> <li>• Does not pose a threat to the structural integrity of the building</li> </ul>	N/A

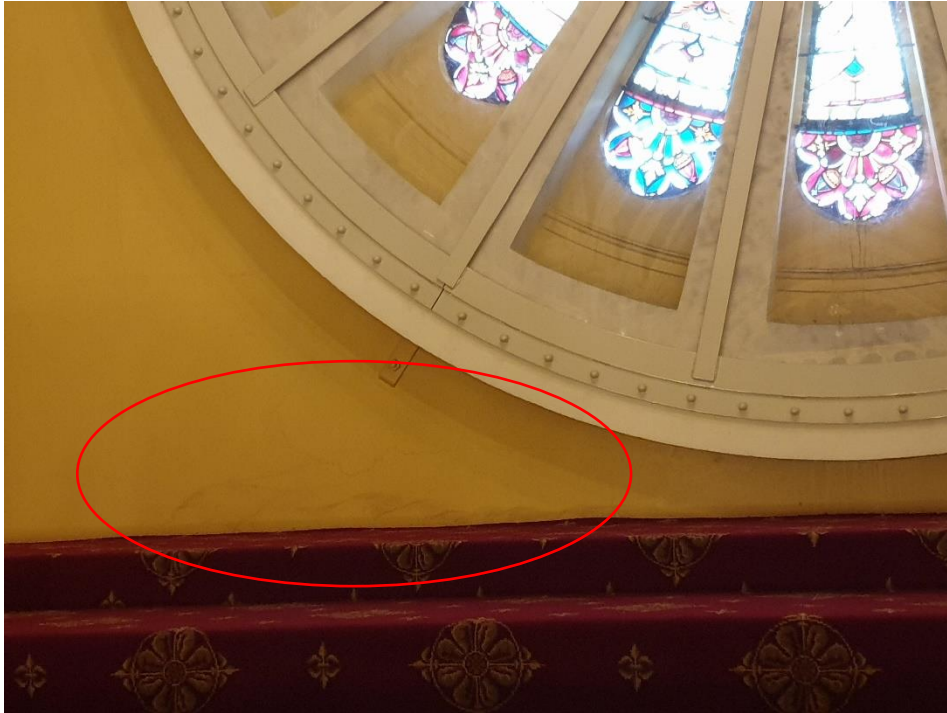
**Defect 23**

Defect No.	Location	Defect Description	Discussion	Action Required
23	Ladies Gallery, below Eastern Rose window	Minor cracking below window	<ul style="list-style-type: none"> <li>Cracks do not appear to be active, and have been there for quite some time</li> <li>Possibly a result of changes to the original design loads with the addition of reinforced concrete beams for blast protection</li> <li>Does not pose a threat to the structural integrity of the building</li> </ul>	N/A
24	Southern tower, stairs up from Men's Floor, beside stain glass window	Minor horizontal crack	<ul style="list-style-type: none"> <li>Crack does not appear to be active, and has been there for quite some time</li> <li>Possibly a result of ground movement, which is expected in buildings of this age</li> <li>Does not pose a threat to the structural integrity of the building</li> </ul>	Monitor
25	Southern Tower, Ladies Gallery	Paint bubbling above doorway	<ul style="list-style-type: none"> <li>Paint bubbling appears to have formed over a long period of time.</li> <li>Mostly likely a result of water ingress from blockages in the box gutters above or internal pipes.</li> <li>Discussions with the building manager indicate the gutters are regularly cleared.</li> <li>Minor water ingress of this nature does not pose a threat to the structural integrity of the building. If paint bubbling worsens rapidly, investigations should be undertaken to confirm the source of the leak.</li> </ul>	Monitor, investigate source of leakage

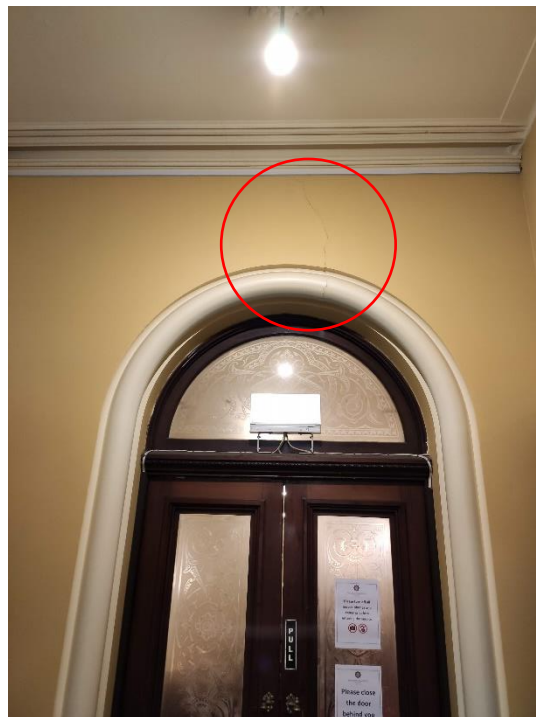
**Defect 26**

Defect No.	Location	Defect Description	Discussion	Action Required
26	Northern Tower, doorway into Ladies Gallery	Moderate crack from top of arch to ceiling	<ul style="list-style-type: none"> <li>Crack does not appear to be active, and has been there for quite some time</li> <li>Possibly a result of ground movement</li> <li>Does not pose a threat to the structural integrity of the building</li> </ul>	Monitor
27	Northern Tower, entryway into Ladies Gallery	Minor cracking in ceiling	<ul style="list-style-type: none"> <li>Cracks do not appear to be active, and have been there for quite some time</li> <li>Possibly a result of ground movement and/or localised settlement or as a result of ground movement and/or the weight of the towers.</li> <li>Does not pose a threat to the structural integrity of the building</li> </ul>	Monitor
28	Northern Tower, single stain glass window	Minor cracking at top of window	<ul style="list-style-type: none"> <li>Cracks do not appear to be active, and have been there for quite some time</li> <li>Possibly a result of ground movement and/or the weight of the towers</li> <li>Does not pose a threat to the structural integrity of the building</li> </ul>	Monitor

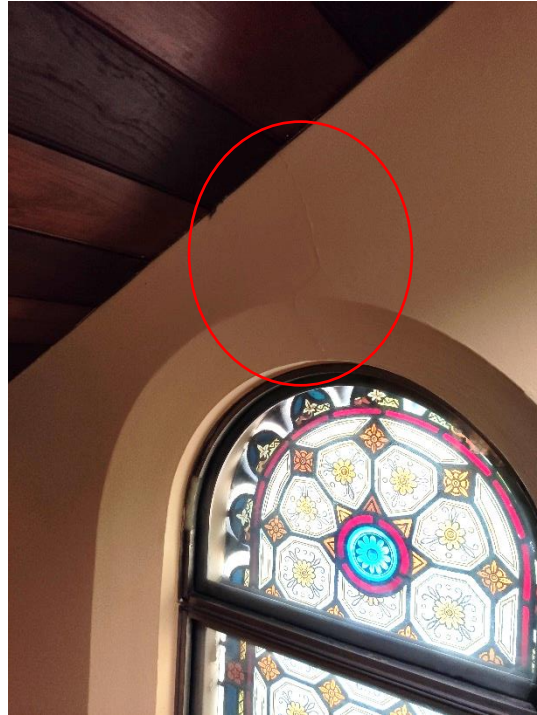
**Defect 29**

29	Northern Tower pair of stain glass windows	Minor cracking at top of one window		Monitor
30	Stairway up to Tower Platform, Northern side	Minor cracking in exposed stone wall		Monitor
31	Tower Platform, Northern side	Stones dislodged Water ingress	<ul style="list-style-type: none"> <li>Water ingress appears to have been occurring for quite some time, and a tarp has been placed on the tower platform to capture water.</li> <li>Stones at the top of the tower appear to have shifted out of place, though appears to be stable at this time, this should be further investigated</li> </ul>	<p>Access the top of the tower space to check the condition of the top stones and the severity of the dislodgement.</p> <p>If the stones are considered to be at risk of falling, consult structural engineer on the safe removal and replacement</p>

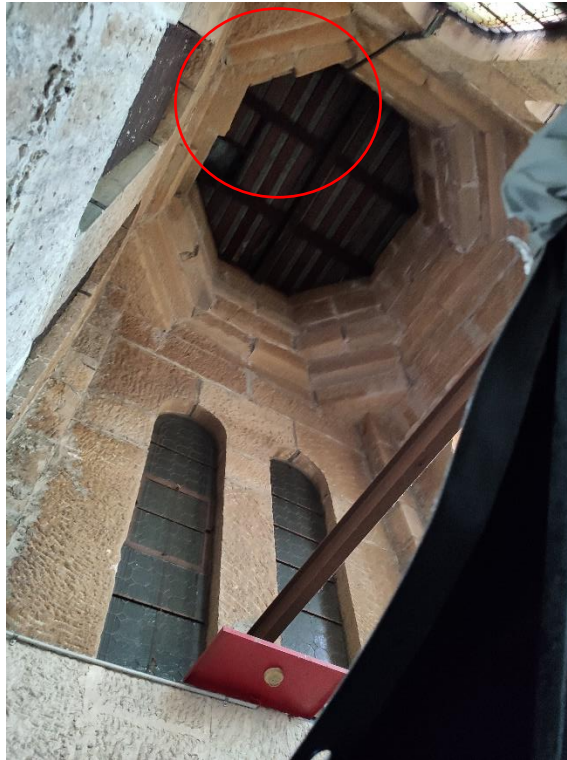
**Defect 31**

From the northern tower platform, it appears that stones may be dislodged towards the top. Further investigations should be undertaken with access higher up the tower, to closely inspect the condition of the stones and severity of dislodgement. If the stones are considered to be at risk of falling, seek the advice of a structural engineer on the safe removal and replacement.

Defect No.	Location	Defect Description	Discussion	Action Required
			<ul style="list-style-type: none"> <li>• Difficult to ascertain the severity of the stone displacement without having access higher up the tower.</li> <li>• Water ingress can cause timber decay and mortar erosion etc. over time</li> </ul>	
32	Classroom on Choir Level	Minor cracking	<ul style="list-style-type: none"> <li>• Cracks do not appear to be active, and have been there for quite some time</li> </ul>	Monitor
33	Wall outside Vestry, facing the boardroom	Minor cracking in top of wall	<ul style="list-style-type: none"> <li>• Most likely due to movement at the building joint between the original building and the extension</li> </ul>	Monitor
34	Wall outside Vestry, facing the classroom	Minor horizontal cracking	<ul style="list-style-type: none"> <li>• Does not pose a threat to the structural integrity of the building</li> </ul>	Monitor

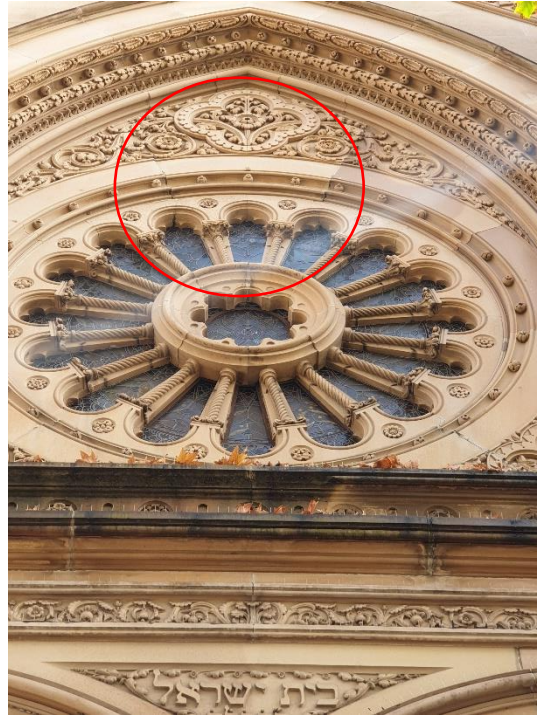
**Defect 35**

35	Elizabeth Street Façade, Stone around Rose window	Evidence of stone slipping out of alignment	<ul style="list-style-type: none"> <li>• Stone movement does not appear to be active and has been set in its current position for quite some time.</li> <li>• Possibly a result of changes to the original design loads with the addition of reinforced concrete beams for blast protection</li> <li>• Does not pose a threat to the structural integrity of the building</li> </ul>	Monitor
