Ethos Urban  
173 Sussex St  
Sydney NSW 2000

6<sup>th</sup> July 2023

## **GREAT SYNAGOGUE – REVIEW OF PREVIOUS CONDITION ASSESSMENT**

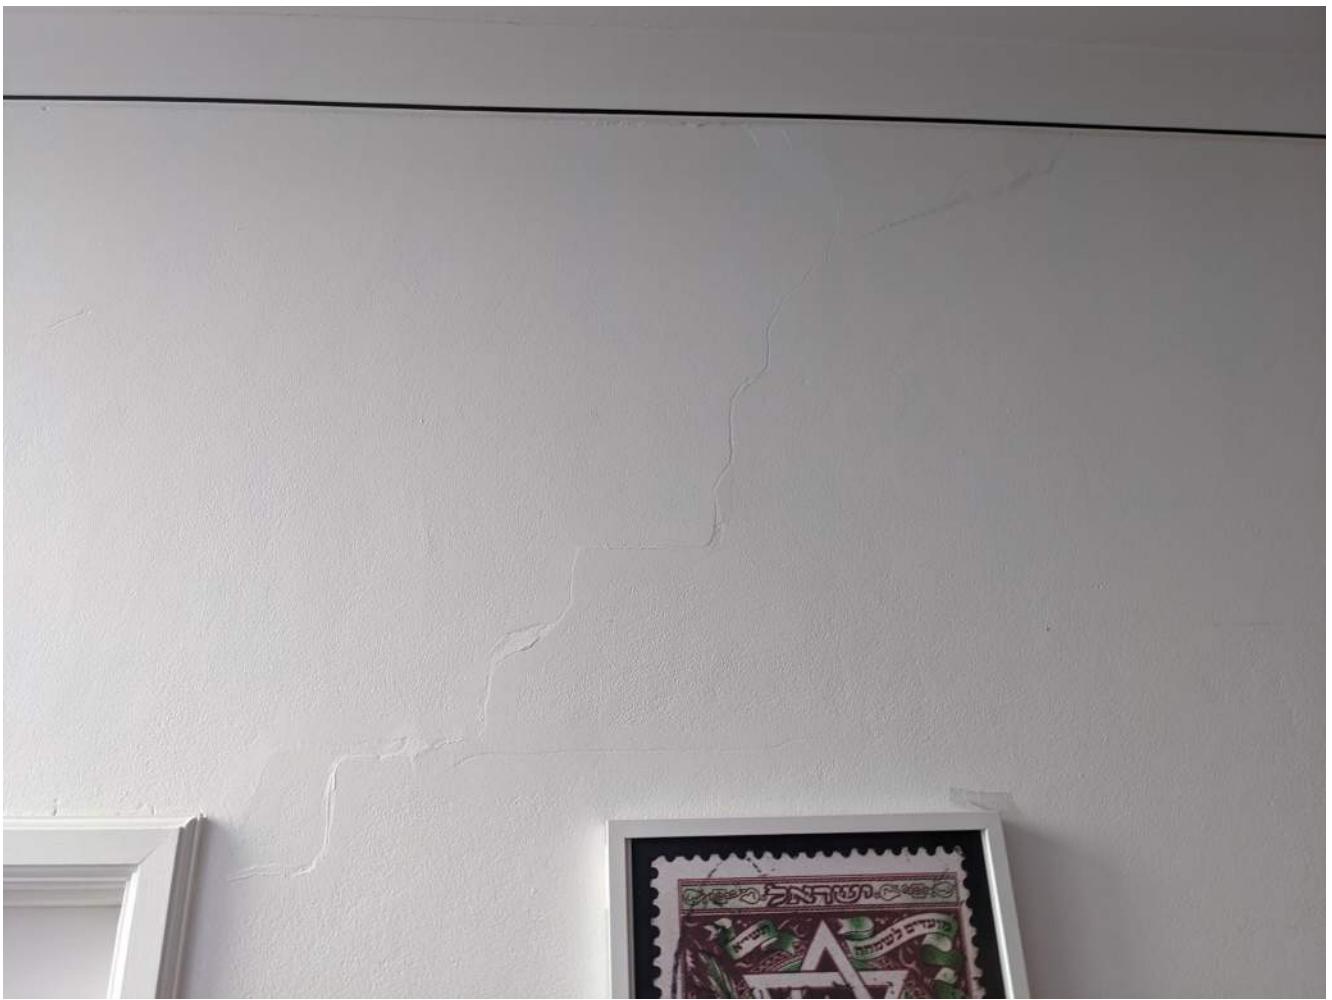
Photo	Location	Defect Description	Discussion	Actions Required
P03	Succah north wall	Diagonal crack	Minor. Painted over.	N/A
P04	Succah west wall below windows	Diagonal crack	Minor. Painted over.	N/A
P05	Succah ceiling	Water penetration, stained ceiling	Potential roof leaking	Consider tracing leak to roof and re-sealing
P06	North stair	Water penetration, stained ceiling	Potential roof leaking	Consider tracing leak to roof and re-sealing
P07	Succah kitchen	Water penetration, stained ceiling	Potential roof leaking	Consider tracing leak to roof and re-sealing
P08	South stair SW corner wall	Crack	Minor defect	N/A
P09	South stair roof	Water penetration, stained ceiling	Potential roof leaking	Consider tracing leak to roof and re-sealing
P10	North stair L3 NW corner	Cracking in masonry wall common, hairline	Painted over, re-opened	Monitor
P11, P13 (Defect 12)		Bubbling paint and timber decay extends to west wall and in ceiling and along full south wall

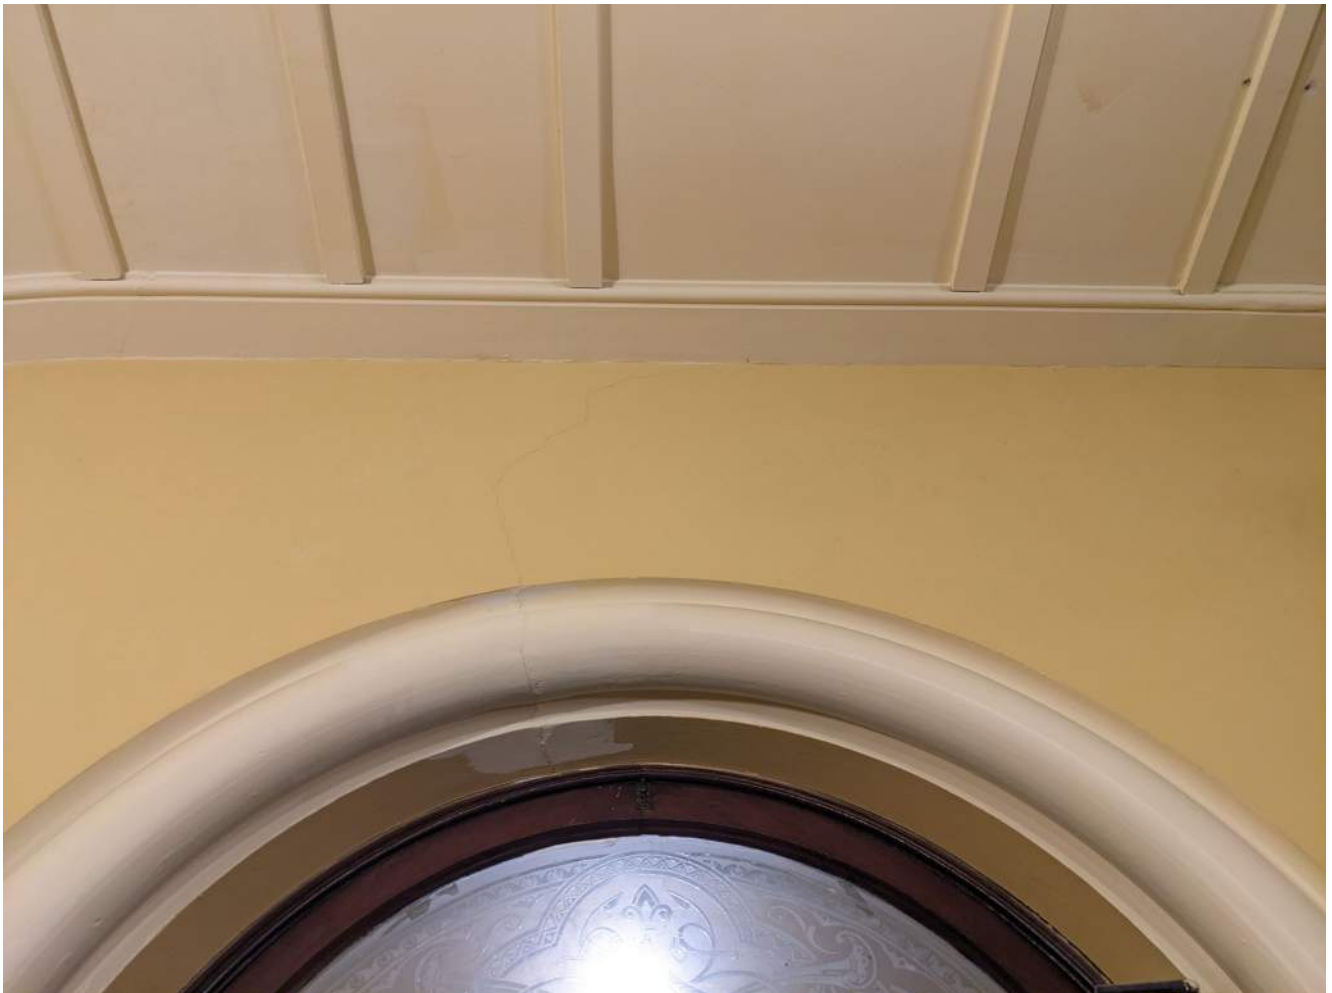
P18	Ladies Gallery eastern door	Minor cracking at top of doorway arch	Minor	Monitor
P19	Ladies Gallery, eastern wall and ceiling	Bubbling paint, water penetration	Roof leaks	Consider tracing leak to roof and re-sealing
P22	North tower east wall	Peeling paint	Water penetration	Monitor. Consider a programme of façade remediation
P25	South tower stair up from Men's floor	Vertical crack above stained-glass arch	Minor	Monitor
P26	South tower stair up from Men's floor	Vertical crack above stained-glass arch	Minor	Monitor

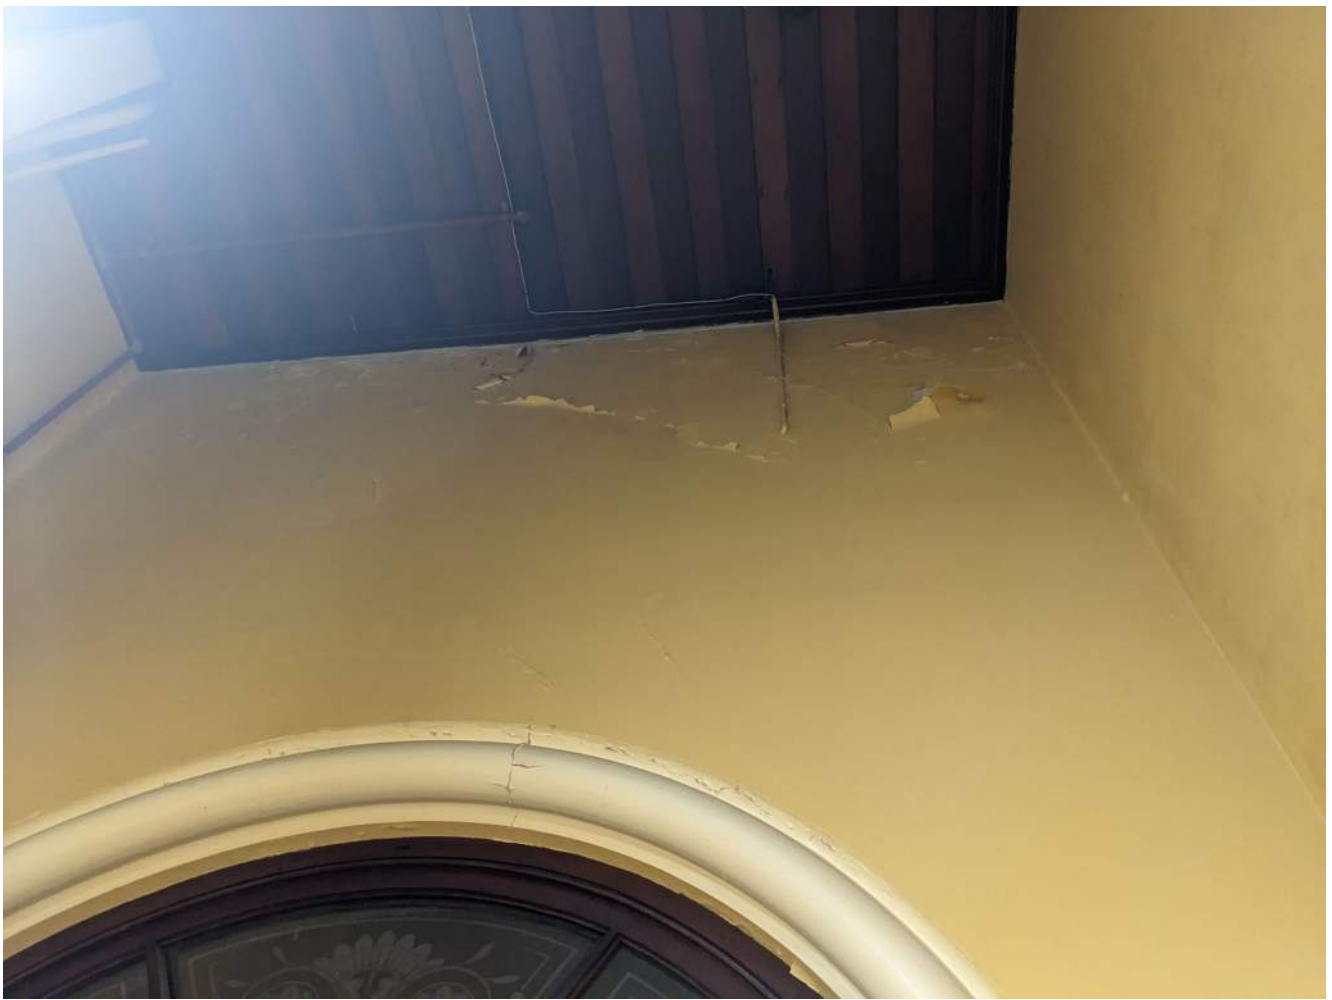
Photo	Location	Defect Description	Discussion	Actions Required
P27 (Defect 21)			Worsening	
P28 (Defect 22)			Worsening	
P30	South tower stairs	Upper stained-glass windows	Mould, spalling render	Weatherproof windows
P31	Choir level hallway	Cracking in wall	Minor	Monitor
P32	Choir level NW corner wall	Various hairline cracks	Minor	Monitor
P33, P34	Choir level locker room	Various hairline cracks	Minor	Monitor
P35	Men's floor ceiling, north side	Cracking in ceiling plaster	Minor	Monitor
P36	Basement stairs	Cracking in brick walls	Minor	Monitor
P39	Entry arch, Castlereagh St	Vertical crack in stone	Minor	Monitor
P40	Castlereagh St facade	Shrinkage cracking in render across façade, and water penetration	Likely to worsen over time	Monitor. Consider a programme of façade remediation
P41, P42, P43, P44	Elizabeth St facade	Mortar loss, fretting stone	Minor	Monitor. Consider a programme of façade remediation
