**350 George Street, Sydney**  
**Conservation Management Plan**

**Appendices A to G**

Prepared for Strata Plan No. 86960

August 2020 • Issue A  
Project number 20 0023

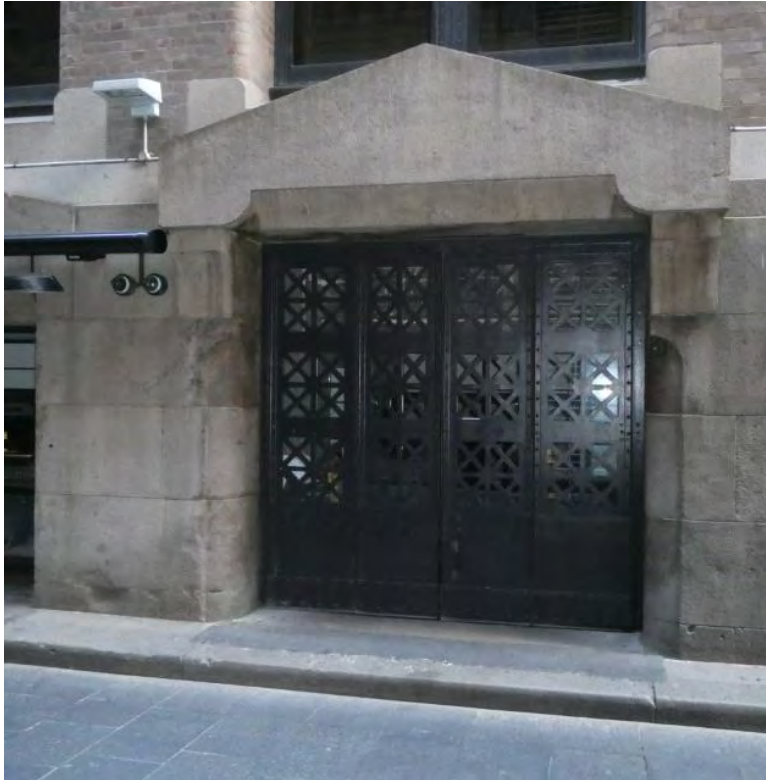
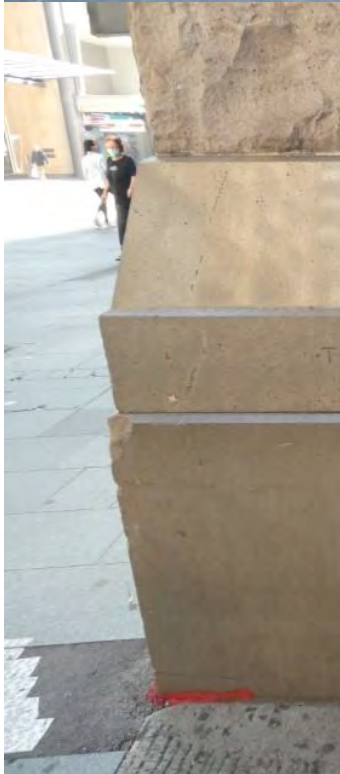
Although the building is generally in very good repair and is well maintained, stonework has been damaged at footpath level on the Ash Street elevation and at the south-western corner of the building. Methodology for repairs to stonework should be investigated and executed by a qualified stonemason under the direction of a heritage architect.

135 *Damaged stone at the ground floor level of the Ash Street elevation (left) and at the south-western corner of the building. Repairs should be undertaken to the hydraulic system for the main entrance doors, located in the basement of the building, which is leaking.*

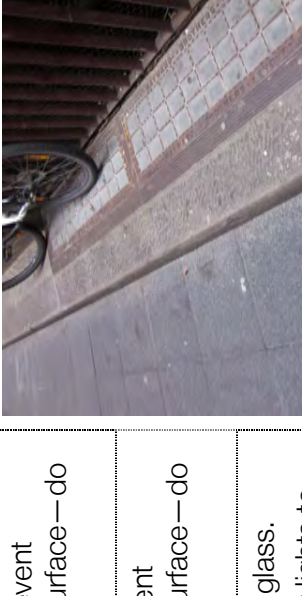
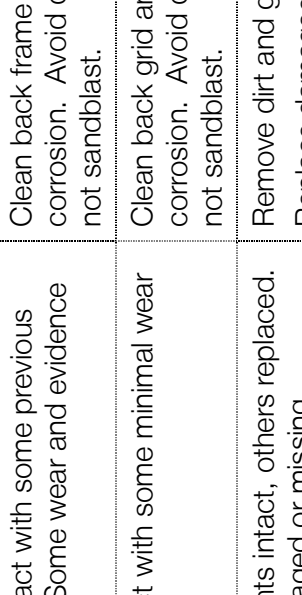
| Bay | Condition | Conservation Works | Images |
|---|---|--|---|
| 10 | <p>Original frame intact with some previous welded repairs. Some wear and evidence of corrosion.</p> <p>Original grid intact with some minimal wear and corrosion.</p> <p>Some original lights intact, others replaced. Some lights damaged or missing.</p> | <p>Clean back frame and treat to prevent corrosion. Avoid damaging the surface—do not sandblast.</p> <p>Clean back grid and treat to prevent corrosion. Avoid damaging the surface—do not sandblast.</p> <p>Remove dirt and grime and clean glass.</p> <p>Replace damaged lights with new lights to match original.</p> <p>Where original prism lights have previously been replaced with flat glass, reinstate with new prism glass.</p> <p>Replace loose and missing grout to match consistency and colour of existing lights.</p> <p>Remove overlying bituminous material and confirm existence of original pavement light.</p> <p>Subject to what is found, consideration is to be given to re-instating the pavement light consistent with the approach undertaken for other pavement lights.</p> | |

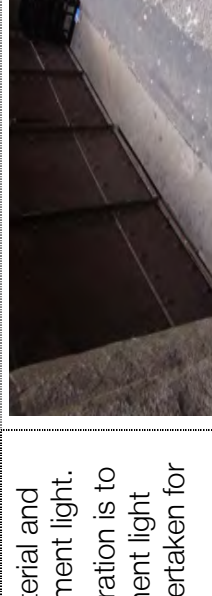
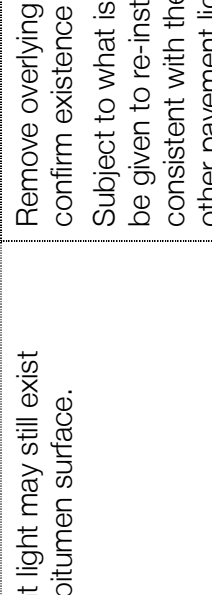
| Bay | Condition | Conservation Works | Images |
|---|---|--|---|
| 11 | <p>Original pavement light may still exist underneath later bitumen surface.</p> | | |

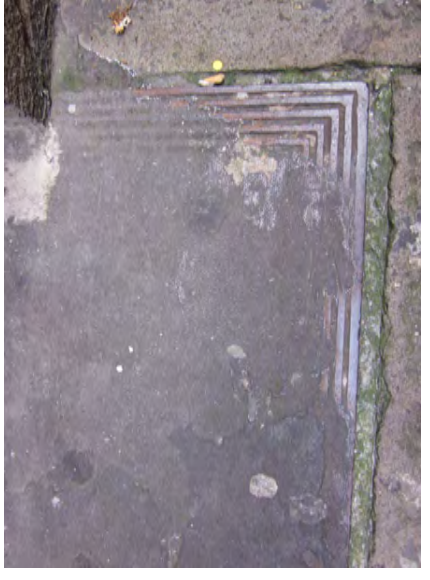
| Bay | Condition | Conservation Works | Images |
|---|---|--|---|
| 12 | The frame of the original pavement light appears to have been retained under a later bitumen surface. It appears to have been cut at the south end to allow for a stormwater pipe to empty into the adjacent gutter. It is unknown as to whether or not the grid and lights have been retained. | Remove overlying bituminous material and confirm extent of original pavement light. Subject to what is found, consideration is to be given to re-instating the pavement light consistent with the approach undertaken for other pavement lights. | |

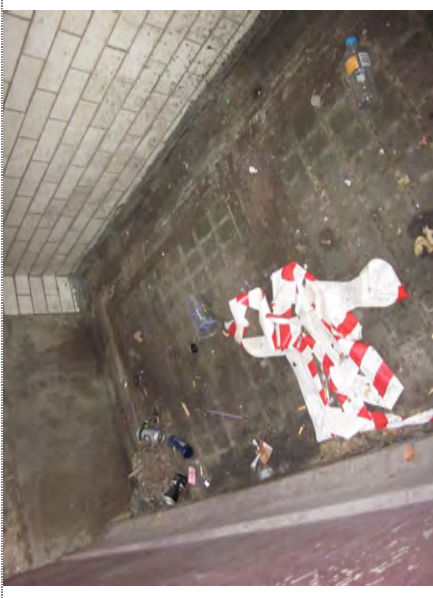
| Condition | Conservation Works | Images |
|---|---|---|
| <p>The existing basement lights appear to be in good condition although there is considerable dirt, grime and rubbish within the vaults.</p> <p>Some basement lights have been removed and others have been penetrated by services.</p> <p>The vents on the street side of the vaults appear to have been infilled.</p> <p>The original drainage (at base of building wall) does not appear to be functional.</p> <p>It is possible that a clear waterproofing material has been applied to the upper face of the basement lights and the vent.</p> <p>The underside of the basement lights and vents have generally been painted throughout.</p> | <p>Remove all rubbish and clean surfaces of dirt and grime with water and a hard brush—do not use high pressure water jets and do not saturate other elements.</p> <p>Inspect for damage to vents, framing, grids and lights.</p> <p>Repair framing and grids as necessary.</p> <p>Replace damaged lights with new lights to match original.</p> <p>Replace missing grout to match consistency and colour of existing grout.</p> <p>Inspect adequacy of drainage and repair or replace as necessary—ensure that all drains are functional.</p> <p>Inspect for existence of any waterproofing applied to the upper face of the basement lights and the vents. If a waterproofing membrane has been applied then consideration is to be given to its repair, replacement or removal, subject to the assessed adequacy of the basement lights and drainage to adequately collect and dispose of stormwater etc.</p> <p>Consideration is to be given to the removal of the paint to the underside of the basement lights, where this would benefit use of the basement level.</p> | |
