Mirvac Office Developments Pty Ltd
Preliminary Contamination Assessment

55 Pitt Street, Sydney NSW

Preliminary Contamination Assessment

754-SYDEN221350-R01-Rev2

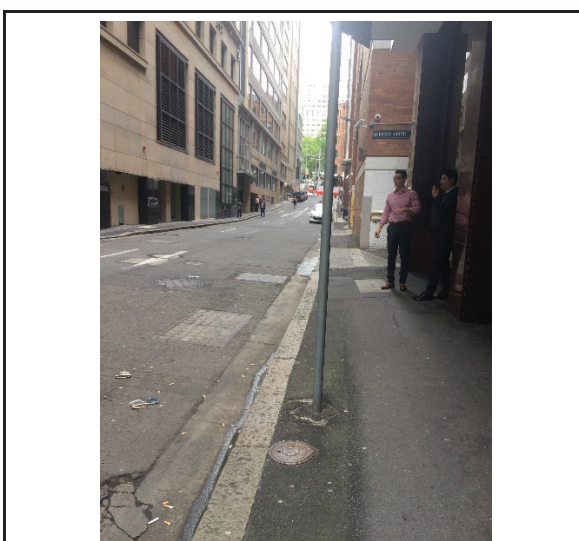
- A fuel fill / dip point observed in the northern footpath on Dalley Street (approximate location is shown in Figure 2)
- Fill of unknown origin within the site boundaries.

Photo 5: Potential dip/fill point on northern footpath of Dalley Street

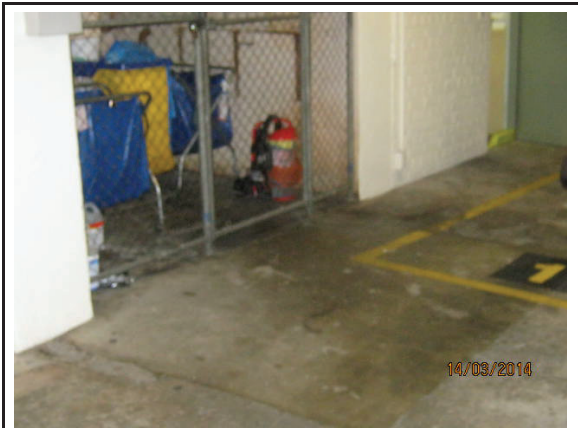
- A diesel tank (10L) was present on the plant room associated with hydrant pump.
- One UST (approximately 5,000L) was observed within the cleaners area in the basement. The UST was reported to have contained diesel and had been decommissioned. The fill point was observed to be located along Dalley Street, along the southern wall of the building. The method of abandonment comprised filling with 'Petrol Fill' (an expanding foam like substance). Golder (2006b) noted that no decommissioning certificate had been obtained through WorkCover NSW. It is unknown if this has been obtained.

Photo 7: Location of UST in basement car park at 51 Pitt Street

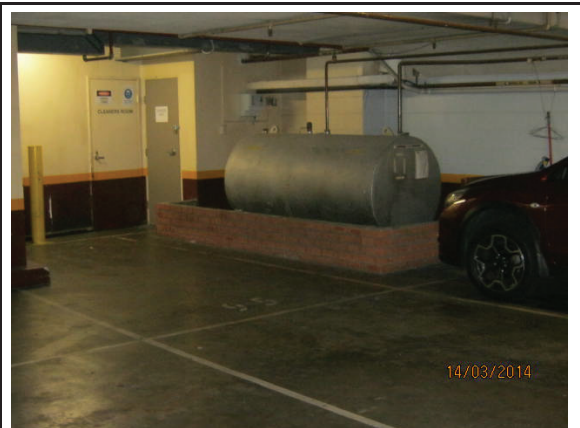
- The concrete surface of both car parks appears to be in generally good condition with some minor cracks observed.
- The 3,000L AST (used to contain diesel) was observed on the upper level of the basement car park beneath 37-49 Pitt Street. The AST was empty and appeared to be in generally good condition with no rust or holes observed on the tank. There was no indication of spills or leaks observed on the concrete beneath the tank. The transfer pipes from the AST appear to lead to fire extinguisher pumps that are no longer in use. The location of the AST is shown in Figure 2.

Photo 8: AST location on upper basement car park at 37 Pitt Street

A number of the ASTs and the UST at 37-49 Pitt St were not sighted during site walkover. It is recommended that the presence of these be confirmed prior to demolition work. It is considered that potential impact from ASTs is considered to be low as ASTs and the areas surrounding them appear to be in condition. It is recommended that AST removal is undertaken appropriately to minimise impact to surrounding area.

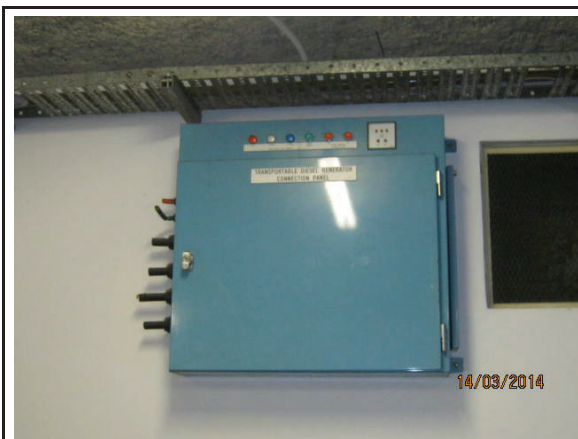
- A diesel databox was observed on the western wall at the entrance to the car park beneath 37-49 Pitt Street, which appeared to no longer be in use as the wiring had been cut.

Photo 9: Disconnected power box to diesel AST

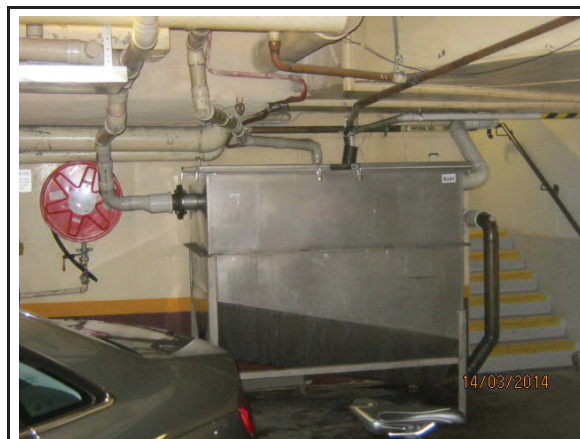
- The building manager's office is located on the upper level of the basement car park at 37-49 Pitt Street.
- An AST associated with the grease trap (size is unknown) was located adjacent to the building manager's office at 37-49 Pitt Street. The AST was made of steel and minor staining was observed around the base of the grease trap. The location of this is not shown in Figure 2.

Photo 10: Grease trap AST located on lower basement level car park at 37 Pitt Street

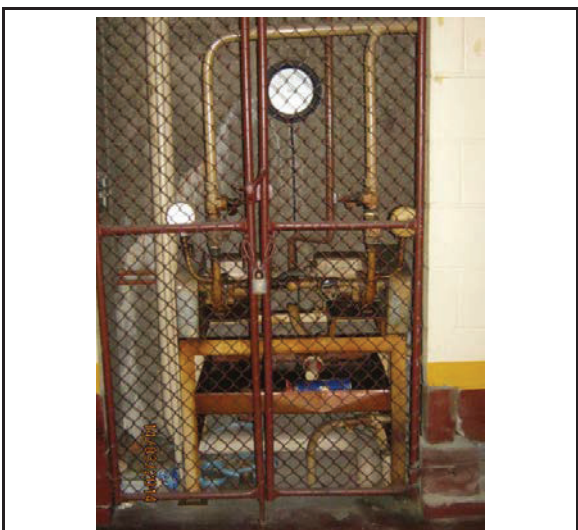
Photo 11: Decommissioned fire hydrant pumps located on lower level car park at 37 Pitt Street

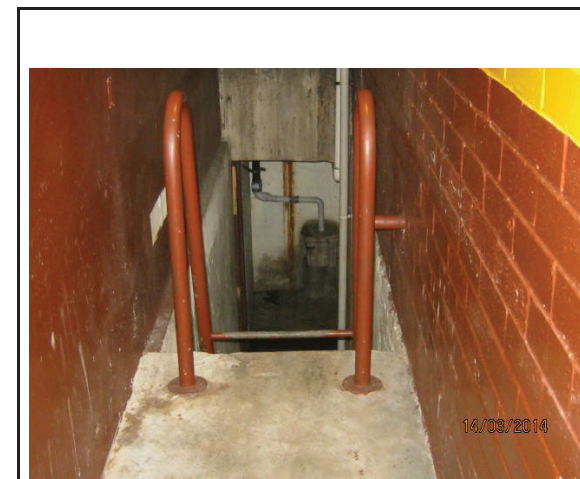
Photo 12: Sump pump room located on lower basement car park at 37 Pitt Street
