Capitol Theatre Condition Assessment

11 March 2019

Mott MacDonald has been commissioned by Urbis to carry out a condition assessment of the Capitol Theatre in Haymarket, Sydney for inclusion in a new CMP being written for the building.

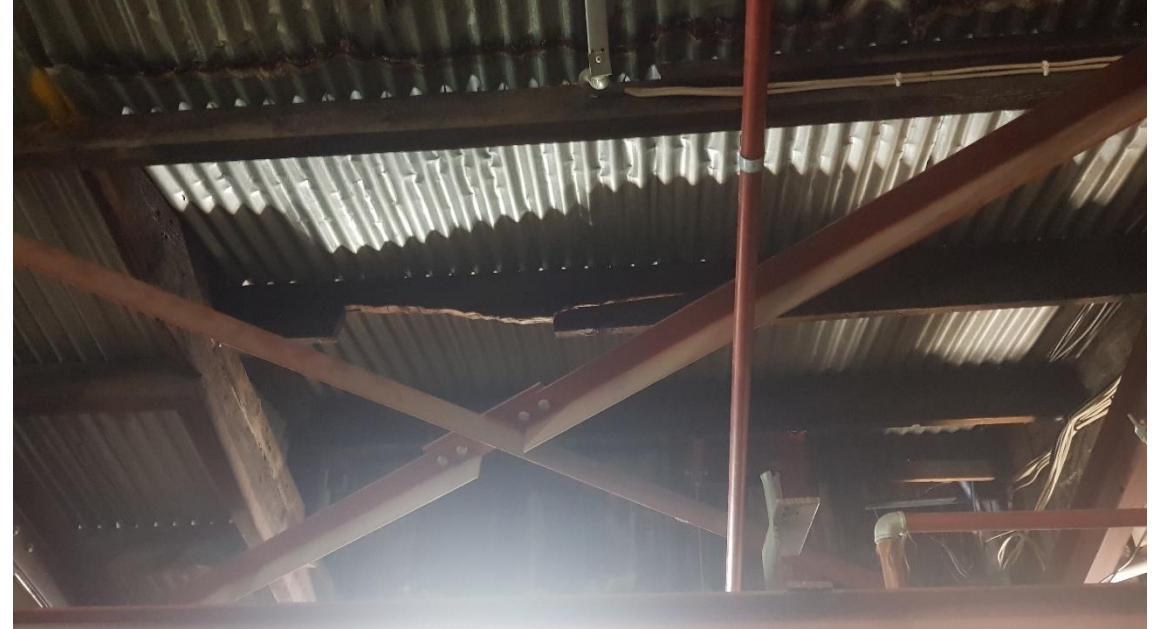
Figure 1: Original Theatre Roof – Existing Timber Purlins, Sheeting and New Steel Bracing

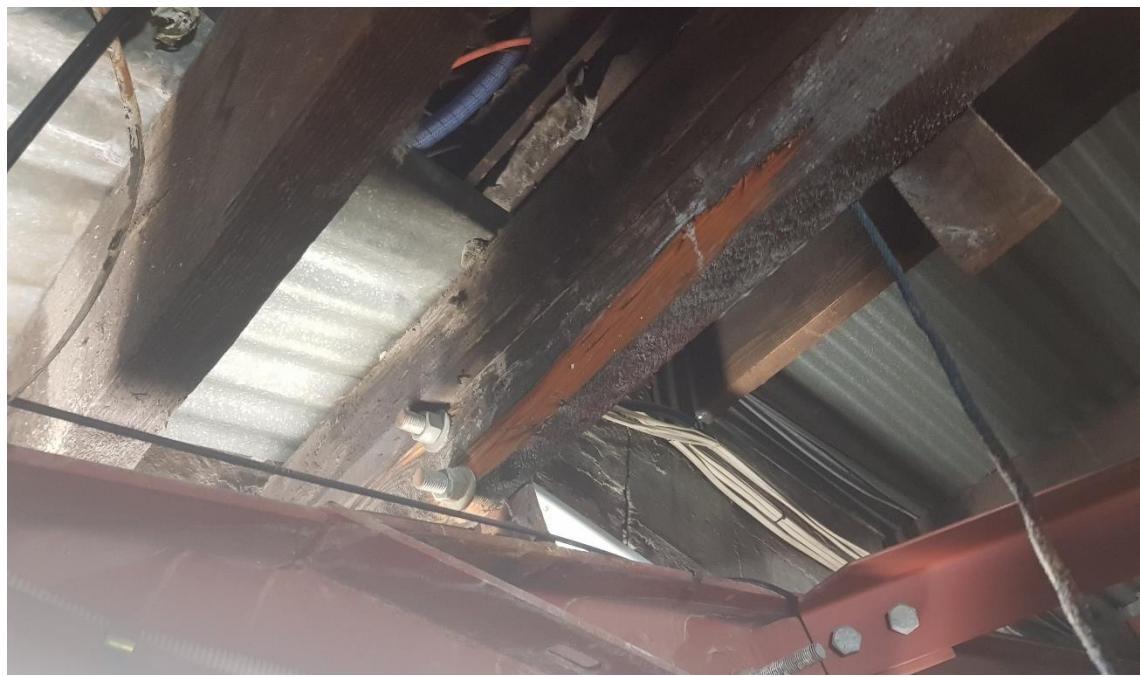
- Timber purlin damage (Figure 1, Figure 2). These defects are low risk as the timber roofing is only supporting weight of the corrugated sheeting and services above, however, should be monitored periodically for any further deterioration.
- Buckled flat truss chord members (Figure 7 and Figure 9). It is uncertain when this
 failure occurred and could be caused by the cutting and rewelding of the truss
 members. These members should be assessed when performing the desktop study and
 the structural check recommended above.

Figure 2: Original Theatre Roof – Timber Purlin Damage

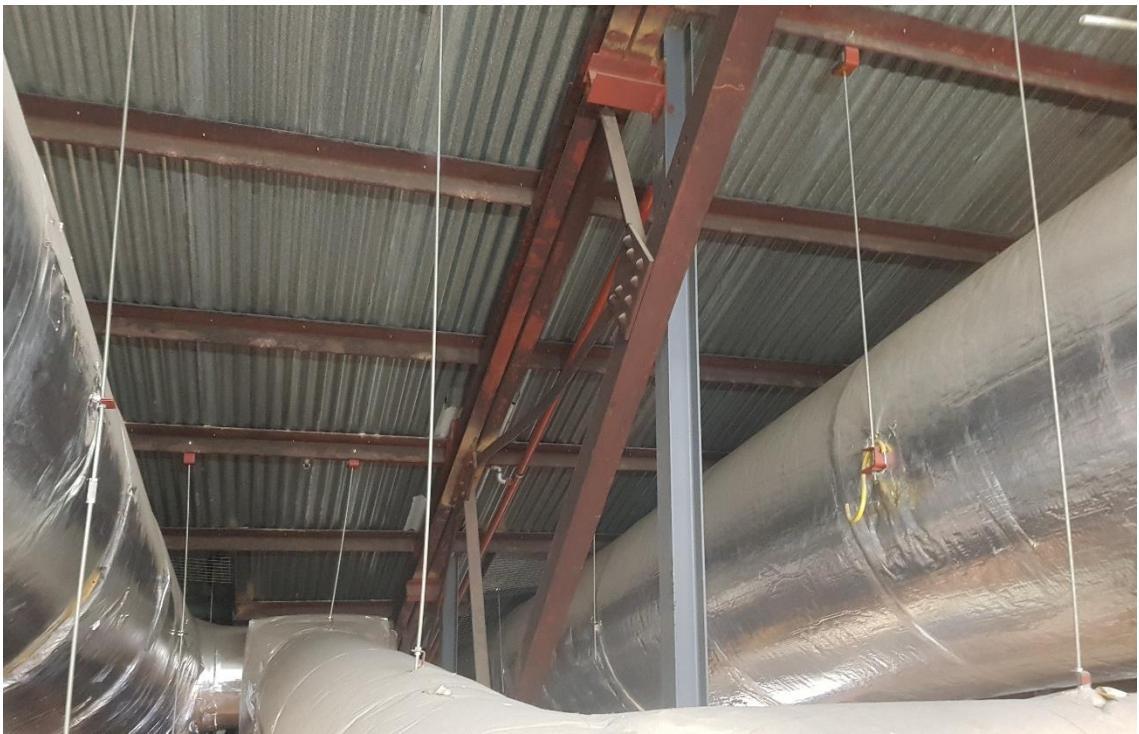
Figure 7: Original Theatre Roof – Buckled Truss Chord

A desktop check is performed to ensure records are kept of each structural change and that these have been checked by an engineer. If no records are found, a structural check should be performed to determine the load paths through the ceiling and roof structures.

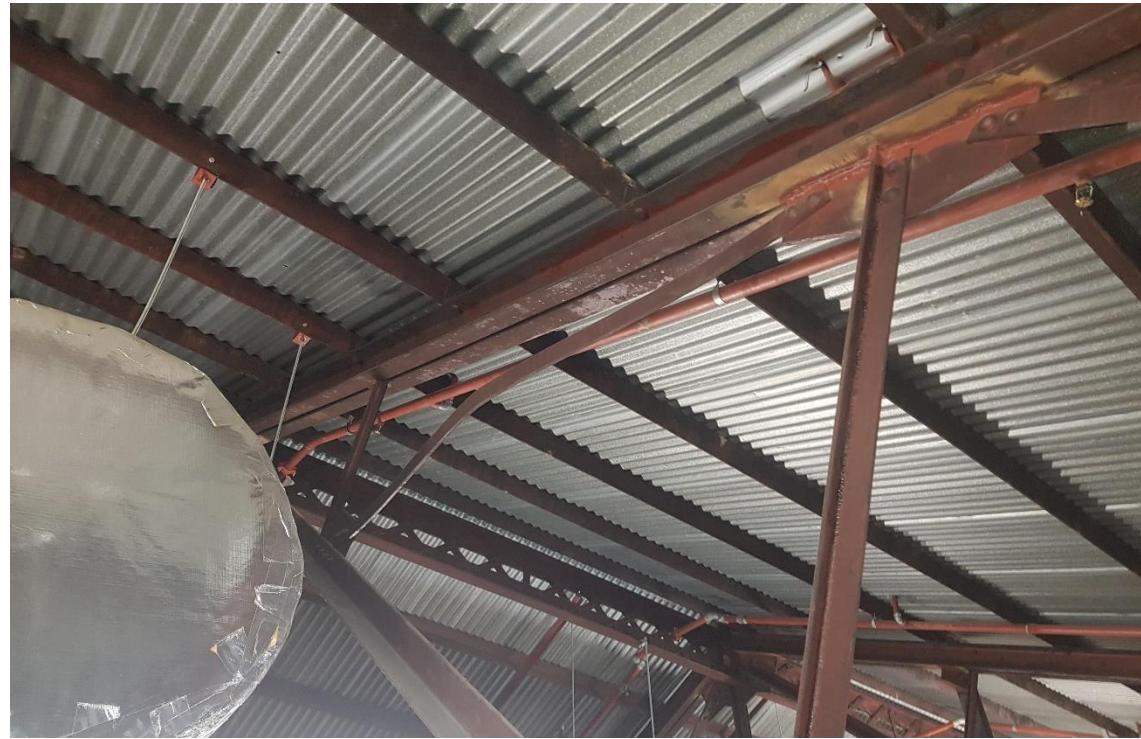
Figure 9: Original Theatre Roof – Bucked Truss Chord

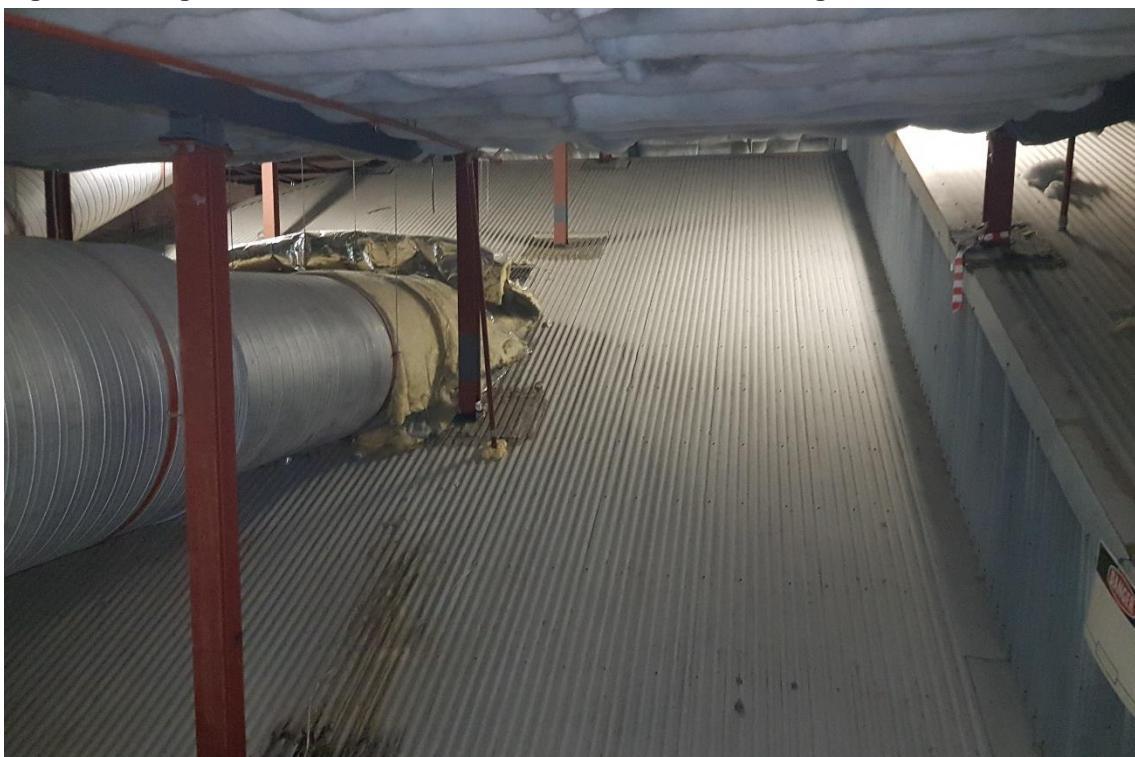
During one of the renovations of the Capitol theatre, a second roof was installed above the original. As shown in Figure 11, the new theatre roof is a steel framed structure supported from posts landing on the original roof trusses. The new roof protects the theatre from weather penetration, particularly preventing water from landing on the original roof structure, as a result, protecting the steel from further corrosion and timber from degradation. The new roof also has the added benefit of eliminating the wind load on the timber purlins of the original roof structure.

Despite the aforementioned benefits, the additional roof has created new load paths along the original trusses. Further load path changes include apparent alterations to the original roof trusses, evidence of cut and re-welded sections, the new steel bracing, and any changes to the access structures and services. With this in mind, it is recommended that:

Figure 11: Original Theatre Roof – New Roof Built Above the Original Roof

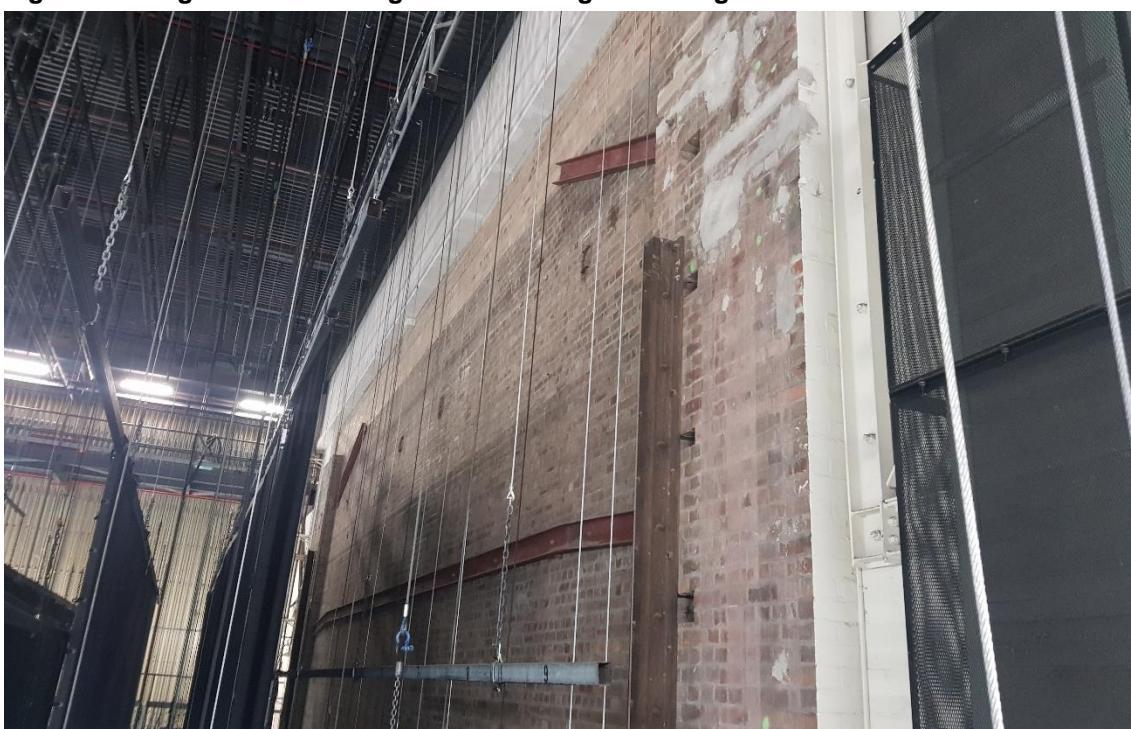
The southern wall (Figure 17), which divides the back-stage area from the theatre seats appears to be a single skin masonry wall that s has long spans between supports in both the vertical and horizontal directions. Due to the size and age of this wall, it is suggested that an engineer be engaged to carry out a desktop analysis to check its structural stability.

Figure 17: Original Walls – Large Wall Dividing Back Stage and the Theatre

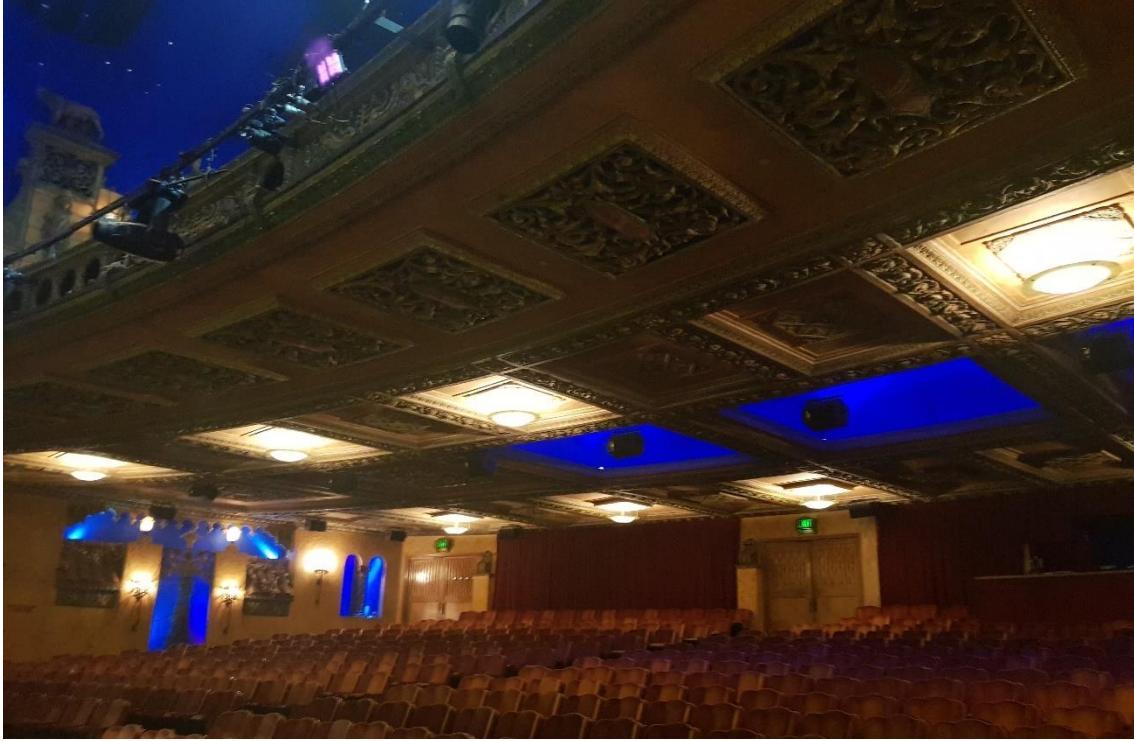
The large cantilevered balcony of the dress circle pictured in Figure 27, presents the highest point of stress and was inaccessible at the time of inspection. Maintenance staff at the Capitol theatre were unaware of any access panels or doors to inspect and maintain this large area. It is recommended that access be provided to this large area and that a maintenance and monitoring scheme of the dress circle trusses is instituted.

Figure 27: Dress Circle Structure – Balcony from below

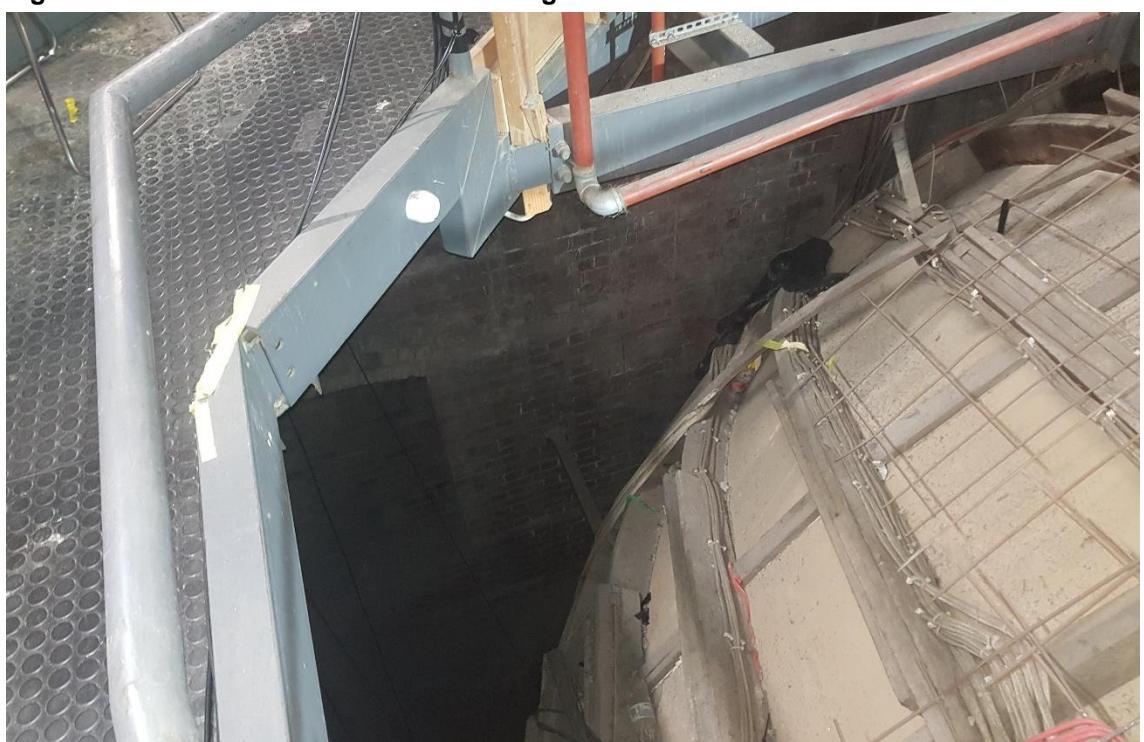
Access routes, such as the catwalk above the original roof as well as ladders and stairs between levels are another area of high risk. Missing bolts (Figure 28) and wobbly railings (Figure 29) were noticed throughout the inspection. It is recommended that the fixings in the aforementioned areas, as indicated on the plan in Appendix B, be addressed and the rest of the elevated access structures be periodically monitored for defects and repaired/ strengthened accordingly.

Figure 28: Roof Access Structure – Missing Bolts

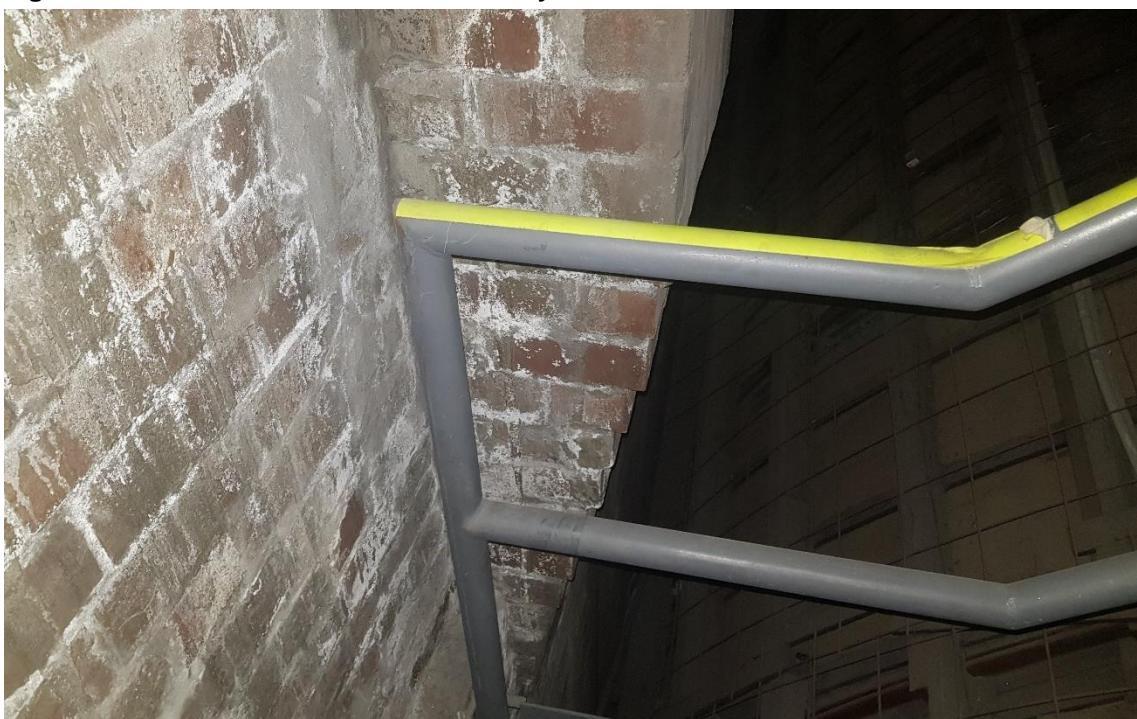
Figure 29: Roof Access Structure – Wobbly Balustrade

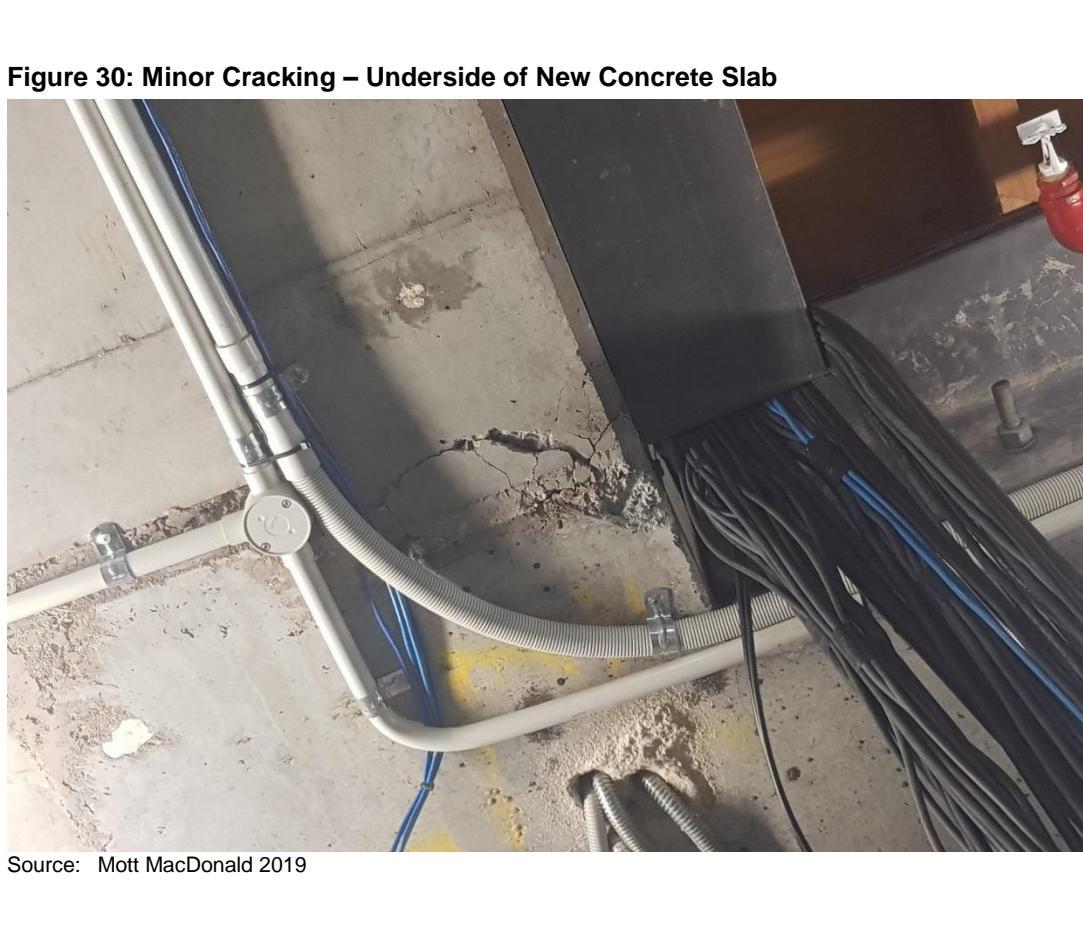
- Cracking due to embedded steel sections in the ground floor slab below the stage (Figure 30)
- Minor crushing of concrete pre-cast panel due to a steel member above (Figure 34)

Cracks throughout the building should be documented and monitored to determine if further movement is occurring. Cracks continuing to grow should be assessed and repaired if necessary.

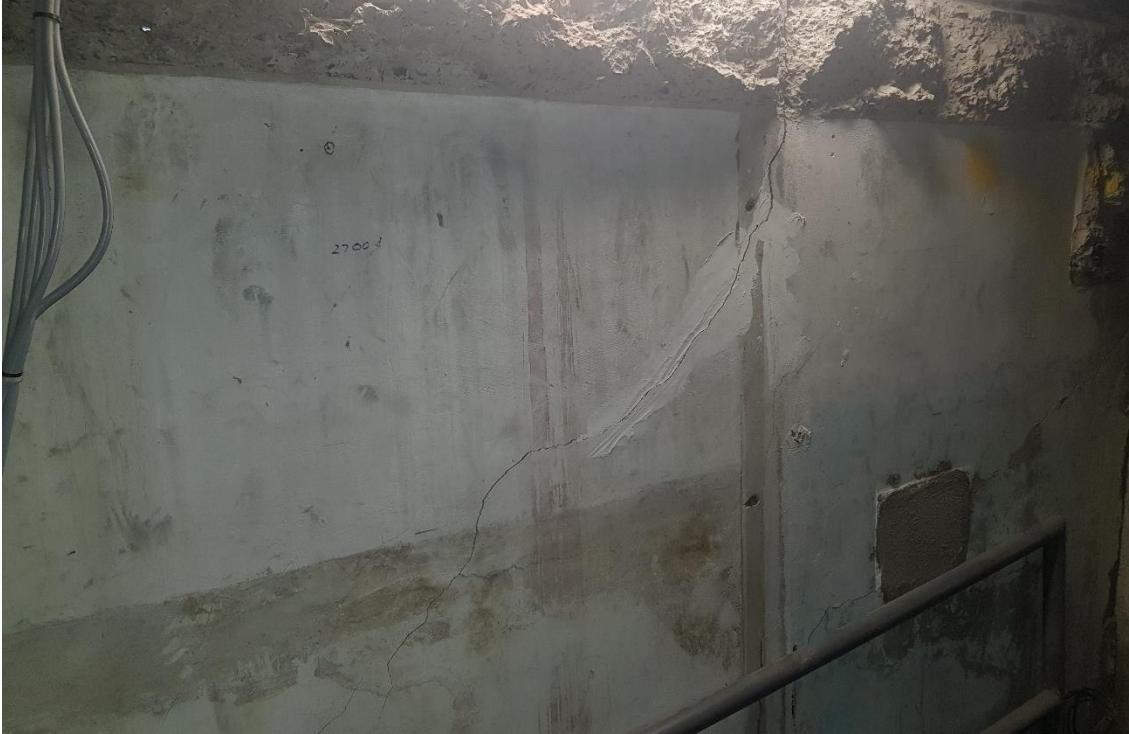
Cracking most likely due to minor building movement (Figure 31 - Figure 33, Figure 35 -Figure 37)

Figure 31: Minor Cracking – Diagonal Crack in the Cement Rendered Masonry Wall

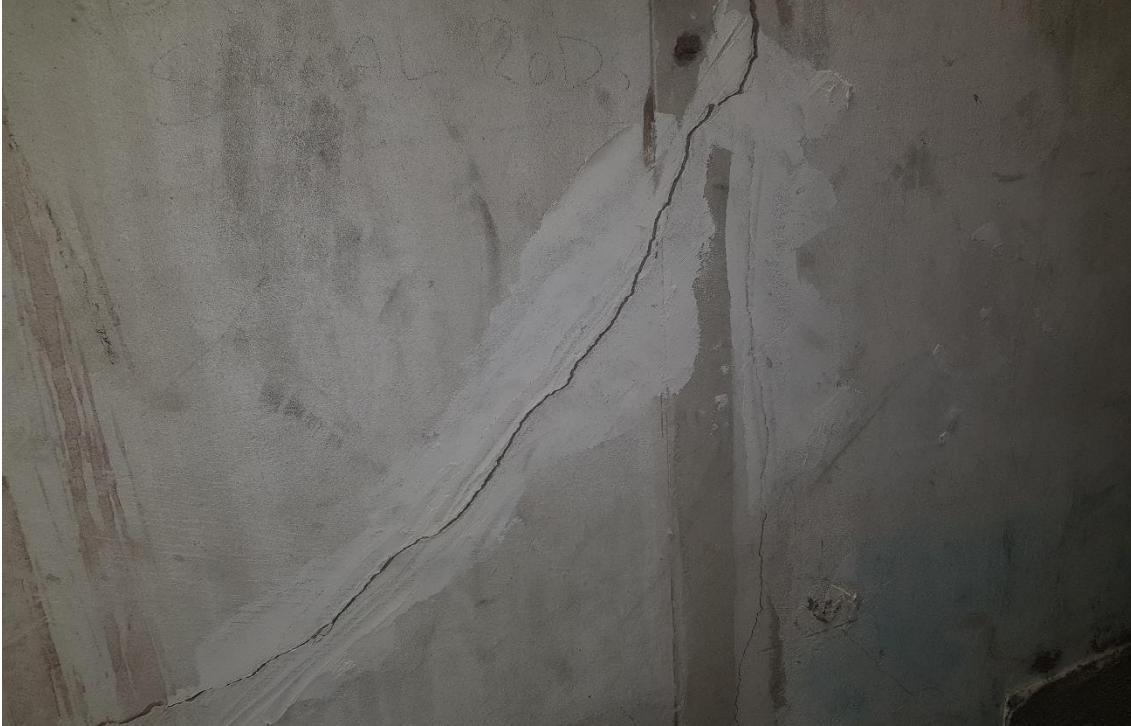
Figure 32: Minor Cracking – Close up of Cement Rendered Masonry Wall Crack

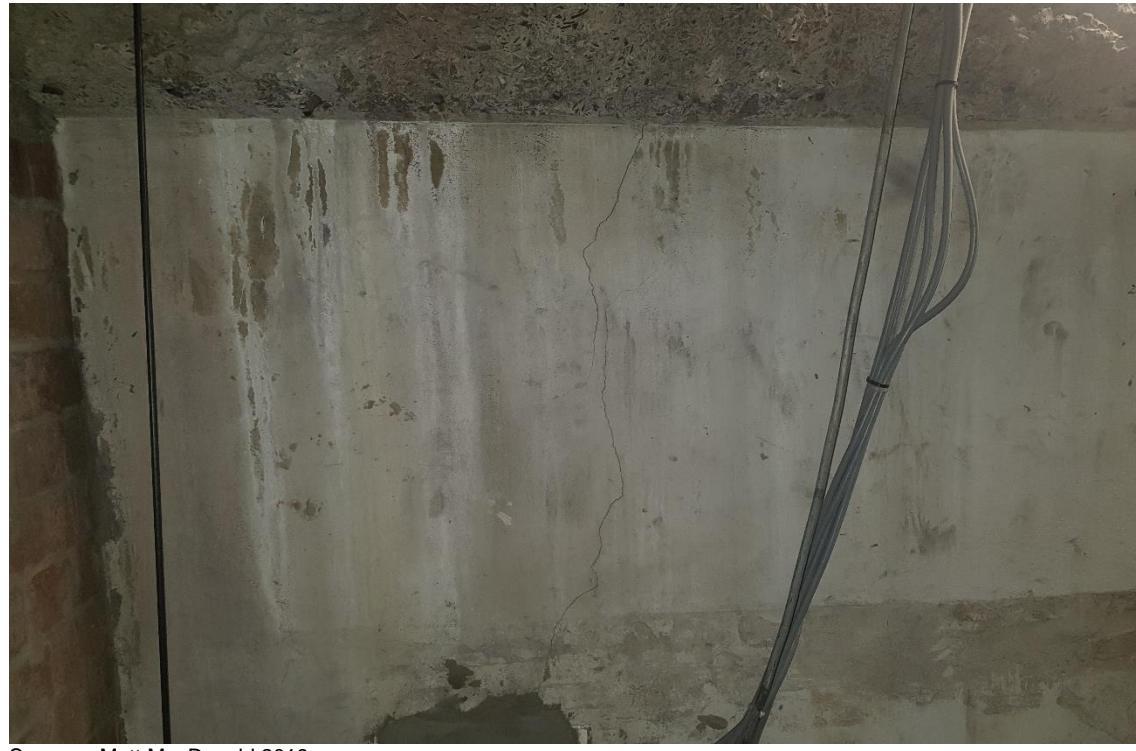
Figure 33: Minor Cracking – Cement Rendered Masonry Wall Crack

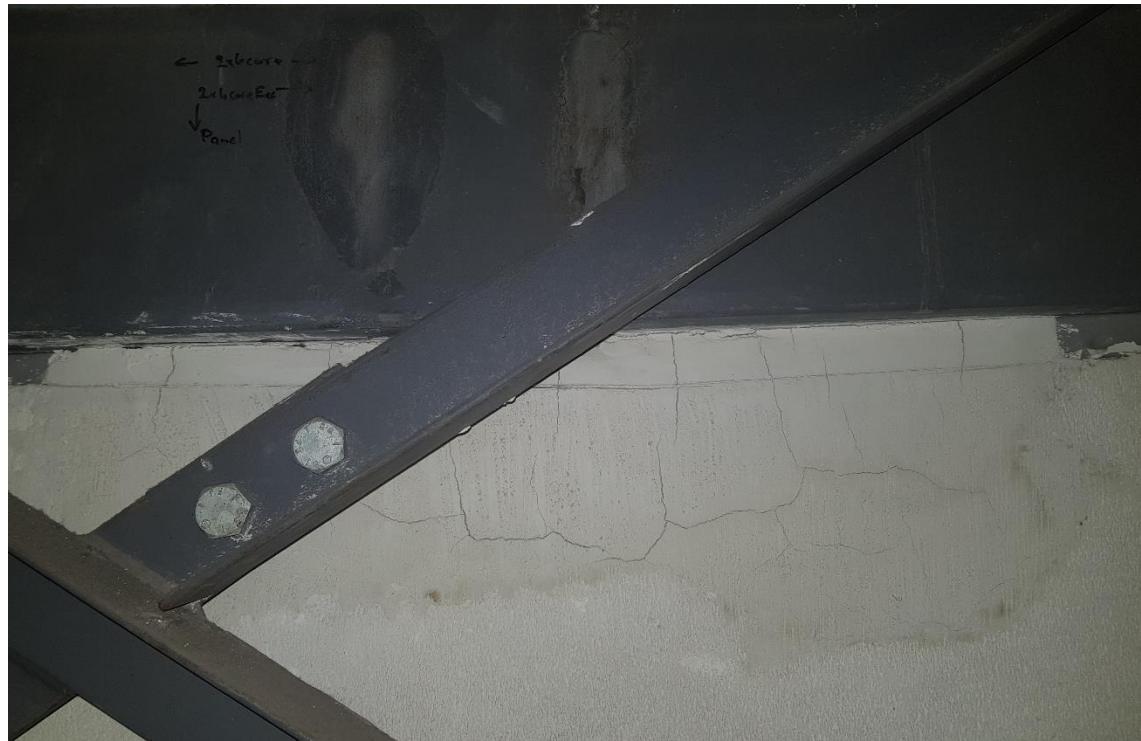
Figure 34: Minor Cracking – Crushing of Pre-Cast Panel below Steel Member

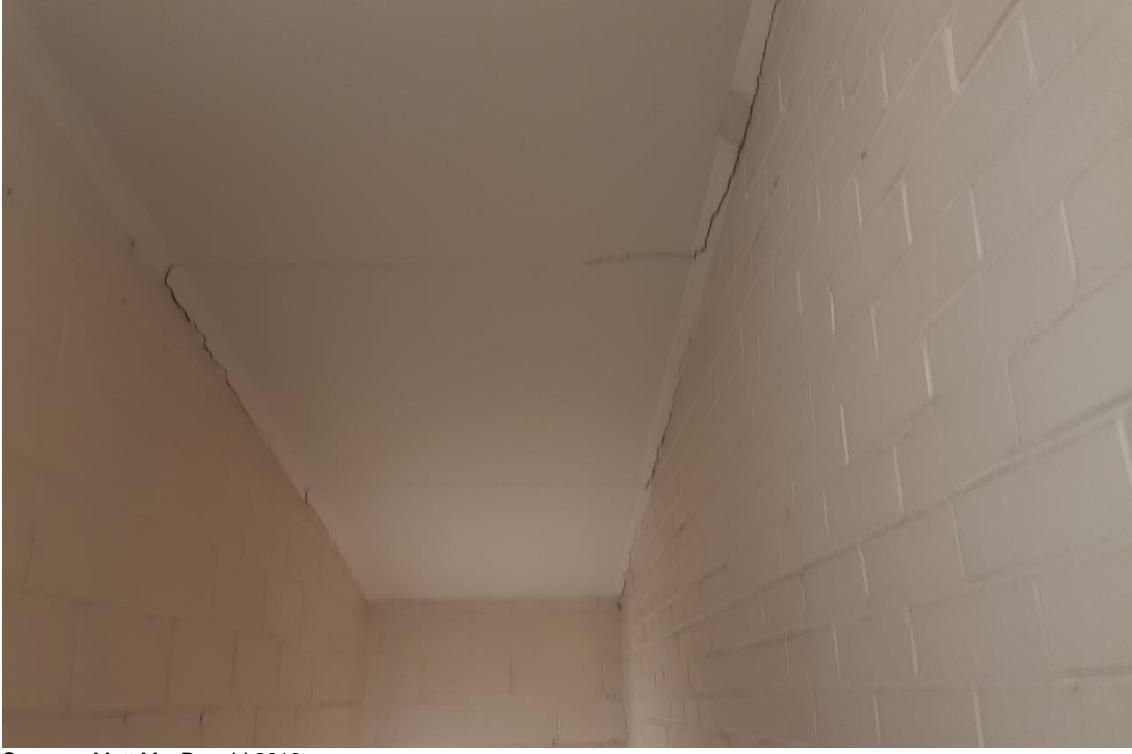
Figure 35: Minor Cracking – Stairwell Roof

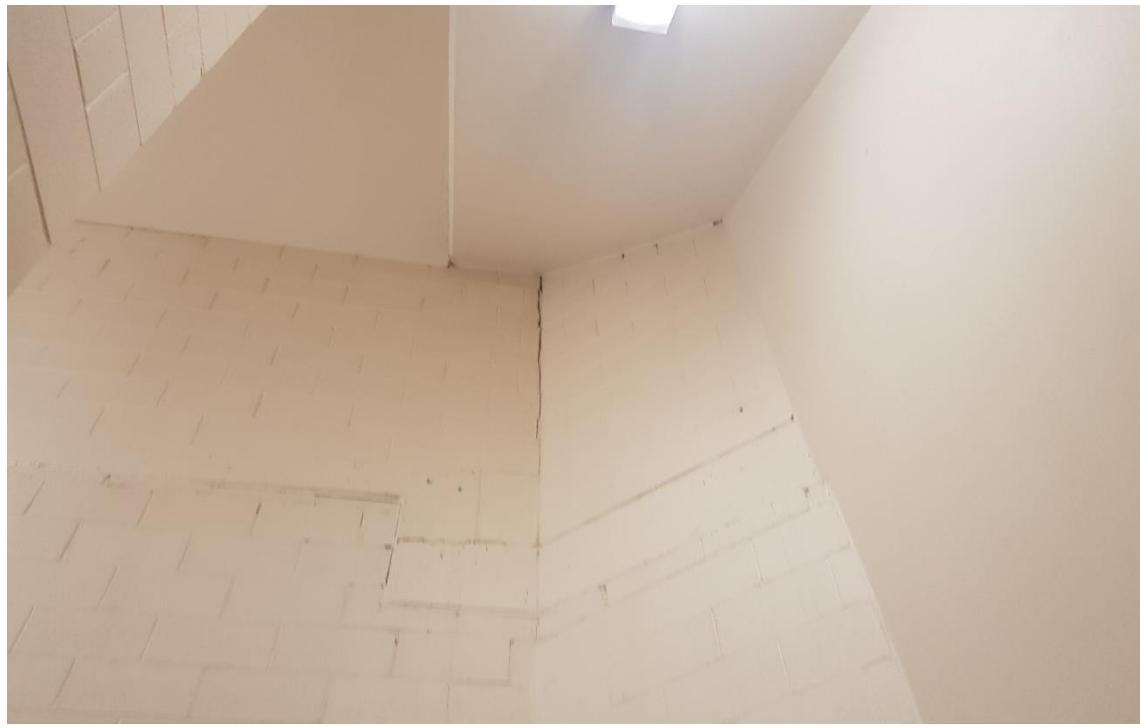
Figure 36: Minor Cracking – Stairwell Wall

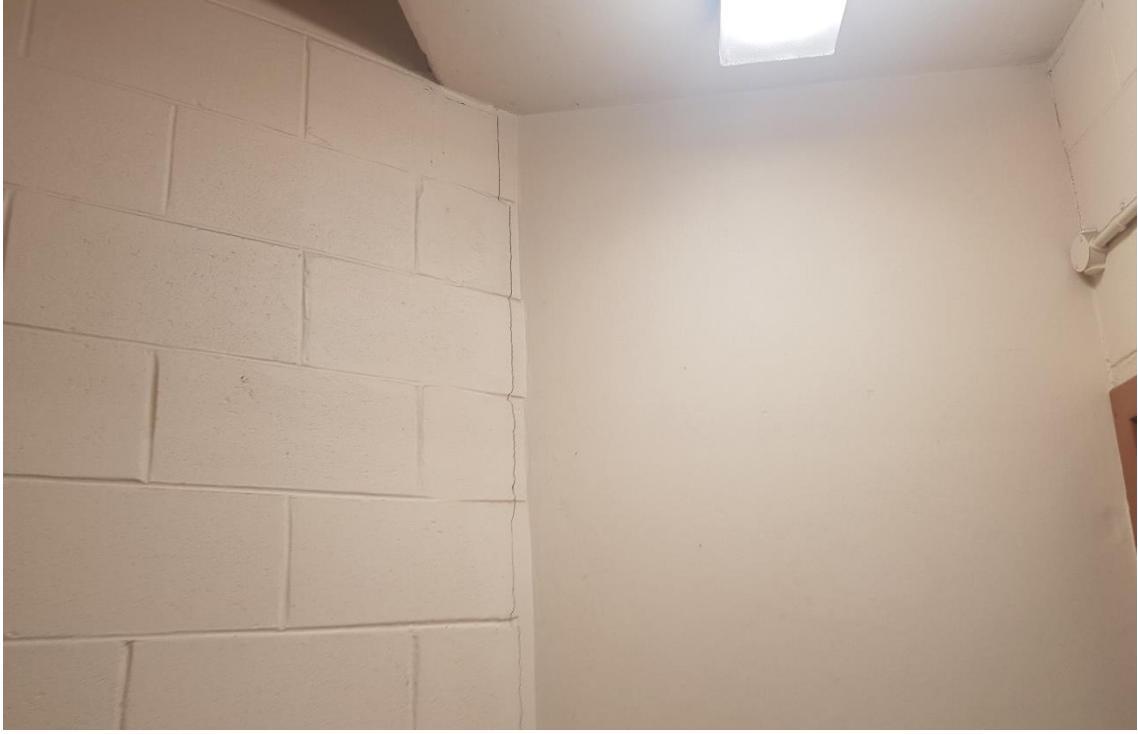
Figure 37: Minor Cracking – Stairwell Wall
