Hyde Park Tree Management Plan

The Hyde Park Tree Management Plan was proposed by the Council of the City of Sydney in October 2004, following the failure and consequent removal of several large trees from Hyde Park North and Hyde Park South.

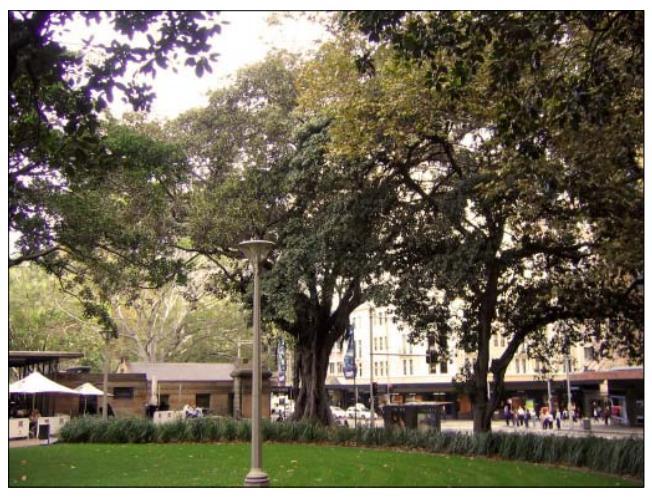
Figure 10: A *Ficus macrophylla* (Moreton Bay Fig), tree No. 211(N) and a *Ficus rubiginosa* (Port Jackson Fig, tree No. 210(N), located on the northern side of the entrance to St. James Station were planted prior to 1928. Both have root zone restrictions from the adjoining retaining wall and pavement.

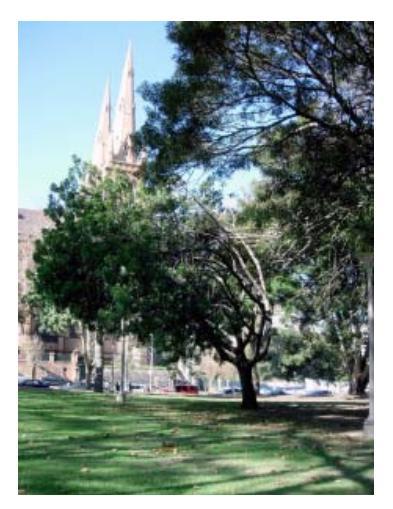
The middle section of this eastern precinct has also been over planted in an ad hoc manner, with many of the existing trees suppressed by the canopies of adjacent trees and no grass understorey.

Figure 12: Suppressed canopy of Harpephyllum caffrum (Kaffir Plum).

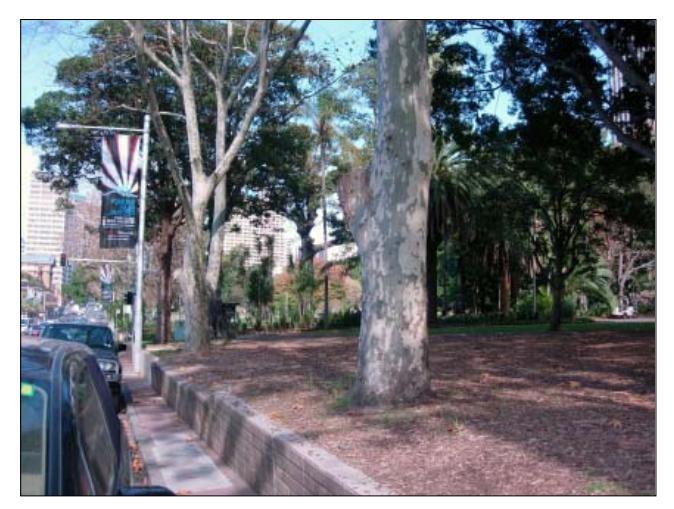
Figure 14: The trees on the College Street boundary have root restrictions from adjacent retaining wall.

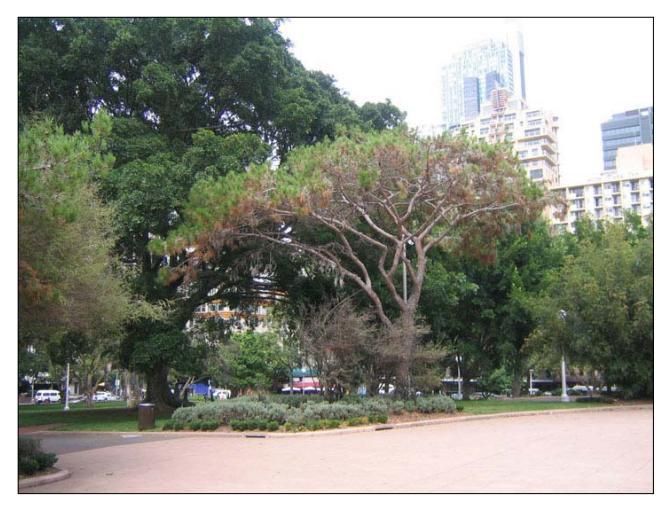
Many of the *Pinus halepensis* (Aleppo/Lone Pines) circling the ANZAC Memorial are in poor condition (Figure 16).

Figure 16: The *Pinus halepensis* (Aleppo Pines) circling the ANZAC Memorial are in poor condition.

The Aleppo Pines within the ANZAC Memorial's curtilage remain an important and significant element of reference and association and therefore the PoM & Masterplan will seek to suggest a more suitable planting location.

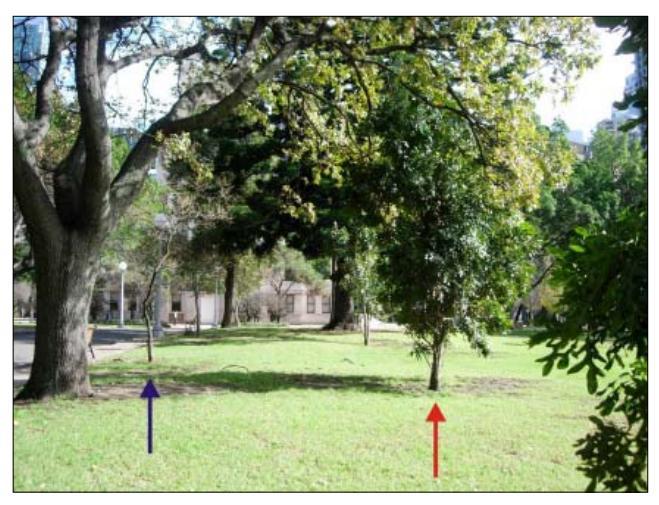
The Sapium sebiferum (Chinese Tallowwood) and Stenocarpus sinuatus (Queensland Firewheel Trees) that have been planted in this section of the Park, parallel to the existing Oak trees, have been suppressed and are in poor condition (Figure 21).

Figure 21: *Stenocarpus sinuatus* (Qld Firewheel, red arrow) and *Sapium sebiferum* (Chinese Tallowwood, blue arrow) have been suppressed and performed poorly.

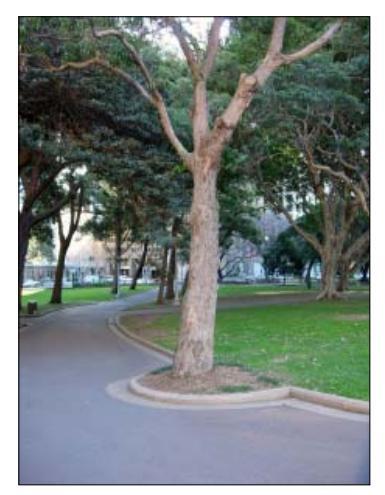
A major upgrade of the Pool of Reflection and the central avenue in Hyde Park South was completed in 1992. During these construction works a number of major tree roots were severed.

Figure 23: Lophostemon confertus (Brush Box) in Hyde Park South had roots severed during pathway upgrade.

It is difficult to predict the consequences of this damage, however it is highly likely that a number of these trees could fail during the next ten years. If major roots are severed a tree can immediately become liable to collapse (Lonsdale 1999).

The general debilitation of trees due to root severance can also make it easier for some decay fungi, such as *Armillaria sp.*, to invade and colonise the trees.

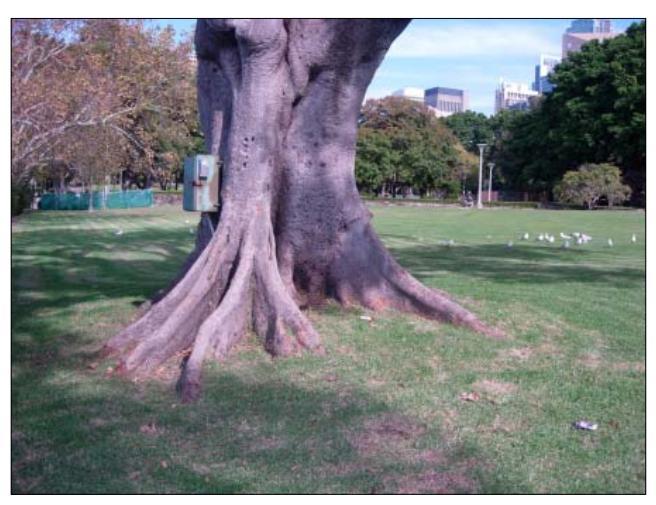
A number of the existing trees have basal injuries caused by heavy mowers and weed whippers (Figure 24). This type of damage, which is evident on the thick-barked buttresses of many mature specimens, can also allow the entry and development of decay fungi.

Figure 24: Mechanical damage to roots of *Ficus macrophylla* (Moreton Bay Fig) in Hyde Park.

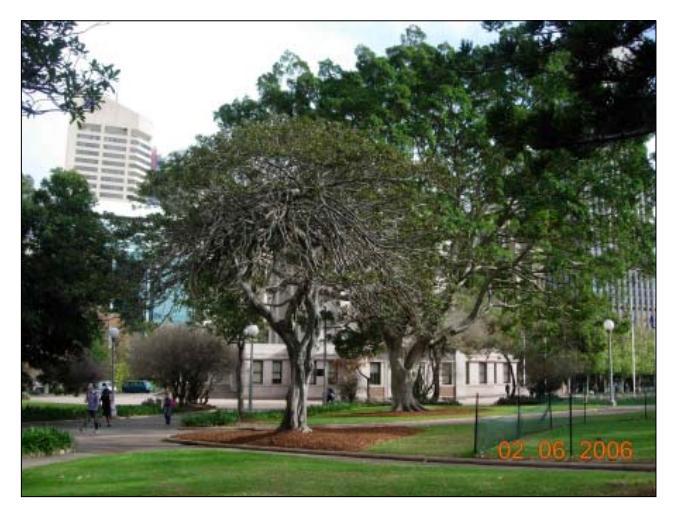
A number of the *Ficus rubiginosa* (Port Jackson Fig), in Hyde Park South, are severely stressed from root damage and soil compaction and this has resulted in defoliation and mild sunburn (figure 25). In several situations the soil around the root plates of these trees is compacted.

Figure 25: Defoliation of severely stressed *Ficus rubiginosa* (Port Jackson Fig) in Hyde Park South

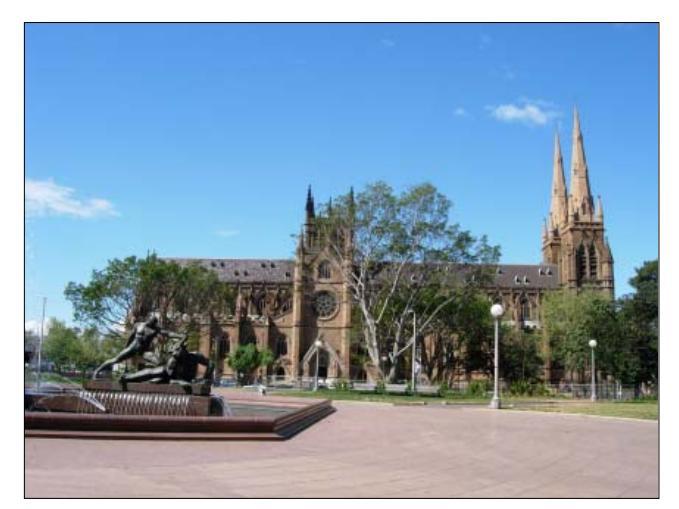
As the 1996 report predicted, several of the Hill's Figs growing in the central avenue and around the Archibald Fountain have been removed.

Figure 26: The Hill's Figs growing on the eastern side of the Archibald Fountain in Hyde Park North have ceased to provide the amenity commensurate with the importance of Hyde Park. The trees have been infected with *Phytophthora sp.* and are declining at a rapid rate. (Figure 26 shows the thinning canopies of these trees)

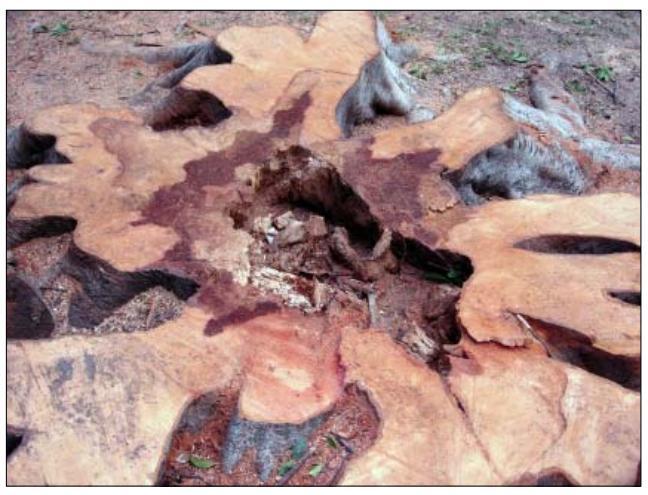
In August 2005 the investigation of the remaining trees in the central avenue was taken to a more detailed level and involved the removal of soil from specific locations at the base of the trees, using an Air Knife. Excavation by Air Knife is a non-destructive method of soil removal. This method has proven to be the most successful in gaining access below the root crowns to determine if the trees have decay or cavities. The results of these detailed tree assessments identified that 34 trees required immediate removal to ensure public safety. The trees were removed on 19 September 2005.

Figure 27: Decay within the trunk and buttress roots of a Hill's Fig that was removed on 19 September 2005.

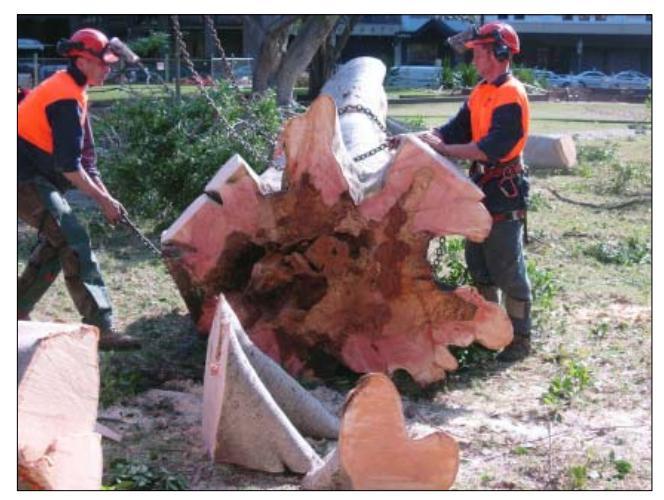
Figure 28: Removal of Hill's Fig infected with Phellinus sp.

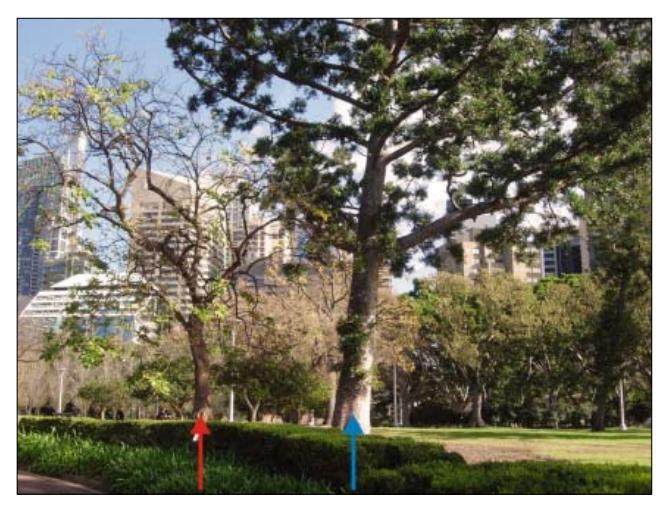
Figure 30: The *Erythrina sykesii* (Coral Tree, red arrow) which has been planted under the canopy of the *Agathis robusta* (Kauri Pine, blue arrow) is crowding the natural form of the larger tree.

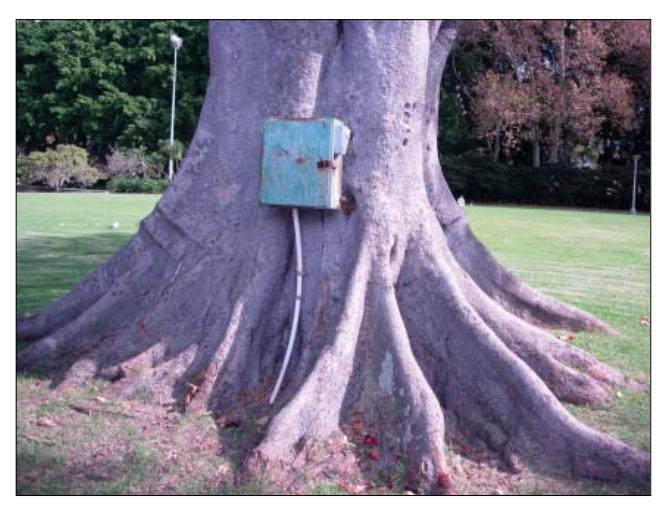
Figure 35: Past practices to accommodate events have seriously compromised the health of the trees.

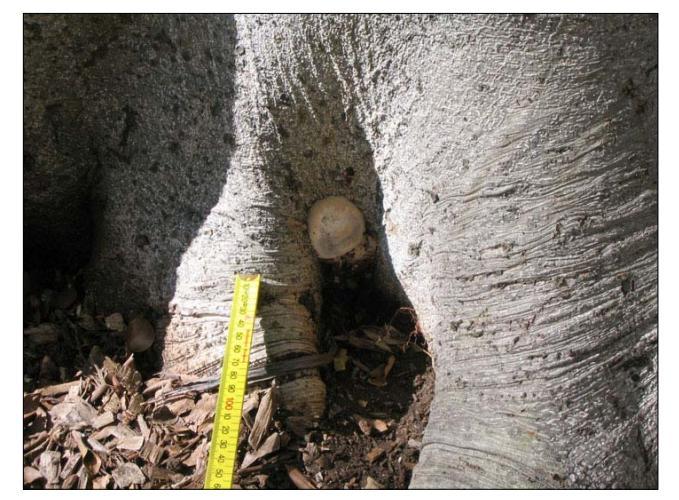
Figure 36: Fruiting body of Phellinus sp. detected by Council officers on 4 May 2005, on tree No.70(S), a Hill's Fig located in the central avenue of Hyde Park South.

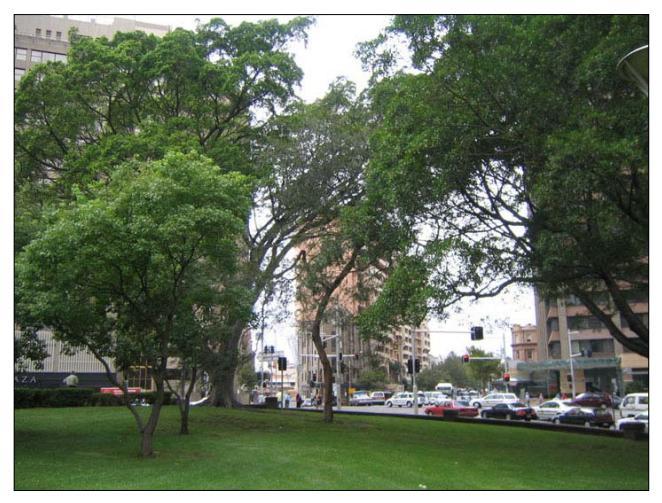
Figure 37: *Ulmus parvifola* (Chinese Elm) suppressed by adjacent Fig tree.

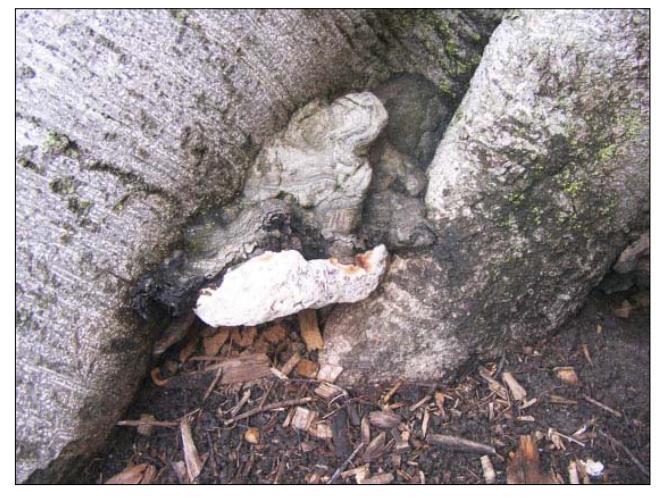
Figure 42: Fruiting body of Phellinus sp.

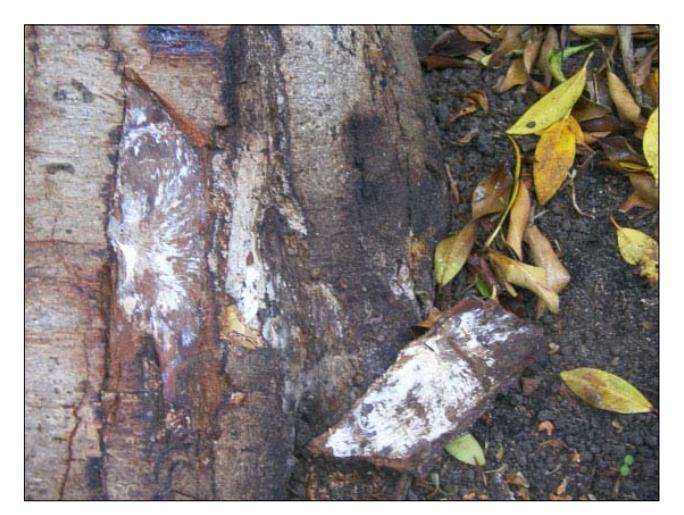
Figure 43: White threads of fungi growth under the bark trunk indicate that the tree is infected with *Armillaria luteobubalina*.
