arboricultural impact assessment report

AIA-01

Revision A, Issued for Planning Proposal 13 May, 2020

GLEBE MID-RISE PROJECT

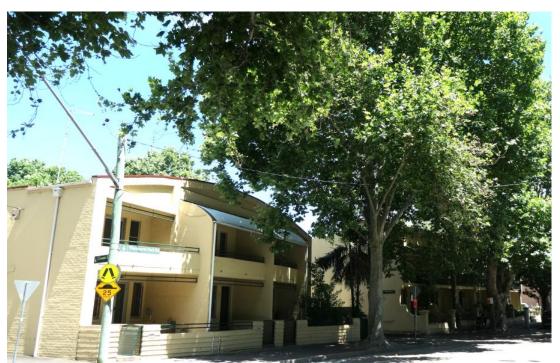
Figure 3 – 2 Wentworth Park Road. Note Platanus x acerifolia (London Plane Tree) street tree (T01). (Image: Arterra, Nov. 2019)

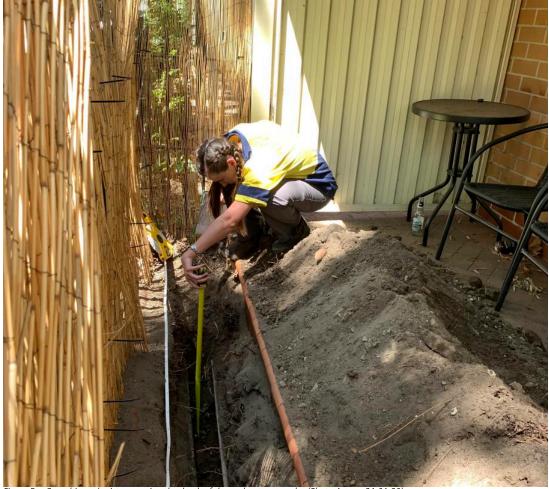
- There was evidence of roots on the western side of the T13 tree having previously been cut, possibly to accommodate footpath or services installation and or repairs.
- Trenching exposed a substantial concrete footing for the boundary hob brick wall at a depth of 300mm
- A copper water pipe was exposed at a depth of 300mm and ran along the face of the adjacent verandah on the western side of the trench.
- The first substantial root that was exposed at a distance of 4.7m from the BM, 70mm Ø, depth 340mm, growing through PVC pipe and perpendicular to boundary wall. The direction of growth, towards the boundary wall, indicated that the tree of origin was within the site. Given the direction of

- No roots from T13 *Grevillea robusta* (Silky Oak) CoS street tree, were encountered in the exploratory trench to a depth of 600mm on the western side of the site boundary wall.

Figure 5 – Consulting arborist measuring the depth of the exploratory trench. (Photo Arterra 21.01.20)

Based on the above, it is our conclusion that no major roots from the street tree, (T13) *Grevillea robusta* (Silky Oak), remain or were encountered within the exploratory trench immediately inside the site boundary wall. The trench was excavated to a depth of 600mm for a distance of 4.5m along the boundary immediately adjacent to the subject tree. We therefore believe that excavation within the site can be undertaken for the proposed building with minimal impact to the tree. The required setback of the building has therefore been set to primarily limit the required pruning of the canopy that overhangs the site to acceptable levels. No root impacts are expected to this tree as part of the works.

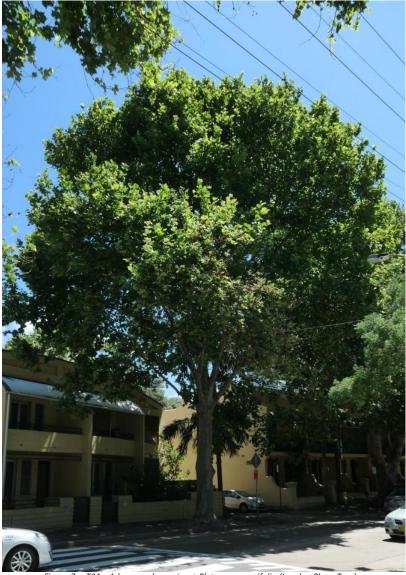
The proposed development is likely to result in an incursion from the pruning required to provide clearance to the tree for the construction of the upper levels of the building facing Wentworth Park Road. The proposed construction of the building has been set back to accommodate this tree. It has been calculated that the removal of roots to the southern side of the tree represents an incursion of approximately 7% of the nominal TPZ. According to AS4970-2009 this is considered a minor incursion and unlikely to adversely affect the condition of the tree in the longer-term. It is proposed that the existing structures between the proposed building and the tree will be carefully demolished and any roots existing below these structures will be retained and protected. It is the author's opinion that the proposed new structures to achieve access and landscaping in front of the proposed building can be built in a way to minimise the loss or damage of the existing roots.

Figure 7 – T01 - A large and prominent Platanus x acerifolia (London Plane Tree) – Street tree adjacent to 2 Wentworth Park Road.

Some canopy pruning will be required to the southern side of the tree to accommodate the new building and clearance for construction period scaffolding. This pruning is considered acceptable and is dealt with more specifically in Section 3.2 - Canopy Pruning and Methodology.

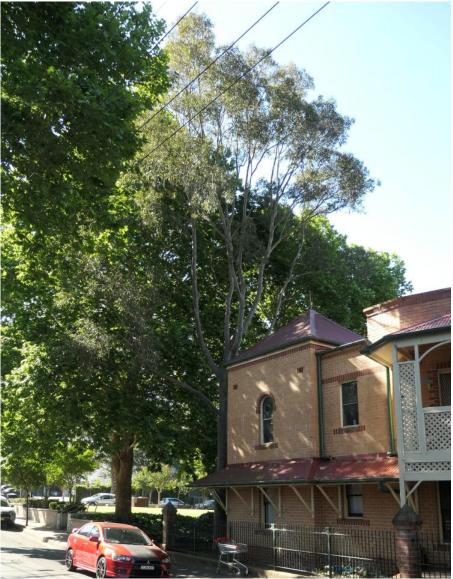
The building and basement has been designed to retain this tree with a nominal incursion of 10%. The existing ground levels around the tree are proposed to be retained. A portion of the ground level terrace building structure does further encroach over the root zone, however this has been designed to sit above the existing

surface levels in an area that is already largely impacted by the pre-existing buildings (to be demolished). It is the author's opinion that this can be constructed with minimal impact to the tree if appropriate construction period measures are put in place and no excavation takes place in this area apart from supporting piles. The high branching nature of this tree means that the existing canopy and branches can be retained without the need for any pruning.

Figure 8 – T06 - A Corymbia maculata (Spotted Gum) on the site in the south-west corner.

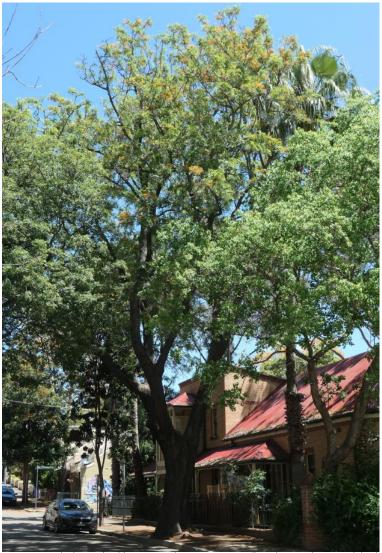
<u>T13 – Grevillea robusta</u> (Silky Oak). This is a very large street tree located on the eastern side of the proposed development. It is 18m tall with a canopy spread of 14m. It has a significant main branch crossing the eastern boundary at approximately 9.0m in height above the footpath level. This tree also forms part of the heritage listed group of street trees along Cowper Street, which include *Grevillea robusta* (Silky Oak), *Flindersia australis* (Australian Teak) and *Castanospermum australae* (Moreton Bay Chestnut) species. This results in this tree having greater significance in the landscape and should therefore be retained as part of the development. Though the tree is heritage listed, due to the tree being a less than desirable and somewhat invasive species and an older specimen with some defects it has been given only a 'Moderate' retention value.

development of the site. In Arterra's opinion, basement excavations for the proposed development, as long as they are within the site boundaries, are unlikely to significantly impact this trees health or stability.

Figure 9 — View from Cowper Street looking at 'High' retention value tree — T13 Grevillea robusta with proposed development site beyond to the right. (Photo: Arterra 05/11/19)

Though basement excavations may not cause significant impact to the tree or restrict development at the ground level, it is still important to consider the extent of the proposed development above ground with respect to the existing canopy which overhangs the site to the west. This has constrained the building setback and extent of development on the eastern side of the site. Major pruning works that would remove substantial foliage or branches and make the tree lop-sided would not be supported by the Council.

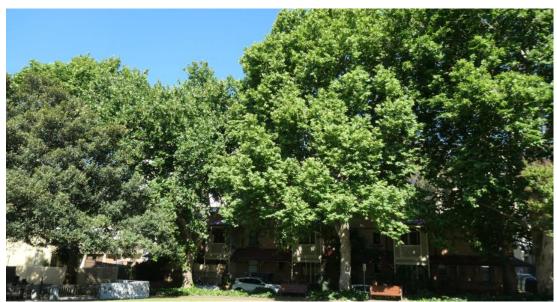
T02, T03, T04 & T05 – *Platanus x acerifolia* (London Plane). This is a row of four very visually and environmentally significant trees. These trees are situated to the west of the site, within the adjoining MJ Doherty Reserve and adjoining Mitchell Lane. These trees have been rated with a 'High' retention value. They have relatively large spreading canopies that extend over Mitchell Lane and are within close proximity to the site. These 'High' value trees provide good landscape amenity and serve to screen and soften any proposed development from the adjoining reserve and will provide a level of 'instant landscape' to any proposed building setting. Being large and deciduous trees they also provide excellent summer shade together with winter sun to the reserve and the development site. It is our assessment that these trees will have minimal to no impact from the proposed development.

Figure 10 — View to the east from MJ Doherty Reserve looking at 'High' retention value trees - TO2, TO3, TO4 & TO5 Platanus x acerifolia with proposed development site beyond. (Photo: Arterra 23/10/19)

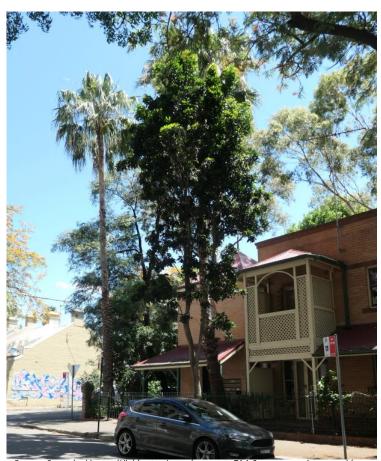
The other remaining 'High' value tree is a street tree T14 *Stenocarpus sinuatus* (Queensland Firewheel Tree). This tree ties in with two others, T15 & T16 of the same species which are of 'Moderate' retention value. The moderate value trees are smaller more recently planted specimens. This species are nominated as the preferred tree species in the current CoS's Street Tree Master Plan for Cowper Street. They should be retained and protected.

Figure 11 — View from Cowper Street looking at 'High' retention value tree — T14 Stenocarpus sinuatus with proposed development site beyond. (Photo: Arterra 05/11/19)

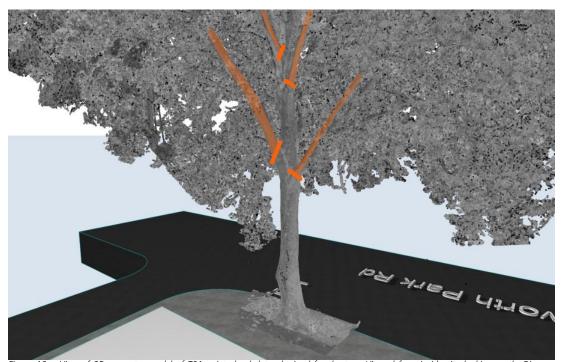
Figure 16 — View of 3D computer model of T01 point cloud data obtained for the tree. Viewed from inside site looking north. Diagram indicates the proposed branches and proposed line of pruning to be undertaken to achieve appropriate clearance for building and scaffold . (Image Source: Arterra)

Branch Qty and Size at Cut	Comment / Notes								
1 x 150mm	Lowest branch to southern side of tree taken back to trunk								
1 x 100mm	Mid canopy to southern side of tree taken back to trunk								
1 x 100mm	To south-eastern side of tree taken back to trunk								
1 x 75mm	Lowest branch to south-eastern side of tree taken back to trunk								
3 x <50mm	Various small branchlets in upper canopy taken back to nearest appropriate								
	junction

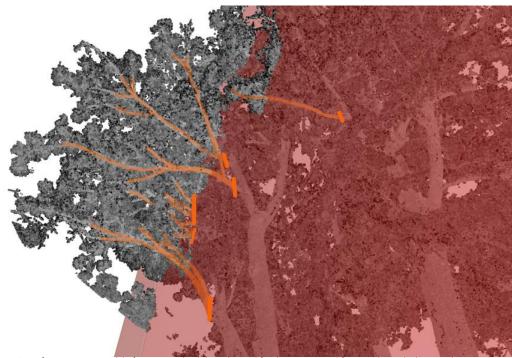
Figure 18 — View of 3D computer model of T13 point cloud data obtained for the tree. Viewed from inside site looking north-east. Diagram indicates the proposed branches and proposed line of pruning to be undertaken to achieve appropriate clearance for building and scaffold. (Image Source: Arterra)
