MASTERPLAN AND PLAN OF MANAGEMENT

MACQUARIE PLACE

1990

Lester Tropman & Associates

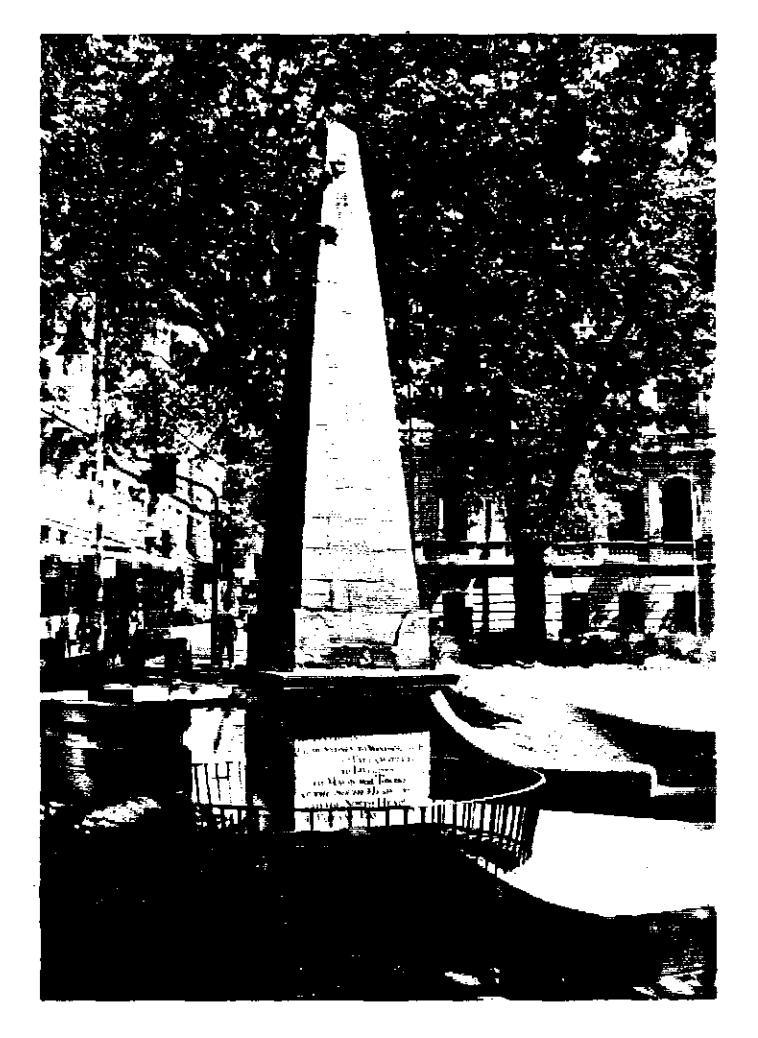
PLATE 4.1

The obelisk suffers from rising damp, bringing with it rising salts which accumulate under the cornice and at the base of the obelisk. This aggravates the problem of stonework and mortar deterioration. Dirt has also accumulated, staining the sandstone, particularly on ledges and weatherings.

Further deterioration of this historic landmark will diminish its aesthetic, and historic significance. It must be preservatively treated as soon as possible.

The obelisk should undergo preservative treatments as recommended in the obelisk restoration report (see Appendix A). The report's recommendations are summarised below:

- The decorative acroteria details need to be brushed down, coated with retardant, and applied with coats of silicone rubber of a colour similar to sandstone.
- Some stonework to be replaced, joints chalked prior to cleaning, and mortar restored.
- The foundations of the obelisk are to be inspected to verify stability.
- Accumulated salts are to be removed by cyclic periods of saturation and then washing down of the salt affected areas.
- Return the ground around the base of the obelisk to its original level.

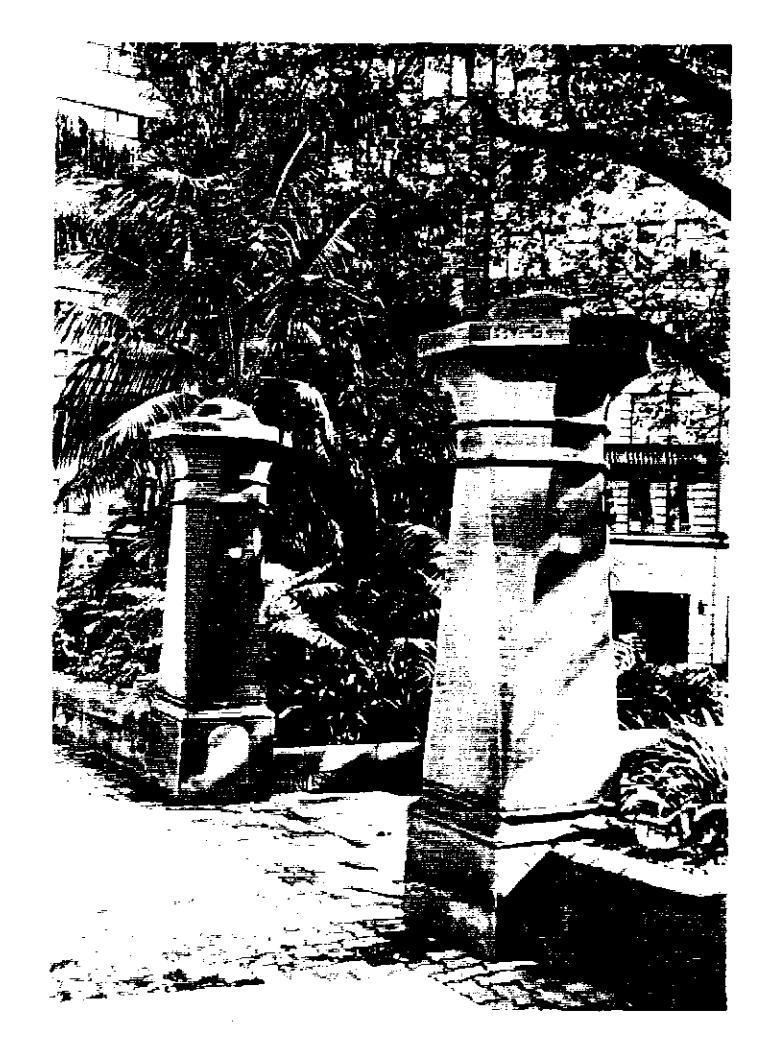
PLATE 4.6

The gate posts are generally in good condition. The cavities for the original iron gates have been grouted over. Markings on the gate posts themselves suggest that the position of the gate posts may have been changed during this Century.

Engraved gate posts show evidence of relocation on base portions. Sockets for iron gates are also evident.

Maintain.

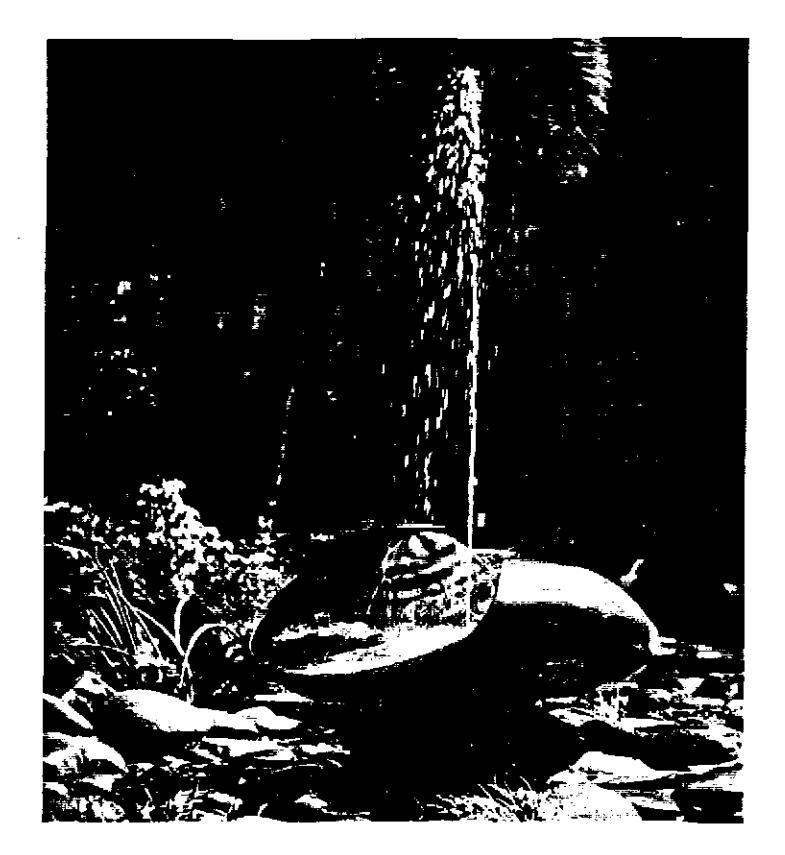
PLATE 4.8

Gerald Lewers' fountain.

- Thoroughly clean and repair fountain to remove dents and clear water jets.
- Relocate fountain to a more suitable position, not necessarily in Macquarie Place (any new location of the Lewers' fountain is to be advised by Council).
- Remove surrounding pond.

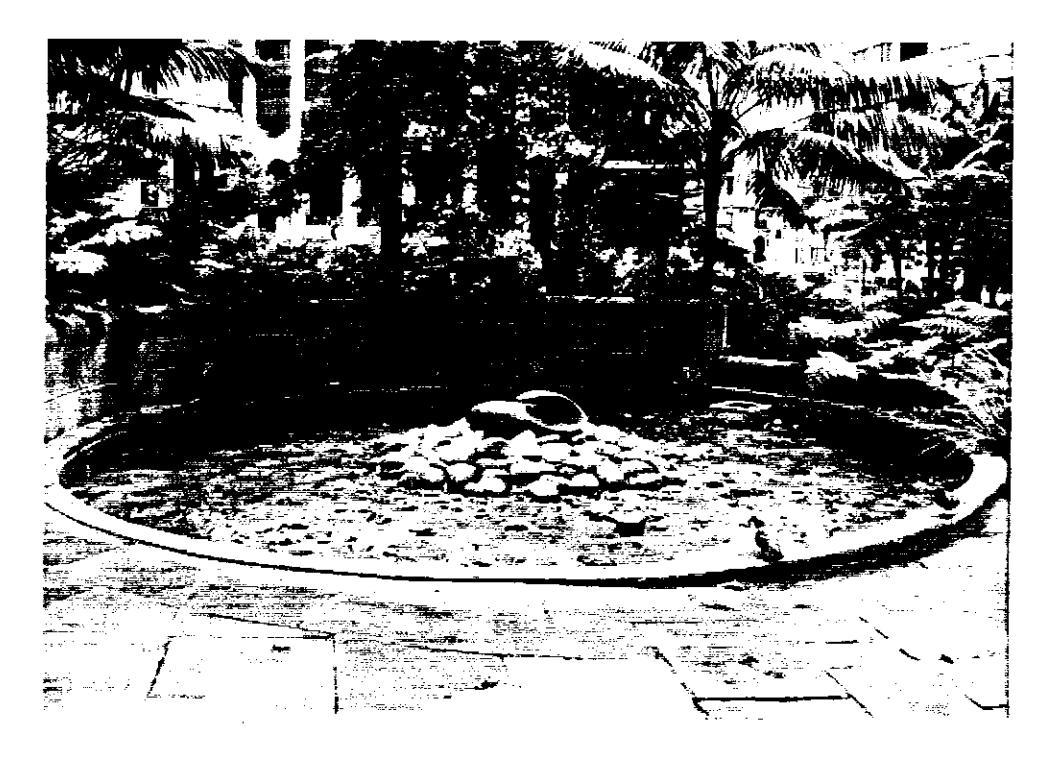
PLATE 4.9

The circular pond in which the Lewers' fountain has been placed is an inappropriate setting for such a small informal fountain.

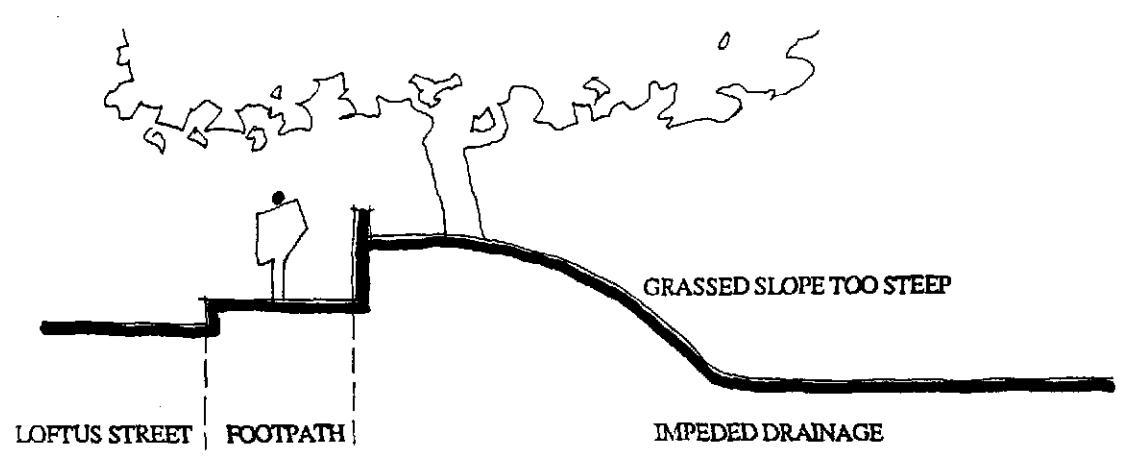
Certain low points in the turfed area are susceptible to poor drainage due to the heavy clay soils and the severe embankment slopes. The section below shows the large area of grass which is often too wet to sit on. Even when dry, however, people often prefer to sit on elevated areas.

- Grade the slope more evenly so that the slope is more comfortable to sit on, and there are fewer drainage problems.
- A series of agricultural subsoil drains connected to the stormwater system should be installed to further assist in draining the Park.

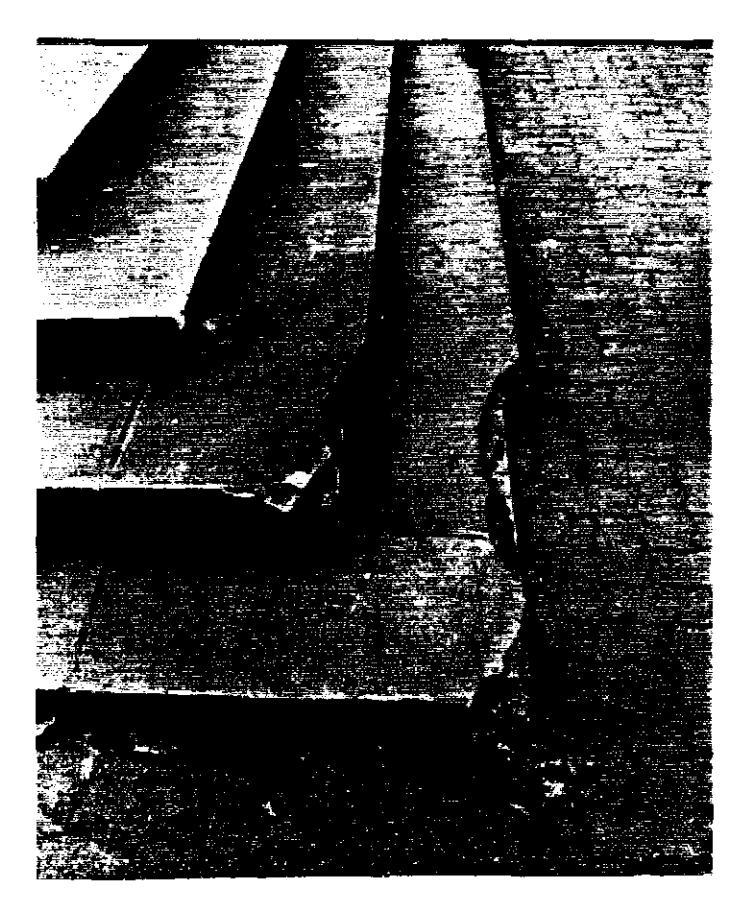
PLATE 4.12

The steps are badly damaged due to the overhang tread detailing. The podium also has several functional liabilities:

The steps are badly damaged and slabs often require replacement.

Remove the podium and reinstate a straight edge to the Park and create smaller entries that will not encourage drinkers to enter the Park.

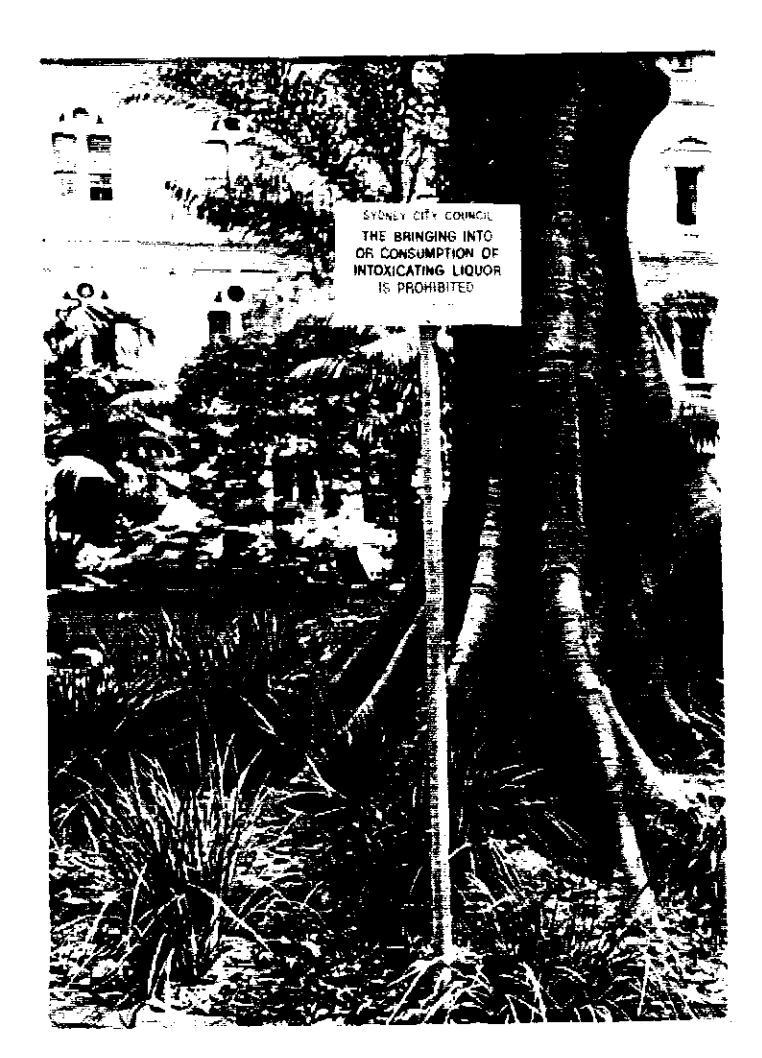
The removal of the podium opposite the Customs House Hotel would make the use of such signs unnecessary

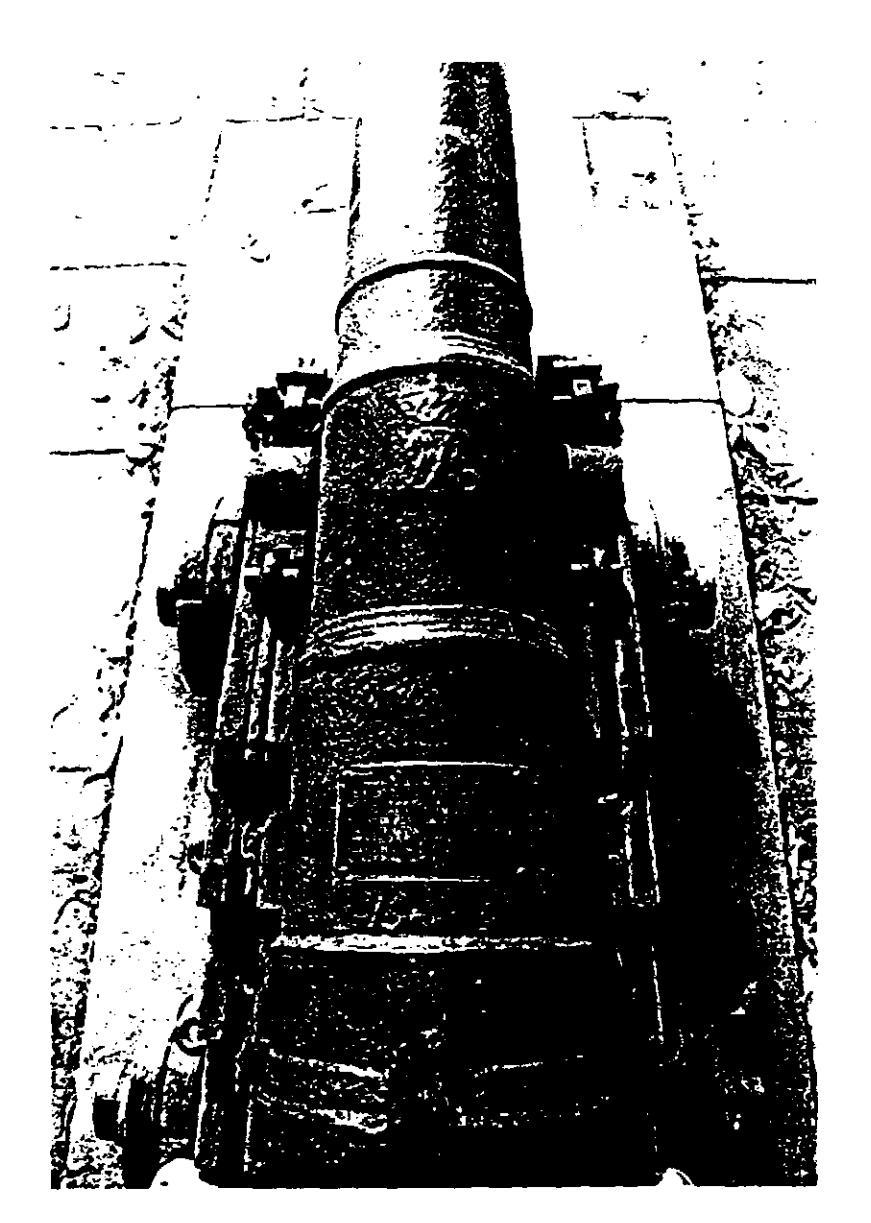
Fig. 5 Near the vent hole spots of the black micaceous iron oxide top coat are missing revealing the red oxide under-coat.

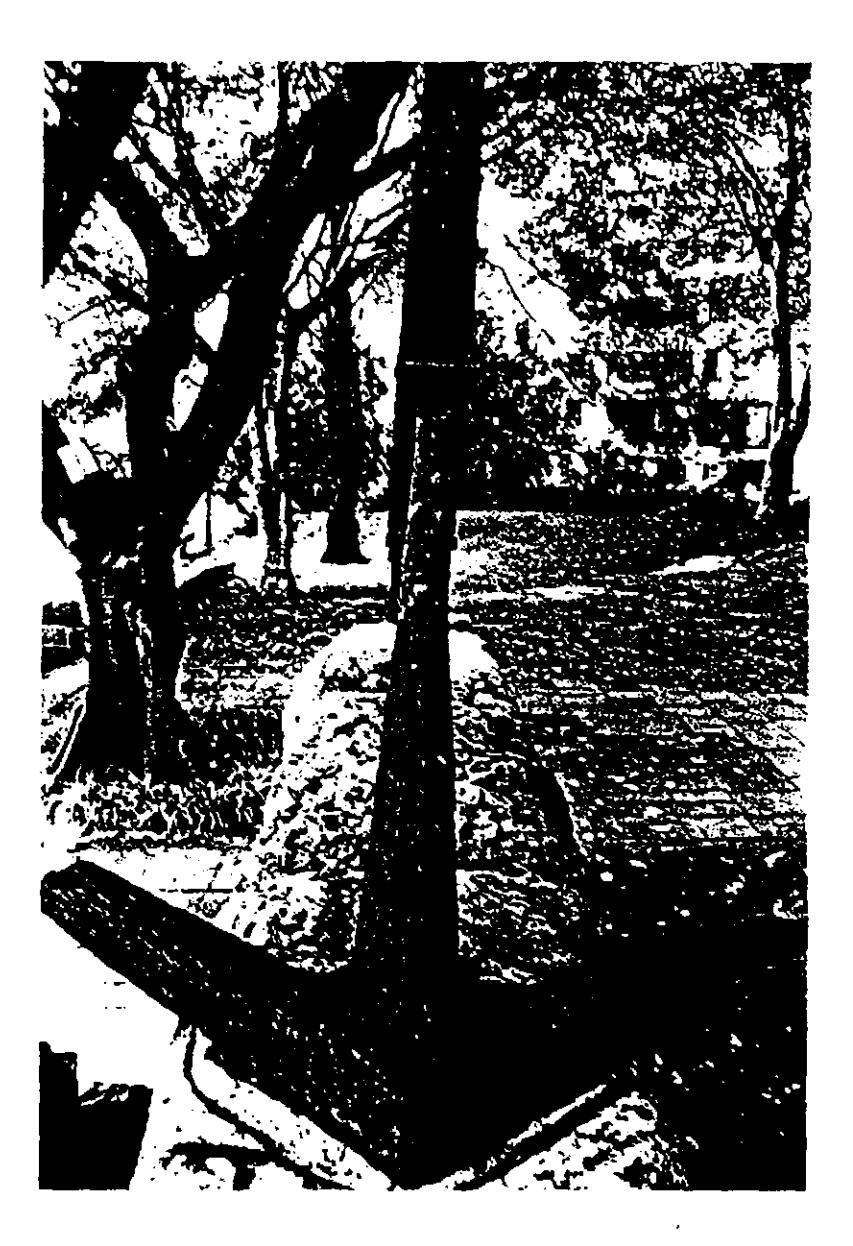
Fig. 9 Sirius anchor showing the typical wood grain appearance of corroded wrought iron.
