# **CONSERVATION MANAGEMENT PLAN**

**CAPITOL THEATRE,  
HAYMARKET**

**3-21 CAMPBELL STREET,  
HAYMARKET**

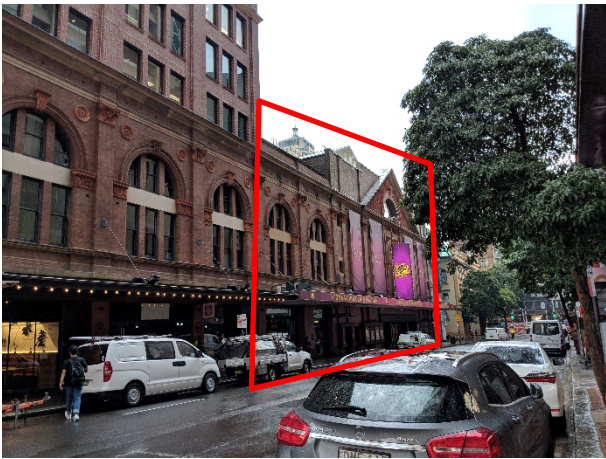
Figure 10 – View of Campbell Street elevation which continues the Manning Building elevation, with the Capitol Theatre elevation outlined in red.

The first floor elevation of Campbell Street features the most detailed fabric of the elevation. Each pilaster at first floor are surmounted by moulded terracotta capitals. Sandstone string courses run across the length of elevation. The east-most portion of the elevation continues the arched openings of the Manning Building. Two large arched openings, divided by a concrete spandrel and double hung, timber framed windows are featured, with moulded brick surrounds, terracotta keystones, and moulded terracotta imposts. Moulded terracotta medallions also adorn the façade above the arched openings. The remainder of the first floor elevation is characterised by a series of five bays, with a central infilled arched opening matching that of the other arched openings, with moulded terracotta spandrels and terracotta friezes above. Four infilled stuccoed bays flank the central arched opening. Small casement windows are located above each opening. Each of these five bays are obscured by the temporary fabric theatre signage. At the western-most end of the elevation at first floor is a vertical metal sign with neon lighting reading 'CAPITOL' and neon peacock (the symbol for the Capitol Theatre).

The second floor elevation of Campbell Street has a brick pediment featuring a central semi-circular lead light window, surrounded by moulded brickwork and terracotta key stone with sandstone scroll pediment. The pediment is decorated with moulded terracotta tiles with floral motifs and features a sandstone cornice. Either side of the pediment is a brick parapet which continues the expression of pilasters from the floors below.

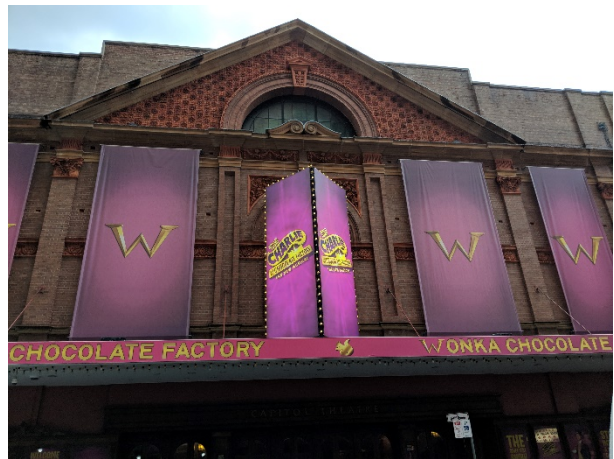
Figure 13 – Pediment at Campbell Street

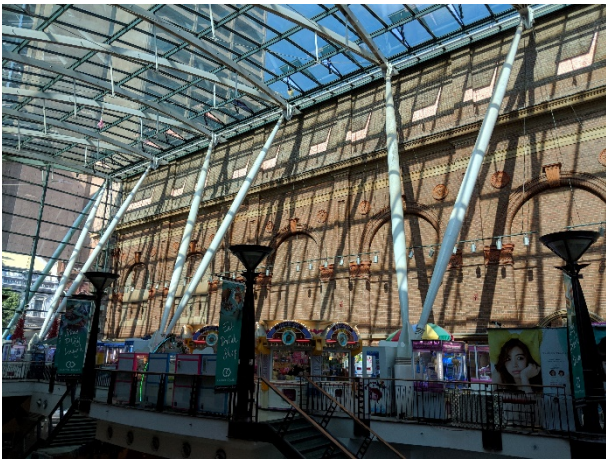
Figure 18 – West elevation viewed from the interior of Capitol Square

The west elevation, located within Capitol Square, is obscured at ground floor by the series of shops built within the complex. The first floor elevation continues the detailing of the Campbell Street elevation, with brick pilasters and moulded terracotta capitals which divide the elevation into bays. The sandstone string coursing continues from the Campbell Street elevation and across the length of the west elevation. Seven blind arch openings are featured across the elevation, with moulded brick surrounds, terracotta keystones, and moulded terracotta imposts. Moulded terracotta medallions also adorn the façade above the arched openings. The second floor of the elevation continues the brick parapet from Campbell Street which continues the expression of pilasters from the two floors below.

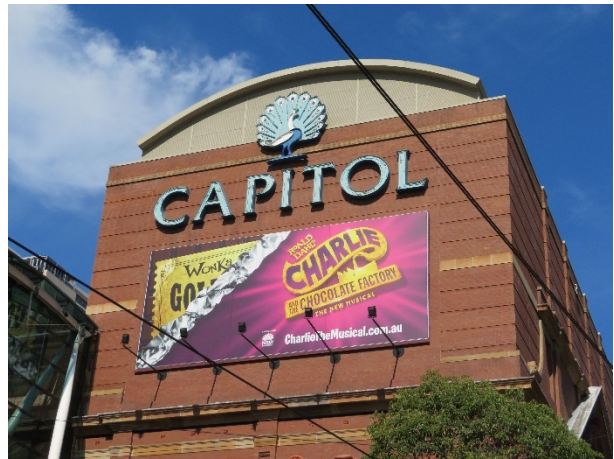
Figure 21 – Flytower west elevation

The south portion of the elevation is the fly tower, which is visible from Hay Street. This portion of the elevation was constructed during the 1990s redevelopment works. The elevation rises to a height of around six storeys, and features indented brick banding. A large temporary poster board covers a large area of this portion of the elevation. Above is a metal and neon sign reading 'CAPITOL' with a neon peacock above. The curved metal roof of the flytower is visible above.

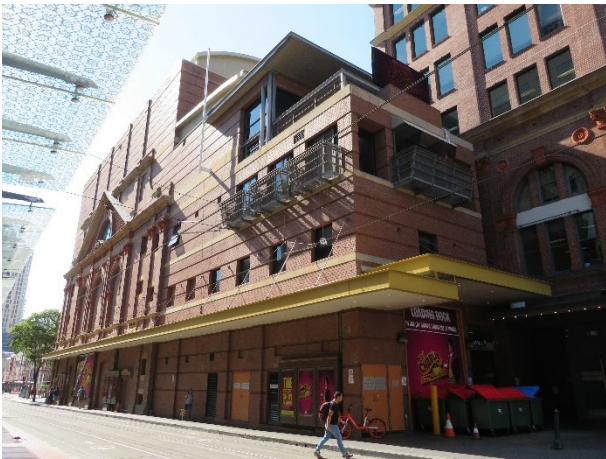
Figure 22 – Hay Street elevation

The south elevation along Hay Street continues the details of the elevations. The east portion of the elevation was constructed in the 1990s as part of the redevelopment works. The ground floor of the earlier elevation (1927) features a series of blind openings set within the bays of the pilaster. The plinths of each of the pilaster are trachyte. Sandstone arched lintels and sills decorate the smaller blind openings of the elevation. A narrow metal awning divides the ground floor from the first floor. At the first floor of the earlier elevation, are three blind arched openings with features moulded bricks, moulded terracotta keystone, spandrels and imposts. Two sandstone Juliet balconies are located either side of the arched blind openings. Above the central arched blind opening are a series of moulded terracotta garland friezes. The second floor elevation features a matching pediment to the Campbell Street elevation, with semi-circular lead-light window surrounded by moulded brick, terracotta and sandstone detailing. The pediment is enclosed by a parapet, with sandstone detailing and blind brick openings. The elevation extends to the height of the fly tower continuing the 1990s brickwork of the west elevation with indented brick bands and concrete rendered string courses. The remainder of the elevation at its east side was constructed during the 1990s and continues the brickwork of the flytower with indented brick banding and rendered concrete stringcourses. Six square openings are located at the first floor, two being blind and four with awning windows. Three metal Juliet balconies adorn the elevation at the second floor with double-leaf aluminium framed doors. A terrace with metal balustrades is featured at the third floor and steps the building back.

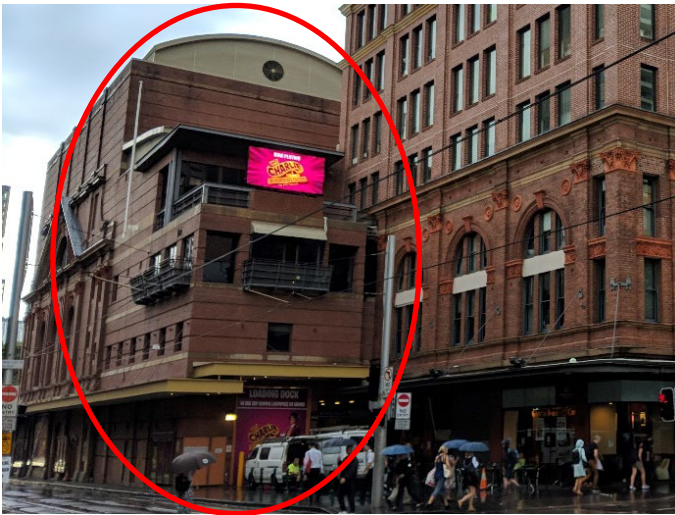
Figure 26 – East Elevation

The east elevation of the building comprises fabric constructed during the 1990s, and continues the use of red brickwork with indented banding and rendered concrete string courses. At ground floor is the loading dock and stage door. At the second floor is another metal Juliet balcony with a set of double leaf aluminium doors. The third floor features the terrace. A large screen is attached to the east wall of the terrace and advertises the latest show at the theatre.

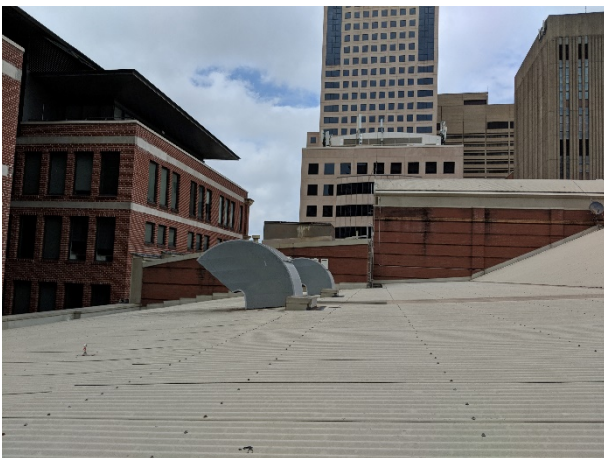
Figure 28 – Roof above east plant room and fly tower (background)

A new roof was installed to the Capitol Theatre during the 1990s works. The roof is divided into several sections. The main gable roof is positioned directly above the auditorium. The early gable roof over the auditorium remains below the existing roof and is clad in corrugated metal sheeting. A skillion roof extends from the gable roof to the east and extends over the new foyer and gallery. The fly tower and south-east portion of the roof feature curved roofs clad with corrugated metal sheeting. The north-east portion of the roof is flat and trafficable and covered in a waterproof membrane.
