2.4.1. Front of House

2.4.1.1. Original Foyers

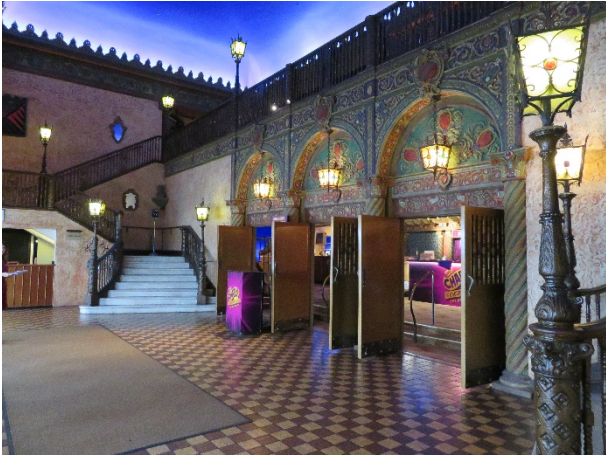
Figure 38 – Ground floor foyer

The original foyers of the Capitol Theatre are located in the north-west portion of the building at ground and first floor. Created as part of the 1920s atmospheric theatre and restored during the 1990s, the foyers reflect the original design and detailing of the atmospheric theatre. Access to the spaces are gained via Campbell Street by a set of eight reconstructed double leaf timber doors which open onto the ground floor foyer. Twisted columns and candelabra style lighting flank the doors and an elaborate polychrome entablature surmounts the doors. The foyer is split into two levels, one at ground floor, which leads into the original gallery, and the second at first floor, which leads into the dress circle of the auditorium. At ground floor, the floors are laid with mottled cream and brown terracotta floor tiles laid in a checkerboard pattern, with individual tiles with heraldic motifs. The walls are finished with variegated stucco and an electric blue coved ceiling is featured overhead.

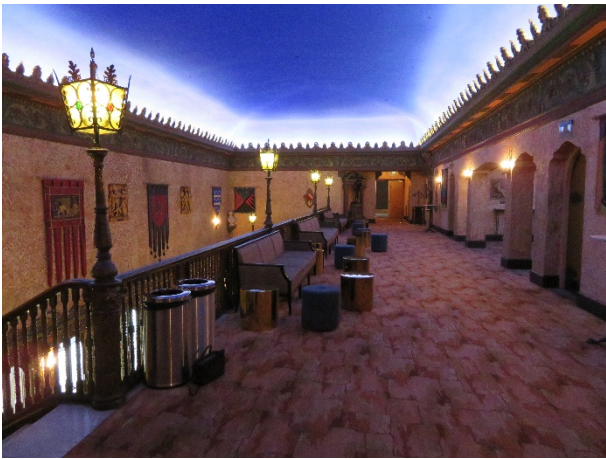
Figure 44 – Dress circle foyer looking east

At the dress circle foyer, the floors are laid with replica carpet with a stone flagging pattern. The walls too are variegated stucco, with inserts of niches and archways featuring replica statuary. Banners, light fittings, shields, and mirrors also decorate the walls. Below the coved ceiling is an elaborate polychromatic cornice with antefixes concealing the junction of the ceiling with the walls. Strategic lighting illuminates the ceiling from behind the cornice, giving the effect of a night sky. At either end of the dress circle foyer are the entrances to the auditorium. Each entrance is detailed with columns, decorative brackets, and a domed ceiling with polychromatic cornice and antefixes.

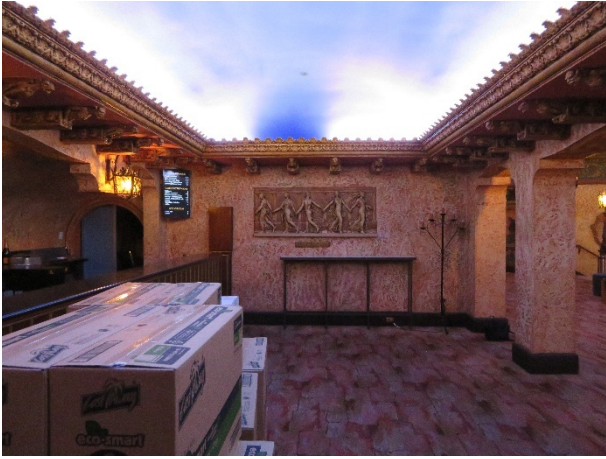
Figure 50 – Gargoyle Bar

Within the dress circle foyer is the Gargoyle Bar located in the centre of the south wall. Delineated by a set of three reversed ogee style arches, the bar draws its name by the series of replica gargoyles which line the border of the ceiling. A small coved ceiling, painted blue, features in the centre, bordered by a small cornice with antefixes. The coved ceiling is illuminated from behind the antefixes. Replica bas-reliefs feature on the east and west walls of the space, and on the south wall is a contemporary bar area. Male and female bathrooms are located either side of the Gargoyle Bar. The bathrooms contain a mix of original, reconstructed and contemporary fabric. The anterooms to each of the bathrooms continue the reconstructed carpet from the foyer, with variegated stucco walls with mouldings, and tray ceilings. Some portions of the original ceilings remain in the air lock and cubicle spaces, however the remainder of the fixture and fittings are contemporary.

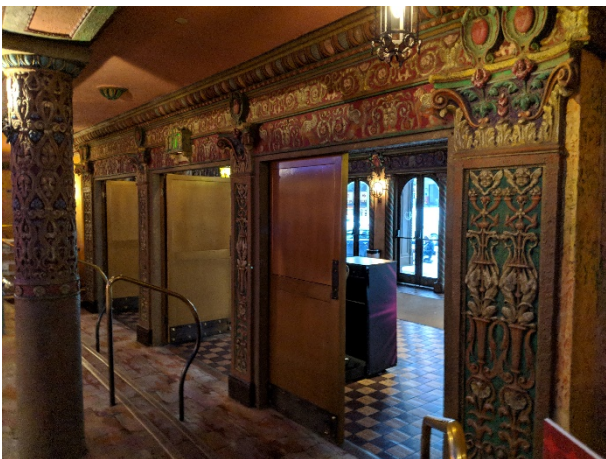
Figure 58 – Doors from foyer to gallery

The original stalls gallery continues the materiality of the original foyers. The stalls gallery is accessed via the set of three reconstructed timber double leaf doors which lead from the foyer. Each door opening is flanked by decorative pilasters and surmounted with an elaborate entablature in polychromatic paint finish. The stalls gallery curves from east to west, conforming with the shape of the rear of the auditorium. The space features the same carpet used in the dress circle foyer and the same variegated stuccoed wall. A series of columns divide the north portion of the space from the south. The north portion of the ceiling has a rough plaster finish with egg and dart cornices, while the south portion of the ceiling is divided into sections by an elaborate entablature with antefixes, and a smooth plaster ceiling painted electric blue, bordered by a smaller cornice. Along the south wall of the stalls gallery are two contemporary bars and a merchandise desk. To the rear of the merchandise desk is the outer wall of the technical room (located within the stalls of the auditorium) which is fashioned as the exterior of a trellised pergola. The east and west walls of the stalls gallery feature niches and arches with urn shaped lights. Along the south wall are doors which lead to the stalls of the auditorium, to the east through to the new box office and foyer and to the west to the fire exit onto Campbell Street. In the north-east corner of the stalls gallery are a pair of reconstructed double leaf doors which lead down a set of stairs to some female bathrooms. The walls of the stairway down to the bathrooms feature the same variegated stucco finish, and mouldings similar to the other bathrooms anterooms in the first floor foyer.

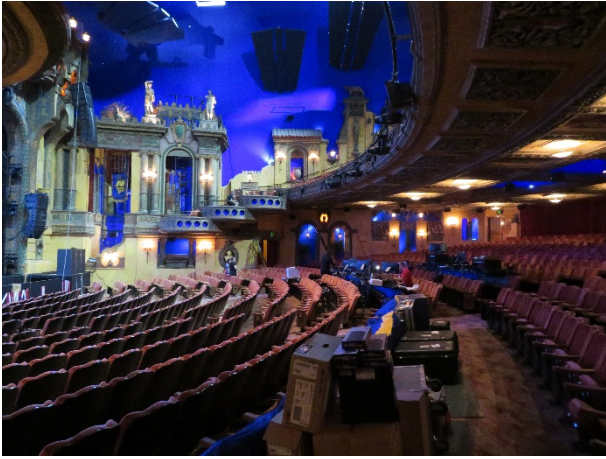
Figure 68 – West wall of stalls

The Auditorium is split over two floors, the stalls and dress circle. It is the most elaborate space of the original atmospheric theatre. Statuary adorns the alcoves, niches, terraces and small temples that line the east and west walls of the auditorium. White pigeons rest on a gazebo and cypress trees and vines adorn the many arches, niches and alcoves. A single peacock sits atop an arch and are scattered throughout the proscenium arch moulding. A pergola spans across the rear of the dress circle, adorned with vines, while the space is drawn together by the electric blue coved ceiling which spans across the auditorium, accented by the many small lights reminiscent of the night sky. Several suspended acoustic panels adorn the ceiling and three long narrow panels are cut into the ceiling for theatre lighting.

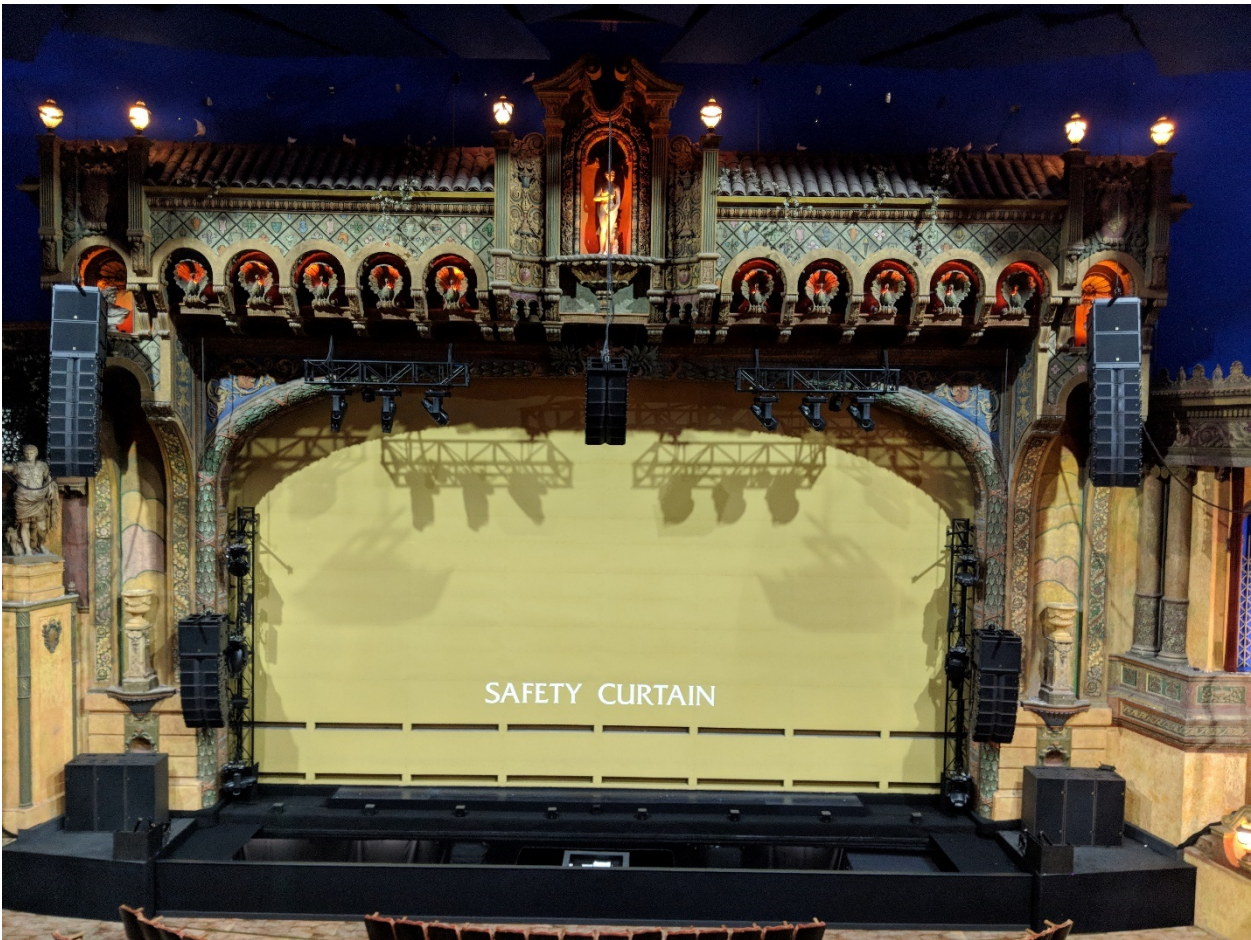
Figure 80 – Proscenium arch

The focal point of the auditorium is the original proscenium arch which frames the stage with statuary, mouldings, lamps, artificial vines and doves and a series of moulded peacocks. The original spandrels of the arch were removed and reconstructed as part of the 1990s works.

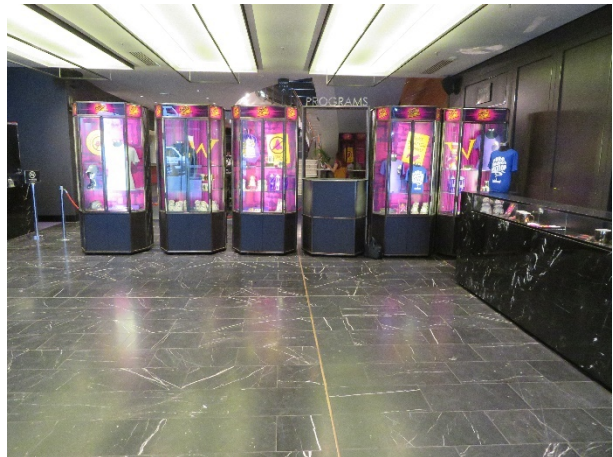
Figure 84 – Box office

The foyer and gallery located on the east side of the building at ground and first floor are within the former Manning Building. Public access to the foyer and gallery is via Campbell Street, which leads directly into the box office area on the ground floor. The box office area has been recently redesigned and features charcoal marble floor tiles, timber veneer wall cladding, dropped plaster ceilings with suspended, can and down lighting.

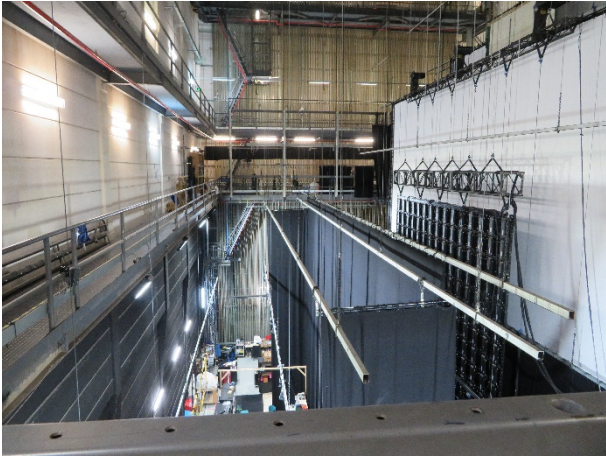
Figure 101 – Fly loft, looking west

The existing fly tower, which contains the stage, orchestra pit and workshops, among other smaller rooms, was constructed during the 1990s. The new fly tower directly connects with the original south wall of the auditorium. The exposed brickwork of this wall can be seen from within the fly tower at the rear of the proscenium wall. The walls of the remaining fly tower are constructed of concrete blockwork and are painted. The Capitol Theatre utilises a counterweight system that was installed during the 1990s works. Fly floors and cross overs are accessed via the backstage foyers at the second and third floors.

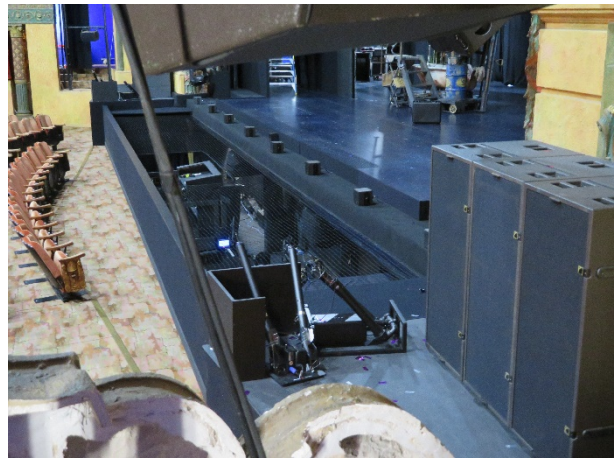
Figure 104 – Stage viewed from west side of stalls

The stage deck is constructed of timber joists with supported on steel beams within the substage area and is overlaid with timber boards and sheeting and a theatre floor surfacing. The stage floor has been modified over times to accommodate different productions, for installations such as trap doors. Directly in front of the apron of the stage is the orchestra pit which is accessed via the sub-stage level. The size of the orchestra pit can be modified to three different sizes, depending on the size of orchestra required for a performance. This is achieved through the temporary removal of seating within the first few rows of the stalls seating and the erection of temporary partition walls.

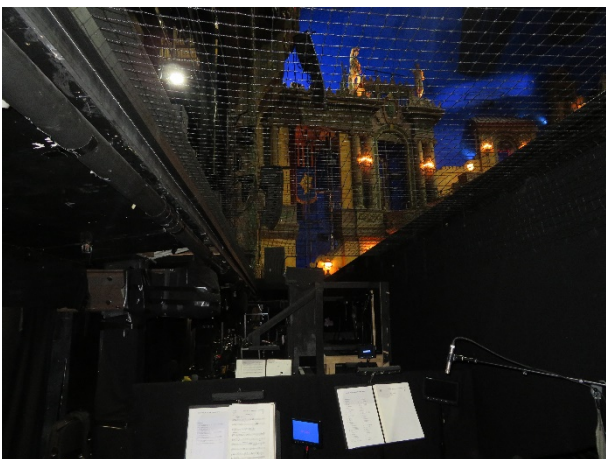
Figure 105 – Orchestra pit, looking west

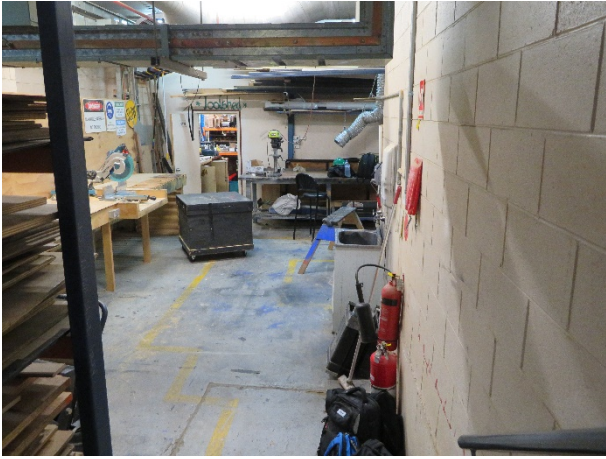
Figure 107 – Technical workshops, sub-stage level

Directly below the stage is the sub-stage areas which include technical workshops and trap room. These areas are constructed from the same concrete blocks as the other 1990s portions of the building and have concrete slab floors. A steel mezzanine floor is built into the sub-stage area for storage.

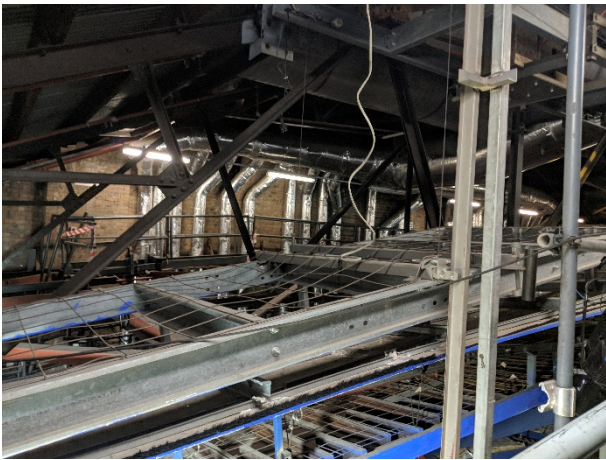
Figure 109 – View from within roof space of auditorium, with proscenium wall visible

Catwalks over the auditorium ceiling are accessed via the third floor fly floors. The catwalks extend over the auditorium ceiling to allow access to the lighting bridges and through to the follow spot booth at the rear of the auditorium. The earlier structure of the 1920s auditorium ceiling is still in place and was modified during the 1990s works. The earlier roof structure over the auditorium ceiling has been retained under the new roof structure, and is reinforced with contemporary materials. At the rear of the dress circle seating area is the follow spot booth.

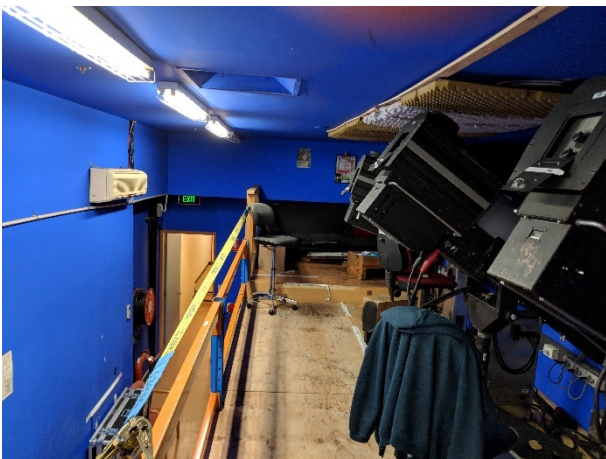
Figure 111 – Mezzanine of follow spot booth

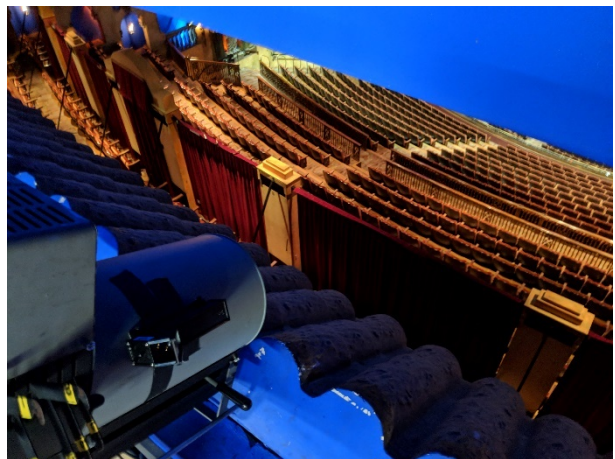
Figure 112 – View from follow spot booth to rear of dress circle seating

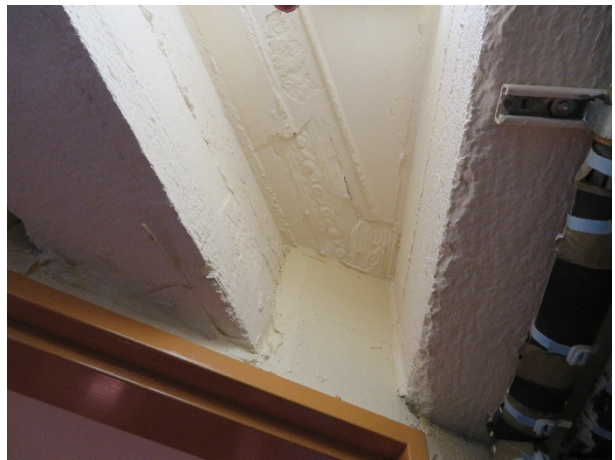
Figure 125 – Ceiling in kitchenette with remnants of pressed metal.

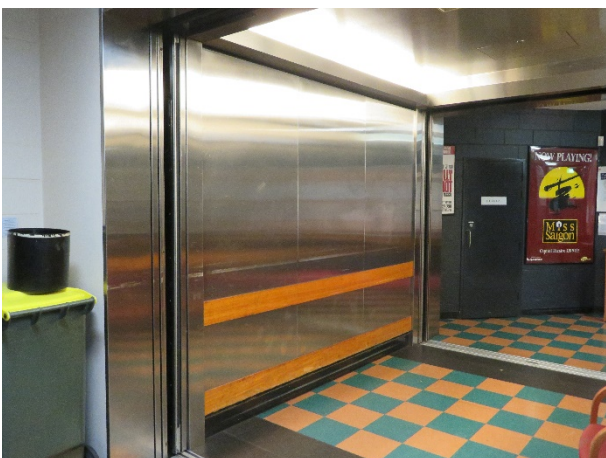
Figure 141 – Goods lift in Back of House area.

The service areas of the Capitol Theatre consists of the lift cores, plant rooms, mechanical and hydraulic cupboards and ductwork. Two passenger lifts are located within the theatre, the first in the Front of House area and a second, goods lift located within the Back of House area. The fire stairs for the Back of House is located directly to the south of the lift. The main plant room for the theatre is located on the third floor directly above the new dress circle gallery. Access to the plant room was not provided.
