CONSERVATION MANAGEMENT PLAN

**QUEEN VICTORIA
BUILDING: 455 GEORGE
STREET, SYDNEY**

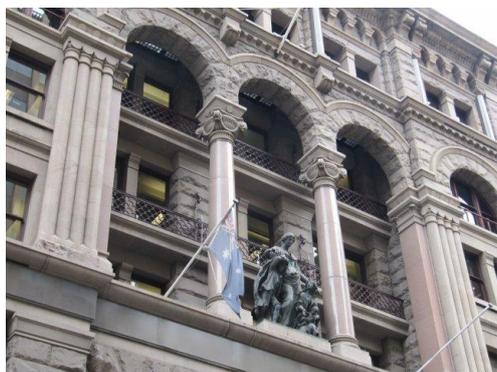
Richardson’s pervasive influences on the design language of the QVB can be best demonstrated by comparing the main central arches with the ‘Syria’ arches of Austin Hall, Cambridge Massachusetts built in 1881-83. The QVB’s facade is less rustic than Richardson’s work. It may be that McRae took his cue from Richardson in finding inspiration from the same Byzantine source.

Figure 4 – Detailing of the Federation Romanesque Architectural Style

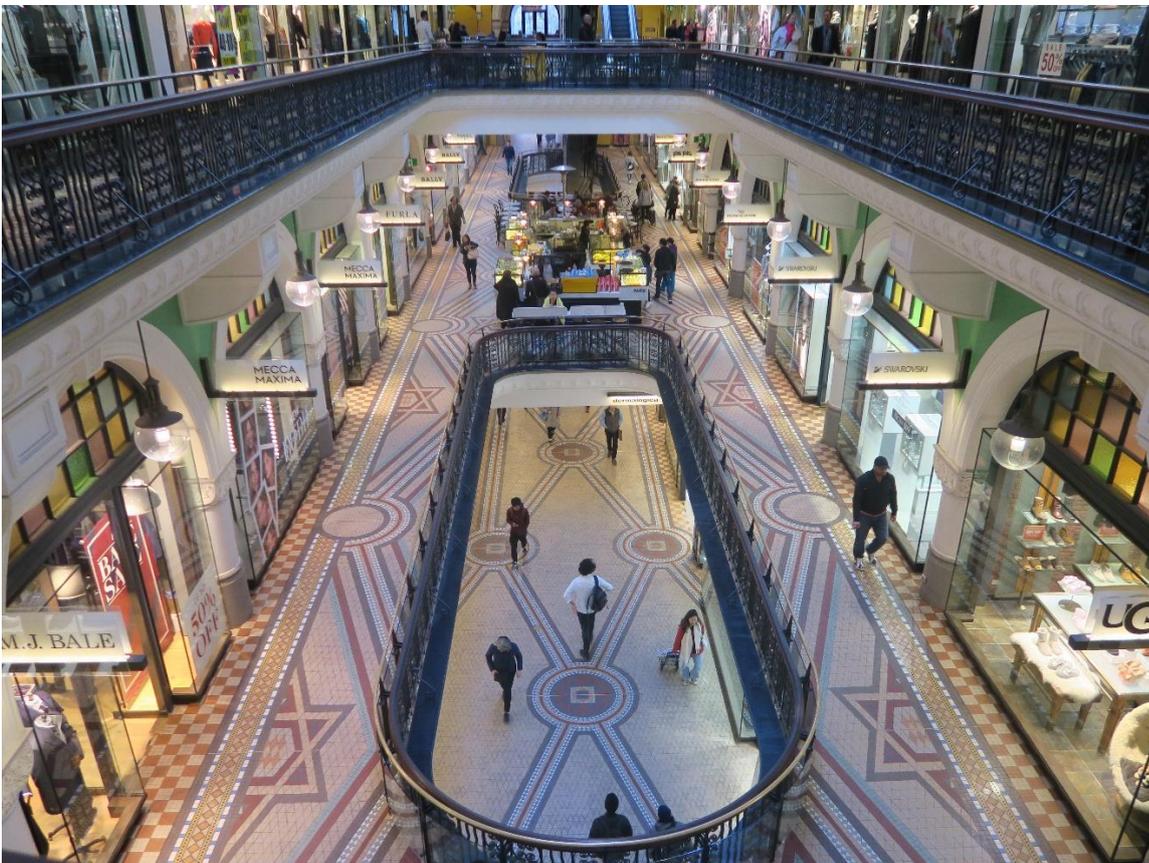
Figure 5 – Internal view of the major spaces and voids within the QVB

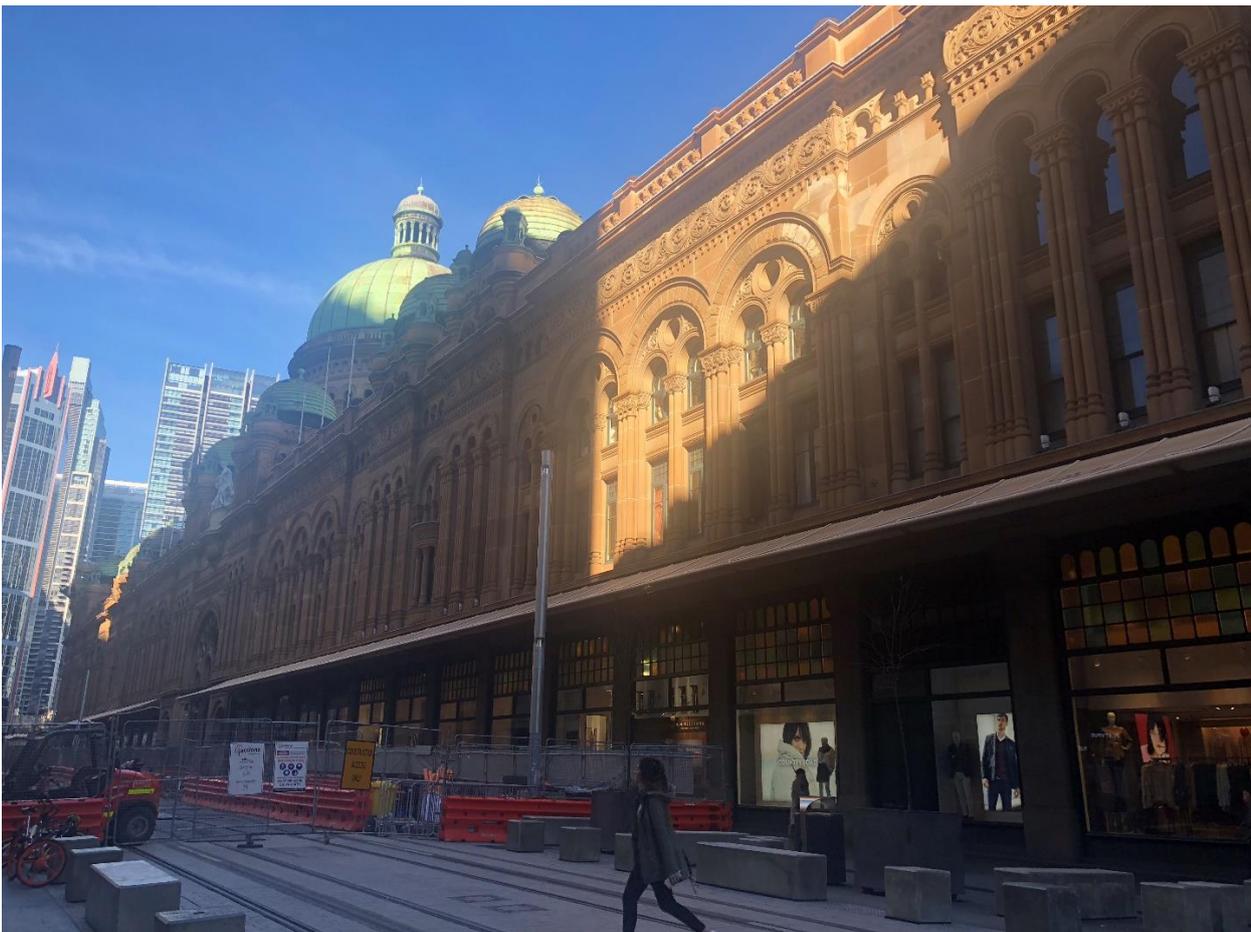
Figure 6 – Eastern elevation of the Queen Victoria Building

The long façades are symmetrically arranged around a central dome positioned above the main entrance. The main entrances feature large wheel windows consisting of polished trachyte spokes and sandstone columns. Stained glass is set into panels between the spokes of the wheel and below the hub. The main dome is set on a circular rendered drum with narrow round head windows set between piers composed of clustered columns. An open gallery is located at the top of the drum just below the dome. The dome itself is constructed of copper panels with ribbed joints. It is terminated by a lantern raised on copper clad columns. At the base of the main dome, smaller domes are placed on separate square sandstone turrets. These minor domes are clad with rectangular Muntz Metal tiles, laid in a pattern intended to imitate stone. The top of each dome contains several eyebrow ventilators and the peaks feature round pendants which double as lightning conductors. The minor domes are set on turrets similar to the circular drum of the main dome with clustered column piers and narrow round head windows between the piers.

The length of the facade is broken by the varied roofline and repeating pattern of windows set between stone piers. The series of domes effectively articulate the long façade into four bays, each bay repeating the pattern of round headed arched windows with clustered column piers.

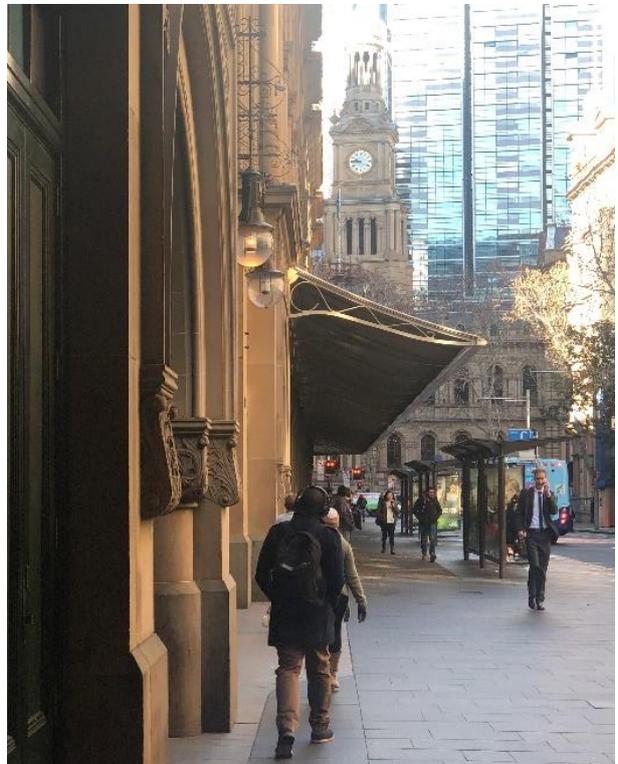
Picture 10 – Profile of cantilevered awning
Source: Urbis, 2018

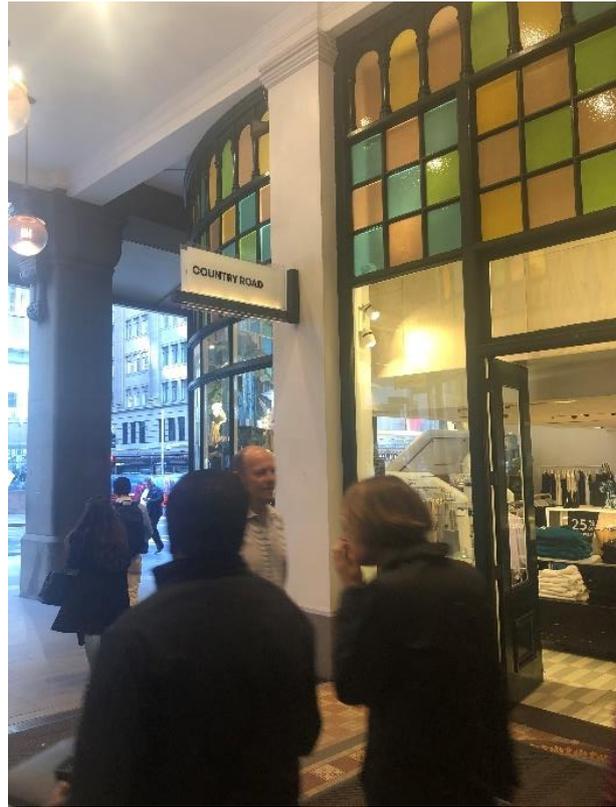
Picture 12 – Market Street entrance, note the curved glass shopfronts

The shorter Druiitt and Market Street facades are also very similar. Both facades contain entrances to the central arcade. The entrances are both framed by a pair of columns with round arches above infilled with decorative stained-glass glazing. Originally this area, which now accommodates commercial tenancies, was open as a large double height space with the first-floor gallery overlooking the entry. The frieze above the entrance now carries the words 'Queen Victoria Building.' The end facades are divided horizontally into a base, middle and upper section similar to the George and York Street facades.

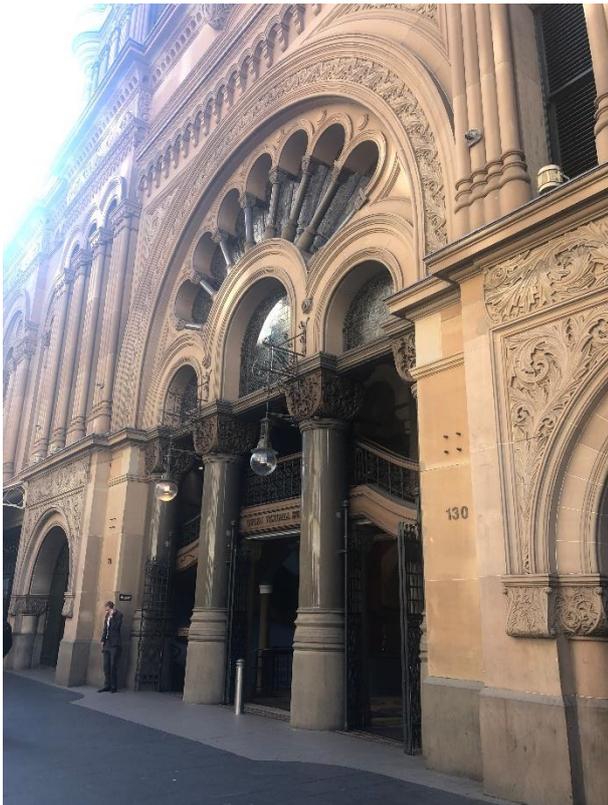
Picture 37 – External stonework and ground floor trachyte columns on York Street entrance

- External stonework to the upper facades, turrets and domes, and ground level trachyte columns.
- Timber windows, including sash, awning and casement.
- Construction frame, including iron and steel frame, timber and terracotta floor framing.
- Arched lattice roof trusses over the gallery spaces, and metal trusses over each of the northern and southern lift lobbies.
- Remnant stained glass fabric to York Street and Market Streets central windows.

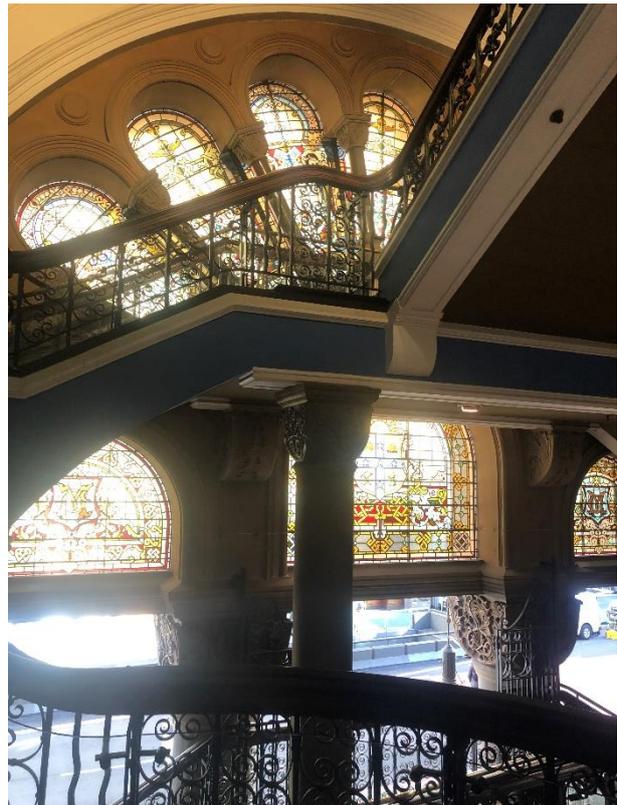
Picture 38 – View of York Street stained glass, some remnant fabric is original

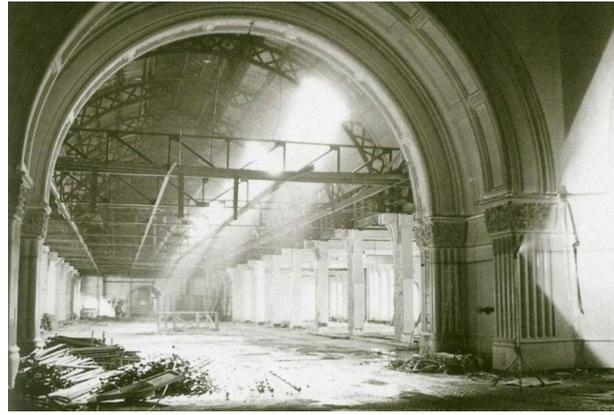
Picture 87 – The top floor at the commencement of works in 1984. The structure which supported the false ceiling under the barrel vault is evident and the concrete infills of the gallery voids had yet to be removed. Sheets of corrugated iron which replaced the original glass had been removed to allow light to be admitted

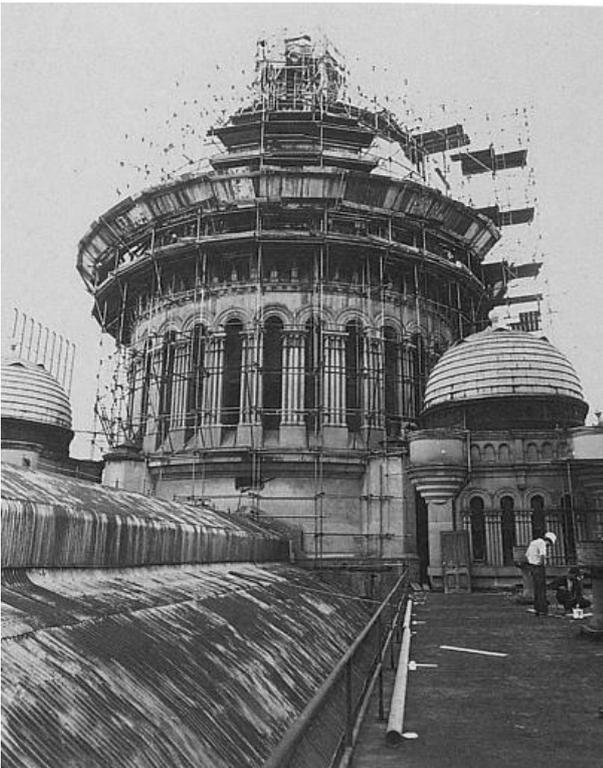
Picture 88 – The roof with corrugated iron still in place

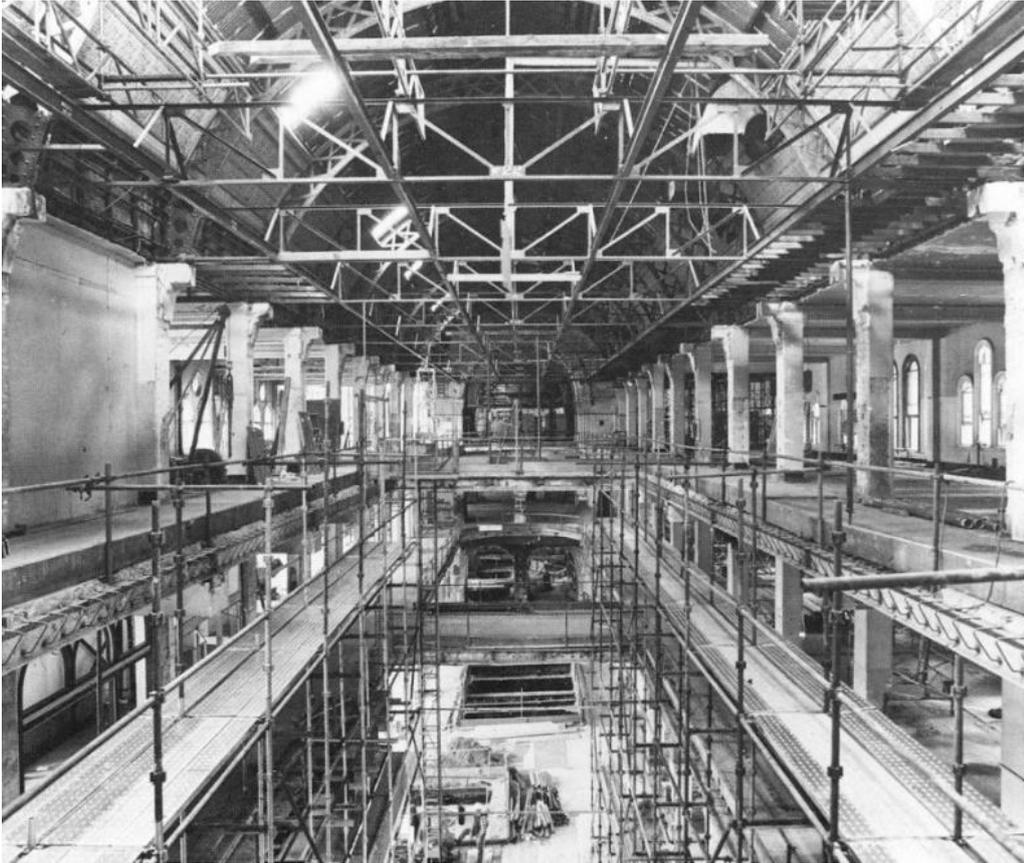
Figure 55 – The concrete slabs were removed by 1985 and the interior voids recaptured, note the extent of original interior fabric

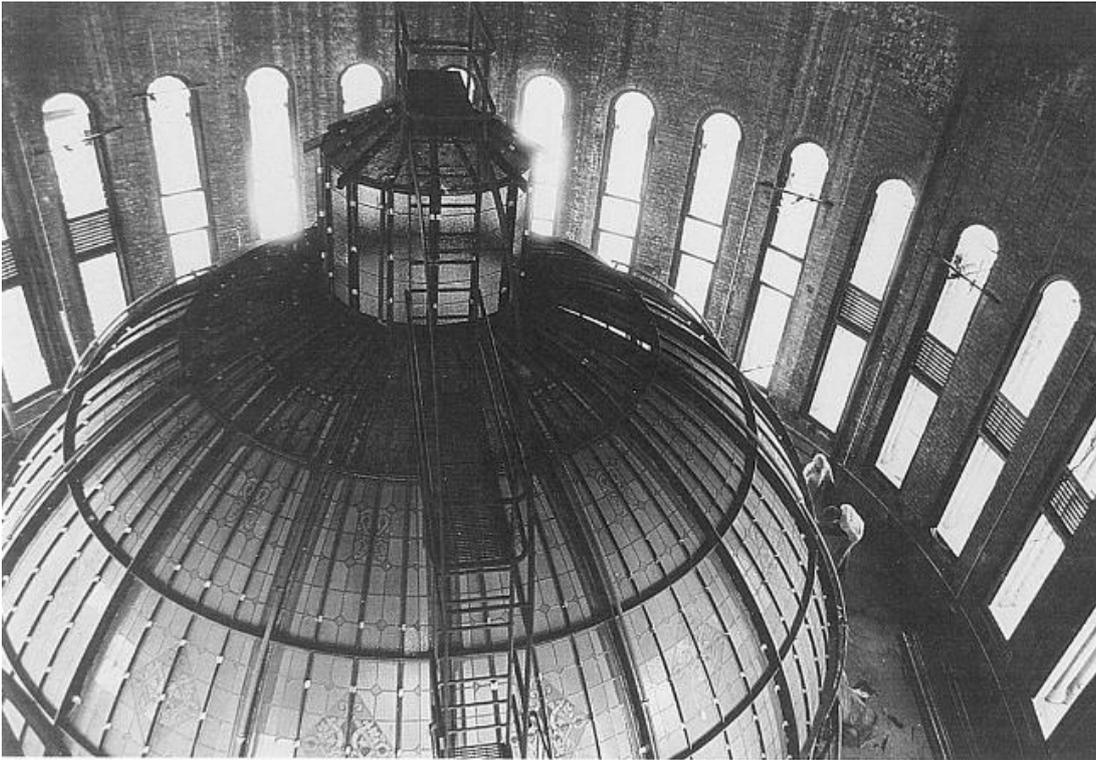
Figure 57 – The completed inner glass dome

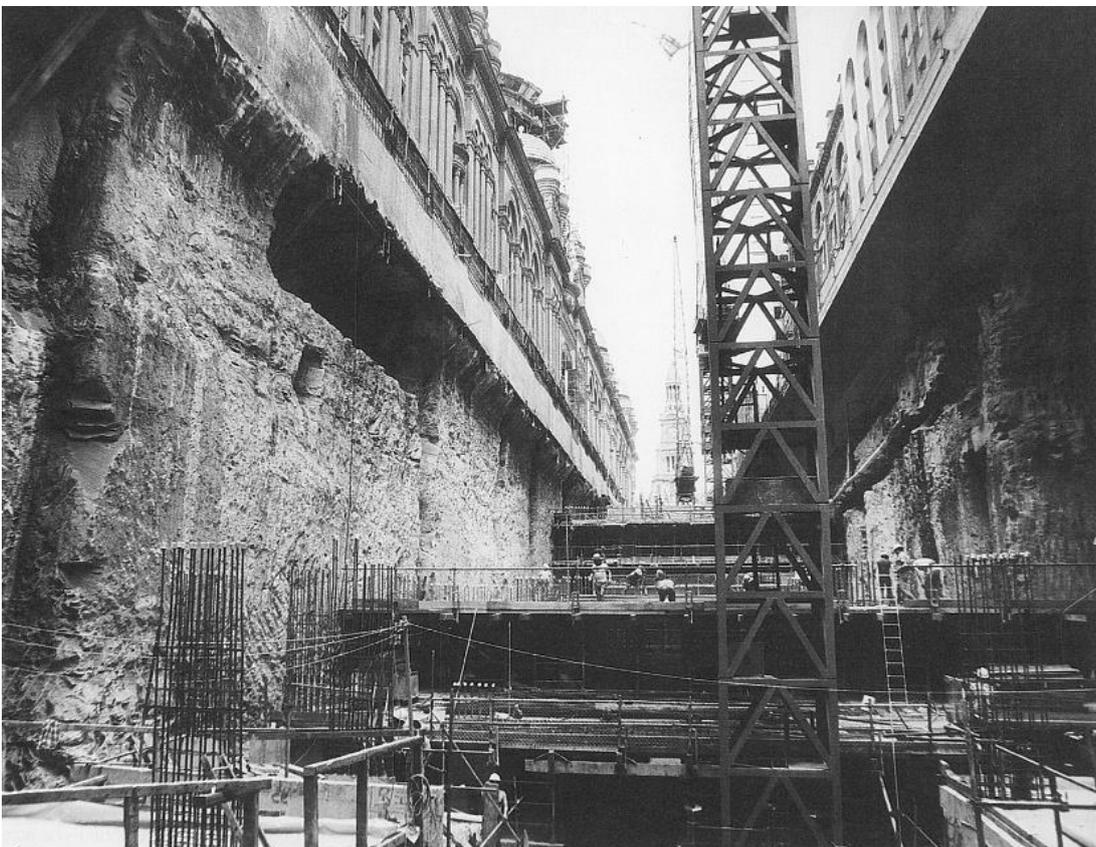
Figure 58 – Excavation for the car park, the QVB can be seen perched on the edge in the top left of frame

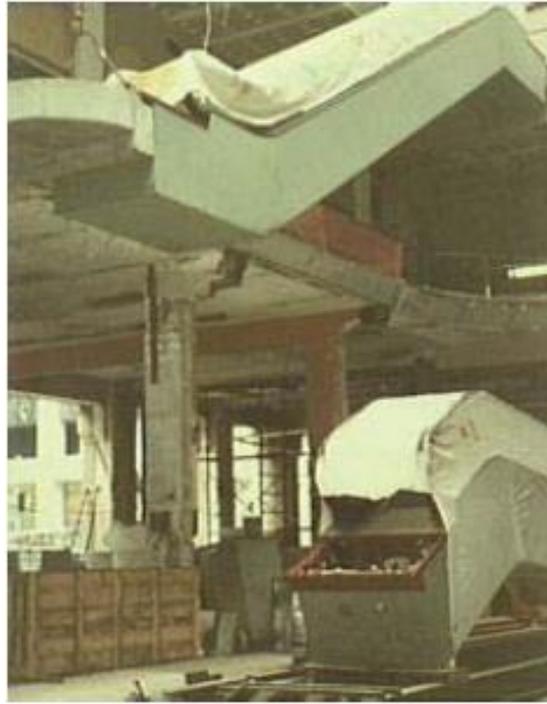
Picture 93 – Escalators were installed in the north and south voids in 1985
