Broughton House

181 Clarence Street, Sydney

Conservation Management Plan

Prepared for
The Owners of Strata Plan 16651 - Broughton House

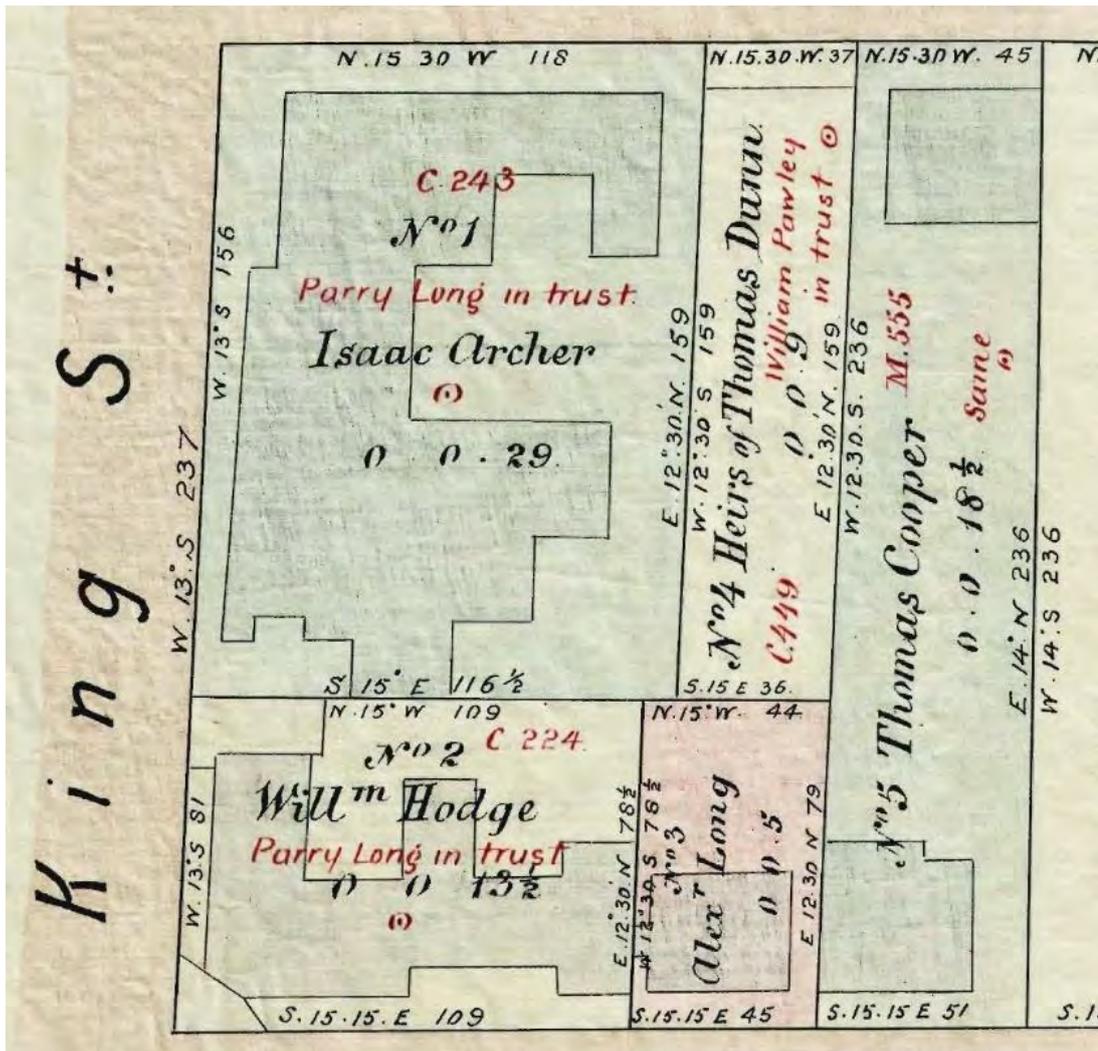
3 Northern portion of the 1833 survey map of Section 28, showing the footprint of development across the 4 allotments that make up the site of Broughton House.
 Source: City of Sydney Archives Historical Atlas - Survey Plans, 1833: Section 28 at <https://archives.cityofsydney.nsw.gov.au/nodes/view/1709204>

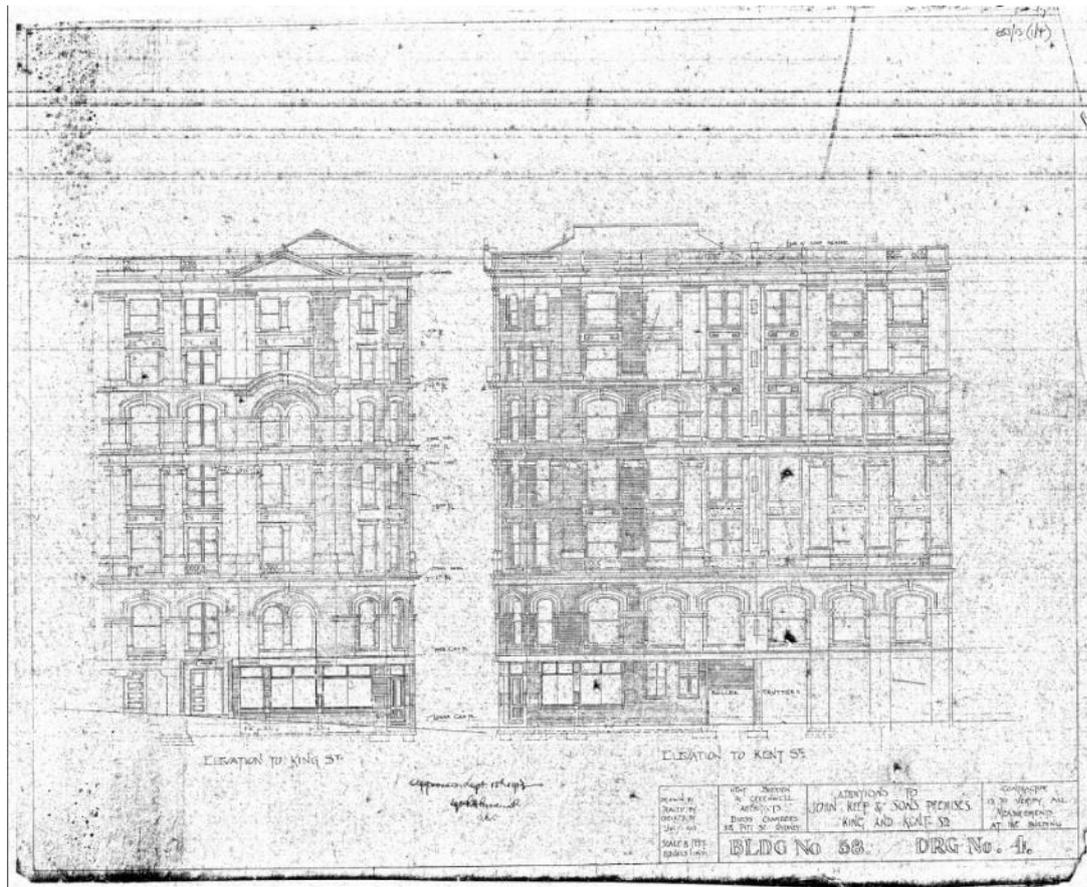
- 15 Drawing prepared in the office of Kent, Budden & Greenwell describing the facades of the building to be erected on Lot 2.
Source: City of Sydney Archives Building Application 0683/13.

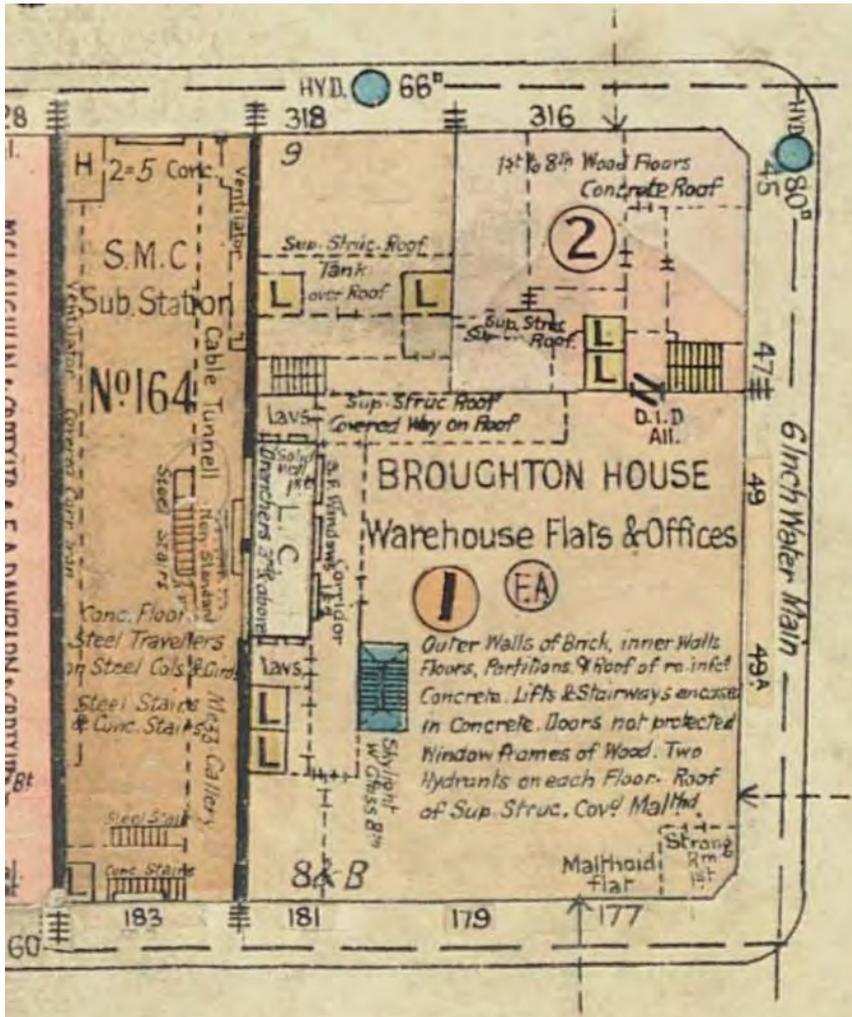
21 Portion of the circa 1930s Fire Underwriters Association of New South Wales survey identified as Connell's Block No 146, Keep's Block No 147, showing the configuration of lifts and stairs in Broughton House, and a description of the building's structure.
Source: City of Sydney Archives Historical Atlas.

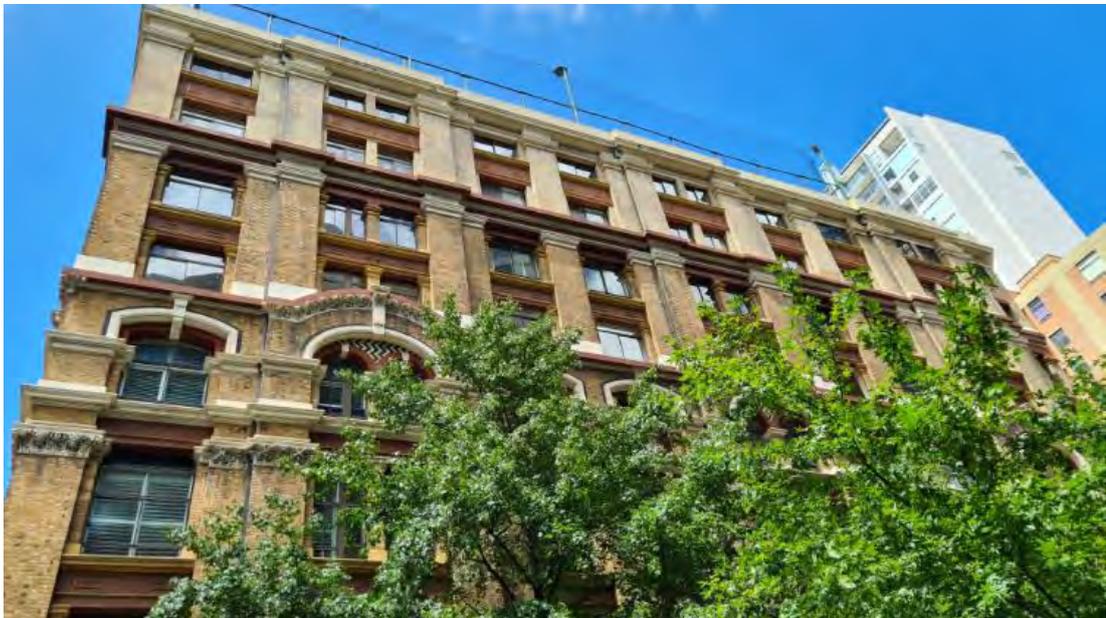
40 Broughton Hall's King Street façade. Note the difference of colour in brickwork above Level 5, where the upper floors were added in the 1920s.

The light brown mellow brick piers and spandrels are relieved by vigorous stucco mouldings in the form of window arches, sills, pilaster caps and mock balconettes. Together with repairs undertaken to the facades, the upper two floors were added in the 1920s by Robertson & Marks and designed in a simpler Classical idiom. External changes to the building associated with the 1979 adaptive reuse include modifications to openings at basement level, the introduction of metal framed windows and modifications to some openings in the upper levels of facades resulting from the formation of balconies.

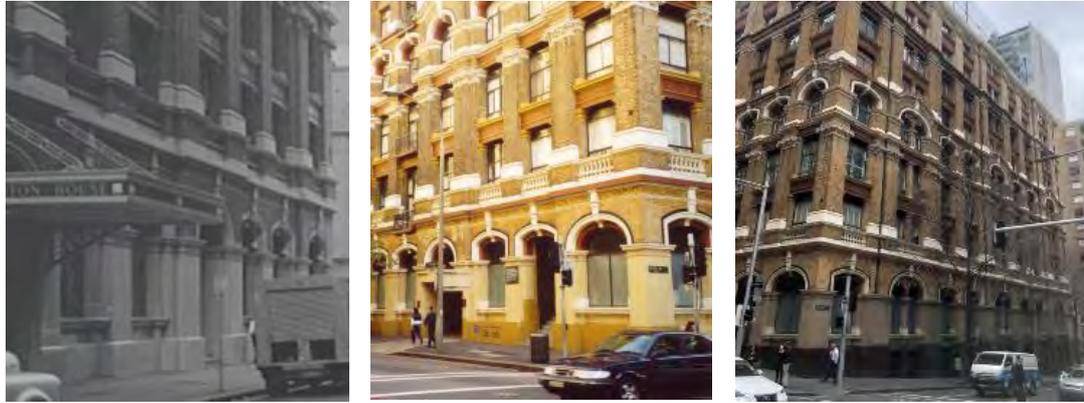
- 43 By 1964, the lower section of the facades at ground floor level had been rendered and painted a light toned colour (left). By 1989 this part of the building had been painted a deep stone colour (centre). Broughton House in 2021, with a darker colour scheme applied to the same areas (right).

Changes to the exterior of the building have included cement rendering the lower section of the facades at ground floor level. It has not been determined when this first took place, but documentary evidence establishes that it had been done by 1964. The rendered surfaces have been painted since that time, if not before. The awning over the Clarence Street entrance has been modified through the replacement of its eastern fascia, while the semi-circular highlight over it is understood to have been replaced. Both the awning and vestibule associated with the main entrance have undergone refurbishment in recent years.

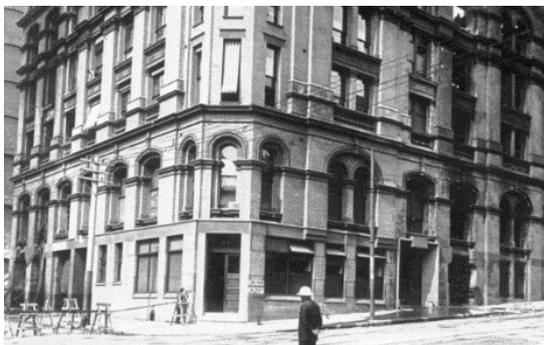
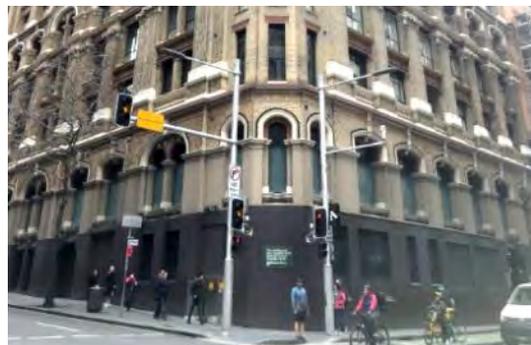
46 A comparison of the circa 1919 photograph of the warehouse shortly after the fire, which shows the original pattern of street level fenestration at the corner of King and Kent Streets with a recently taken photograph from the same location clearly shows changes that have taken place to this part of the building.

The balconies to the Clarence Street façade, also introduced in 1979, are discreet and set within the building line. Their construction involved the removal of some brick spandrel panels and the addition of new concrete sills and metal framed balustrades. New aluminium framed window and door units replaced the original timber window sashes. New aluminium framed glazing and doors were also installed to terraces at the base of the lightwell.

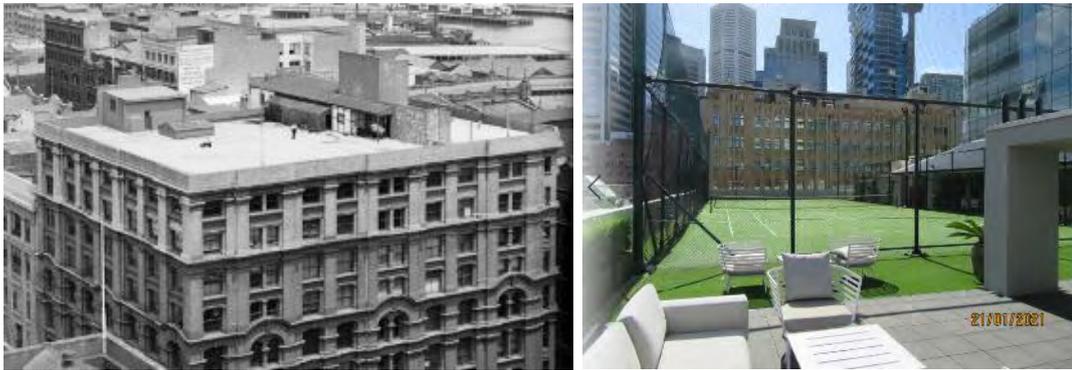
47 Extract of a circa 1928 photograph (left) overlooking the roof level of Broughton House. The building on the left is the Motor Room to the main passenger lifts with the former glass roof over the fire stair. To the right are the Motor rooms for the goods lifts and roof access via a stair. The 1979 drawing notes these rooms as plant rooms, laundry and water tank. The remaining open space was to be redeveloped to a tennis court (right) roof level tennis court in 2021. Source: SLNSW ON 30 / Box 31 No 350, A E Foster photograph.

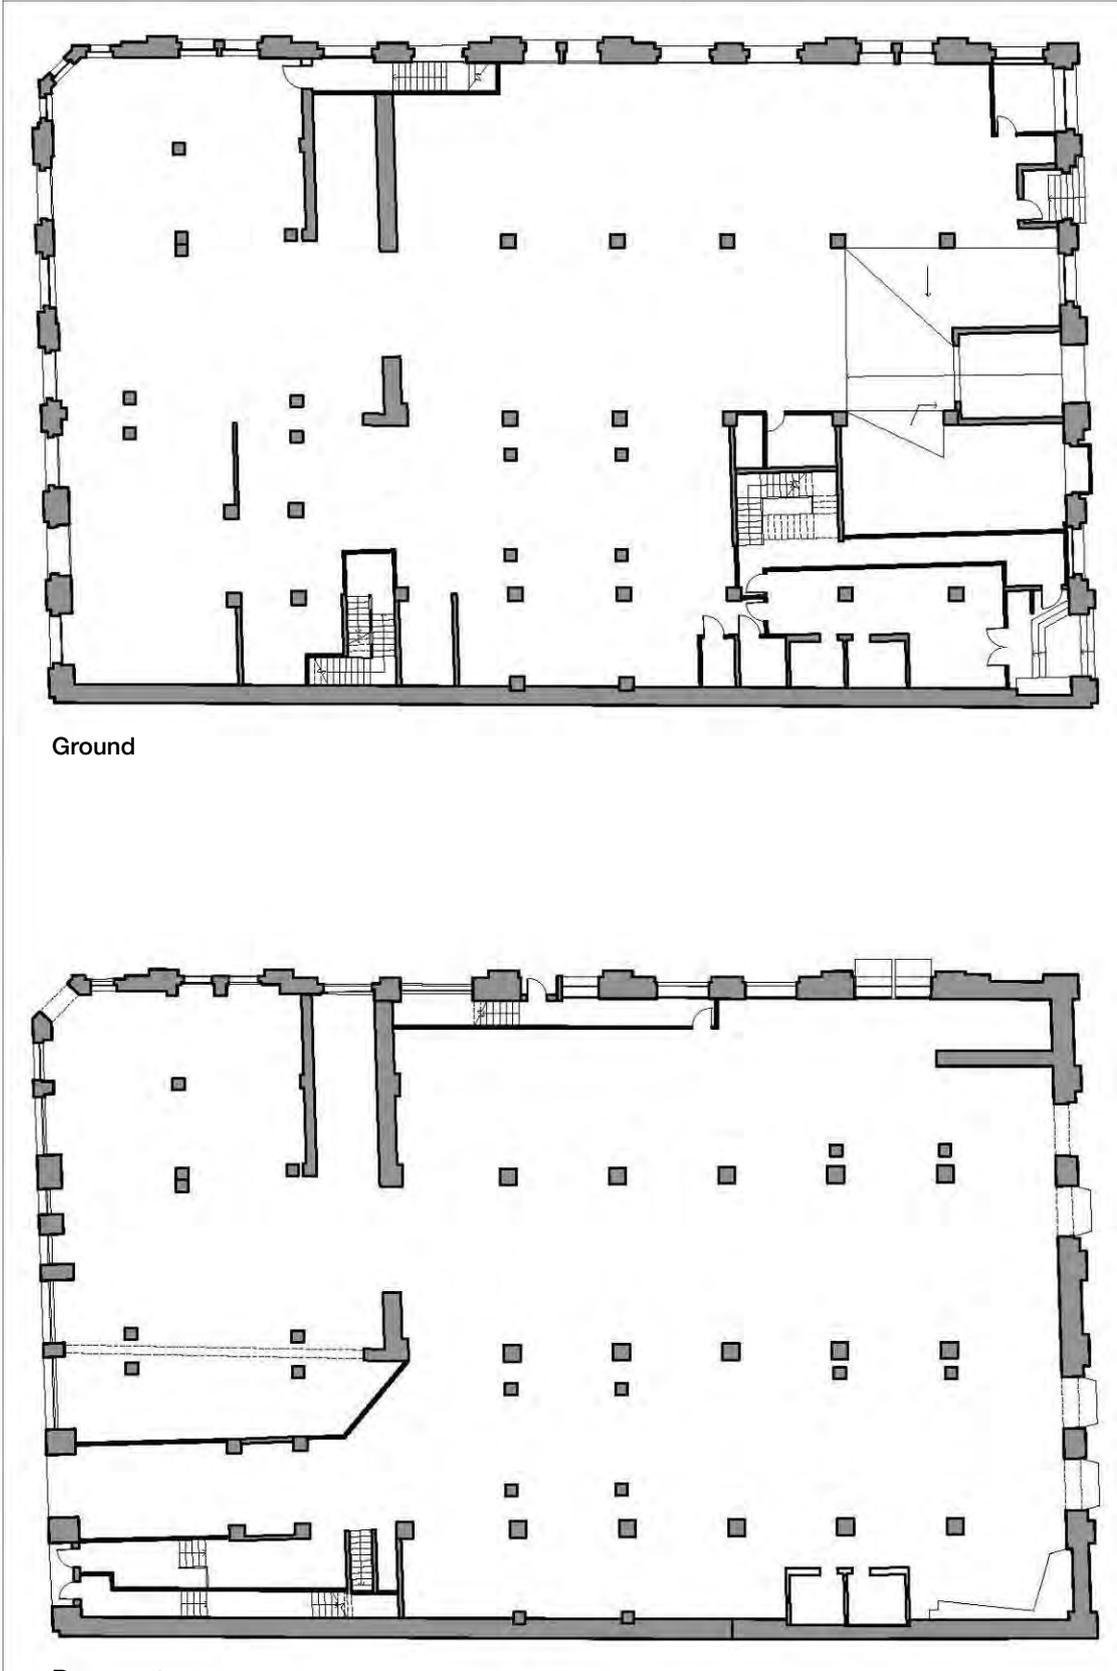
The following plans locate original fabric and show the current layout of spaces.

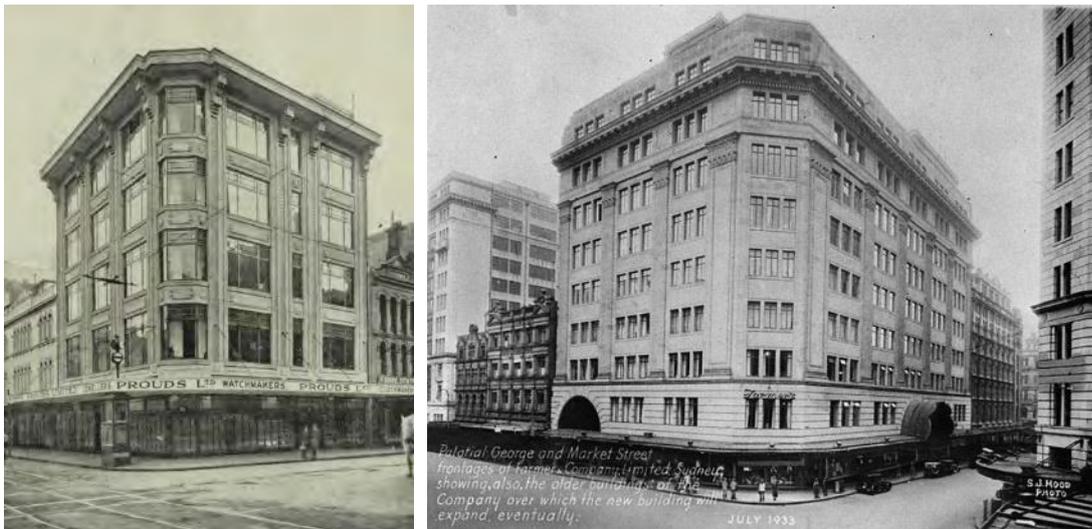
73 The reinforced concrete building designed for Prouds Ltd (left) and the more conventionally steel-framed department store for Farmer & Co (right) are characteristic of Robertson & Marks' work during the 1920s.

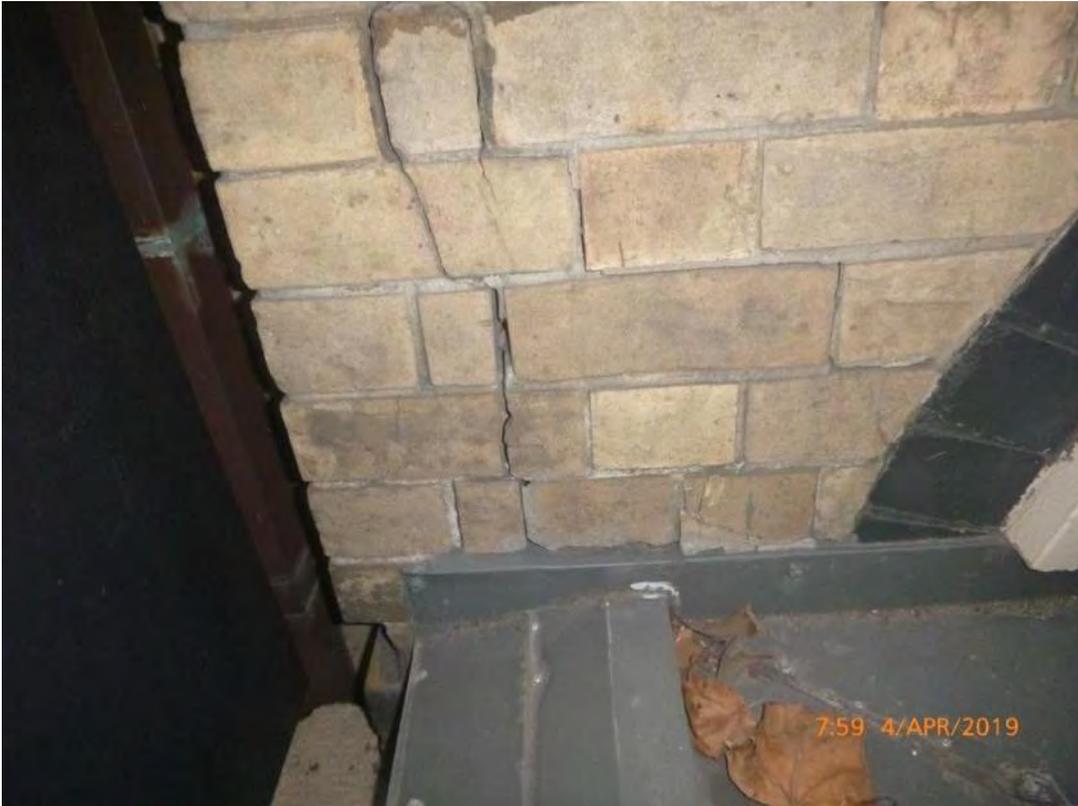
Cracked masonry for investigation and repair (adjacent to the awning).

- There are isolated cracks and missing blocks within the masonry façade on all elevations which will require remediation;
- There are several areas of brickwork that will require repointing, particularly the entire horizontal band alongside the arched window heads on the third floor of the building. Other areas requiring repointing are limited to isolated piers and wall panels;

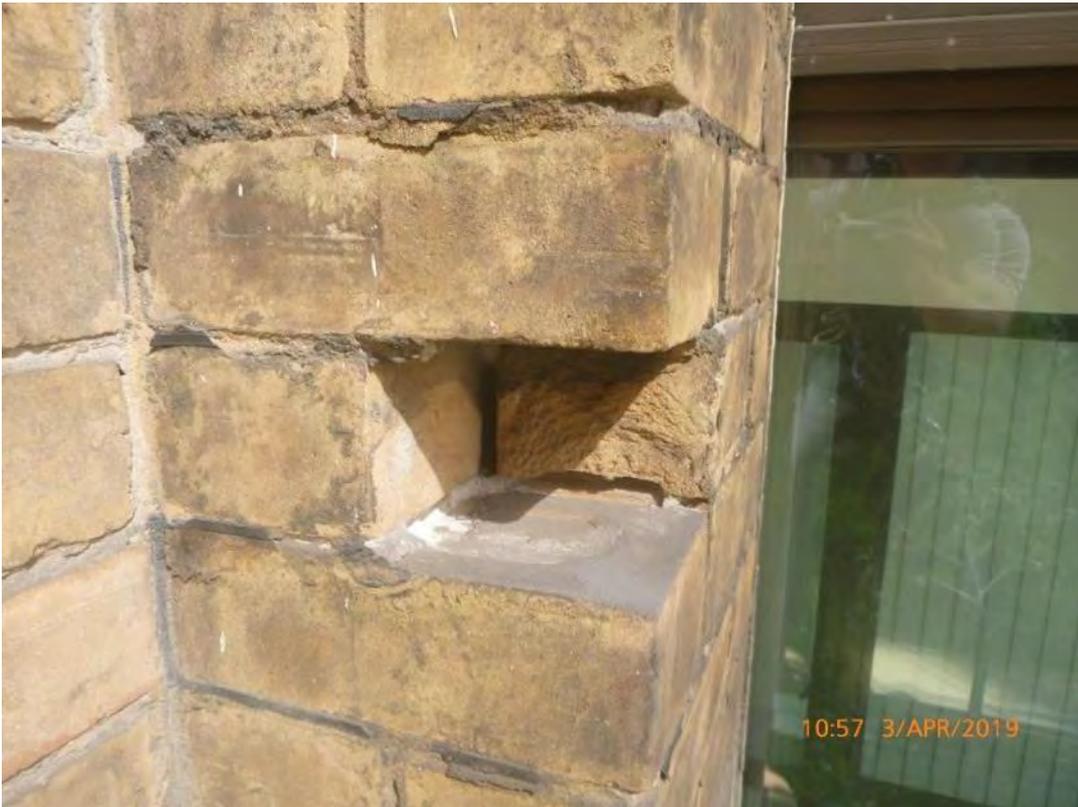
Missing brick for replacement.

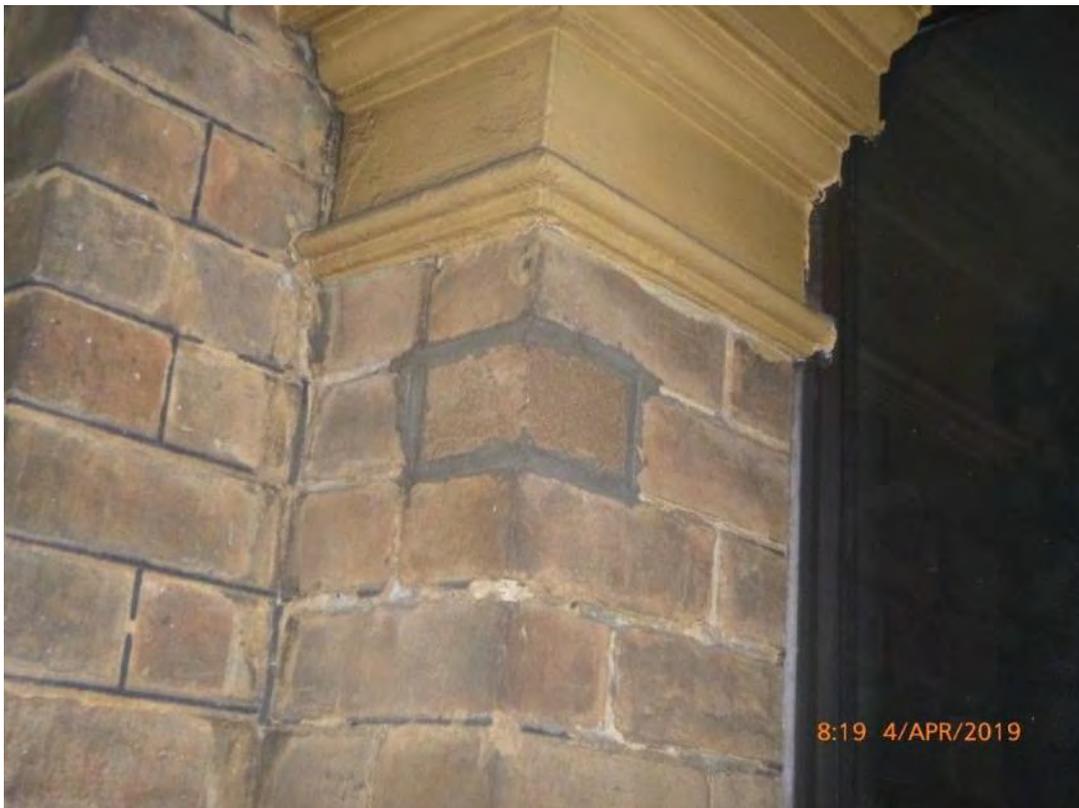
Previously repaired brick for repointing.

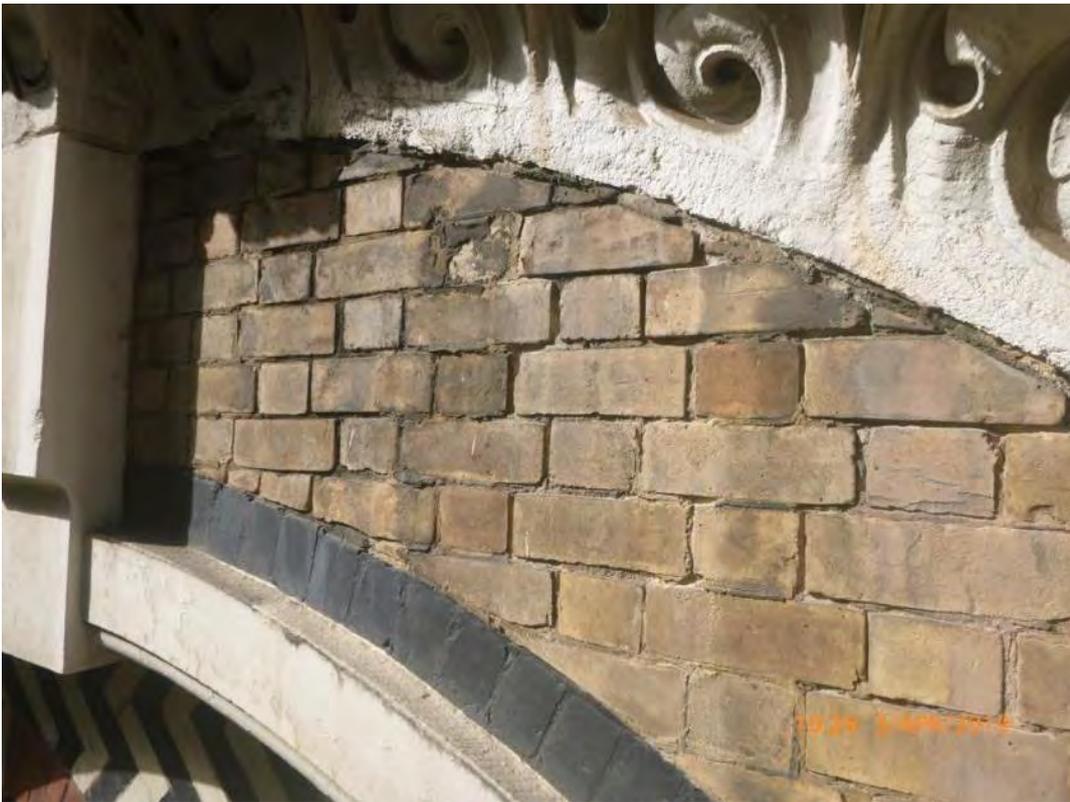
Significant and widespread erosion of pointing mortar.

- Tuckpointing is failing in many locations;
- Very minor cracking is occurring on a small number decorative mouldings;
- There is extensive deterioration to the rendered and concrete elements generally, which appears to have worsened significantly since they were inspected in 2016. Stormwater overflow at roof level is causing damage to parapets, particularly the rendered concrete cornice along the Kent Street façade. This damage may also be occurring in parapets associated with other facades. In particular, there is extensive deterioration in the form of:

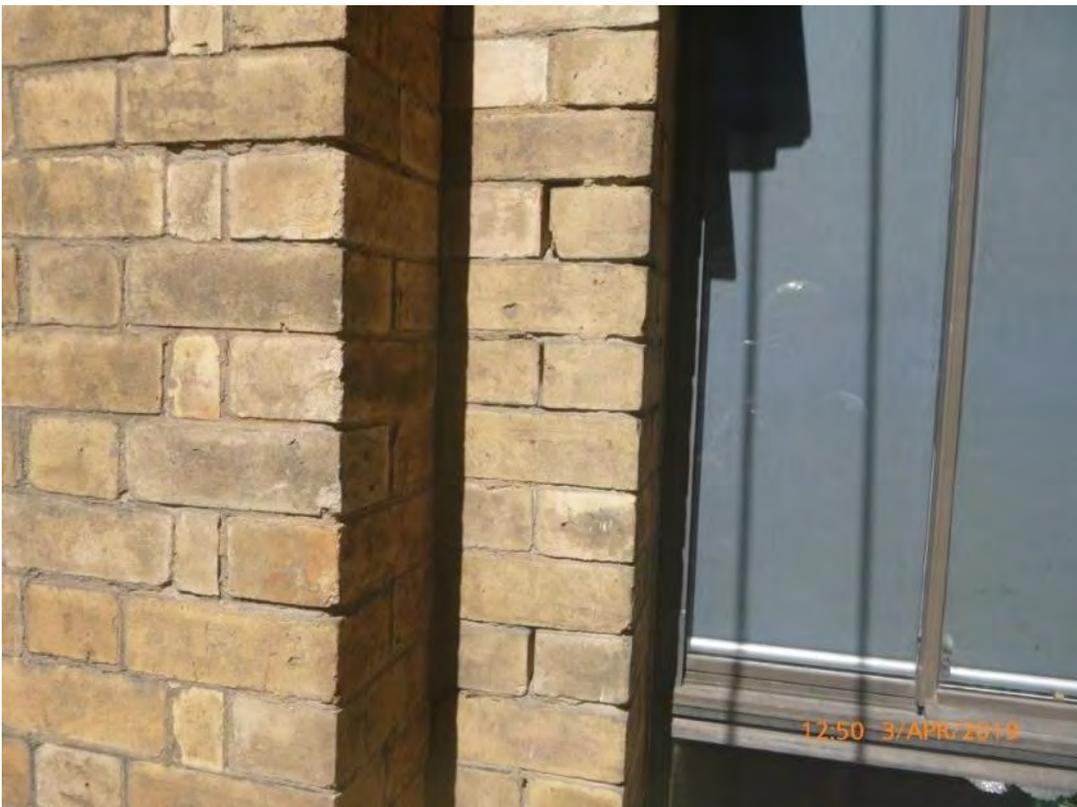
Localised erosion of pointing mortar.

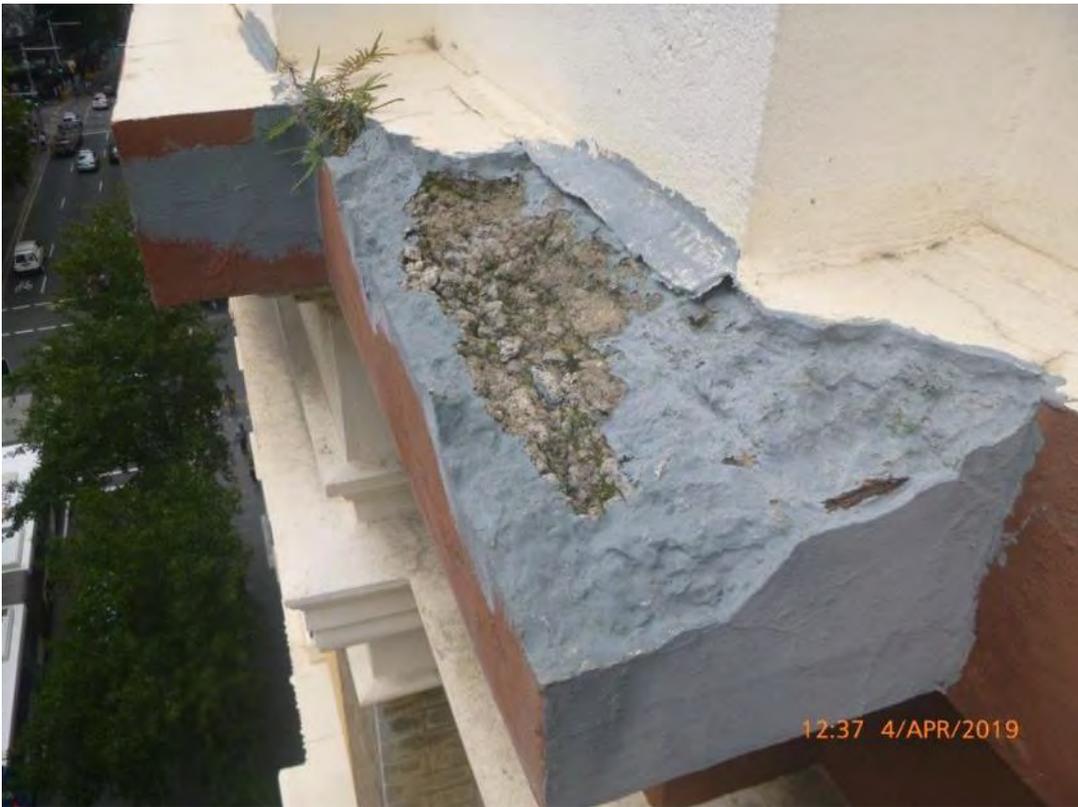
Severe spalling to rendered concrete string course. This has been subject to previous stabilisation attempts, but further deterioration has occurred since.

- Cracking, delamination and spalling of rendered elements, in particular horizontal surfaces associated with string courses and the like;
 - Cracking and spalling of underlying concrete components;

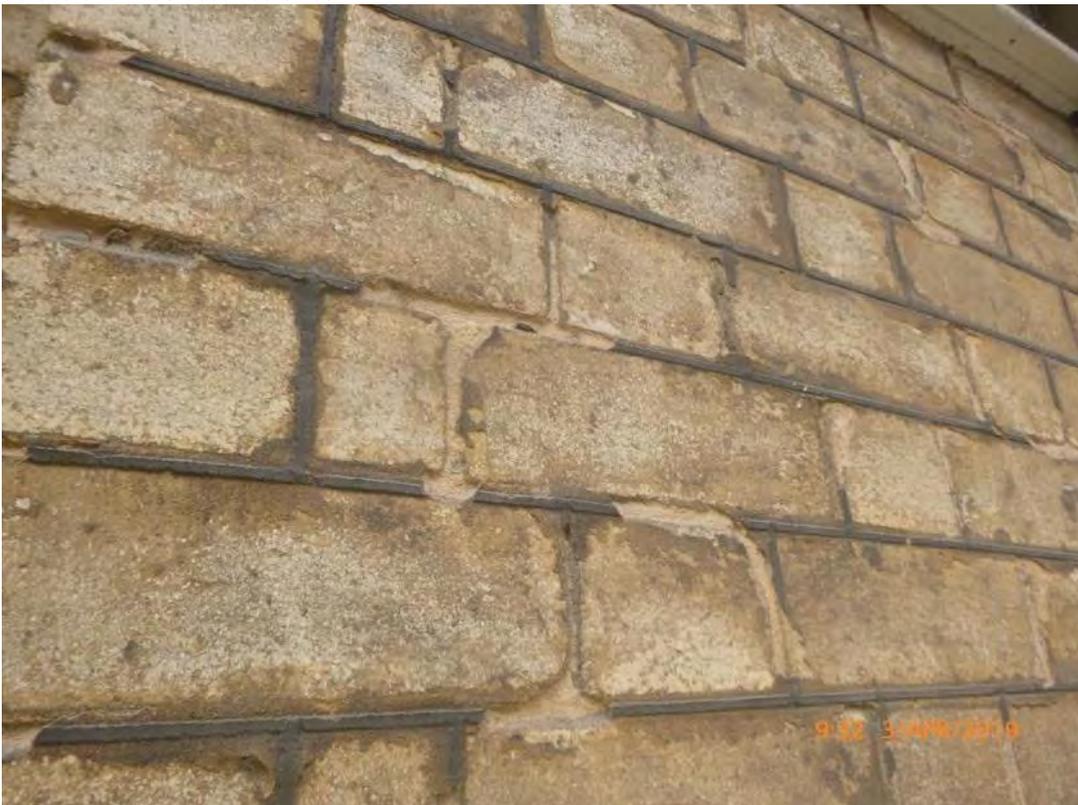
Localised failure of the stencilled mortar.

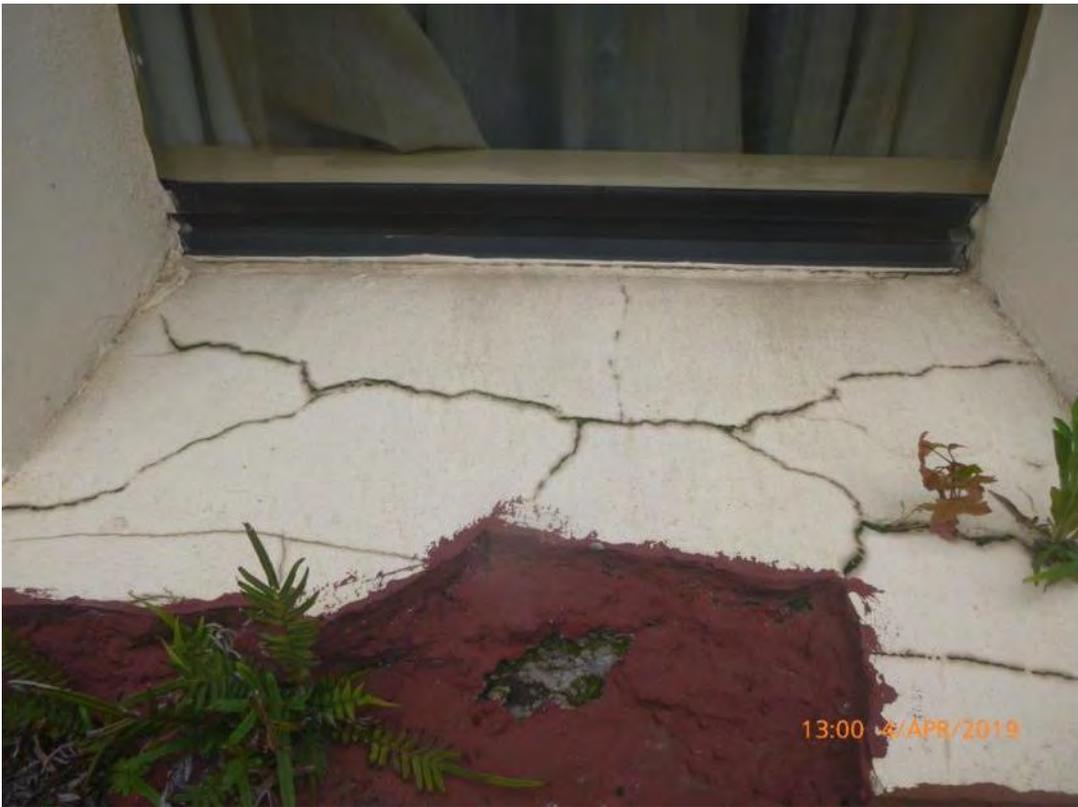
Cracking, spalling, and organic growth to rendered horizontal elements.

- Widespread organic growth, driving cracking;

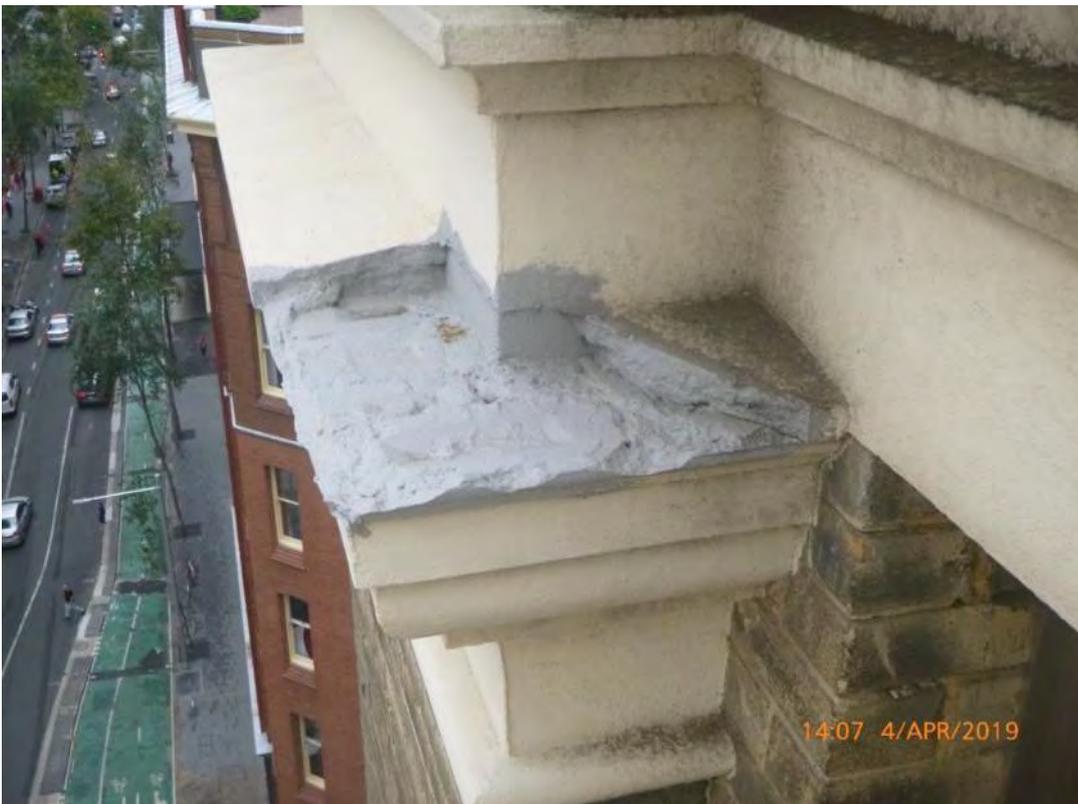
Delamination of rendered surfaces. This area has been subject to previous stabilisation attempts.

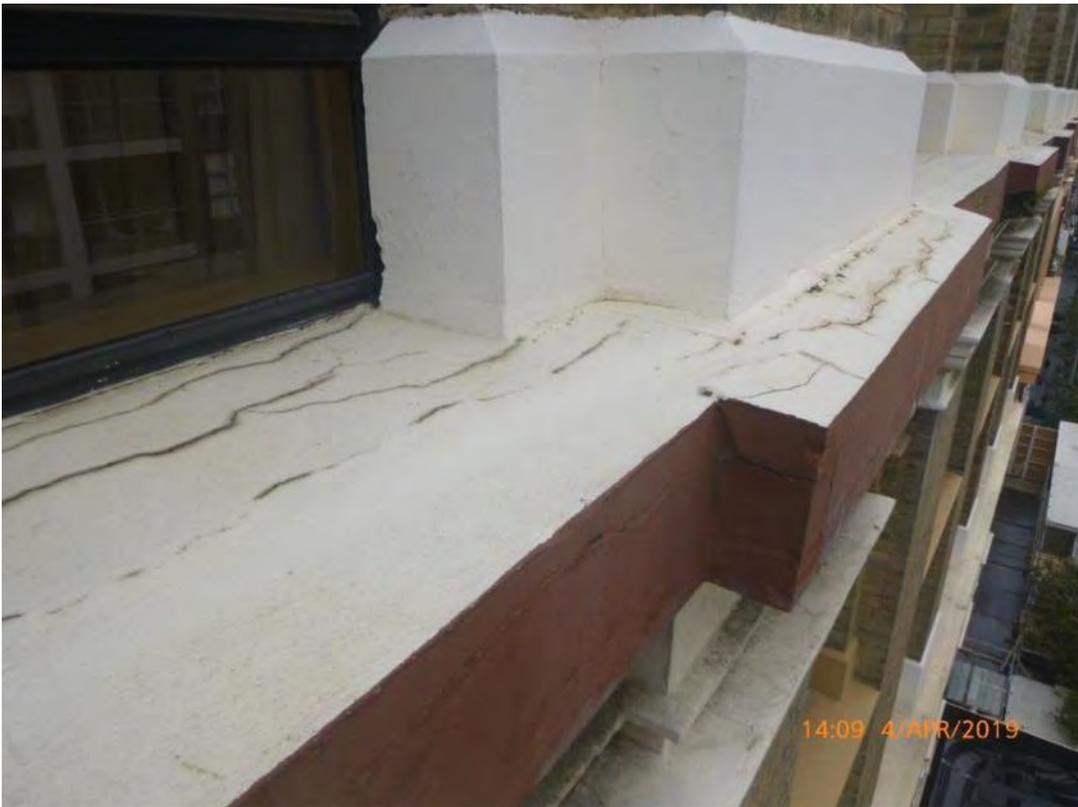
Severe cracking and druminess of horizontal rendered surfaces.

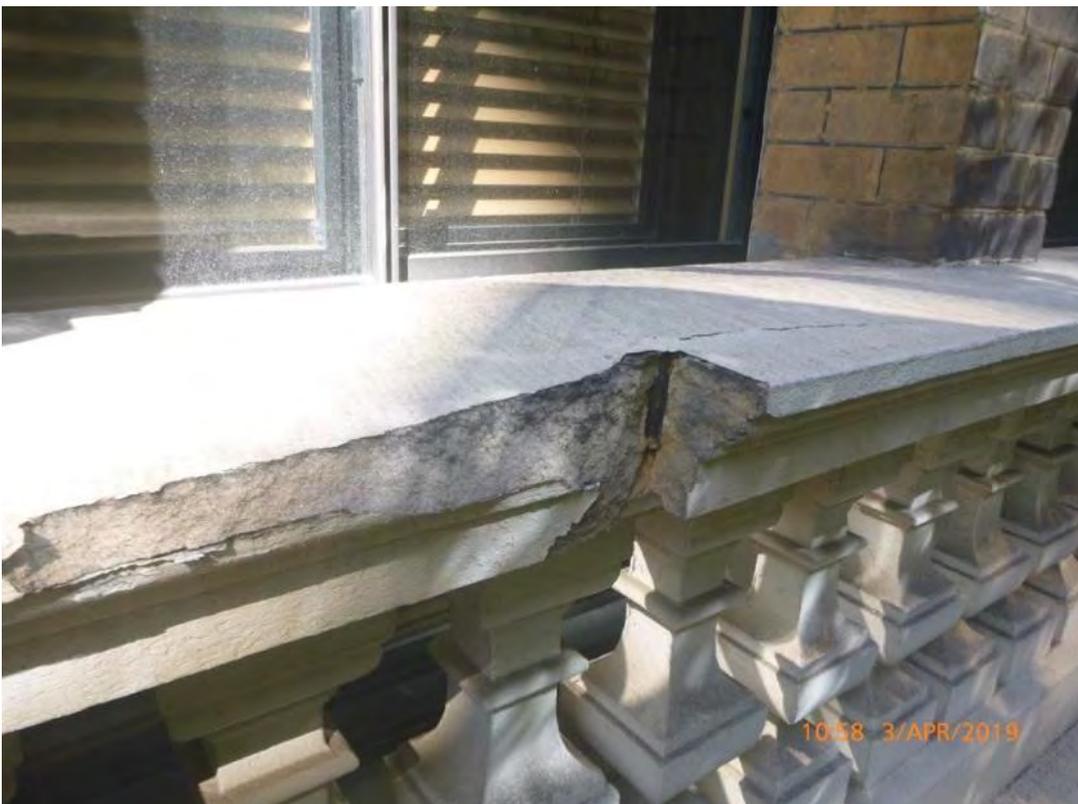
Spalling of rendered concrete elements.

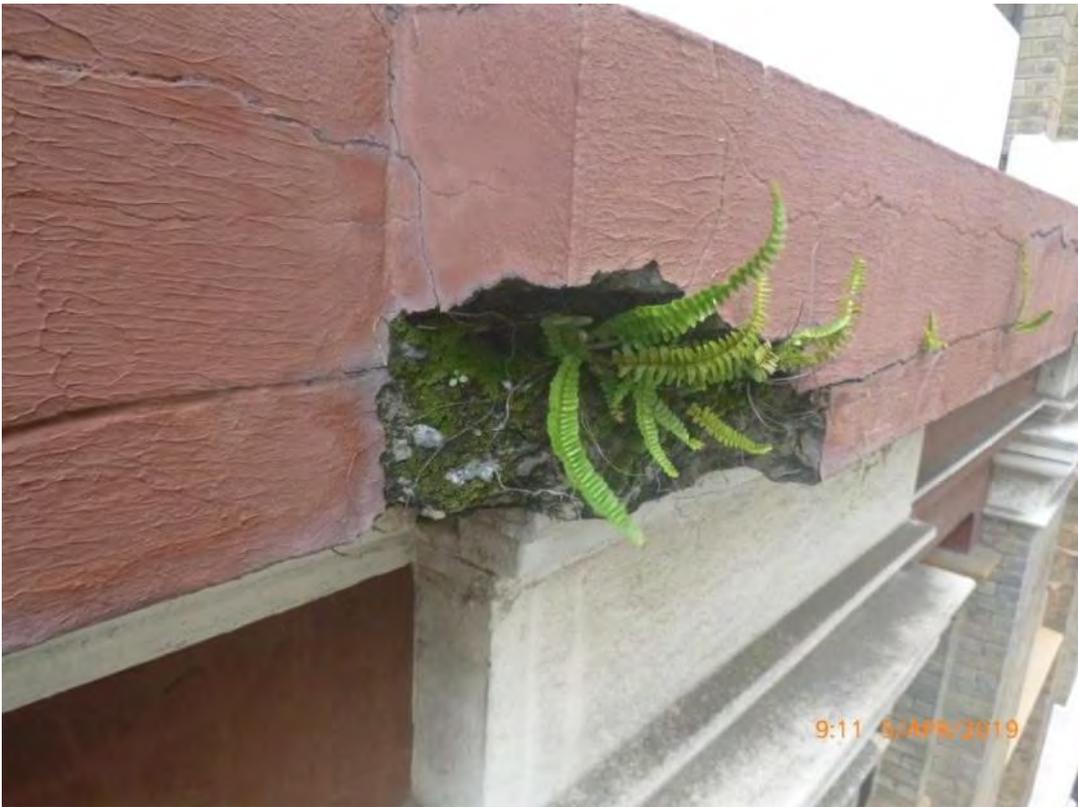
Cracked and spalling edge beams, with organic growth.

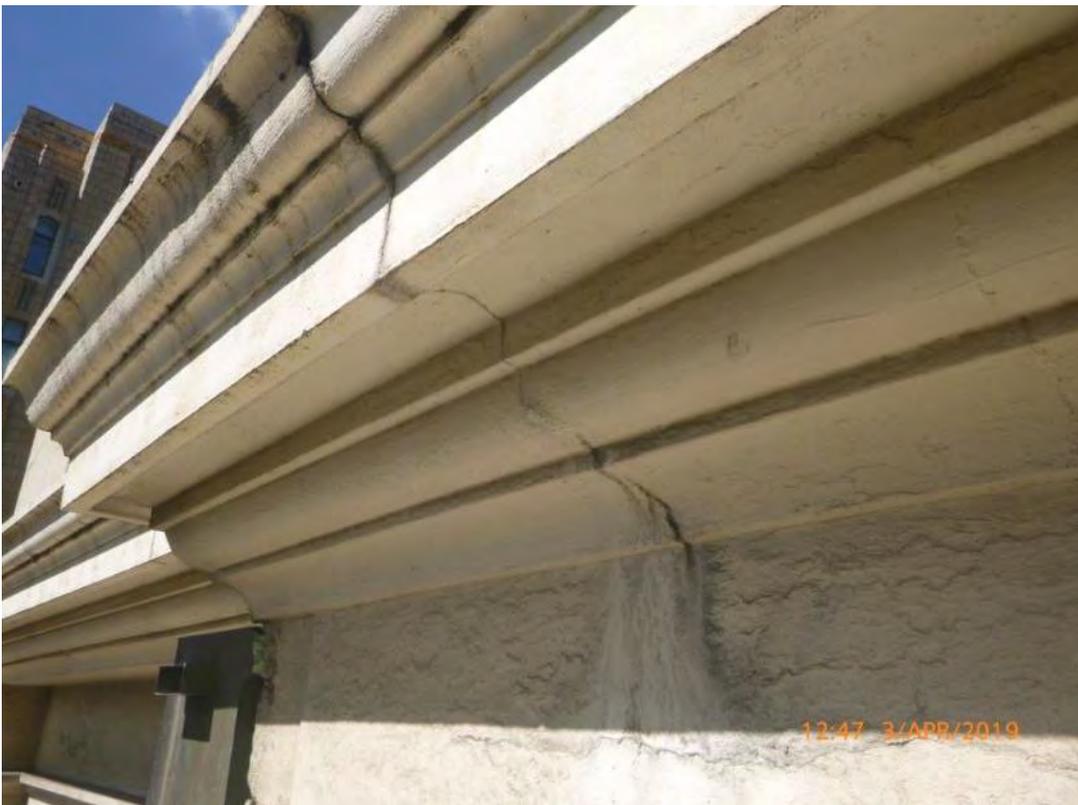
Cracking of concrete cornice, with water penetration through.

- Water penetration through cracked elements.
- Several window frames are cracked at mitre joints;
 - The central cover plate between sashes is detaching in some locations;
 - There are miscellaneous window defects, including detached glazing gaskets.
- The supports for the canopy over the Clarence Street entry are corroding in places and gutter guards to the awning are torn in some places;
- There is minor corrosion to the baseplates of balustrade posts in several locations.

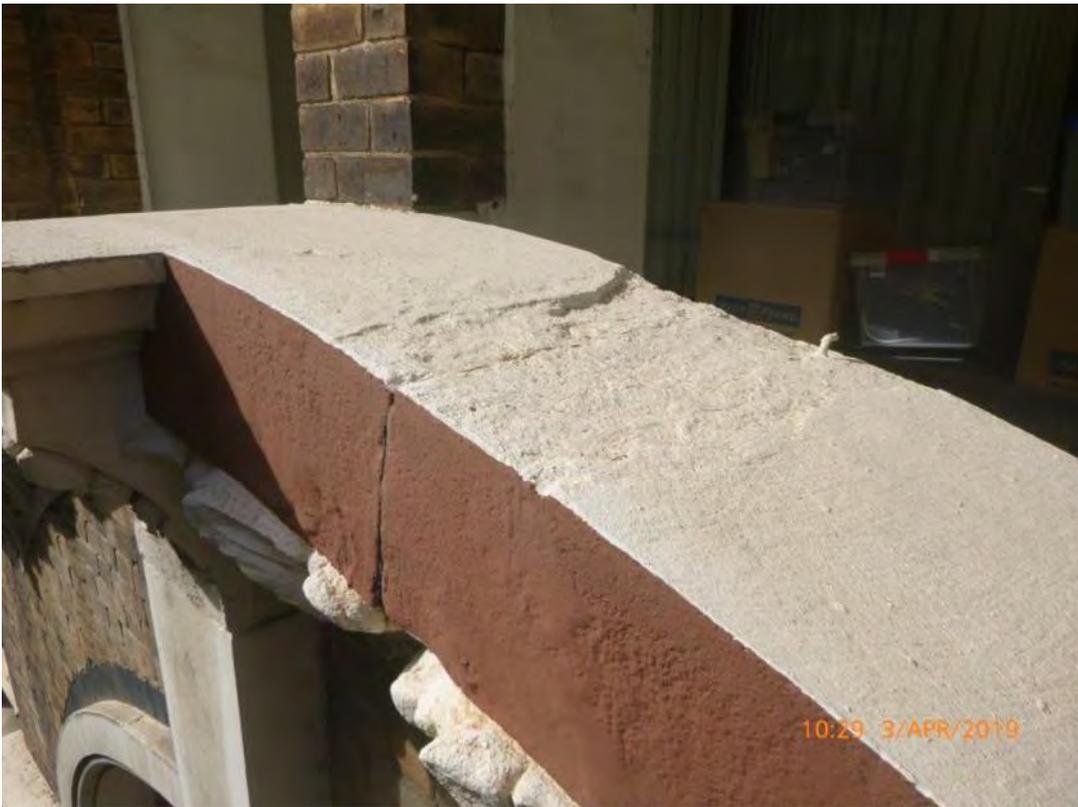
Cracking of concrete feature element.

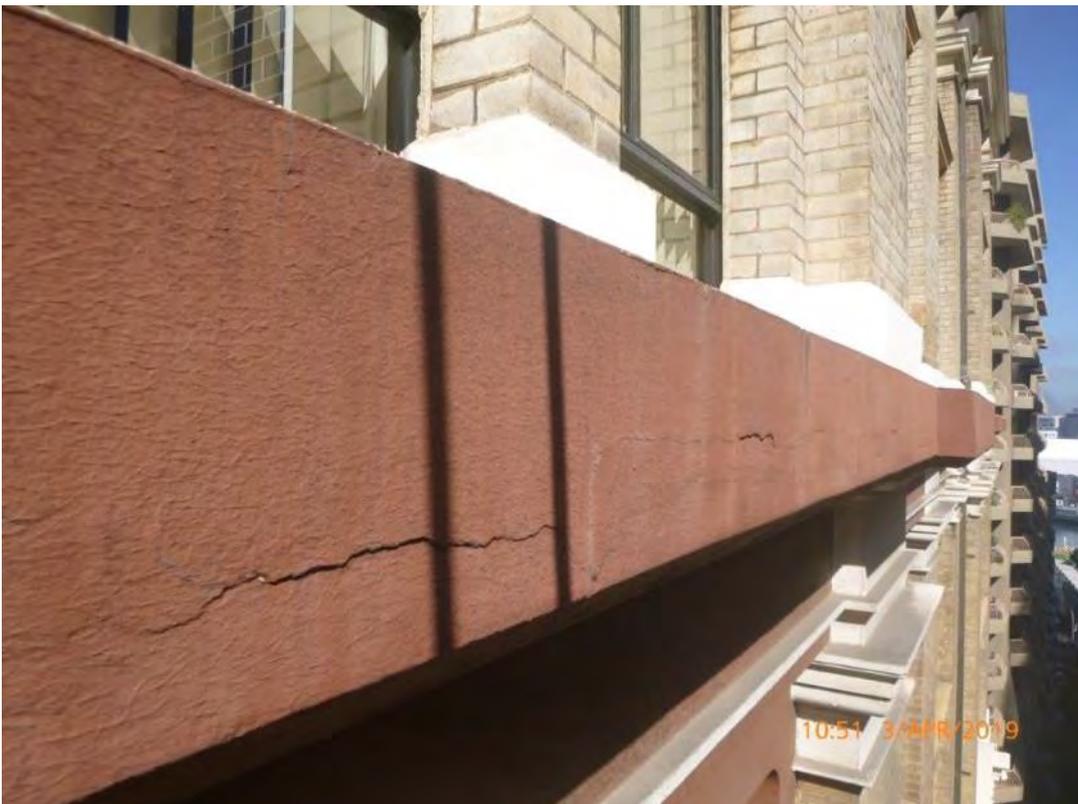
Cracking and spalling to concrete edge beam. Severe cracking, drumminess, and delamination of horizontal rendered sill.

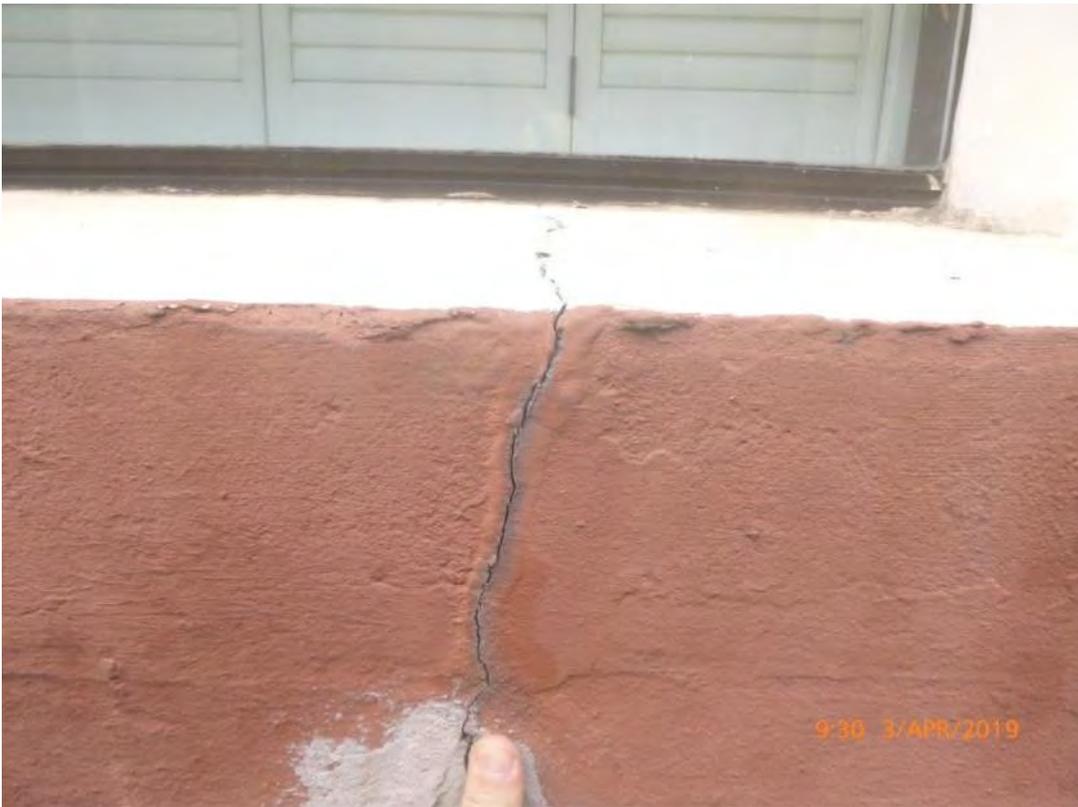
Cracked concrete edge beam
