Broughton House

181 Clarence Street, Sydney

Conservation Management Plan

Prepared for
The Owners of Strata Plan 16651 - Broughton House

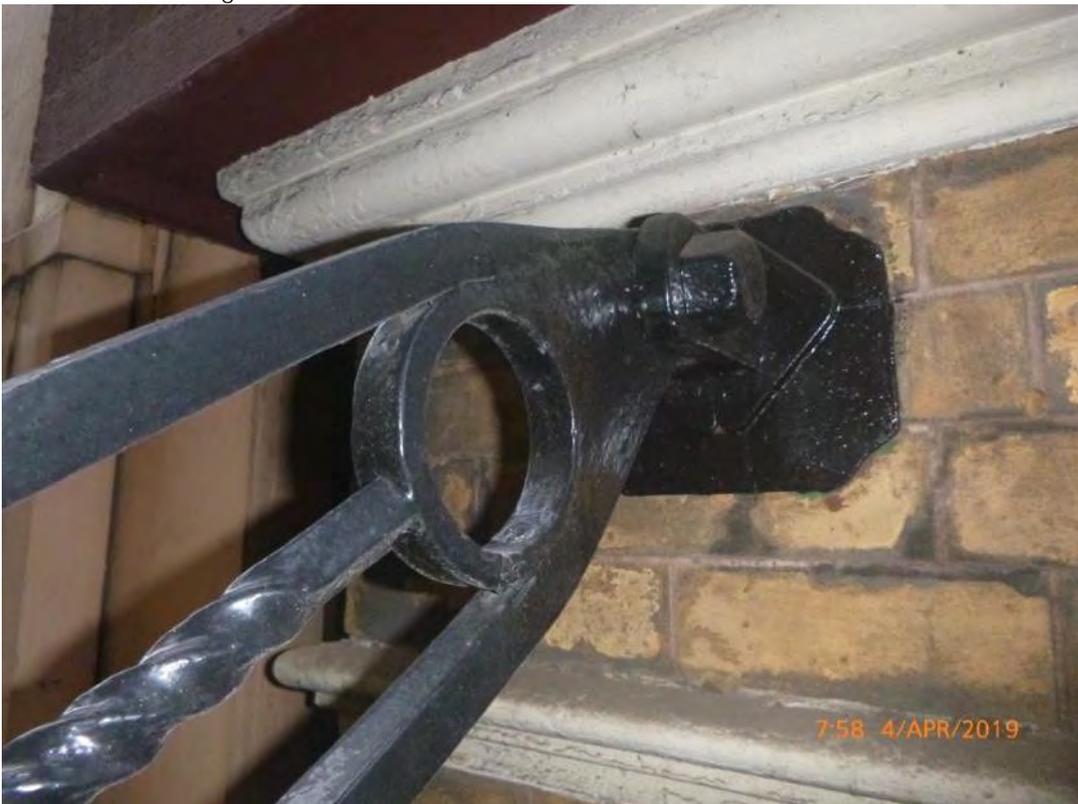
General view of awning support.

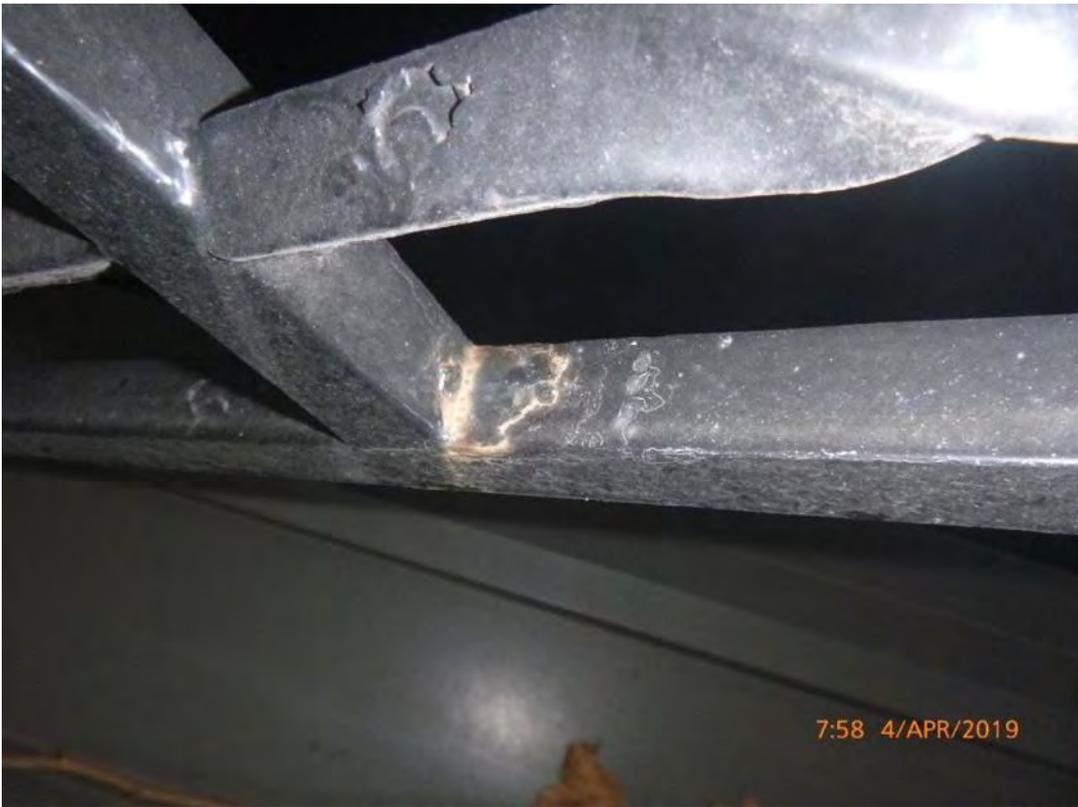
Localised corrosion to awning ties.

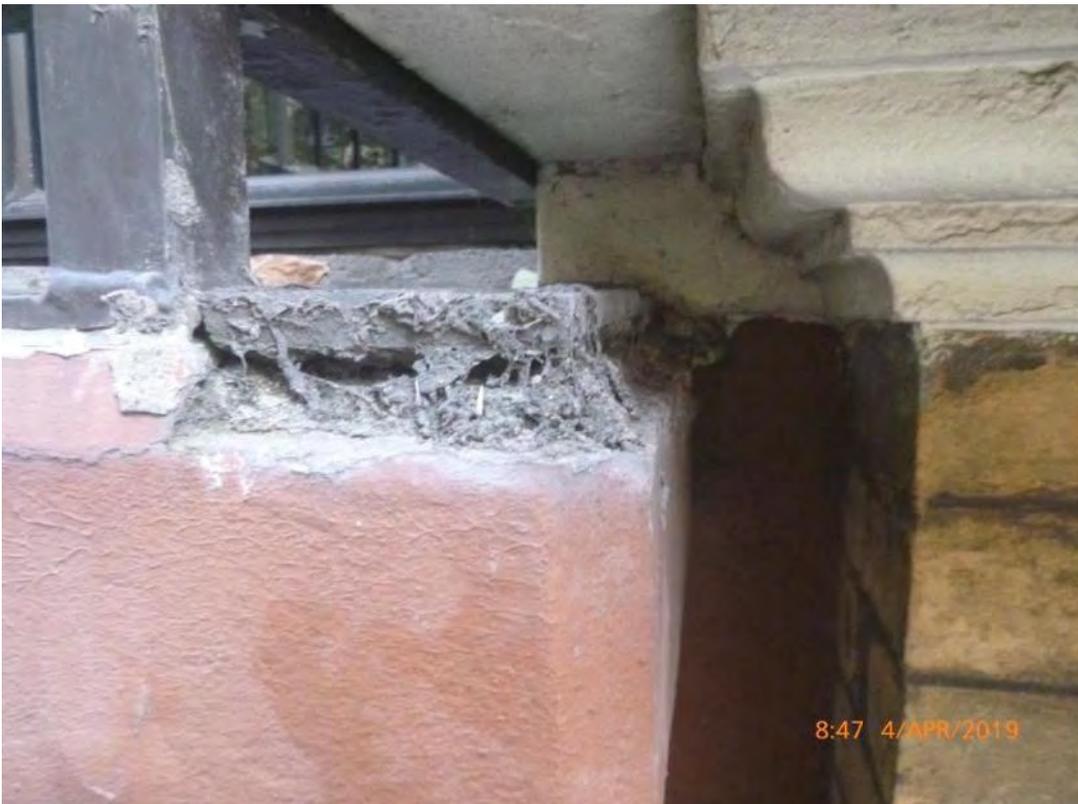
Corrosion to balustrade baseplate.

- Water penetration through cracked elements.
- Several window frames are cracked at mitre joints;
 - The central cover plate between sashes is detaching in some locations;
 - There are miscellaneous window defects, including detached glazing gaskets.
- The supports for the canopy over the Clarence Street entry are corroding in places and gutter guards to the awning are torn in some places;
- There is minor corrosion to the baseplates of balustrade posts in several locations.
