Broughton House, Clarence Street Sydney

Application for Heritage Floor Space

HFS Planning Report

April 2021 • Issue A
Project number 190060

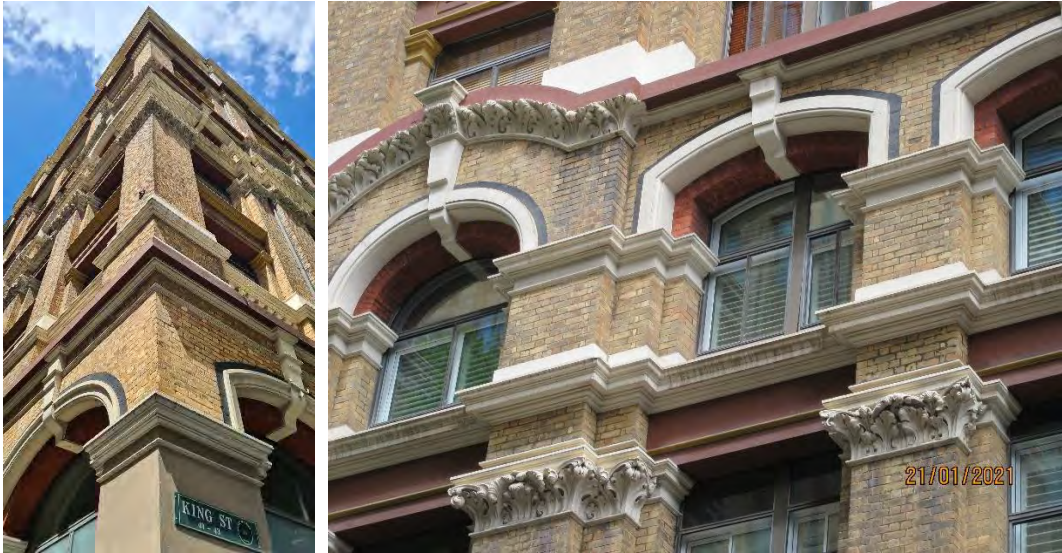
3 Exterior detailing to Broughton House.
Source: TKD Architects, 2021.

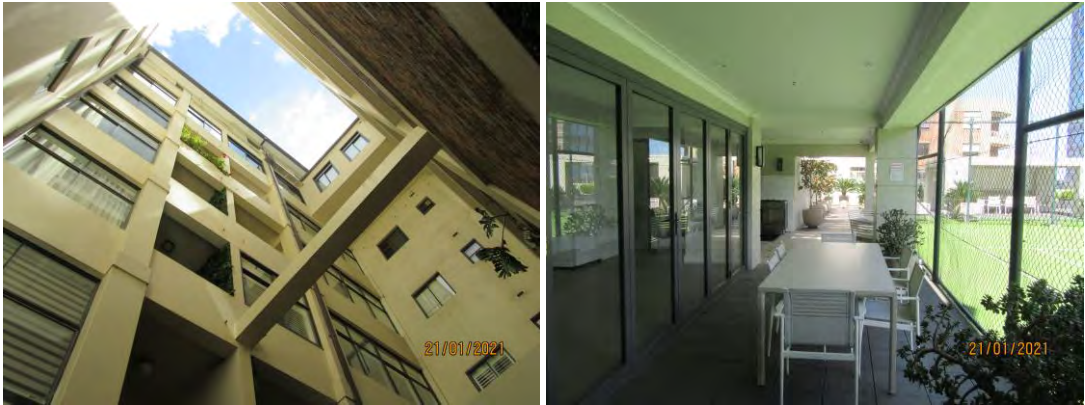
4 Internal lightwell and rooftop additions at Broughton House.
Source: TKD Architects, 2021.

While no major modifications to the building have occurred since 1979, the roof terrace has been upgraded to provide ancillary recreation functions and includes a shade structure, BBQ area, toilets and kitchenette. These modifications have increased the amenity of the tennis court and roof terrace.

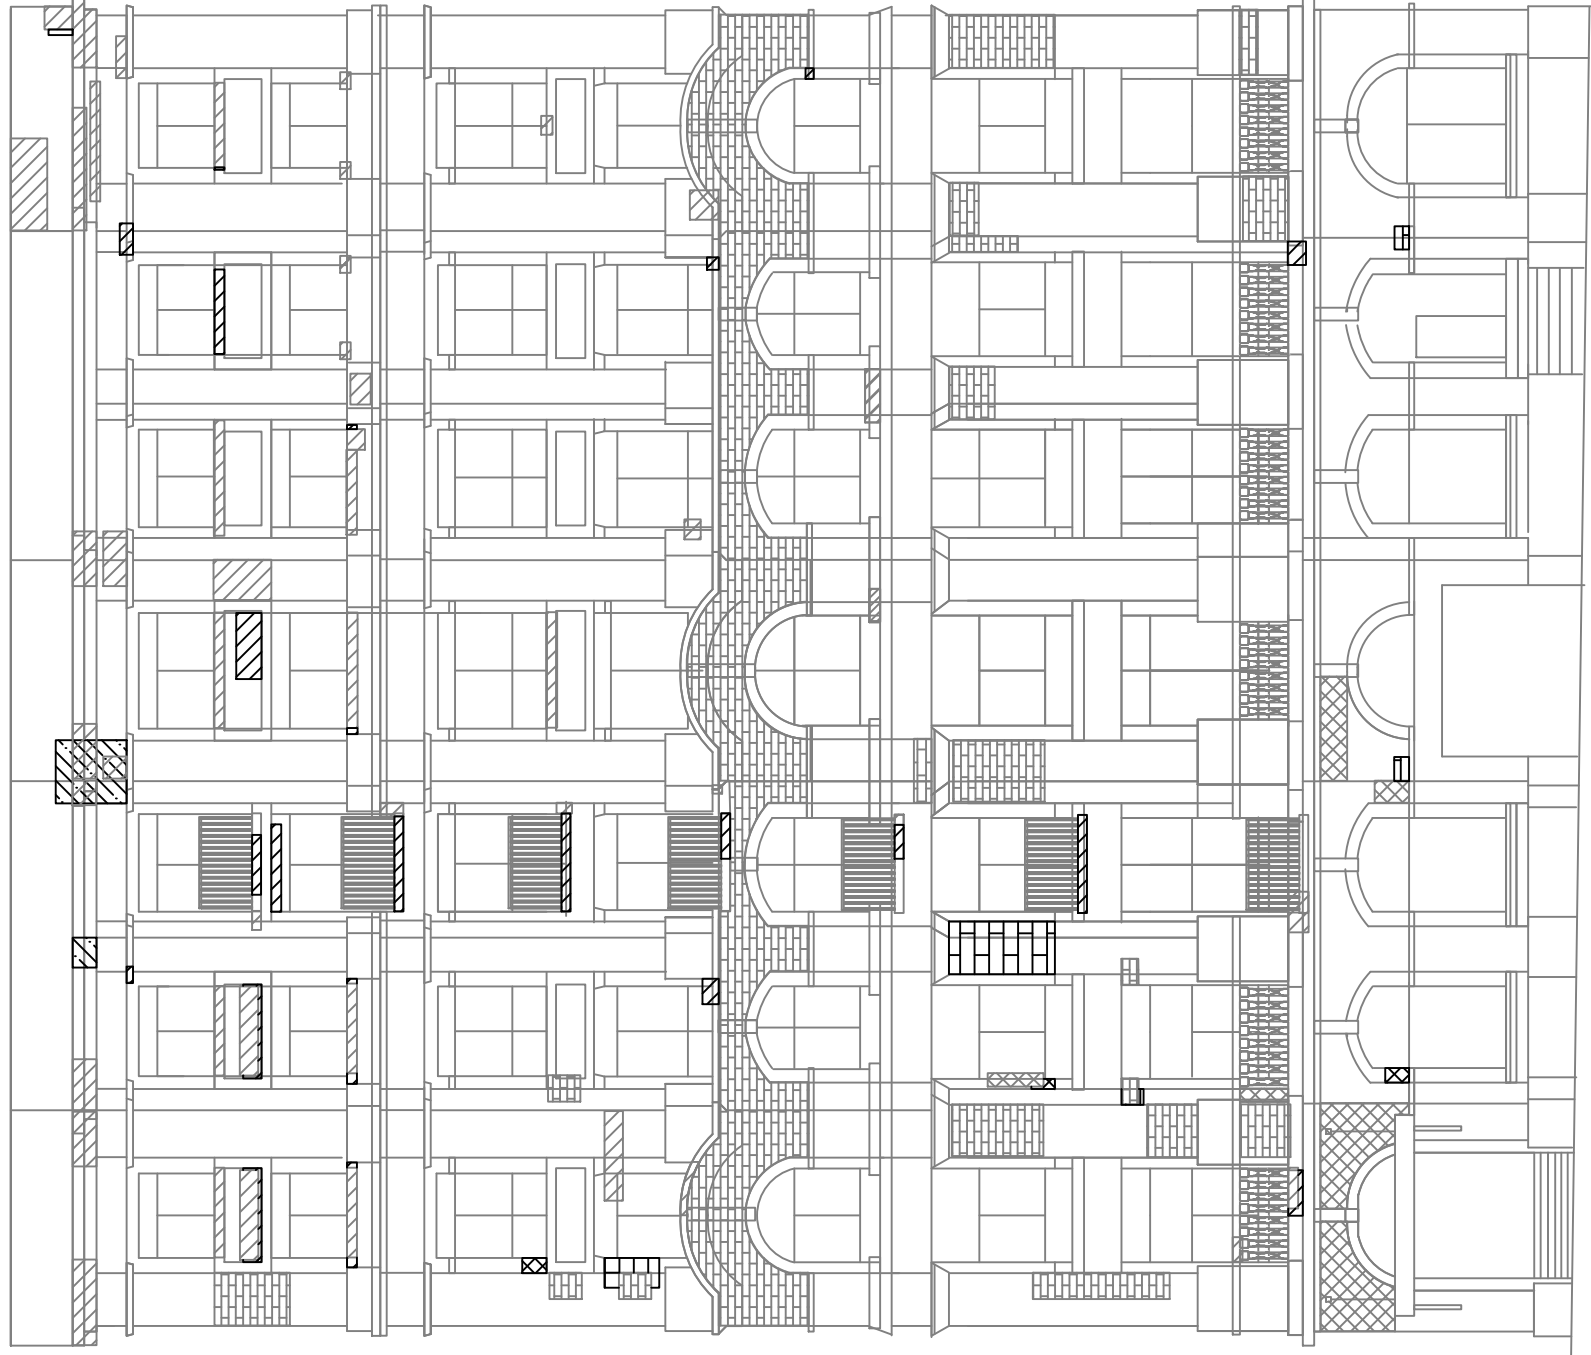
Cracking of brickwork

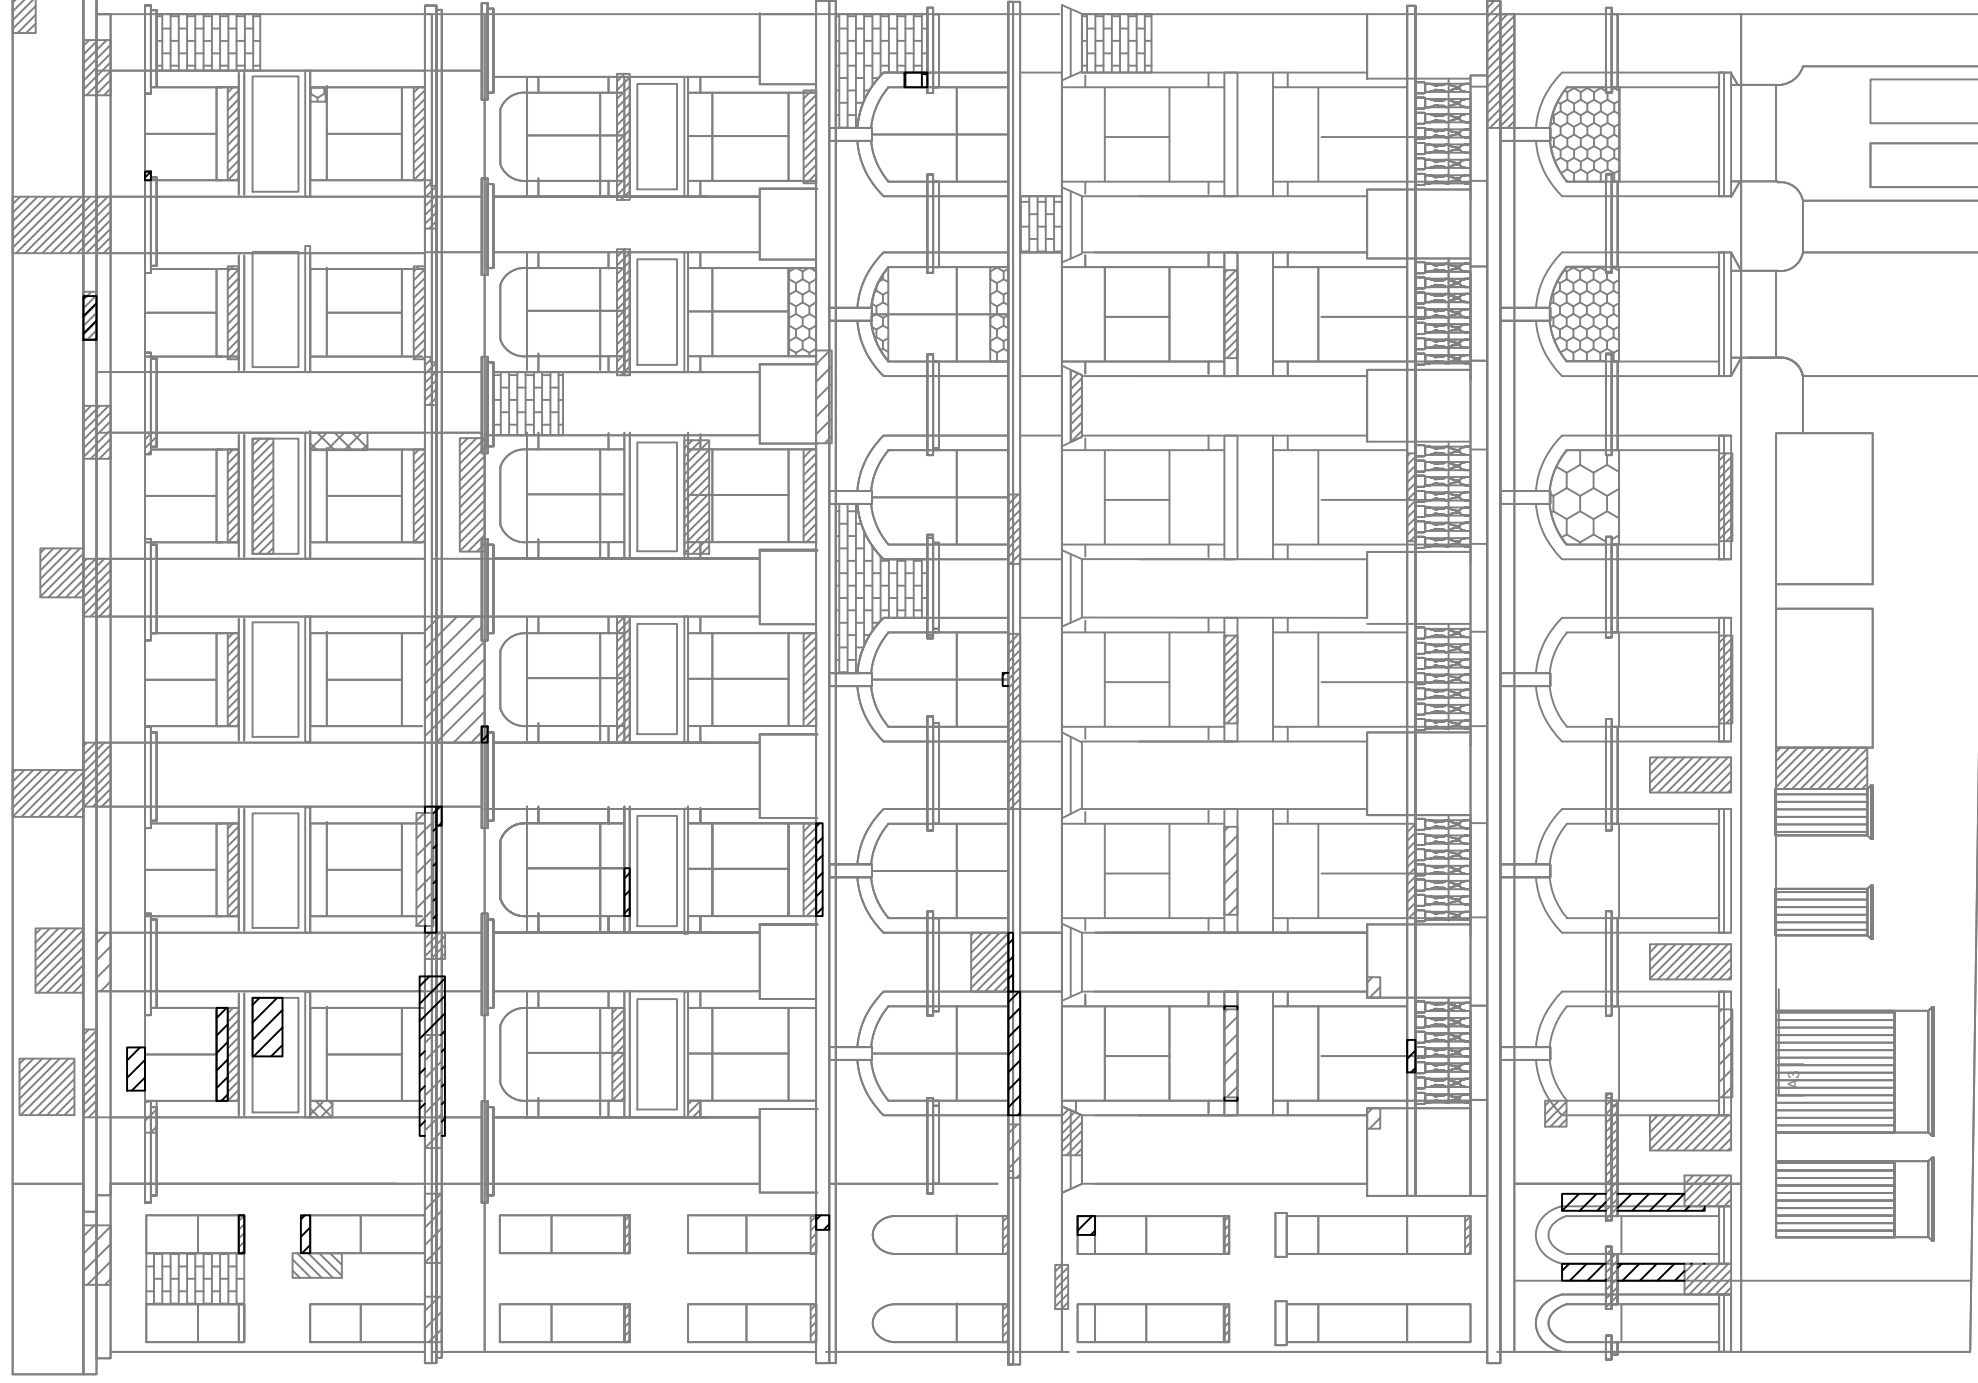
Cracking of brickwork
