1812 – Former “Royal Exchange  
Assurance Building”  
75-77 Pitt Street, Sydney, NSW 2000  
Conservation Management Plan  
March 2023

## 1812 – FORMER “ROYAL EXCHANGE ASSURANCE BUILDING”, 75-77 PITT STREET, SYDNEY – CONSERVATION MANAGEMENT PLAN

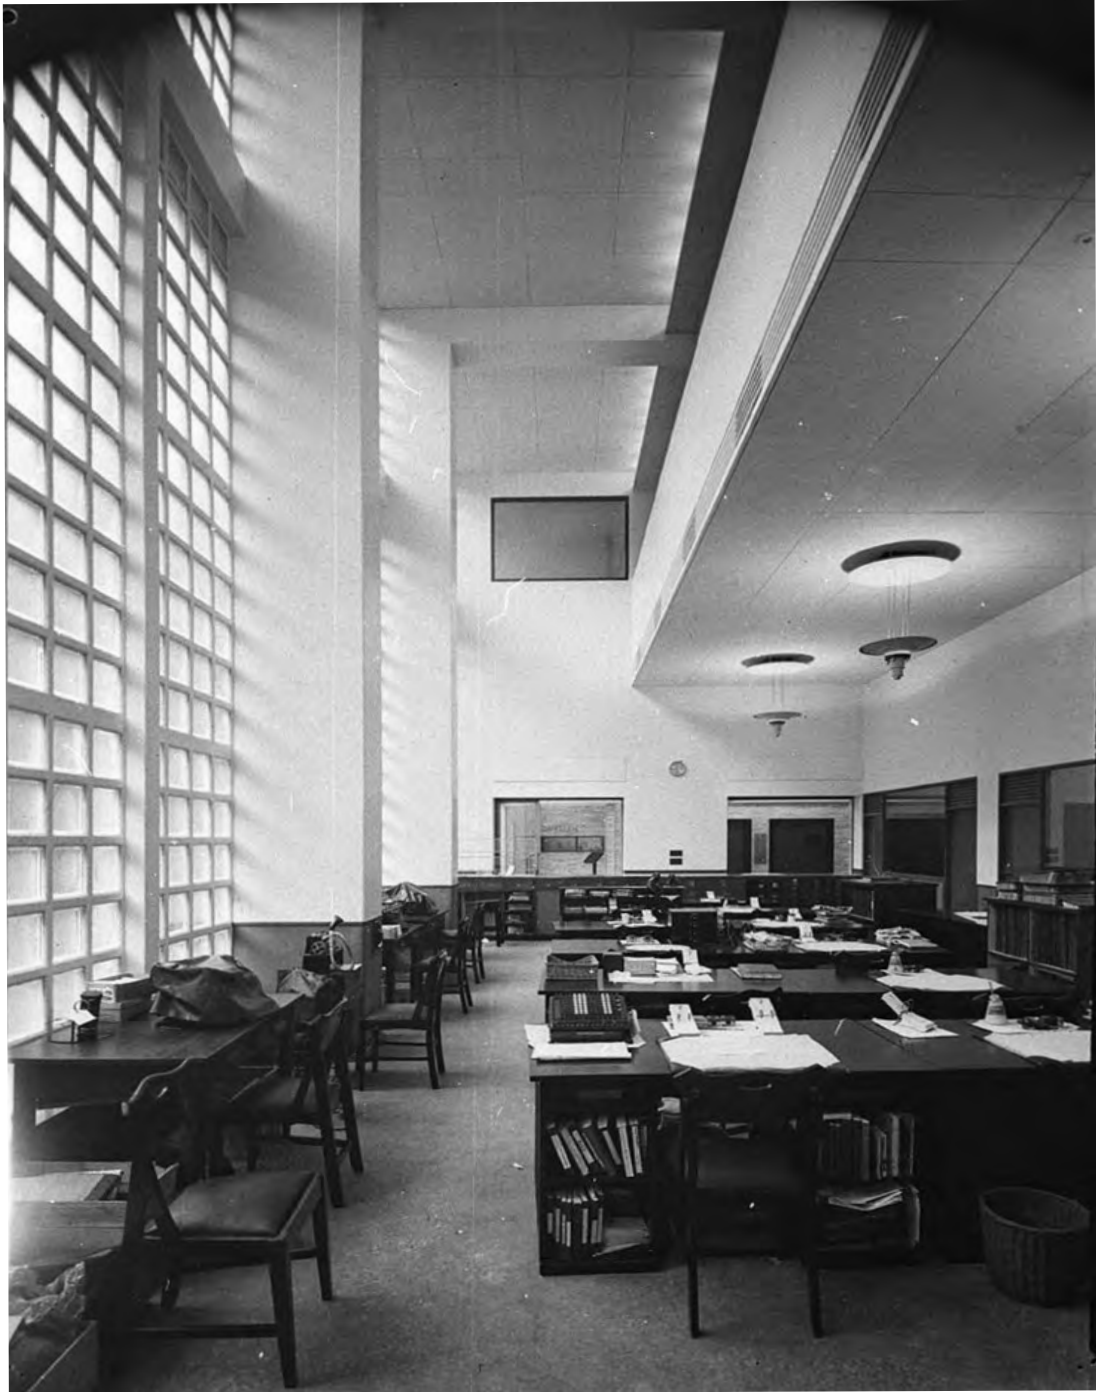
Royal Exchange Assurance Building, section of office  
with filtered light coming through glass brick facade

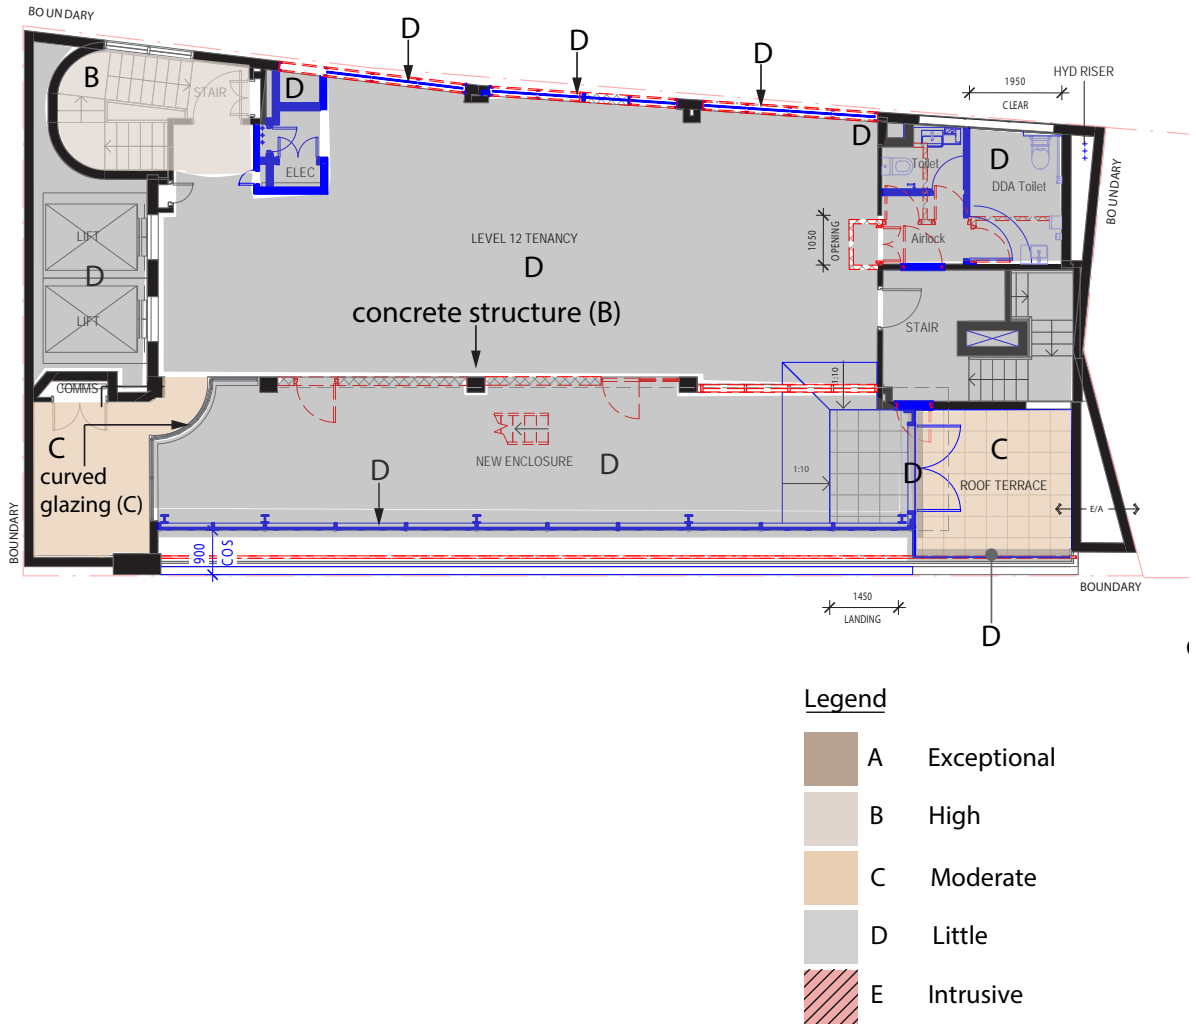
Fig 5.14.4 2022 Grading of Significance Diagram - Level 12 Floor Plan Architectural Projects

A	Exceptional
	B	High
	C	Moderate
	D	Little
	E	Intrusive
