# CONSERVATION MANAGEMENT PLAN

The Great Synagogue, 187A  
Elizabeth Street, Sydney

Prepared for  
**THE GREAT SYNAGOGUE**  
15 September 2023

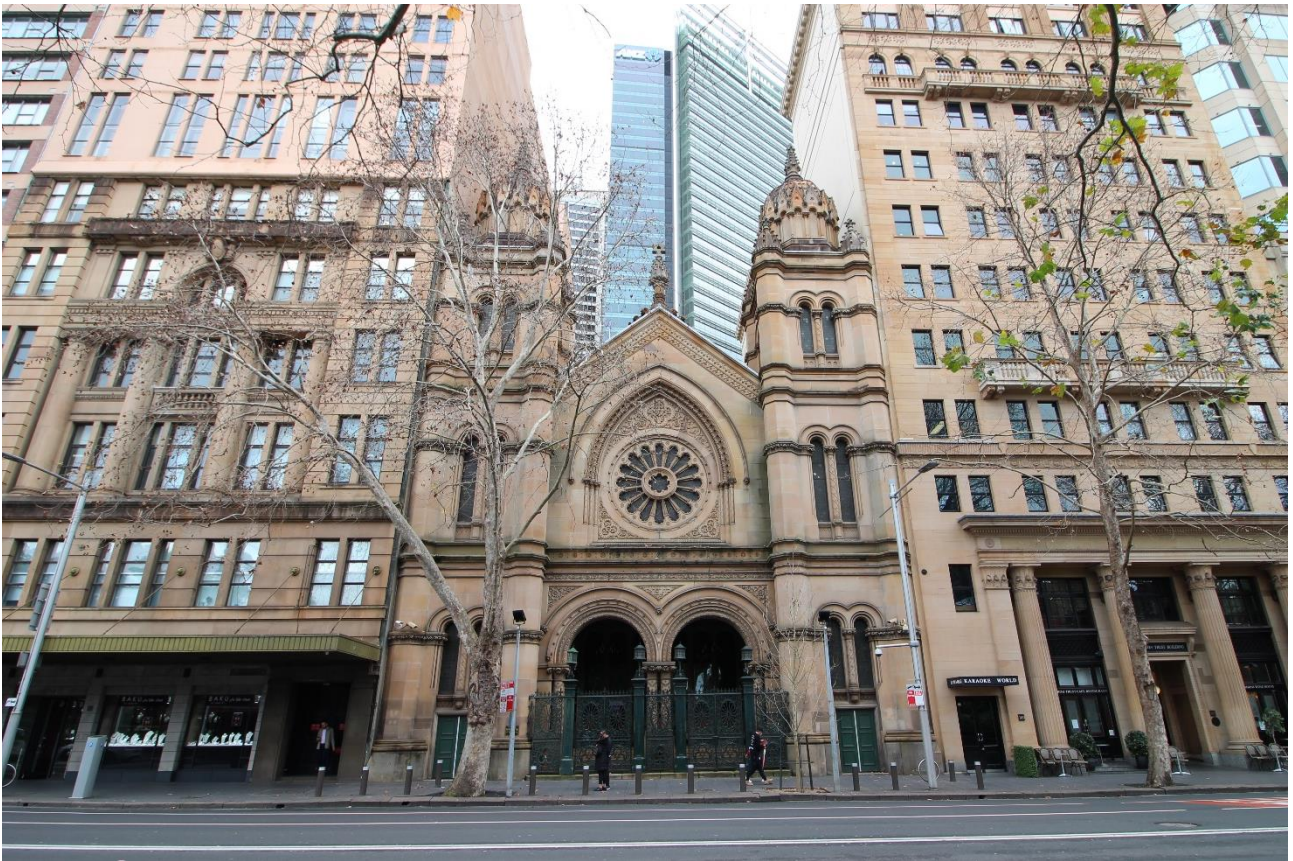
Figure 15 – Elizabeth Street elevation.

The Sanctuary portion of The Great Synagogue located at Elizabeth Street remains largely in its original condition. The Great Synagogue is a Victorian Free Gothic style completed in 1878 to the design of Thomas Rowe. The Elizabeth Street elevation features two square towers with sandstone domes that flank the central gable form with large rose window and elaborate carvings, all constructed from Pyrmont sandstone. A large porch is located in the central of the ground floor, supported by elaborately carved sandstone arches and columns and featuring encaustic floor tiles and a painted timber boarded ceiling. Detailed iron gates enclose the front of the porch from Elizabeth Street. The original Star of David finial has been placed at the entrance to the Synagogue. Leadlight windows adorn every opening of the Elizabeth Street façade, from the paired arched windows of the towers, to the leadlight windows of the porch. The Elizabeth Street façade remains in its original condition, apart from the addition of fire doors at the ground level of the two towers.

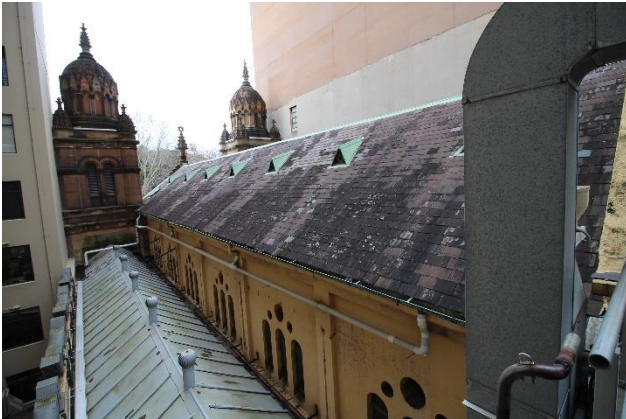
Figure 16 – Detail of roof.

The remainder of the structure of the Sanctuary, beyond the Elizabeth Street frontage, is constructed of brick with cast iron columns and timber floors. The roof over the Sanctuary features a gabled roof clad with slate roof tiles with hooded vents, while the roofs of the galleries feature hipped roof forms clad with later aluminium cladding. At the northern elevation of the Sanctuary clerestory roof are the remains of iron-brackets which original supported an awning that has since been removed.

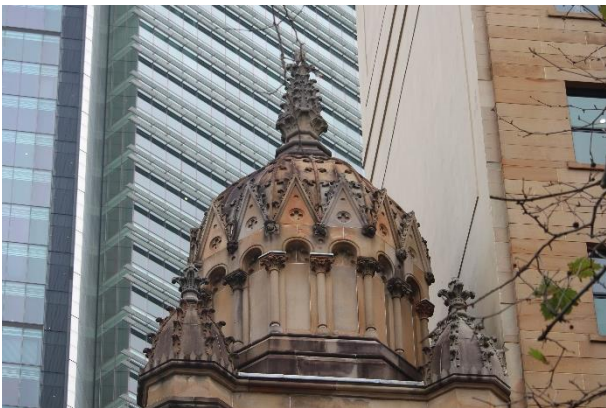
Figure 18 – Detail of sandstone tower dome.

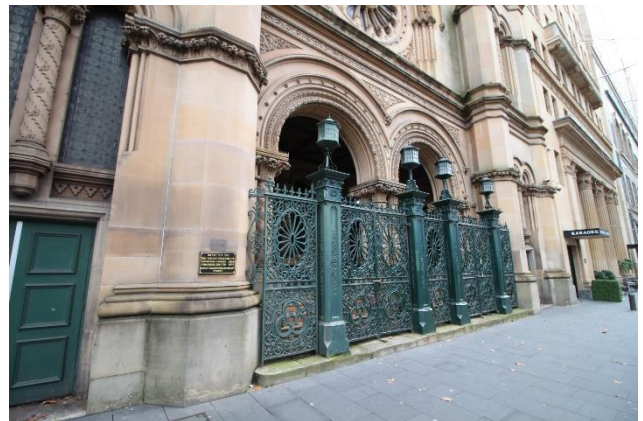
Figure 19 – Ground level at Elizabeth Street with original iron gates.

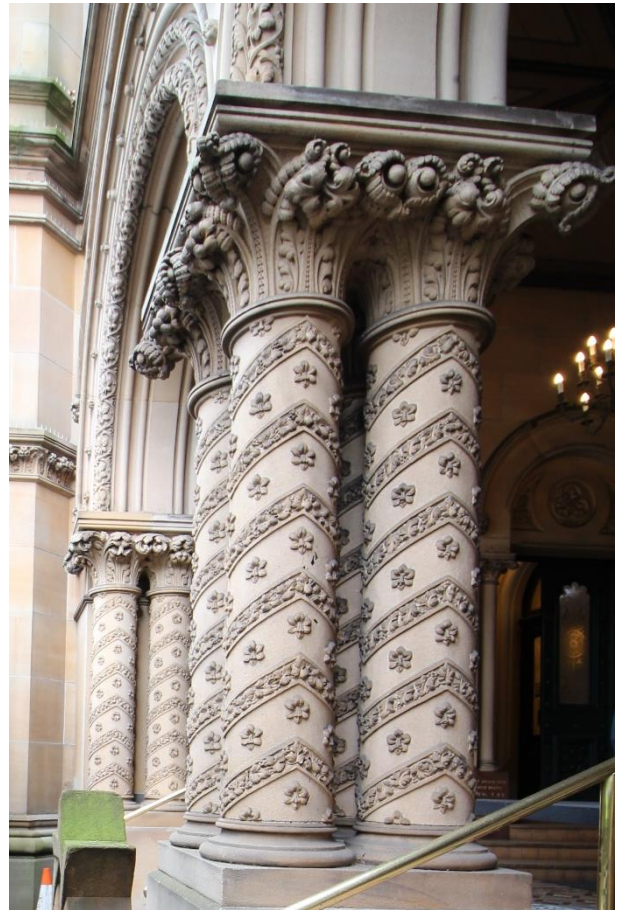
Figure 21 – Detail of columns to portico.

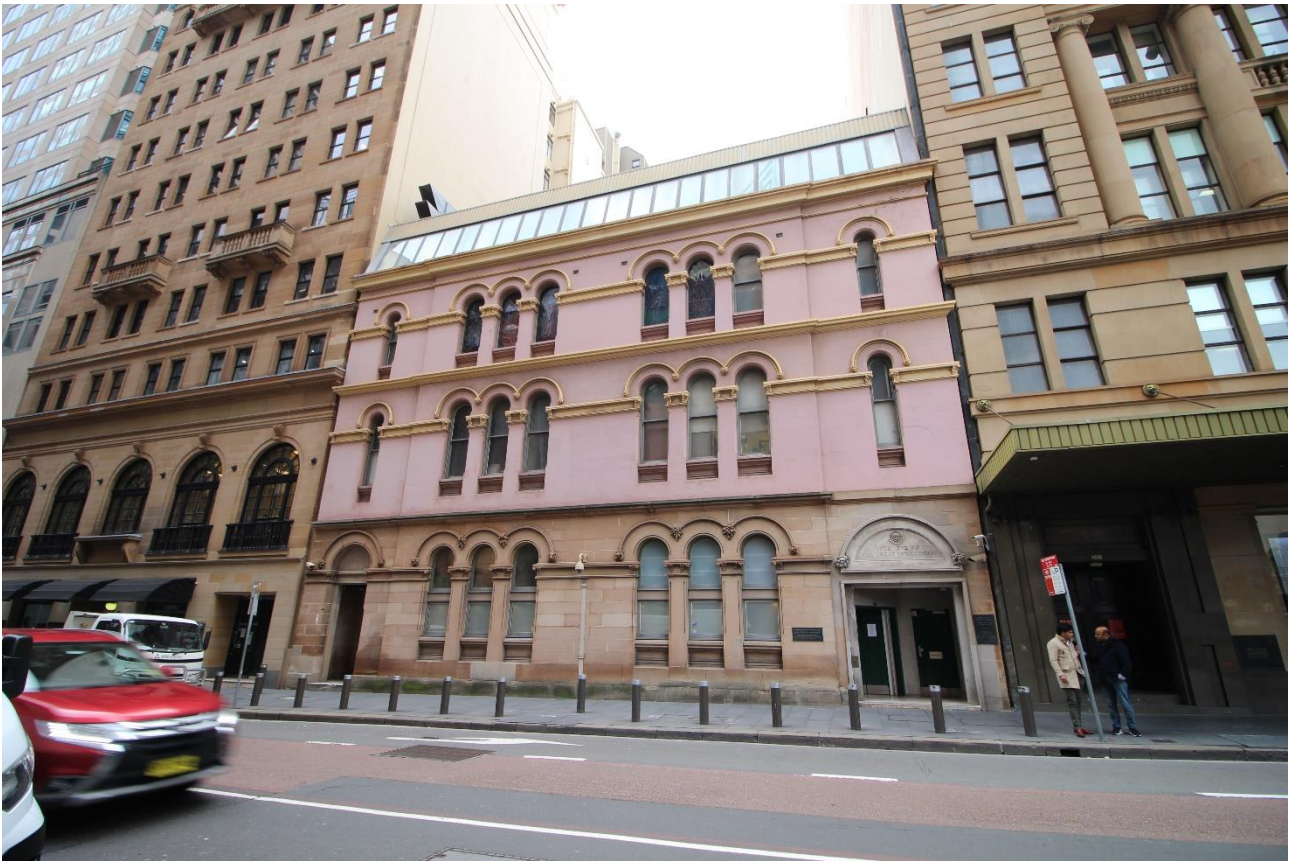
Figure 24 – Castlereagh Street elevation.

The Castlereagh Street façade features the original façade of the Beadle’s residence. The façade features sandstone at the ground level and rendered brickwork at the first and second storeys. The third storey elevation features a glazed mansard roof which was added as part of the Education Centre in the early 1980s. At each level of the façade are two sets of three arched windows with sandstone or plaster string courses and detailing. At the southern end is a modified opening which provide entrance through to the Education Centre and Israel Green Auditorium.

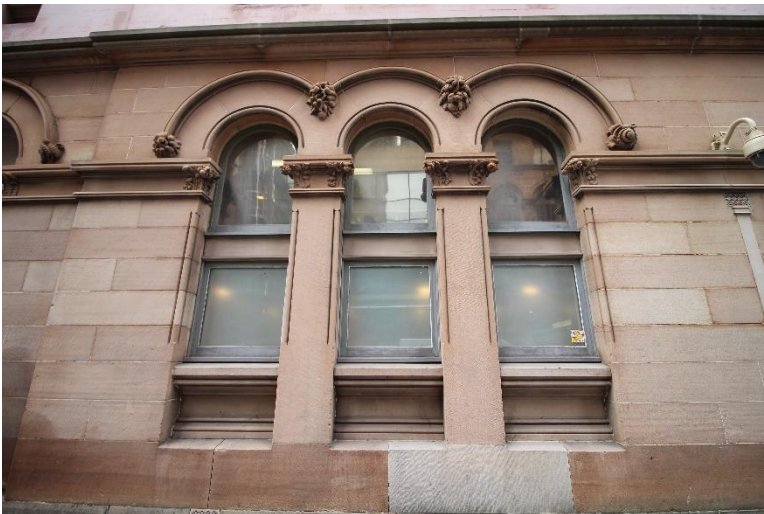
Figure 25 – Detail of ground floor windows with carved sandstone detailing.

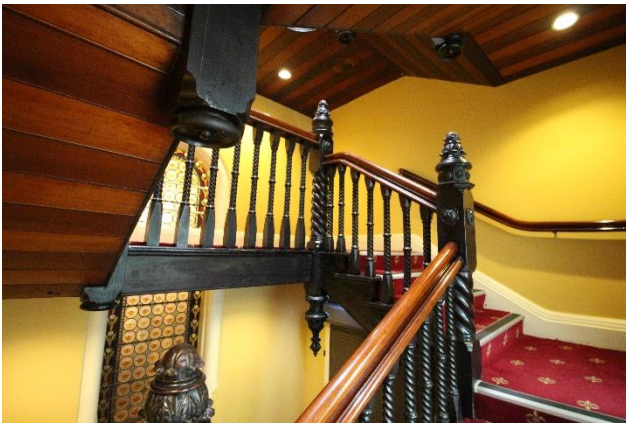
Figure 42 – Staircase in tower.

two towers. The timber staircases within each tower have strongly carved balustrades, and soffits in alternating cedar and pine boards. Sets of double lead timber doors with intricate etched glass provided entrance to the Sanctuary. At the centre of the ground floor at its western end is the Ark, with bimah set at the front of the arch on a timber platform which has been placed over the original steps to the Ark. The original location of the bimah was at the centre of the ground floor, which is surrounded by encaustic tiles similar to those of the porch. The former location of the bimah is covered with timber floorboards. The interior of the sanctuary is elaborately decorated throughout, with moulded plaster, carved timber and leadlight windows adorning the interiors. All walls and detailing are painted with gold leaf highlighting many of the intricacies of the Sanctuary. Electric gasoliers (converted from the original gas) are featured through the space with pendant, standard and wall mounted gasoliers.

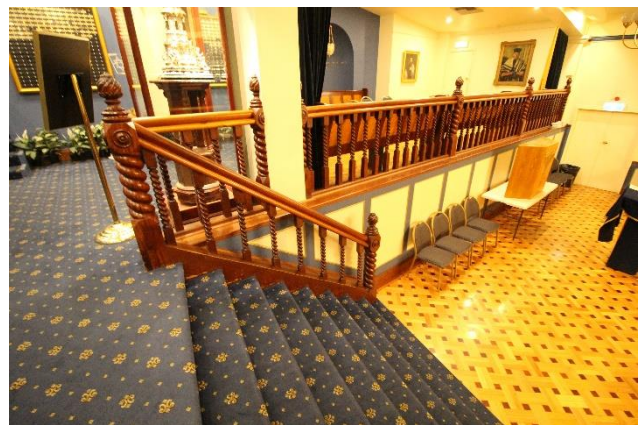
Figure 45 – Salvaged balustrade from former Beadles residence.

The basement underneath the Sanctuary contains the Israel Green Auditorium, which is divided into several space accessed of the central auditorium and stage. At the upper level (Level 2) is the A.M. Rosenblum Museum and Rabbi Falk Library, Mezzanine and toilets. The Museum contains a collection of numerous Jewish artefacts including textiles, ritual silver paintings, sacred scrolls and religious artefacts. The museum periodically host new exhibitions within the place. The Rabbi Falk Library houses a collection of old and rare books and is used as a reference library. At the lower level (Level 1) are kitchens, storerooms and an office. The interiors of the Israel Green Auditorium primarily date to the 1950s and was redecorated in the 1980s. Some elements from the original Beadle's residence have reused in the Israel Green Auditorium, included timber balustrade from the former wester staircase, and timber framed doors with etched glass panels at the mezzanine.

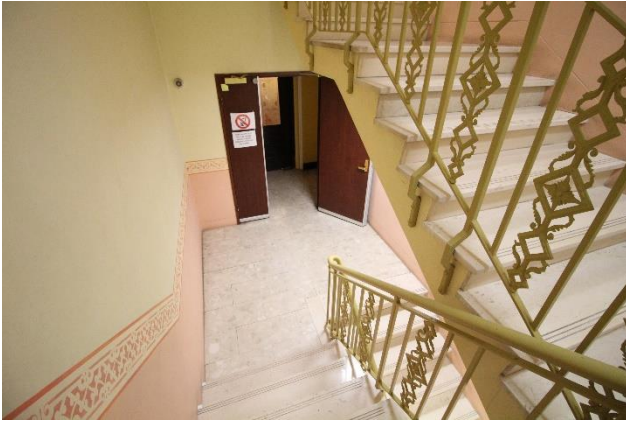
Figure 54 – Fire stairs in Education Centre.

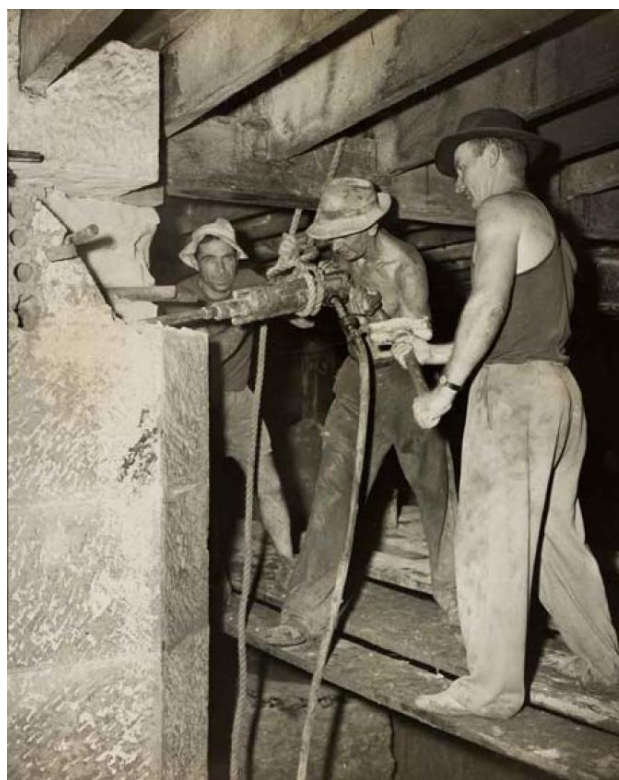
Figure 86 – Building Workmen cutting away the stone piers in the basement for the new centre, 1955.

*The building operations of the War Memorial Centre started in January and impressive progress has been made. The major work of excavation and the underpinning of the whole of the Synagogue structure is almost complete. It was found necessary to go considerably deeper than at first anticipated to reach rock bottom. This has been achieved without disturbance to the main building.*

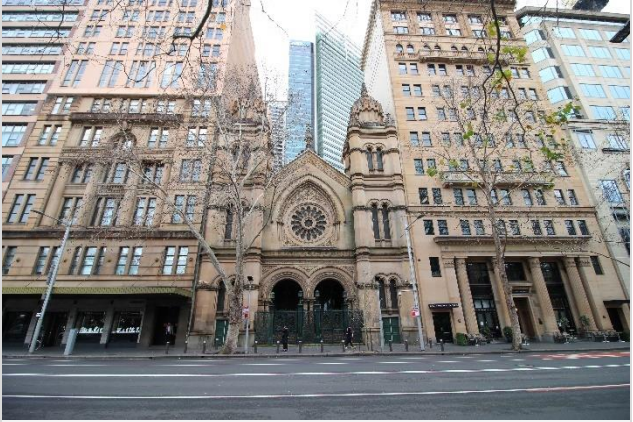
<p>Figure 108 – View 1 to Great Synagogue from Elizabeth Street.</p>

View No	Location & Direction	Significance	Image
1	View west from directly opposite Great Synagogue on Elizabeth Street  The most significant views of The Great Synagogue are appreciated from within close proximity of The Great Synagogue along Elizabeth Street.	High

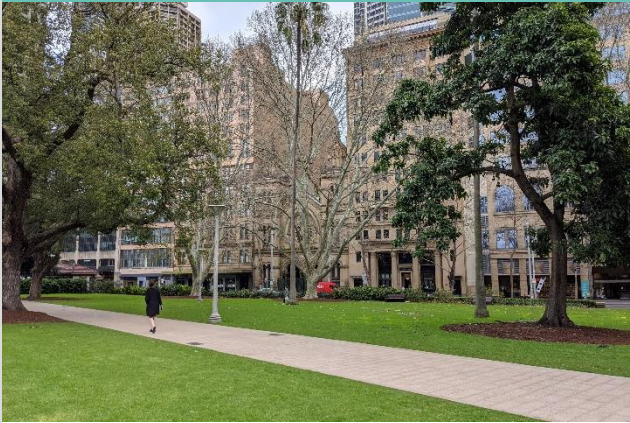
View No	Location & Direction	Significance	Image
2	<p>View west from within Hyde Park</p> <p>Obscured views to The Great Synagogue are appreciated primarily during the cooler months when foliage of deciduous trees have fallen. Views are obscured to a large extent and reduced to pocket views during the warmer months.</p>	Moderate

<p>Figure 109 – View 2 to Great Synagogue from Hyde Park.</p>
3	<p>View north-west from Park Street</p> <p>Oblique views of The Great Synagogue are visible across the corner of Hyde Park from Park Street. Views are generally obscured the further travelled east of the intersection with Elizabeth Street.</p>	Moderate

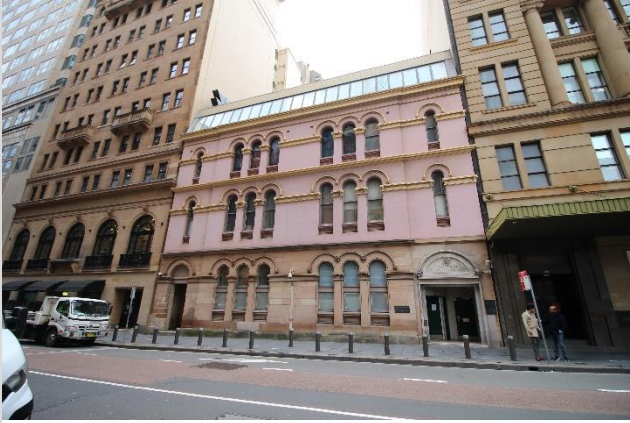
<p>Figure 111 – View 4 to Great Synagogue rear façade from Castlereagh Street.</p>

<p>Figure 110 – View 3 to Great Synagogue from Park Street.</p>
4	<p>View east from directly opposite the rear façade on Castlereagh Street</p> <p>Full views of the rear façade at Castlereagh Street are appreciated from within close proximity of The Great Synagogue along Castlereagh Street.</p>	Moderate

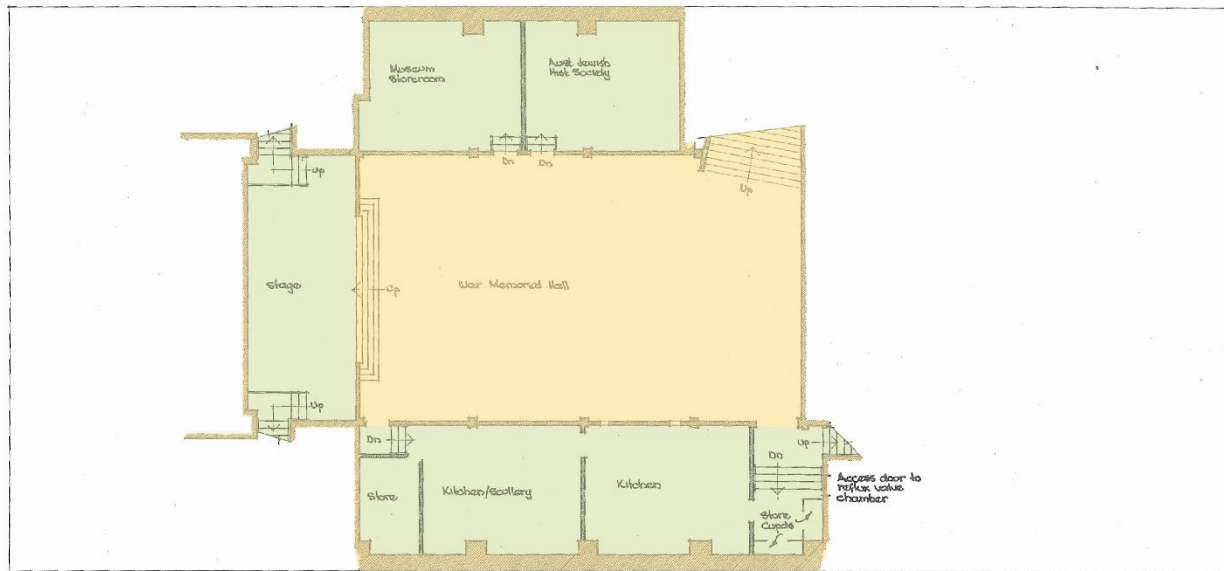
## Level 1

Grading refers to the significance of the overall heritage value structure and spaces. For significance rankings of individual elements and further detail, refer to the Schedule of Significant Elements in Section 6.5.

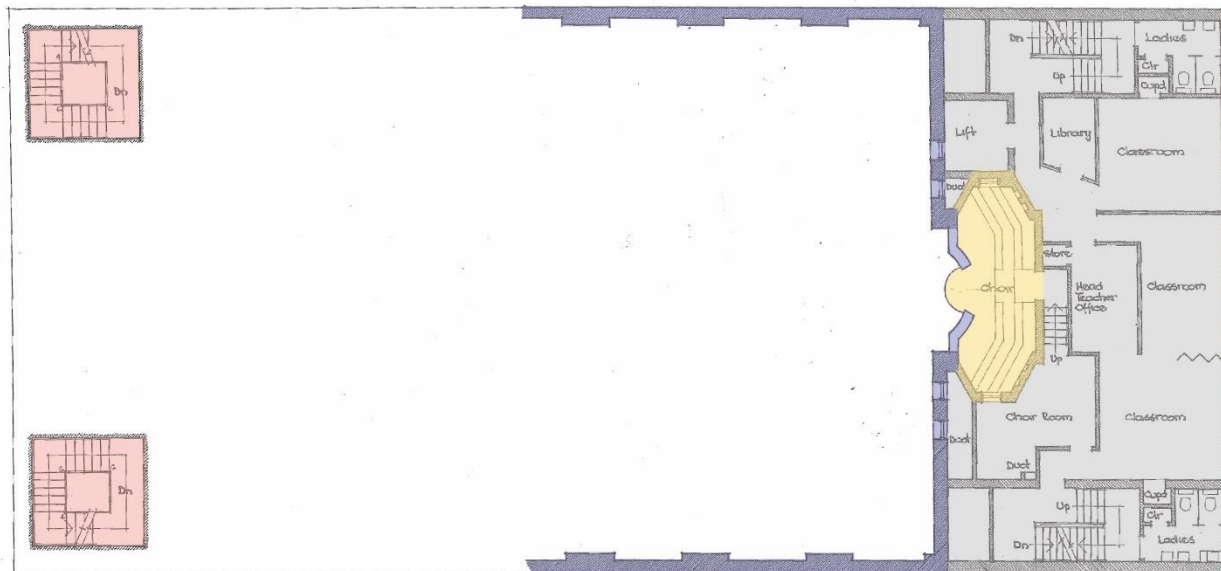
## Level 4

Grading refers to the significance of the overall heritage value structure and spaces. For significance rankings of individual elements and further detail, refer to the Schedule of Significant Elements in Section 6.5.

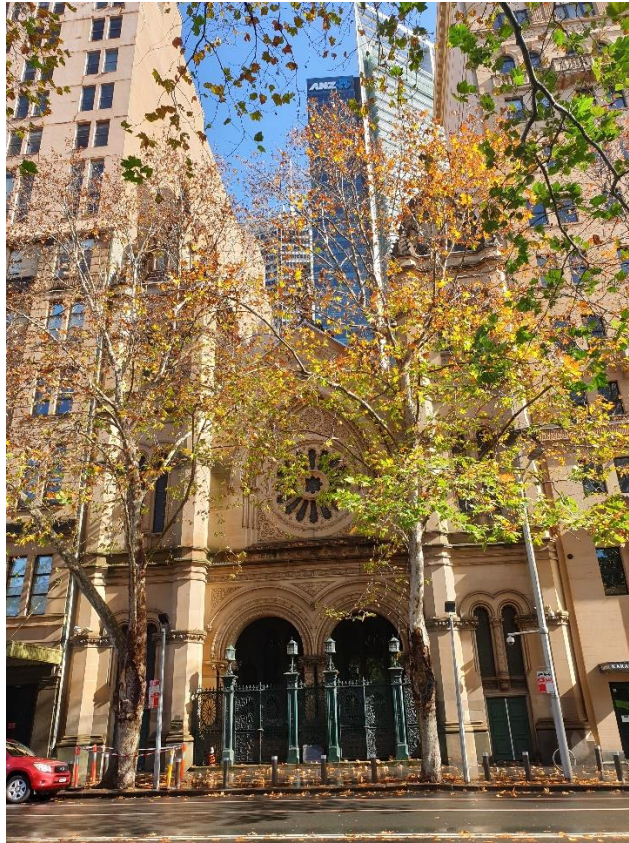
An endorsed Conservation Management Plan can impose additional standards of maintenance and repair.

From the northern tower platform, it appears that stones may be dislodged towards the top. Further investigations should be undertaken with access higher up the tower, to closely inspect the condition of the stones and severity of dislodgement. If the stones are considered to be at risk of falling, seek the advice of a structural engineer on the safe removal and replacement.

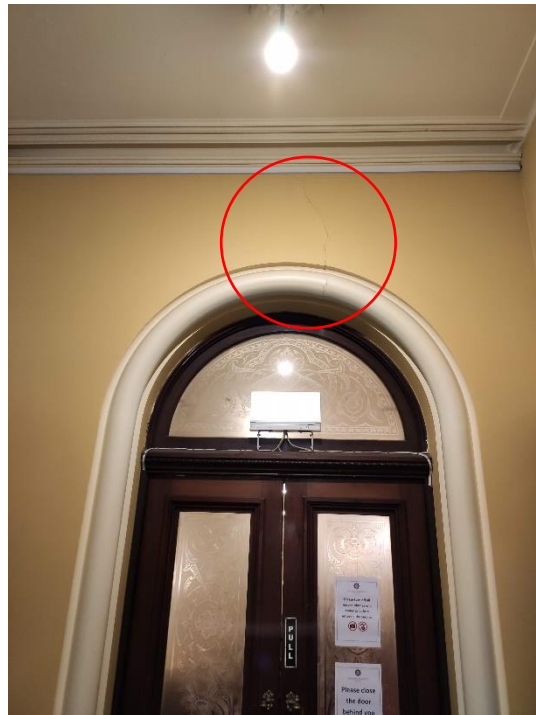
**Defect 26**

Defect No.	Location	Defect Description	Discussion	Action Required
26	Northern Tower, doorway into Ladies Gallery	Moderate crack from top of arch to ceiling	<ul style="list-style-type: none"> <li>Crack does not appear to be active, and has been there for quite some time</li> <li>Possibly a result of ground movement</li> <li>Does not pose a threat to the structural integrity of the building</li> </ul>	Monitor
27	Northern Tower, entryway into Ladies Gallery	Minor cracking in ceiling	<ul style="list-style-type: none"> <li>Cracks do not appear to be active, and have been there for quite some time</li> <li>Possibly a result of ground movement and/or localised settlement or as a result of ground movement and/or the weight of the towers.</li> <li>Does not pose a threat to the structural integrity of the building</li> </ul>	Monitor
28	Northern Tower, single stain glass window	Minor cracking at top of window	<ul style="list-style-type: none"> <li>Cracks do not appear to be active, and have been there for quite some time</li> <li>Possibly a result of ground movement and/or the weight of the towers</li> <li>Does not pose a threat to the structural integrity of the building</li> </ul>	Monitor

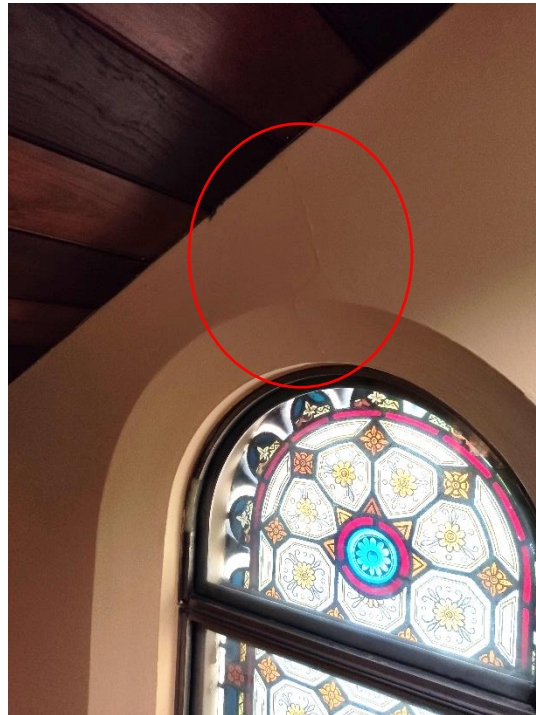
**Defect 29**

29	Northern Tower pair of stain glass windows	Minor cracking at top of one window		Monitor
30	Stairway up to Tower Platform, Northern side	Minor cracking in exposed stone wall		Monitor
31	Tower Platform, Northern side	Stones dislodged Water ingress	<ul style="list-style-type: none"> <li>Water ingress appears to have been occurring for quite some time, and a tarp has been placed on the tower platform to capture water.</li> <li>Stones at the top of the tower appear to have shifted out of place, though appears to be stable at this time, this should be further investigated</li> </ul>	<p>Access the top of the tower space to check the condition of the top stones and the severity of the dislodgement.</p> <p>If the stones are considered to be at risk of falling, consult structural engineer on the safe removal and replacement</p>

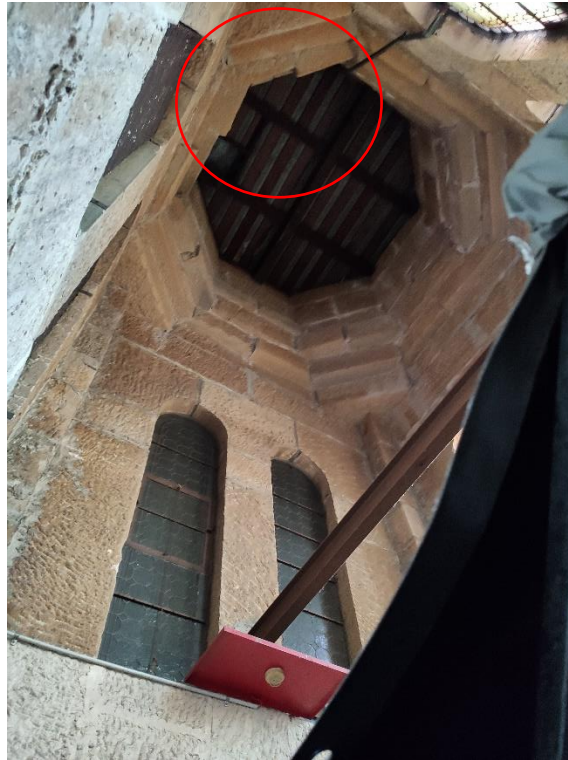
**Defect 31**

Defect No.	Location	Defect Description	Discussion	Action Required
			<ul style="list-style-type: none"> <li>• Difficult to ascertain the severity of the stone displacement without having access higher up the tower.</li> <li>• Water ingress can cause timber decay and mortar erosion etc. over time</li> </ul>	
32	Classroom on Choir Level	Minor cracking	<ul style="list-style-type: none"> <li>• Cracks do not appear to be active, and have been there for quite some time</li> </ul>	Monitor
33	Wall outside Vestry, facing the boardroom	Minor cracking in top of wall	<ul style="list-style-type: none"> <li>• Most likely due to movement at the building joint between the original building and the extension</li> </ul>	Monitor
34	Wall outside Vestry, facing the classroom	Minor horizontal cracking	<ul style="list-style-type: none"> <li>• Does not pose a threat to the structural integrity of the building</li> </ul>	Monitor

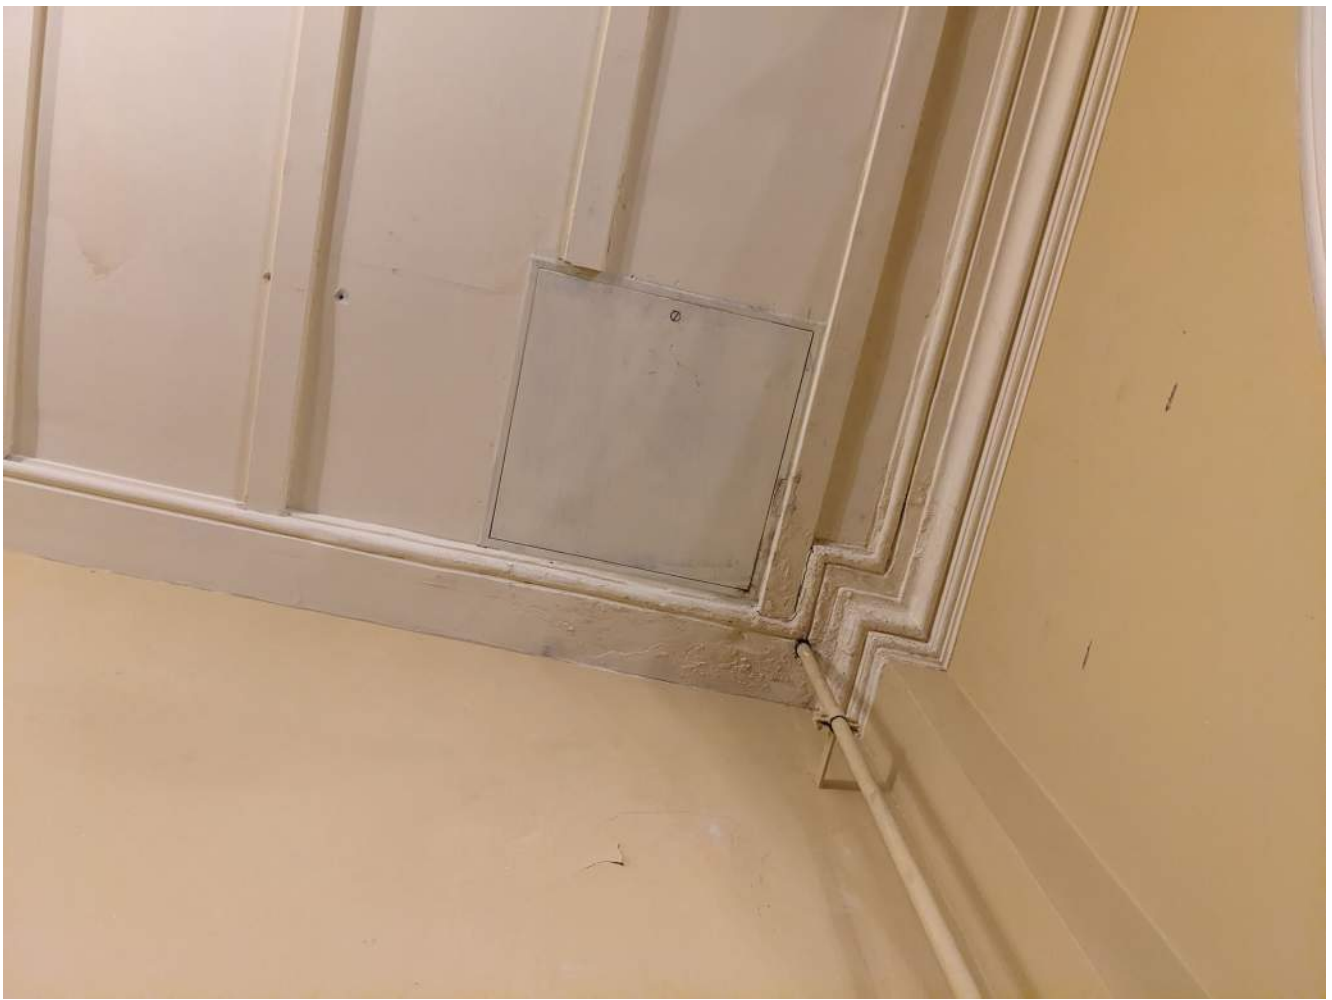
P18	Ladies Gallery eastern door	Minor cracking at top of doorway arch	Minor	Monitor
P19	Ladies Gallery, eastern wall and ceiling	Bubbling paint, water penetration	Roof leaks	Consider tracing leak to roof and re-sealing
P22	North tower east wall	Peeling paint	Water penetration	Monitor. Consider a programme of façade remediation
P25	South tower stair up from Men's floor	Vertical crack above stained-glass arch	Minor	Monitor
P26	South tower stair up from Men's floor	Vertical crack above stained-glass arch	Minor	Monitor

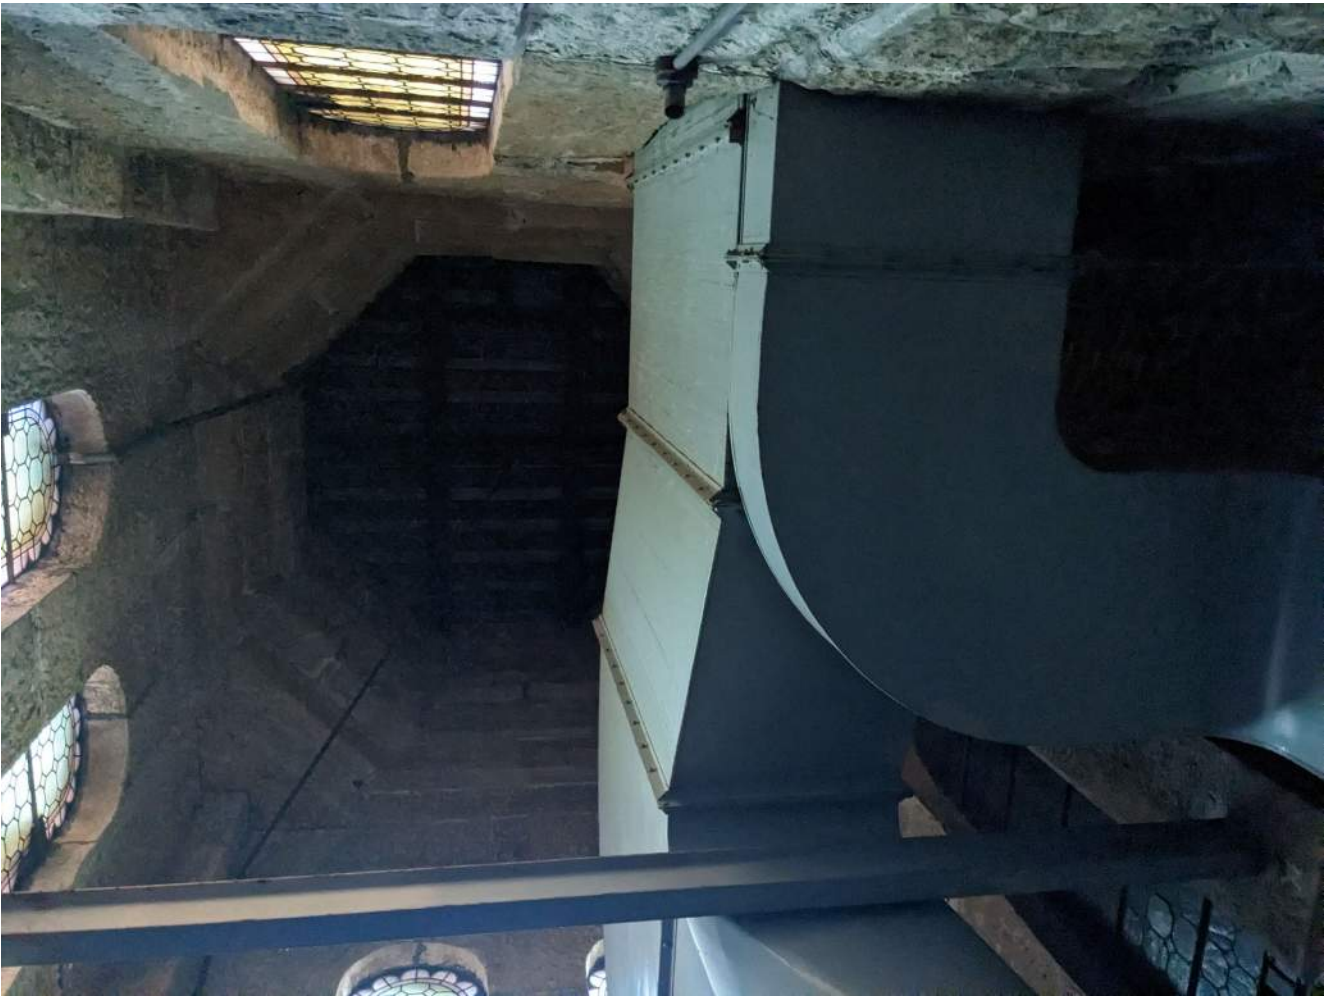
Photo	Location	Defect Description	Discussion	Actions Required
P27 (Defect 21)			Worsening	
P28 (Defect 22)			Worsening	
P30	South tower stairs	Upper stained-glass windows	Mould, spalling render	Weatherproof windows
P31	Choir level hallway	Cracking in wall	Minor	Monitor
P32	Choir level NW corner wall	Various hairline cracks	Minor	Monitor
P33, P34	Choir level locker room	Various hairline cracks	Minor	Monitor
P35	Men's floor ceiling, north side	Cracking in ceiling plaster	Minor	Monitor
P36	Basement stairs	Cracking in brick walls	Minor	Monitor
P39	Entry arch, Castlereagh St	Vertical crack in stone	Minor	Monitor
P40	Castlereagh St facade	Shrinkage cracking in render across façade, and water penetration	Likely to worsen over time	Monitor. Consider a programme of façade remediation
P41, P42, P43, P44	Elizabeth St facade	Mortar loss, fretting stone	Minor	Monitor. Consider a programme of façade remediation
