350 George Street, Sydney
Conservation Management Plan

Prepared for Strata Plan No. 86960

August 2020 • Issue A
Project number 20 0023

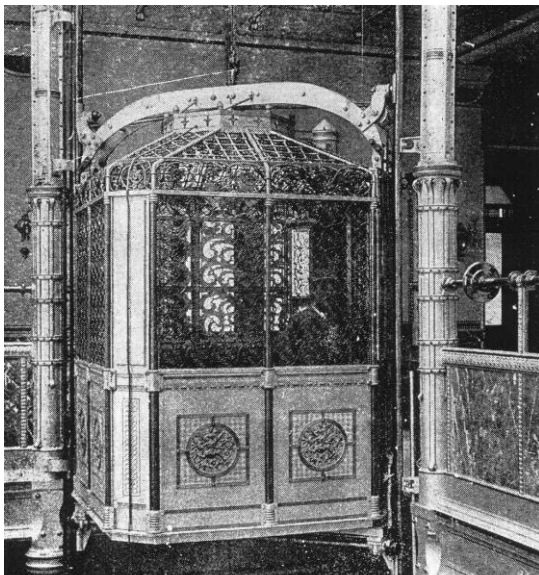
16

An early photograph of one of the two original open cage lifts located within the central atrium of the building. They were replaced in c.1950 by the two new electric lifts contained in a concrete shaft positioned at the north of the central space.

c.1905	The hydraulic mechanism for the original open cage lifts was replaced by electric power.
1923	National Mutual Life Association purchased the building from Equitable Life. National Mutual occupied the building in December 1924.
	Development application received at Sydney City Council from John Reid & Son for a Store Room in the basement.
1940s	During World War II, the glass ceiling above the central atrium was taken down, packed in boxes, and stored in the basement of the building. Parts of the basement were reportedly converted for use as an air raid shelter at the same time. A building application for the removal of the air raid shelter was lodged in July 1945 by architect MVE Woodforde (BA 337/45).
1949	The National Mutual commissioned MVE Woodforde to design and document alterations to the fit-out of the building. This was the commencement of a period of building modifications that continued until about 1960.

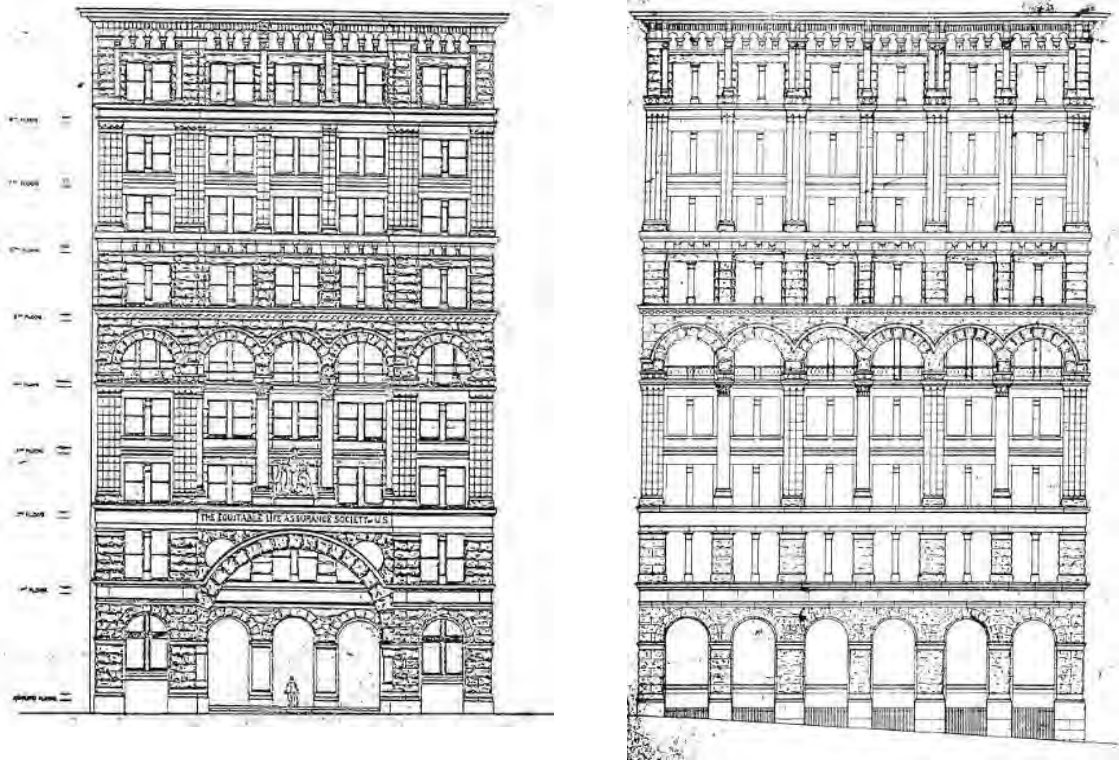
23 Elevations describing the addition of three floors to the building, circa 1900. At left, the George Street elevation, right, the southern elevation to Angel Place (identified as Chisholm Lane South on the plan).

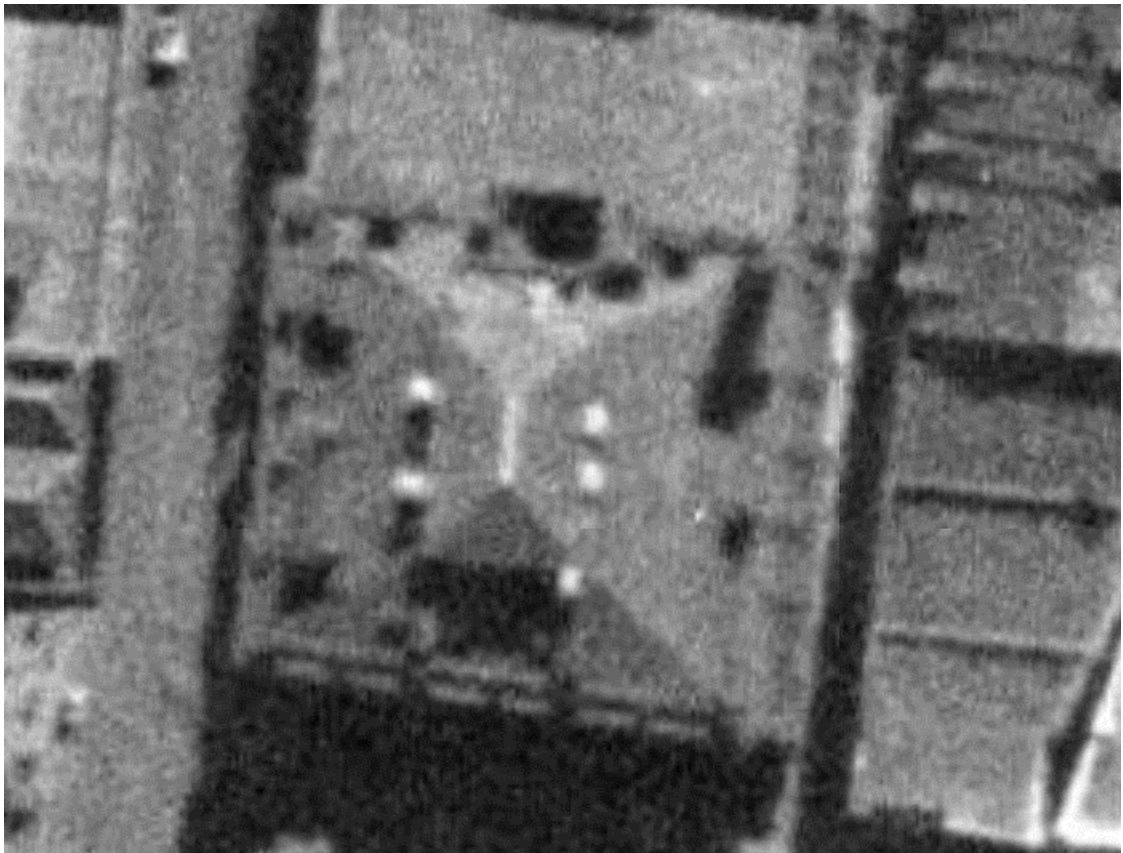
28 The 1943 aerial of Sydney city shows the earlier roofline of the subject site. The roof was modified during the first half of the 1970s.
Source: Department of Lands Spatial Information Exchange (SIX) 1943 aerial) photograph.

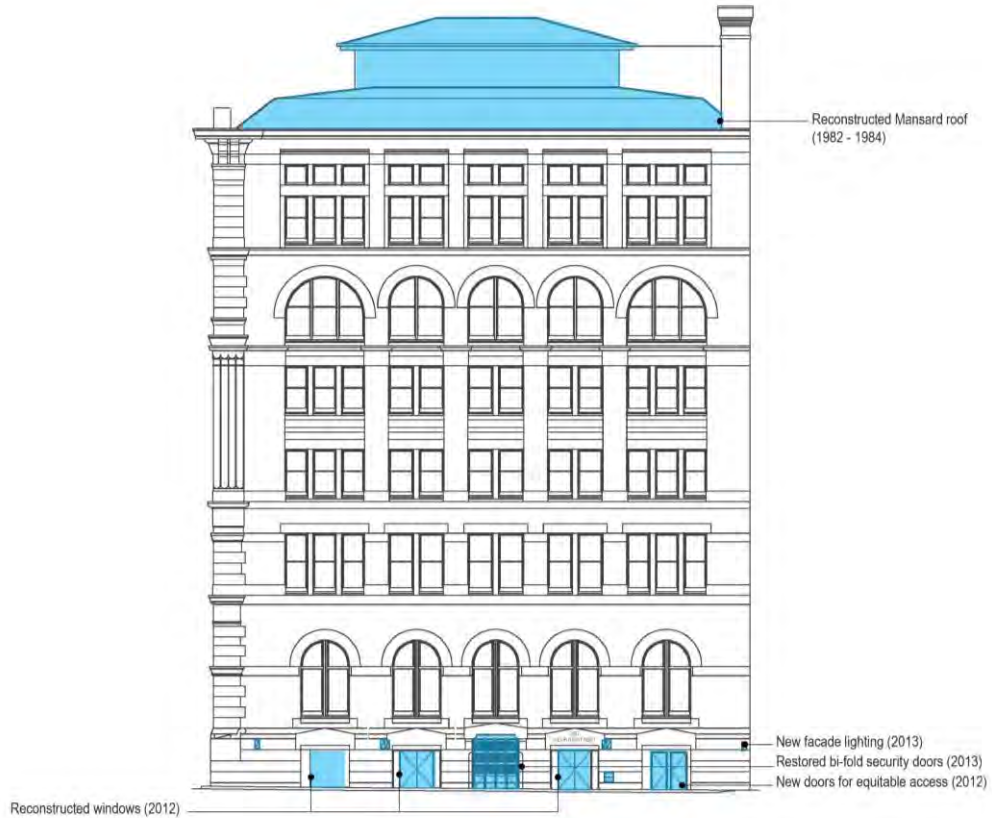
33 Level of integrity and changed elements on the Ash Street elevation. Not to scale. Source: TKD Architects, 2020.

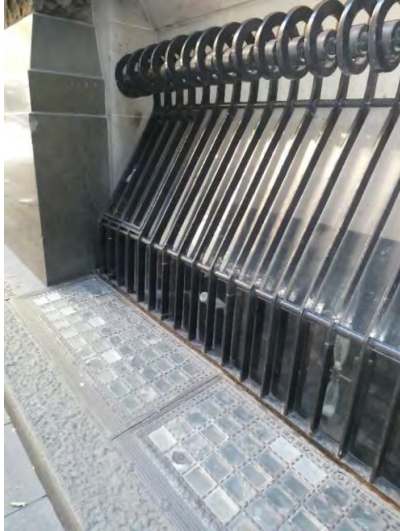
38 Original protective railing and glass pavement lights, Angel Place.

A simplified iteration of the principal elevation's rusticated carved stonework is found along the southern elevation on Angel Place. At street level, metal railings protect the Lower Ground Floor windows, and glass pavement lights provide natural light into the Lower Ground Floor. The Ash Street façade features unadorned, light coloured face brick masonry, with a trachyte base of the Lower Ground Floor level. Access to the Lower Ground Floor level and Basement is provided through two separate entries at the rear of the building. The 2012 conservation and adaptation works reinstated the fenestration details of this facade as well as establishing equitable access into the building.

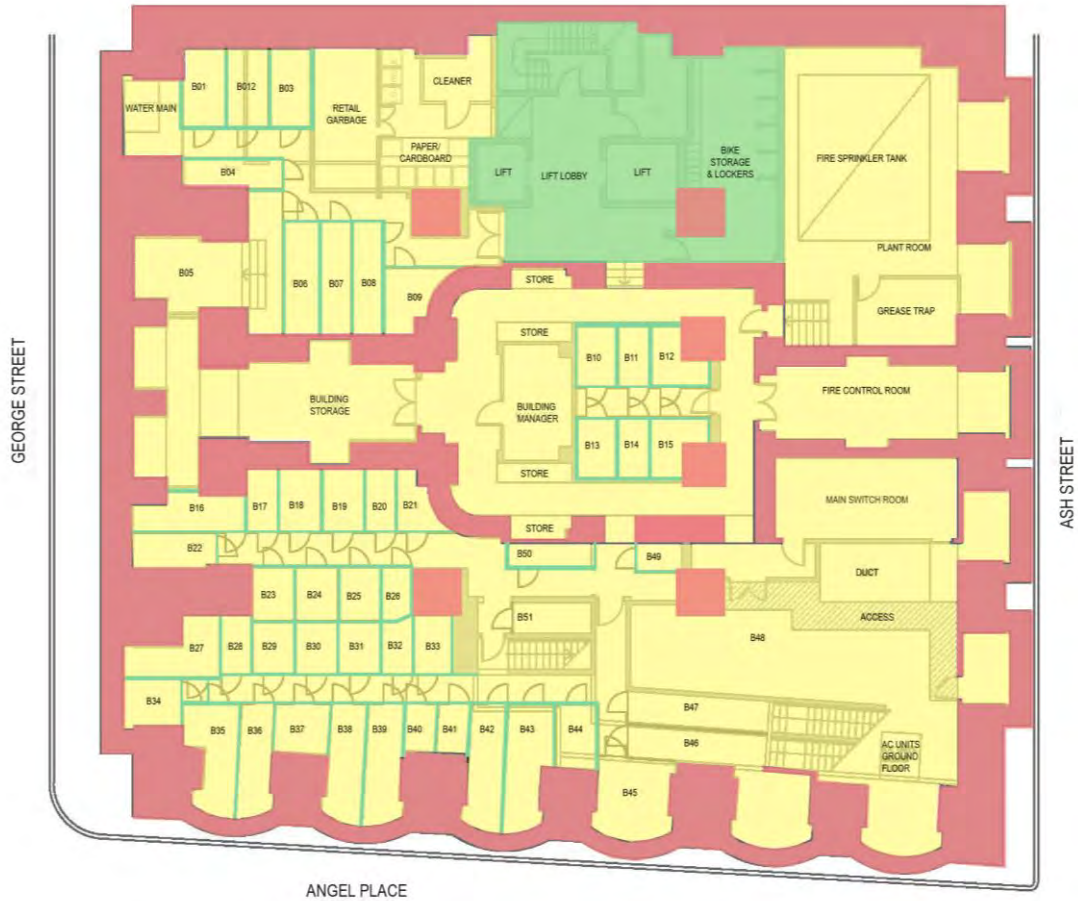
117 Basement plan showing overall levels of significance. Not to scale.
Source: TKD Architects, 2020.

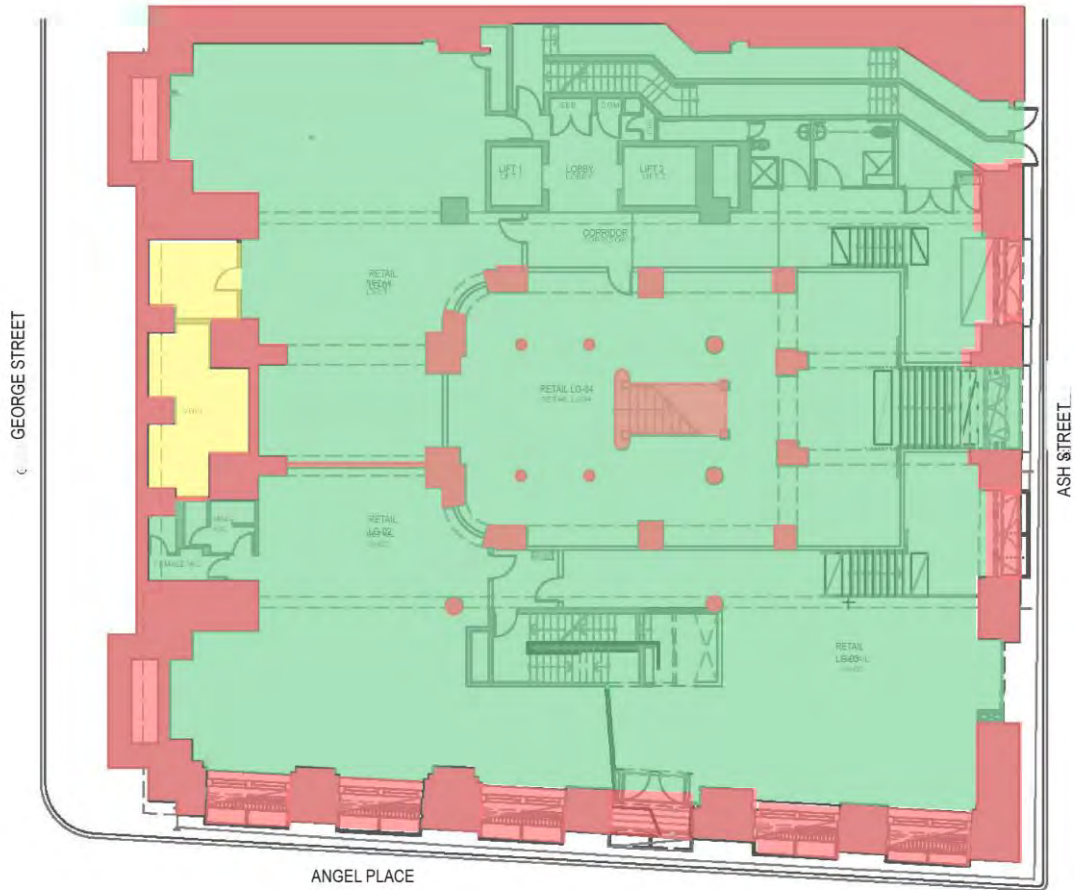
118 Lower Ground Floor plan showing overall levels of significance.
Not to scale.
Source: TKD Architects, 2020.

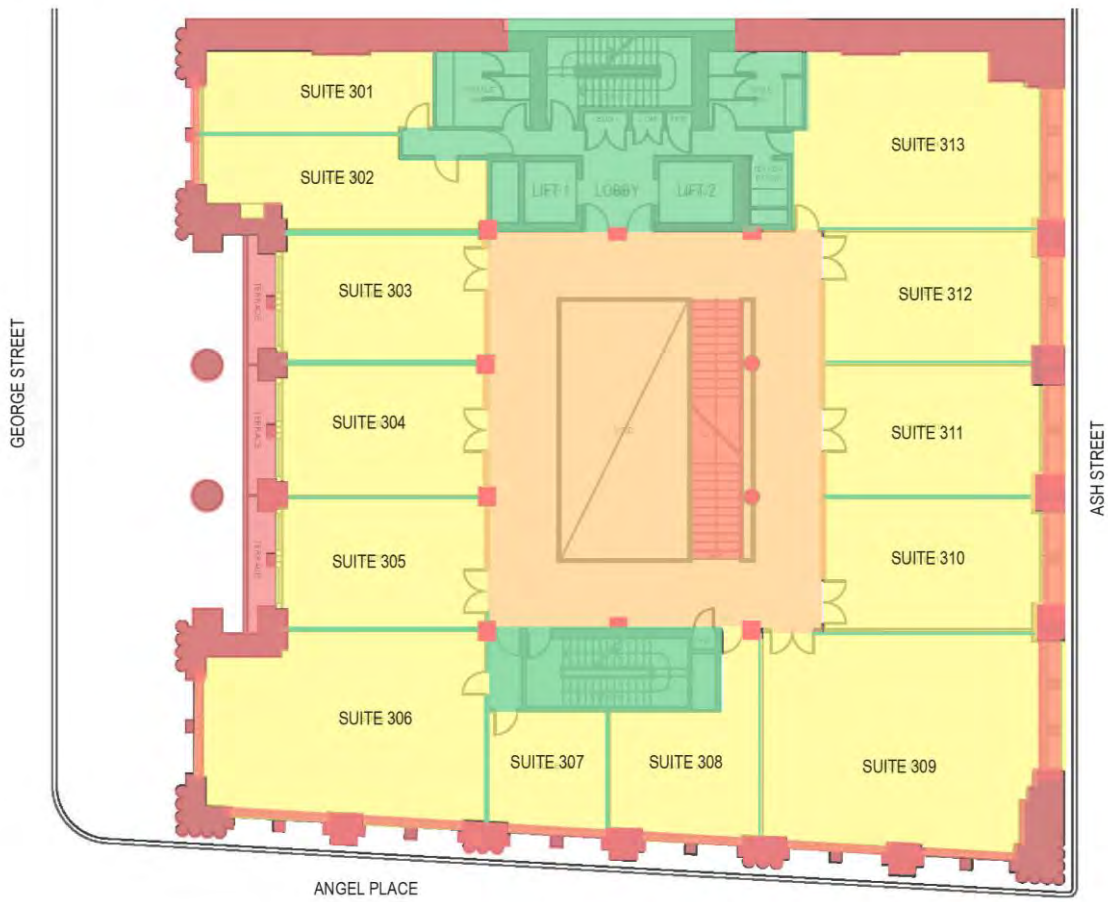
122 Third floor plan with overall levels of significance. Not to scale.
Source: TKD Architects, 2020.

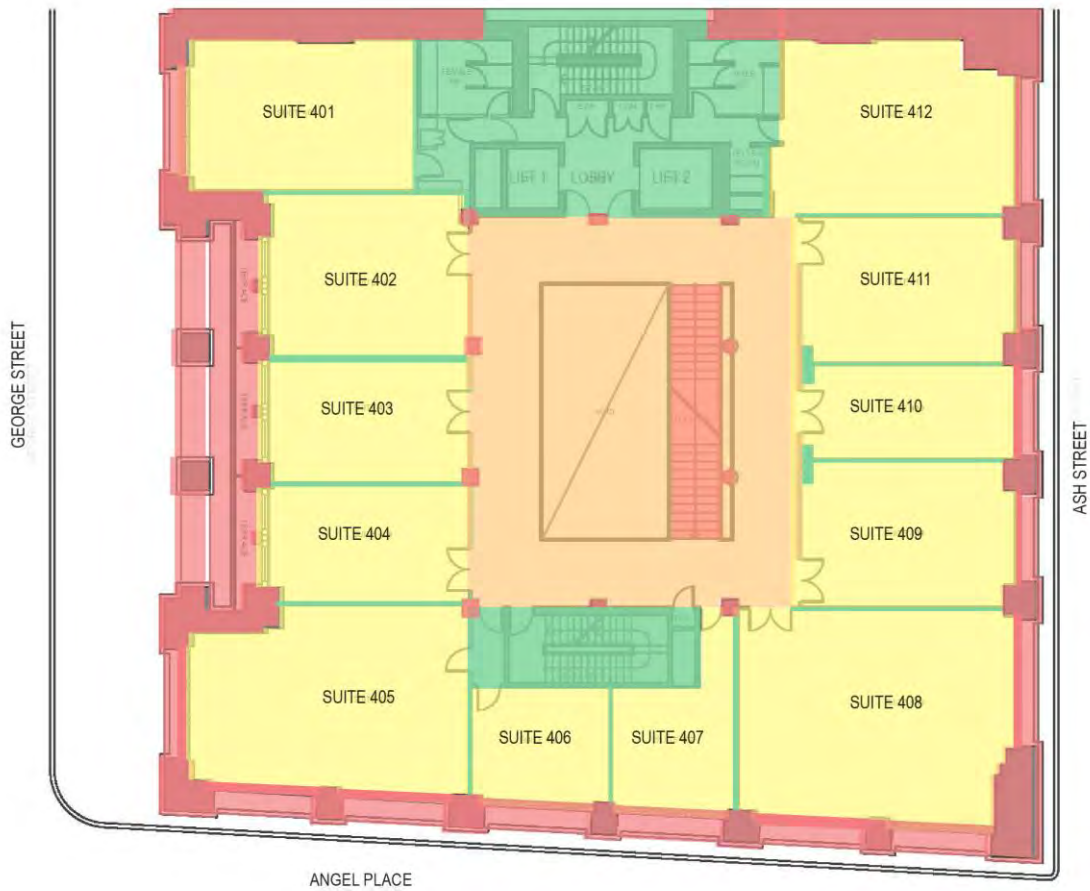
123 Fourth Floor plan with overall levels of significance. Not to scale.
Source: TKD Architects, 2020.

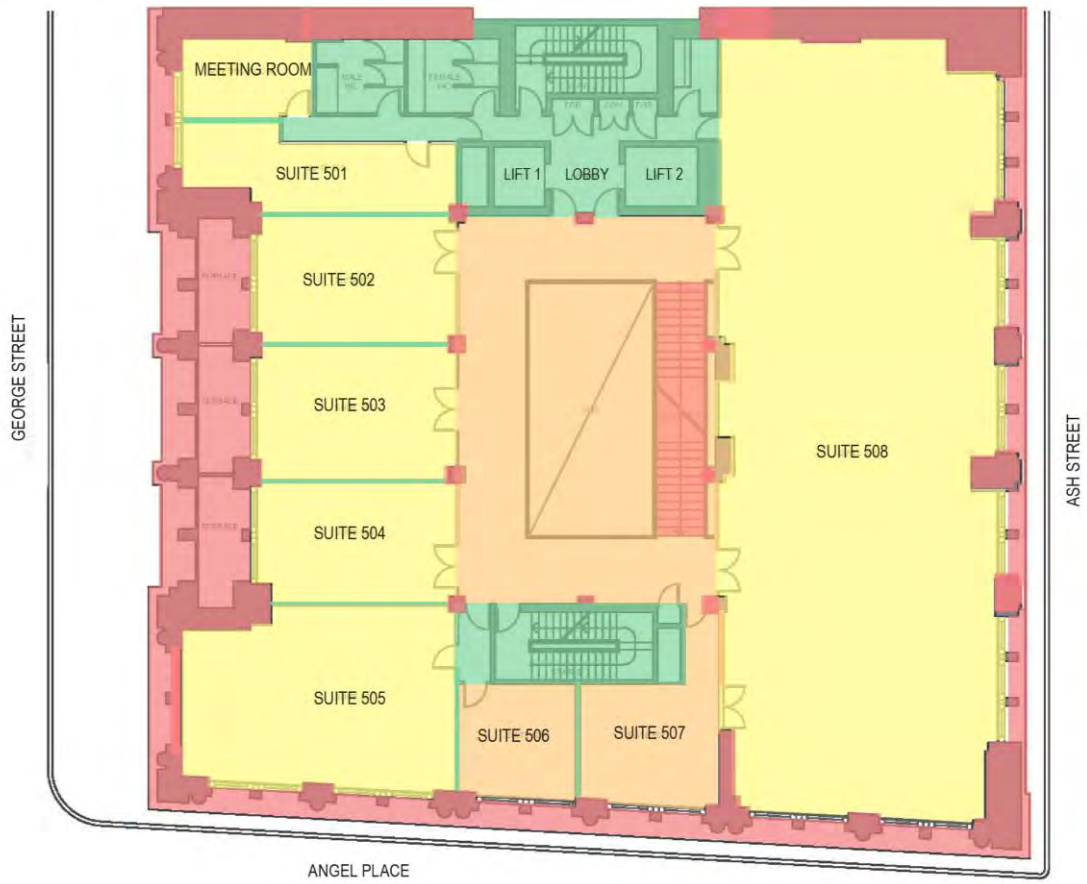
124 Fifth Floor plan with overall levels of significance. Not to scale.
Source: TKD Architects, 2020.

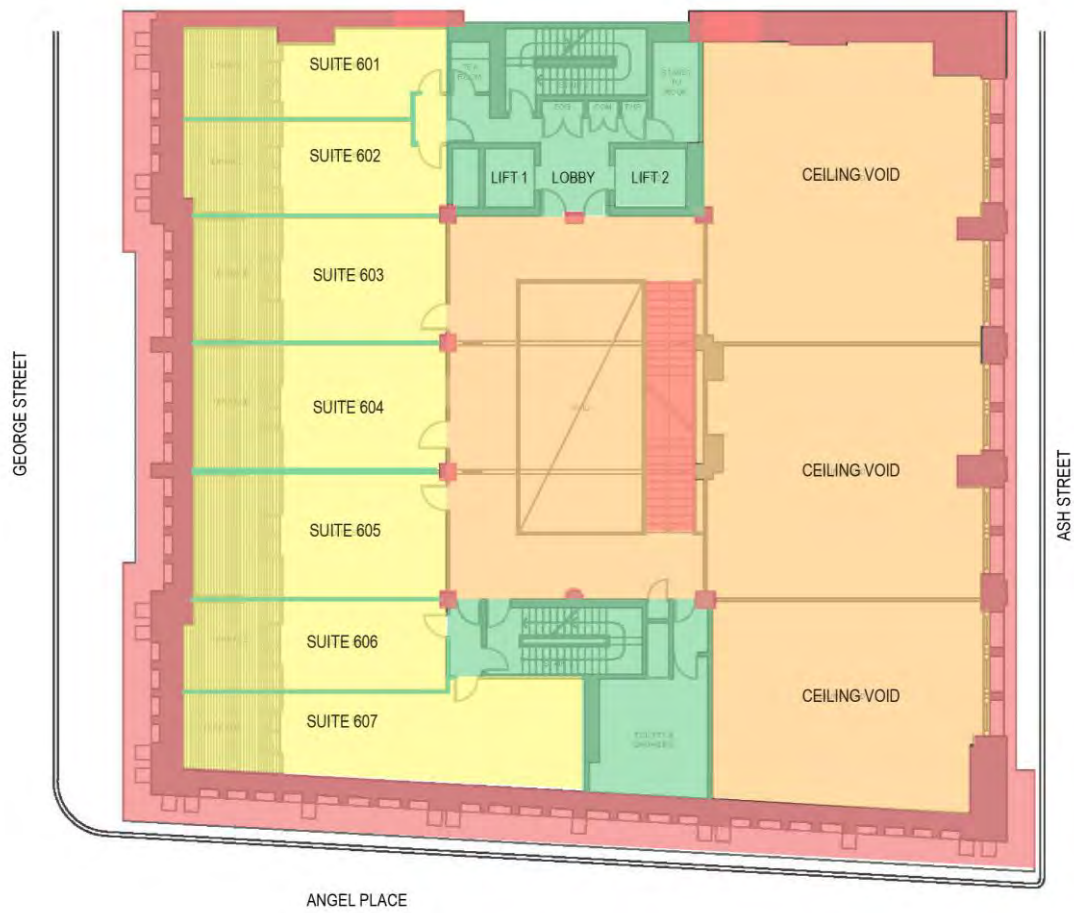
125 Sixth Floor plan with overall levels of significance. Not to scale.
Source: TKD Architects, 2020.

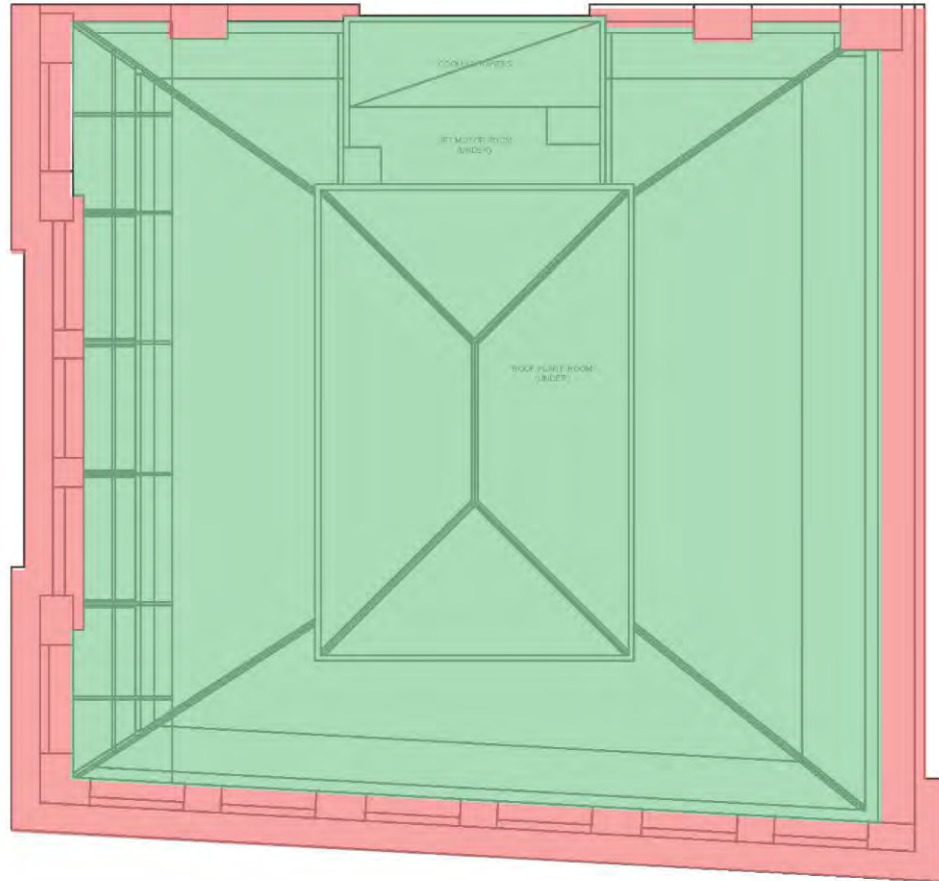
126 Roof plan with overall levels of significance. Not to scale.
Source: TKD Architects, 2020.

Historic documentation reveals that the original roof form was modified during the 1970s, while a new mansard-style structure was constructed over the earlier roof, as part of the 1980s works. During this period, the existing central atrium leadlight ceiling (recreated post WWII) was also removed, and reconstructed using internally lit, stained glass. Site inspection confirms that the mansard form with metal deck roofing, and glass ceiling has remained intact.

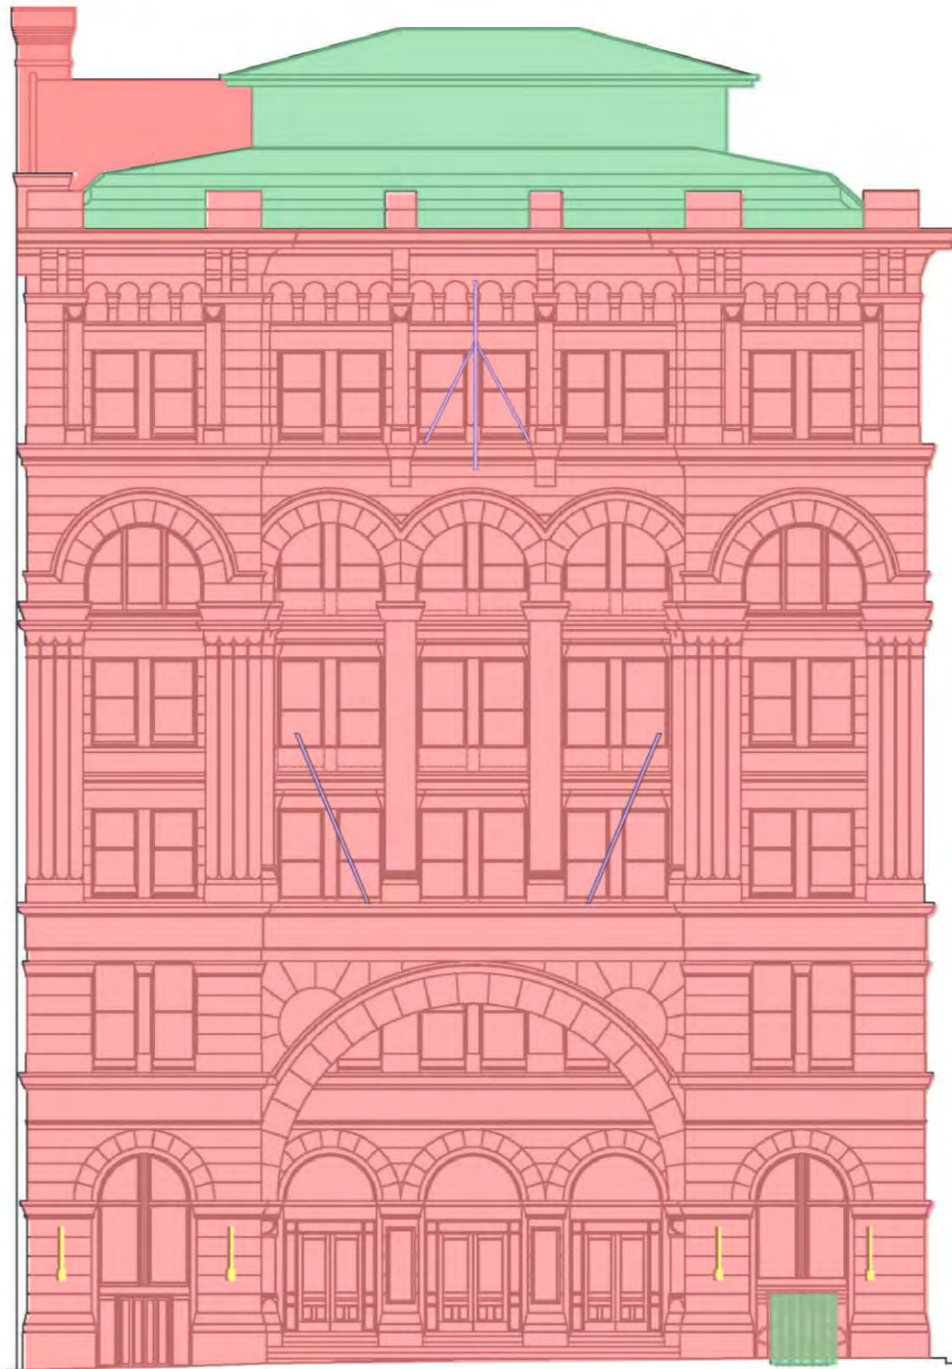
127 George Street elevation with overall levels of significance. Not to scale.
Source: TKD Architects, 2020.

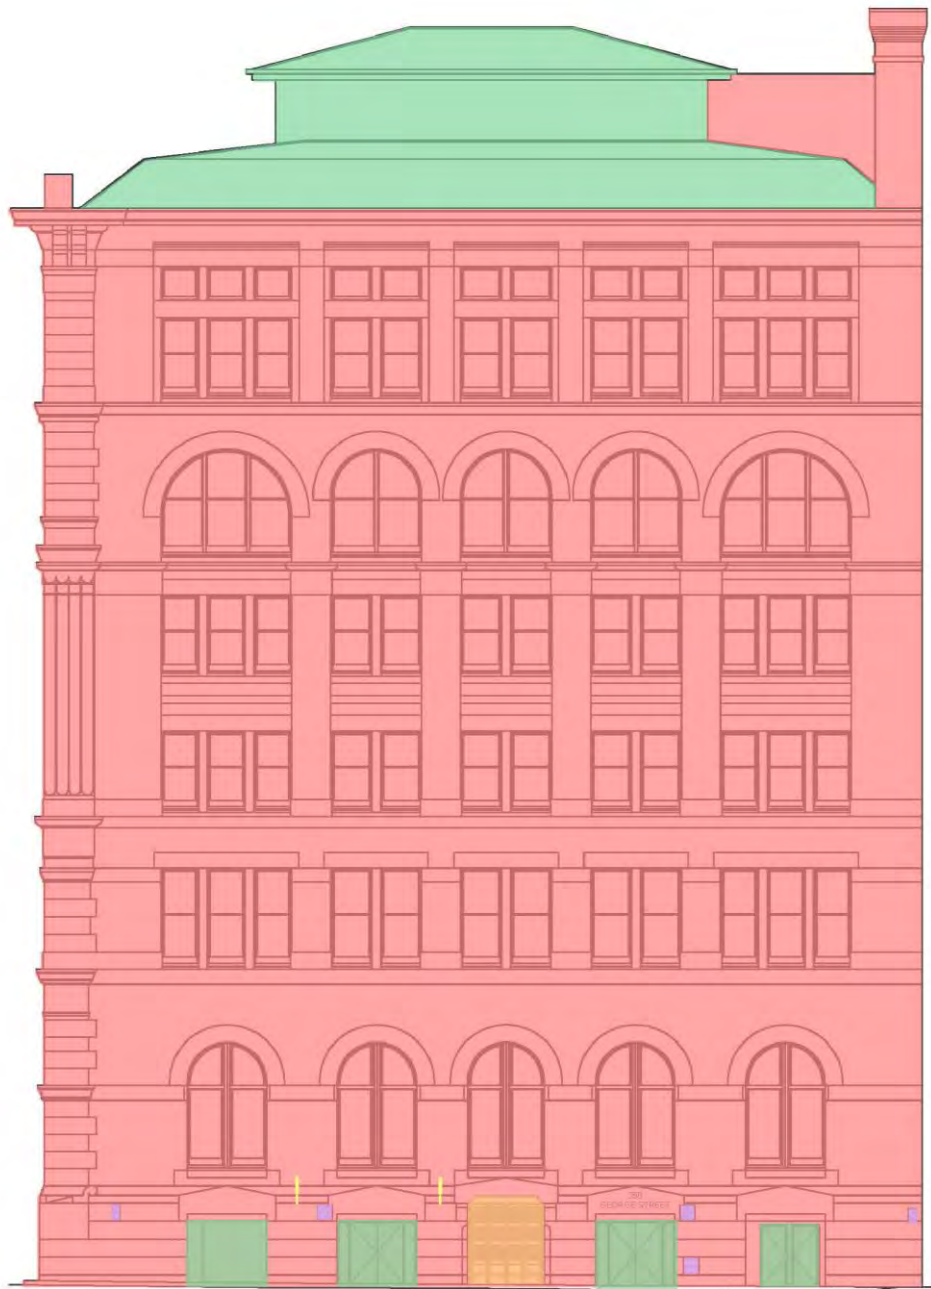
128 Ash Street elevation with overall levels of significance. Not to scale.
Source: TKD Architects, 2020.

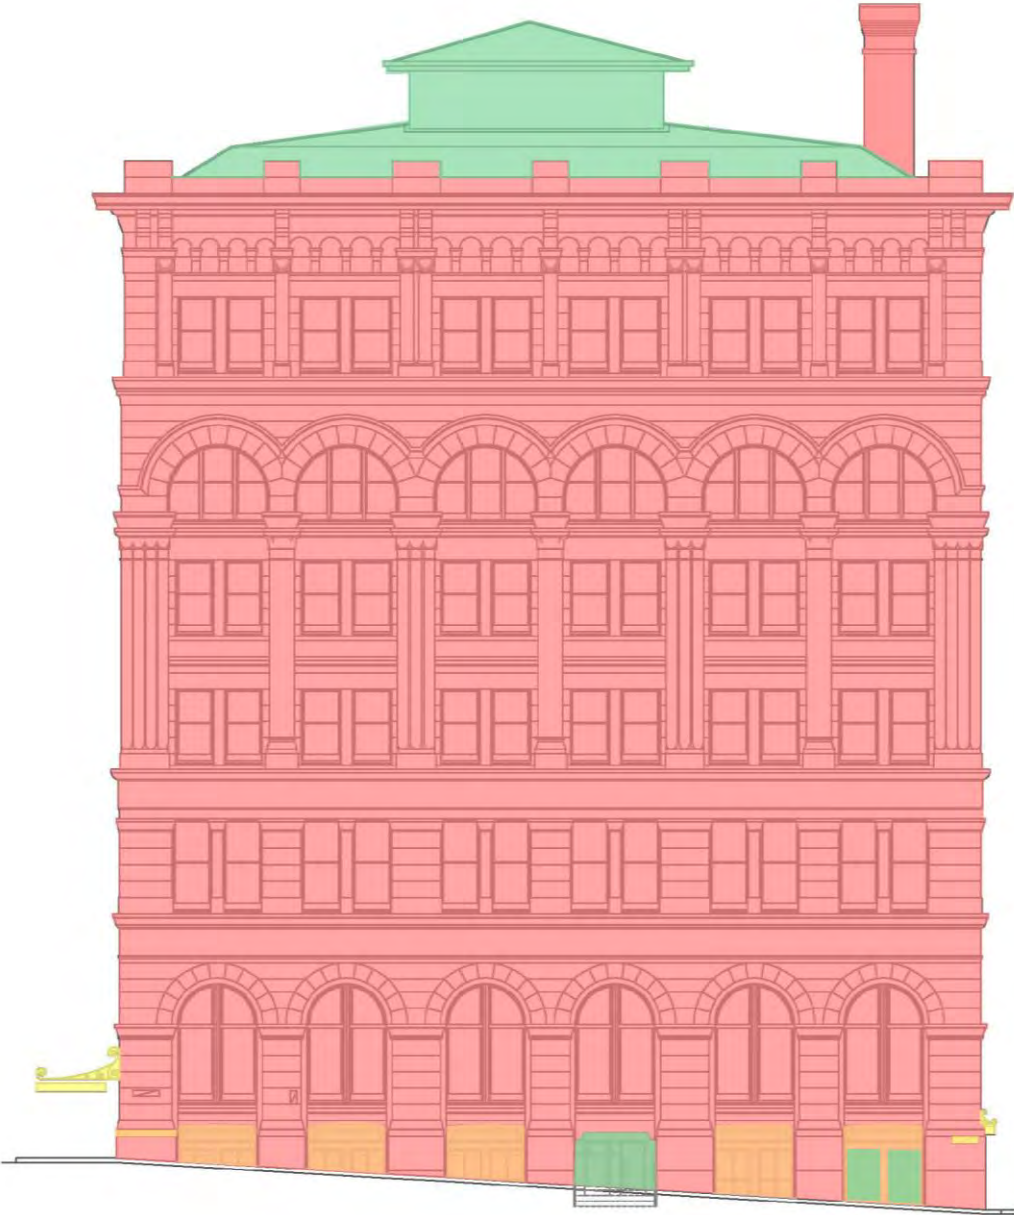
129 Angel Place elevation with overall levels of significance. Not to scale.
Source: TKD Architects, 2020.
