## Glebe Mid-Rise Development Baseline Historical Archaeological Assessment—Planning Proposal Stage 1

Prepared for Land and Housing Corporation (NSW)

May 2020 - Final

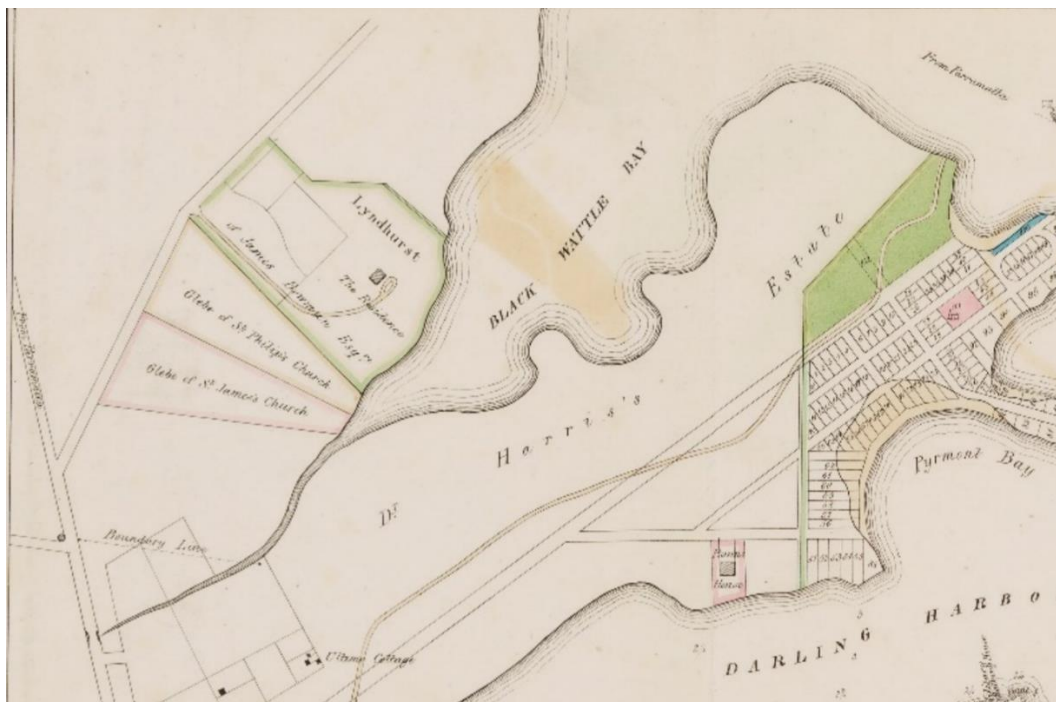
Figure 7. Detail of 1837 Plan of Sydney showing portion of land known as St Phillips. (Source: National Library of Australia, Call No. MAP T 1551).

At the onset of European settlement in 1789 the Sydney Glebe lands were granted to the Church of England. This followed a decree by British Authorities to allocate 400 acres in each township to support a Church of England clergyman. This land remained largely unused until 1828 when the Church and School Corporation subdivided Glebe into 28 allotments (Figure 7). Lots 7 and 8 of this subdivision were handed over to the trustees of St Phillip’s with the income derived to be used for diocesan purposes. The site of 17-31 Cowper Street and 2A-2D Wentworth Park Road is located within this 1828 subdivision which became known as St Phillip’s Estate subdivision.

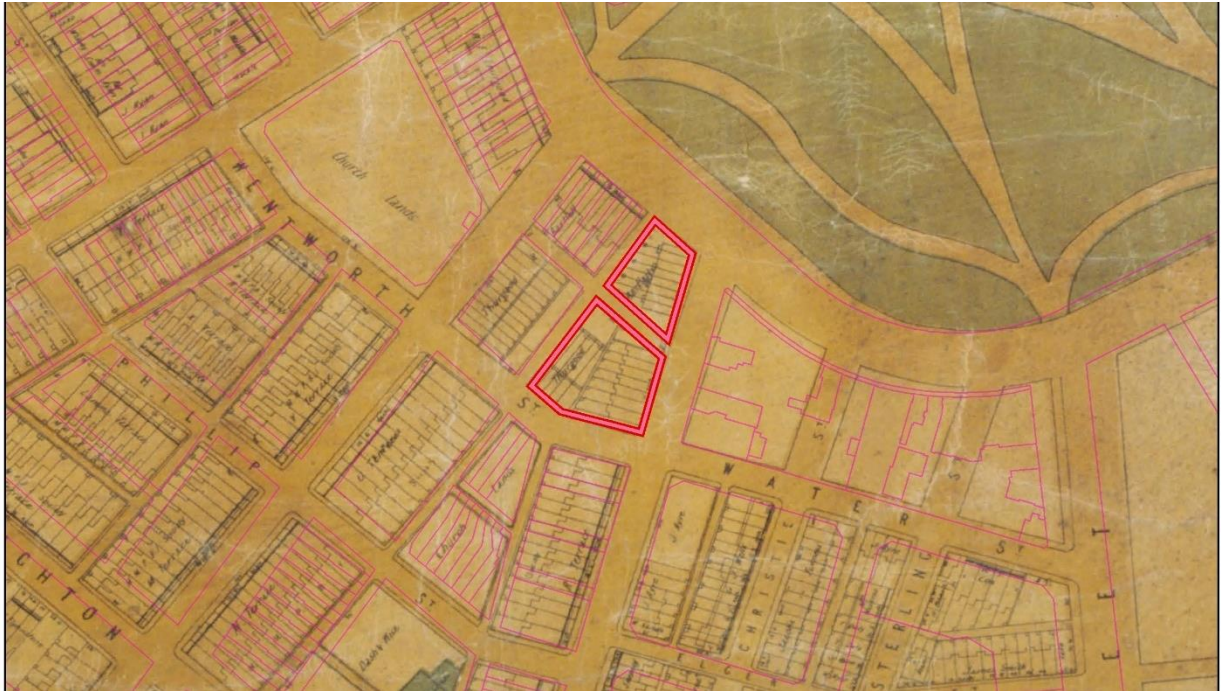
Figure 11. 1888 map of Glebe Municipality showing terraces established within the site (outlined in red) along Cowper Street. (Source: Historical Atlas of Sydney).

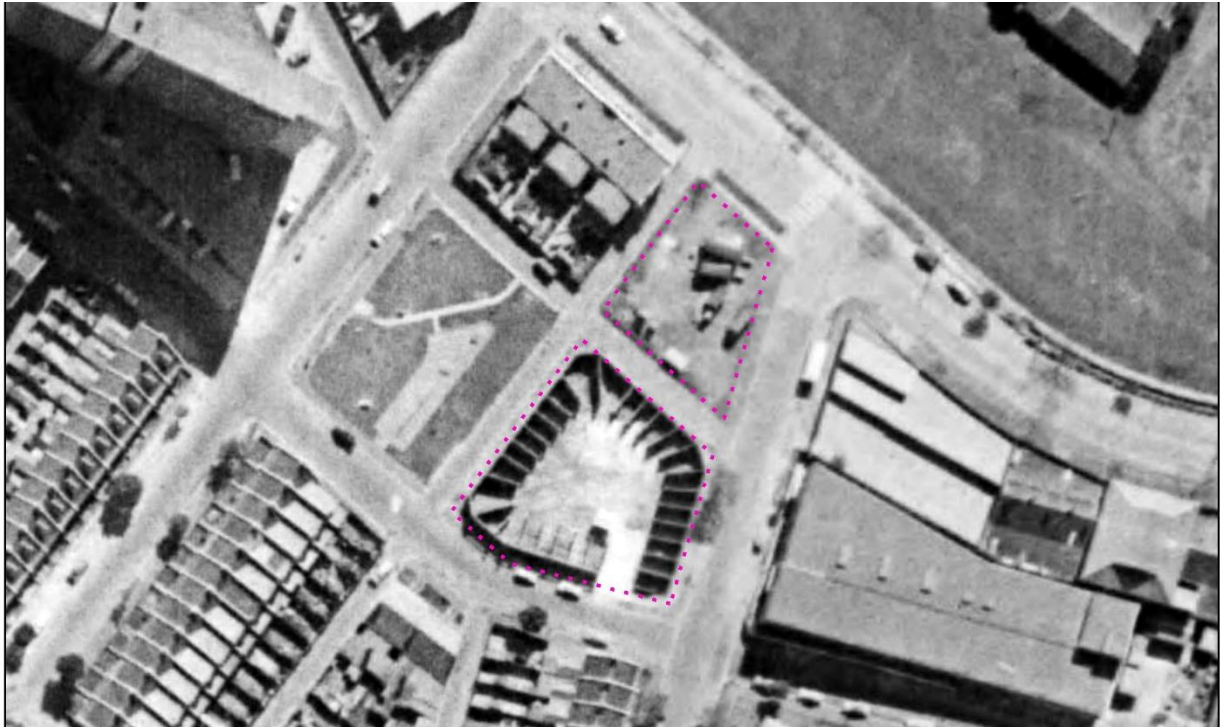
Figure 14. Aerial photograph, 1965 with site outlined in pink. Note the construction of the lock-up garages in progress on the southern lot. (Source: NSW Department of Finance and Spatial Services).

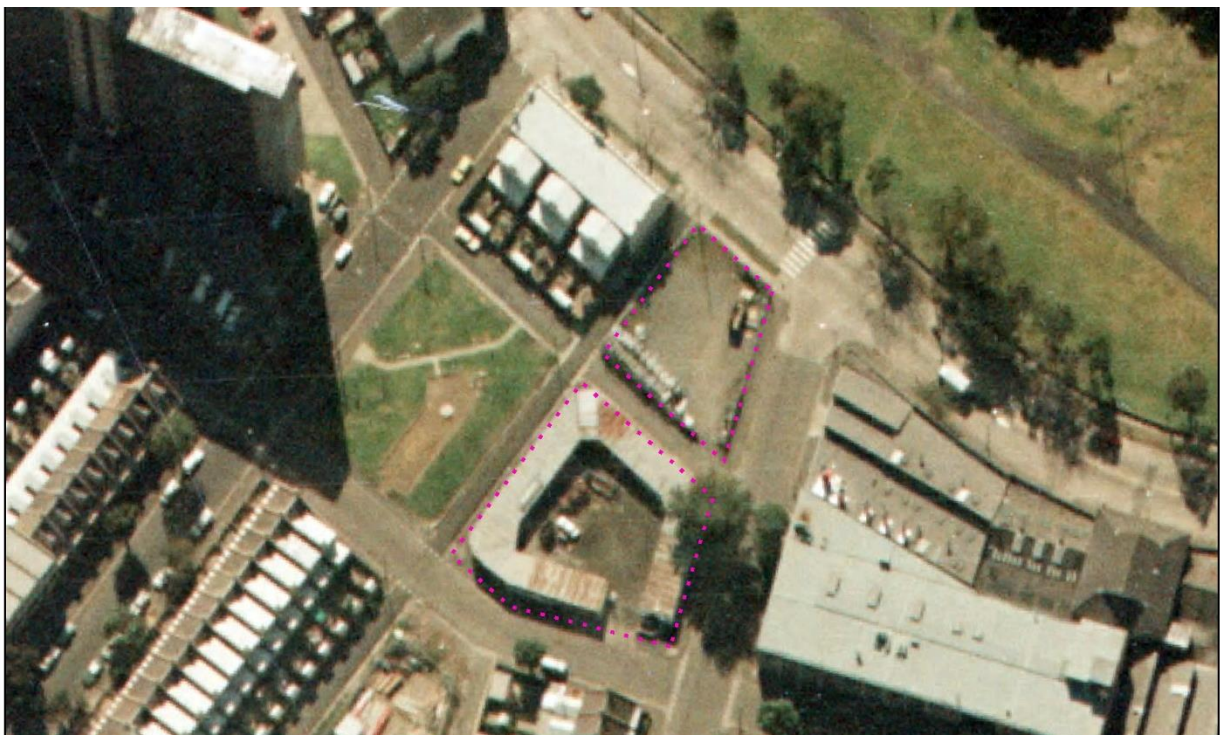
Figure 15. Aerial photograph, 1986 with site outlined in pink. The lock-up garages remain on the southern lot. (Source: NSW Department of Finance and Spatial Services).

Planning street cards for Glebe provide an overview of applications made and actual use of the site from 1949 onwards (City of Sydney n.d.). These show that from 1952-57 17-31 Cowper Street was predominately used as a storage site for fuel containers, empty fruit containers, and the storage of machinery for Wall Machinery Pty Ltd (1952). Between 1957-1964 applications were made to use the area as a Service Station for Broadway Motors, however there is no indication these applications were approved. In 1964, lock-up garages were authorised to be built for the Glebe Administration Board, the construction of which is visible in aerial photographs from 1965 (Figure 14). These planning cards further detail that between 1969 and 1972, 2A-2D Wentworth Park Road was used as an off-street parking lot (City of Sydney n.d.). Based on aerial photography, these appear to continue to be used for these purposes until at least 1986 (Figure 15).

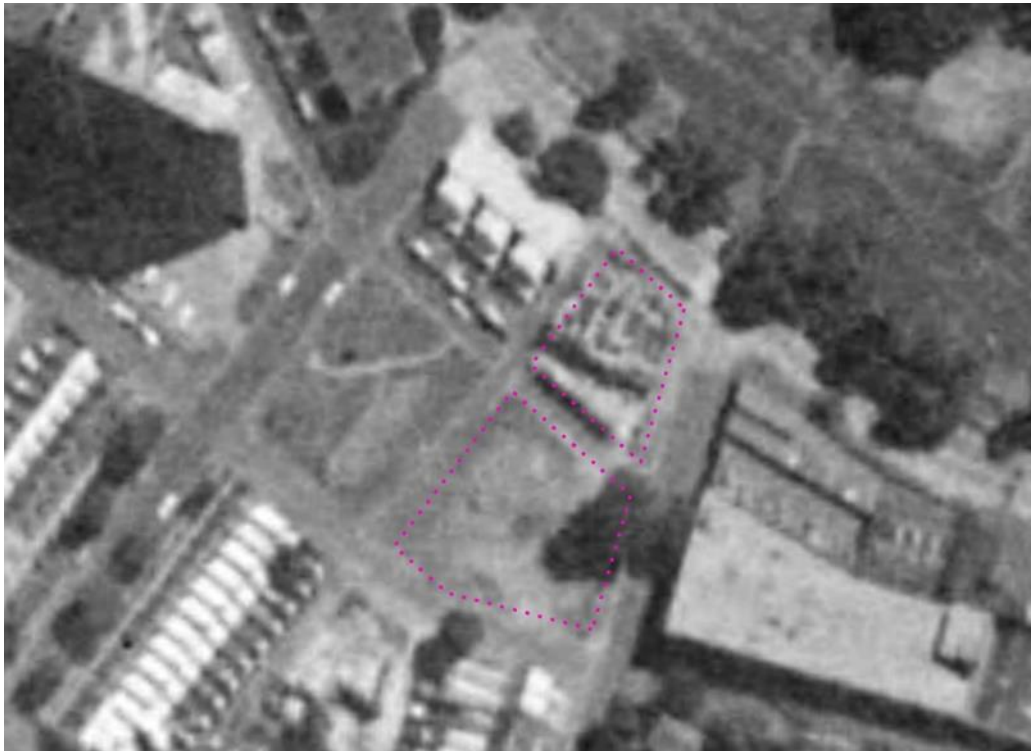
Figure 16. 1989 Aerial photograph with the site marked in pink. Note that the northern allotment appears may have site preparation commenced for the construction of the extant building in 1990 (Source: NSW Department of Finance and Spatial Services).

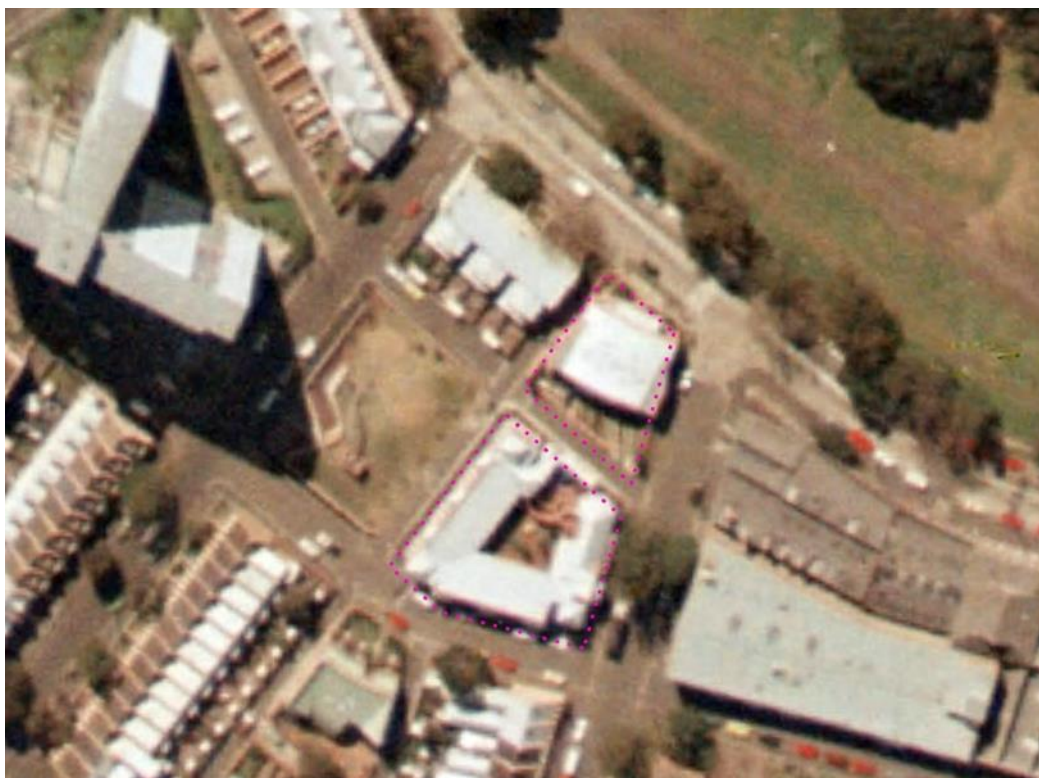
Figure 17. 1991 Aerial photograph with the site outlined in pink showing the two extant structures as they appear today. (Source: NSW Department of Finance and Spatial Services).

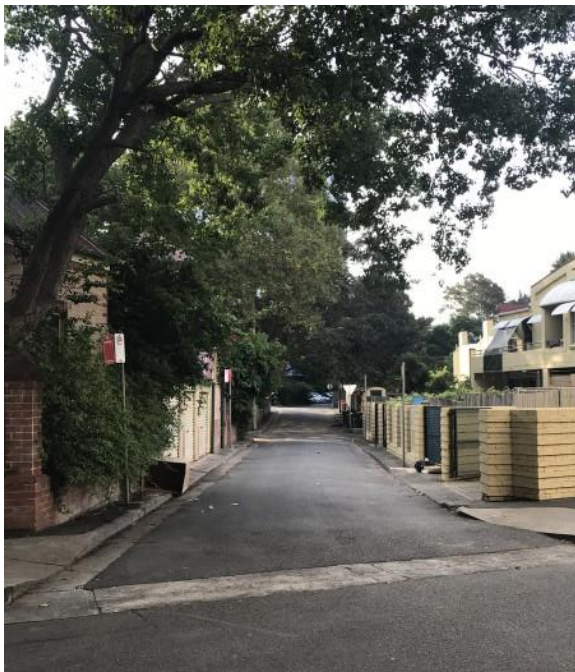
Figure 22. West view of Park Lane dividing the site into two lots.

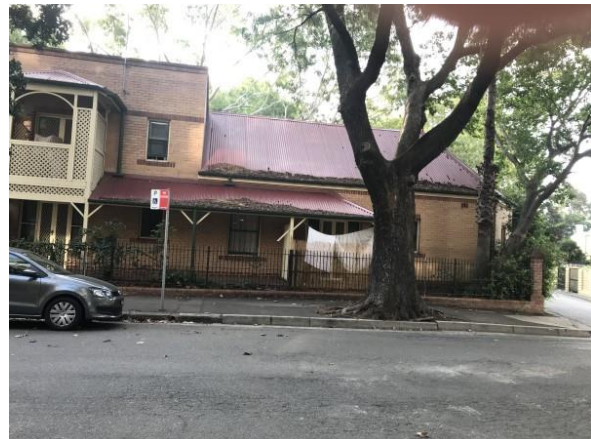
Figure 23. West view of 17-31 Cowper Street, showing a gentle drop in a south-north direction.

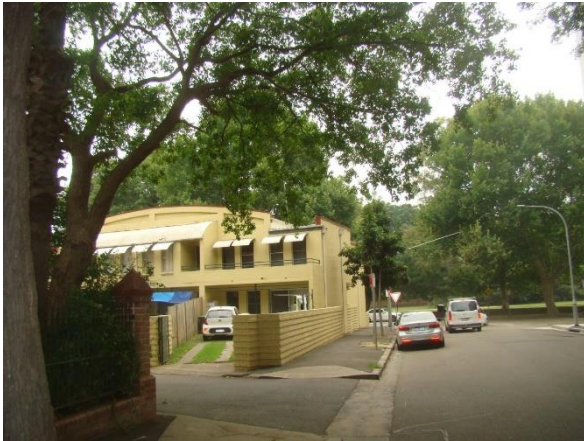
Figure 24. Rear of 2A-2D Wentworth Park Road showing slight elevation, view looking north.

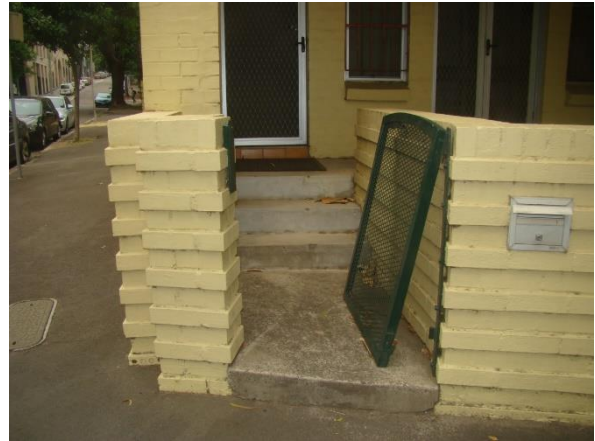
Figure 25. Stairwell at the front of 2A-2D Wentworth Park Road, view looking south.

The topography of the site shows a gentle drop from the south to the north (Figure 23 and Figure 24). This is obvious in both 17-31 Cowper Street and 2A-2D Wentworth Park Road, where the north portion of both lots is slightly raised and accessed by a staircase (Figure 25 and Figure 26). This indicates that at least part, if not all, of both residential blocks was constructed on a layer of introduced fill.

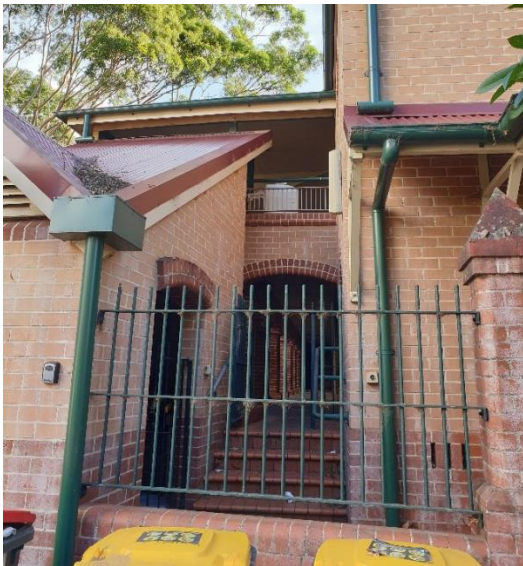
Figure 26. Stairwell at the north access to central courtyard of 17-31 Cowper Street, view looking south.

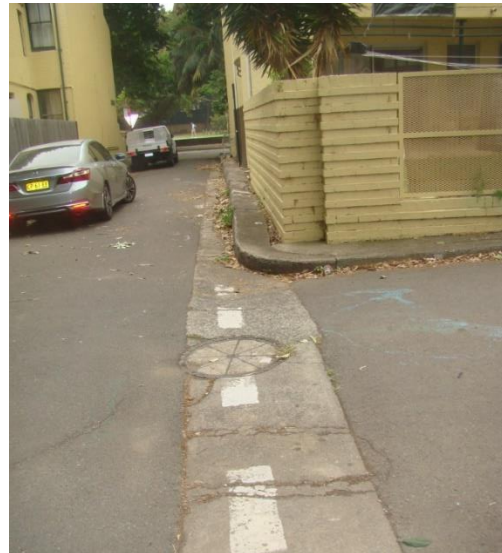
Figure 27. Services along Mitchell Lane, looking north.

The site is surrounded by a number of services and street gutters to which the service networks of both lots are connected (Figure 27 and Figure 28). Several drainage inlets were observed within the central courtyard of 17-31 Cowper Street.

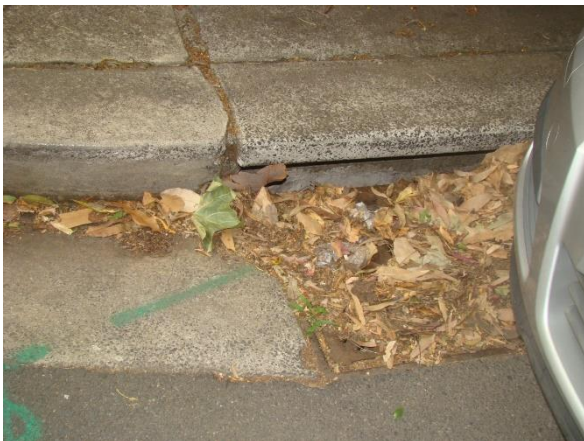
Figure 28. Street gutter inlet along Mitchel Line – obscured by dry foliage, looking east.

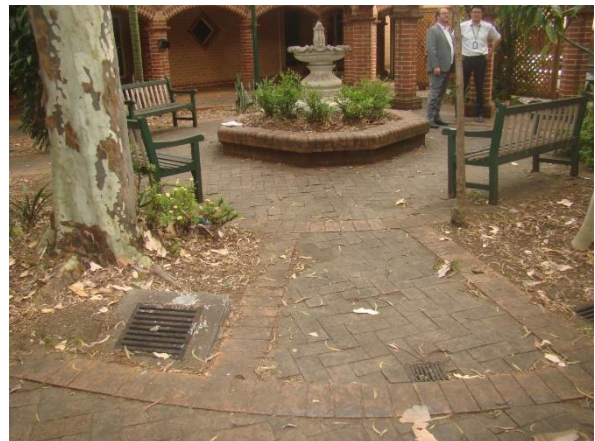
Figure 29. Drainage inlets within the central courtyard of 17-31 Cowper Street.

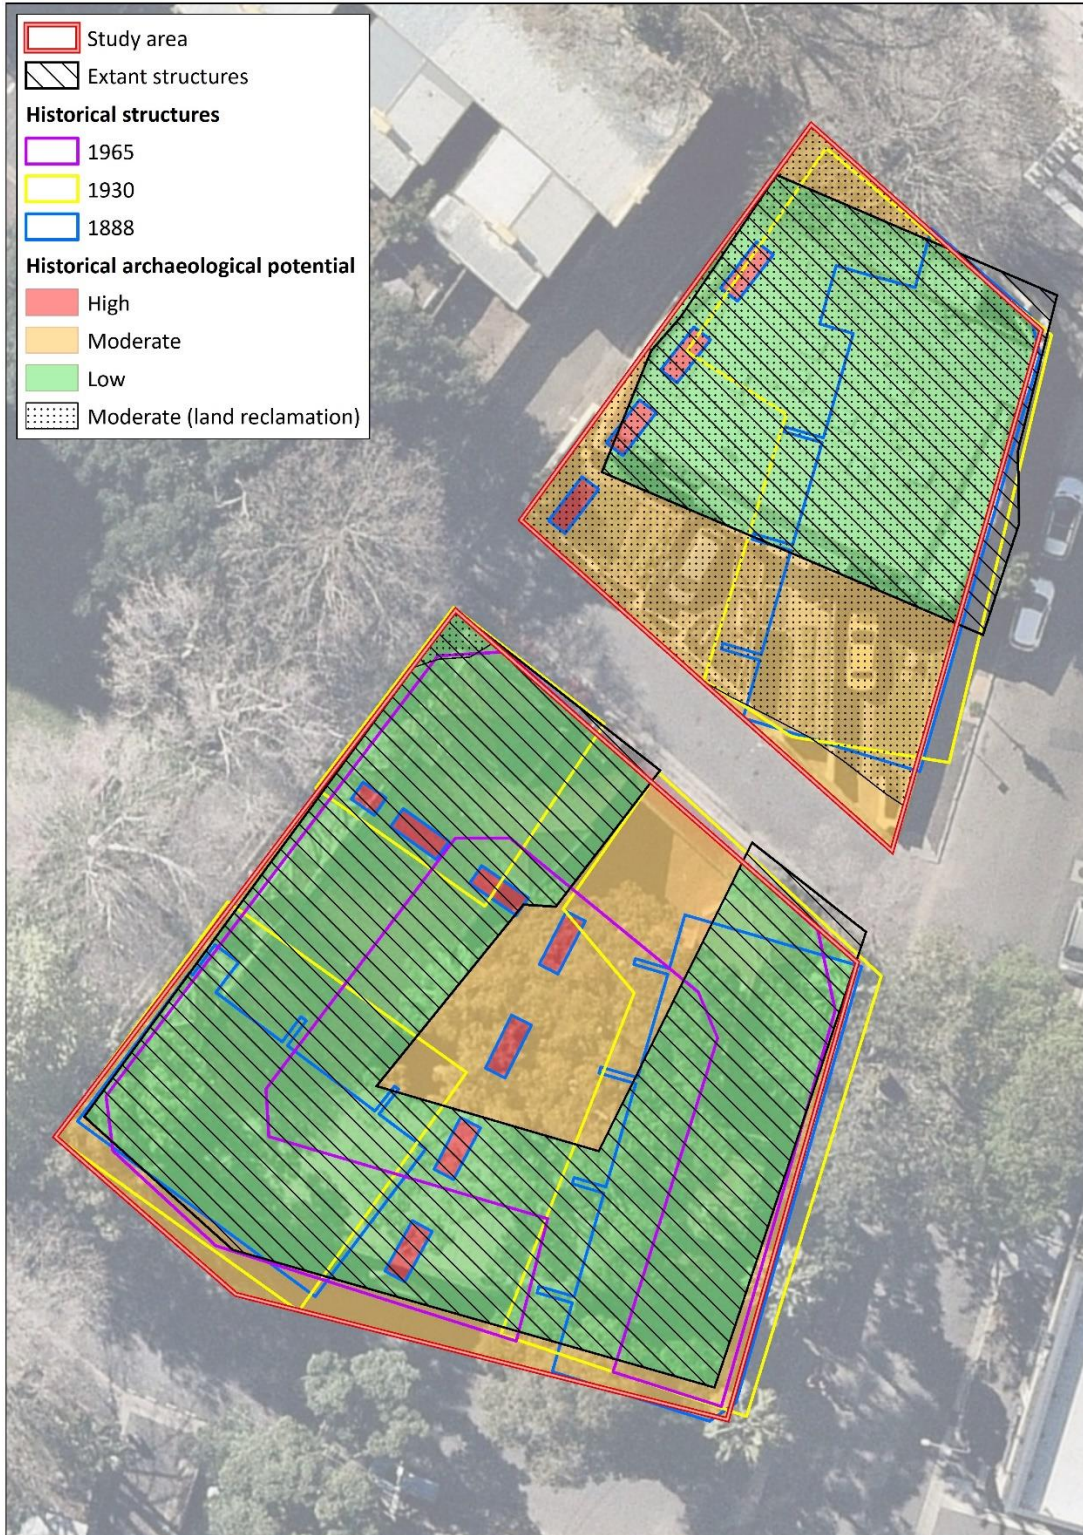
Figure 30. Map of the site with the historical archaeological potential marked.

The level of survival of these items will vary across the site, dependent on methods of demolition, later phases of construction and the impact of service installation in the 20<sup>th</sup> century. Areas within the footprint of the extant structures have less potential for survival than those

outside the footprint. Deeper subsurface features, such as cesspits, would have a greater potential for survival.
