Report on
Geotechnical Investigation

Proposed Mixed Use Development
600-660 Elizabeth Street, Redfern

Prepared for
EMM Consulting Pty Limited

Project 99510.00
January 2020

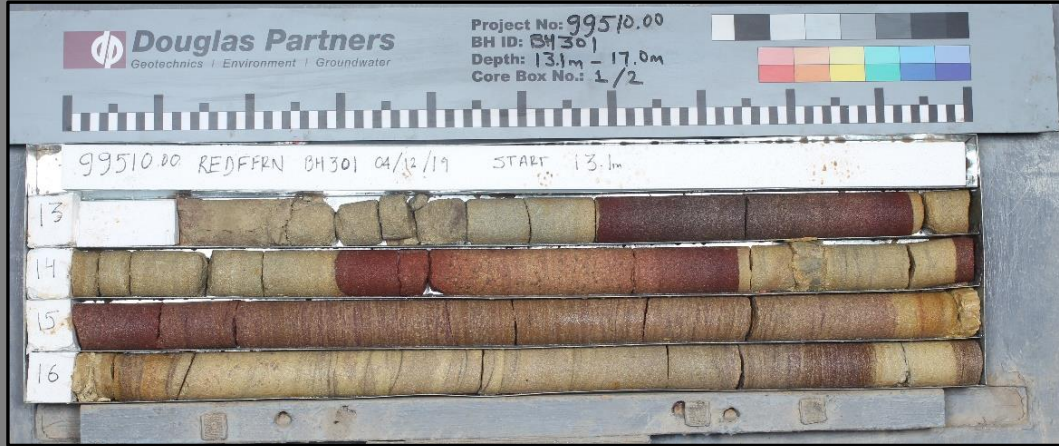
13.1 m – 17.0 m

BORE: 301 PROJECT: REDFERN DECEMBER 2019

The subsurface conditions encountered in the boreholes are described in the logs within Appendix C. Colour photographs of the recovered rock core are also included with the appropriate borehole in Appendix C. Notes defining descriptive terms and classification methods used are also included in Appendix C.

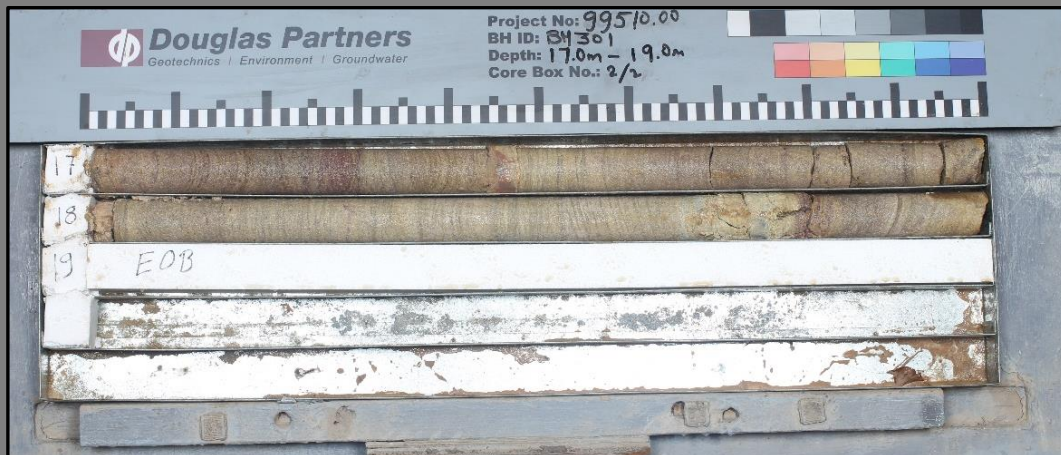
17.0 m – 19.0 m

BORE: 301 PROJECT: REDFERN DECEMBER 2019

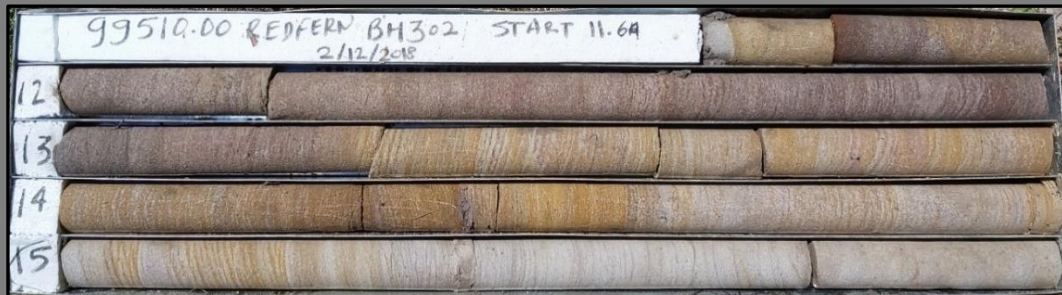
11.6 m – 16.0 m

BORE: 302 PROJECT: REDFERN DECEMBER 2019

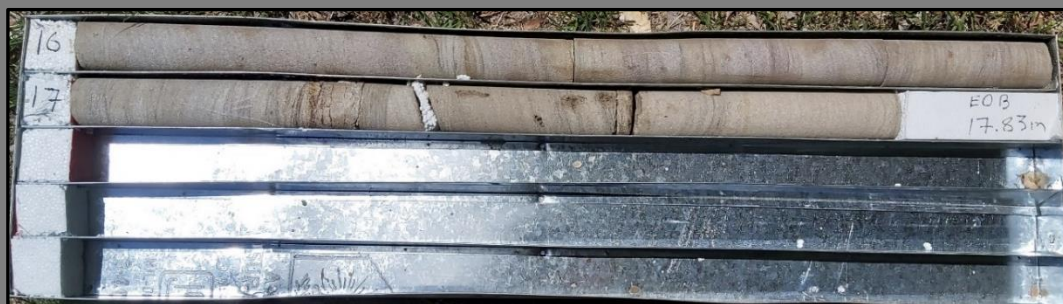
16.0 m – 17.83 m

BORE: 302 PROJECT: REDFERN DECEMBER 2019

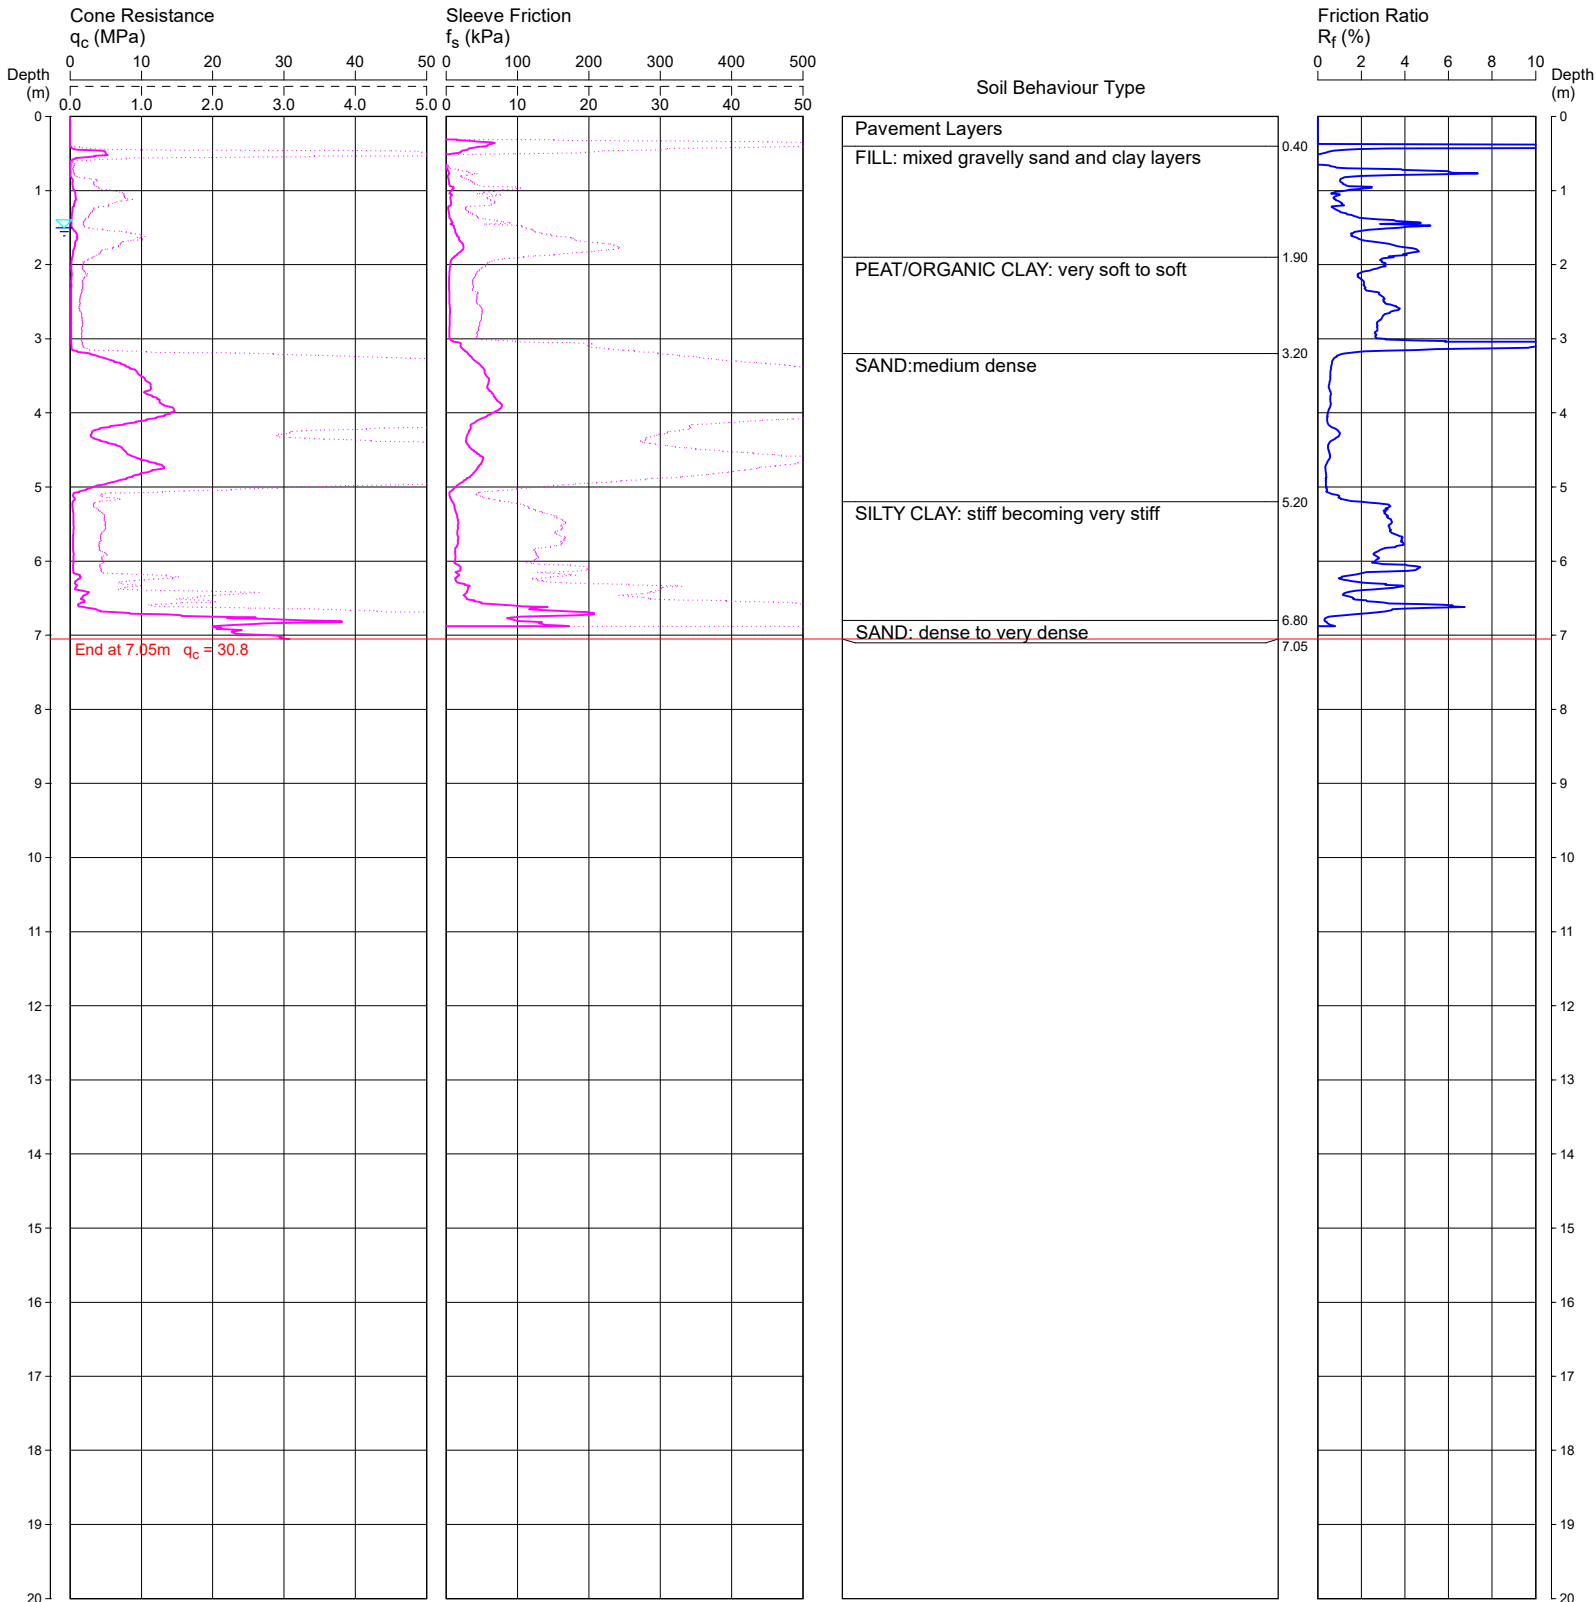
REMARKS: Dummy Cone to 0.4m deep. Test in Asphaltic Concrete Pavement.
Groundwater measured at 1.5m deep

Water depth after test: 1.50m depth (assumed)
