Remedial Action Plan

Gunyama Park Stage 2 and George Julius Avenue
North - Zetland, NSW

Client: City of Sydney

Job No.: 60477507

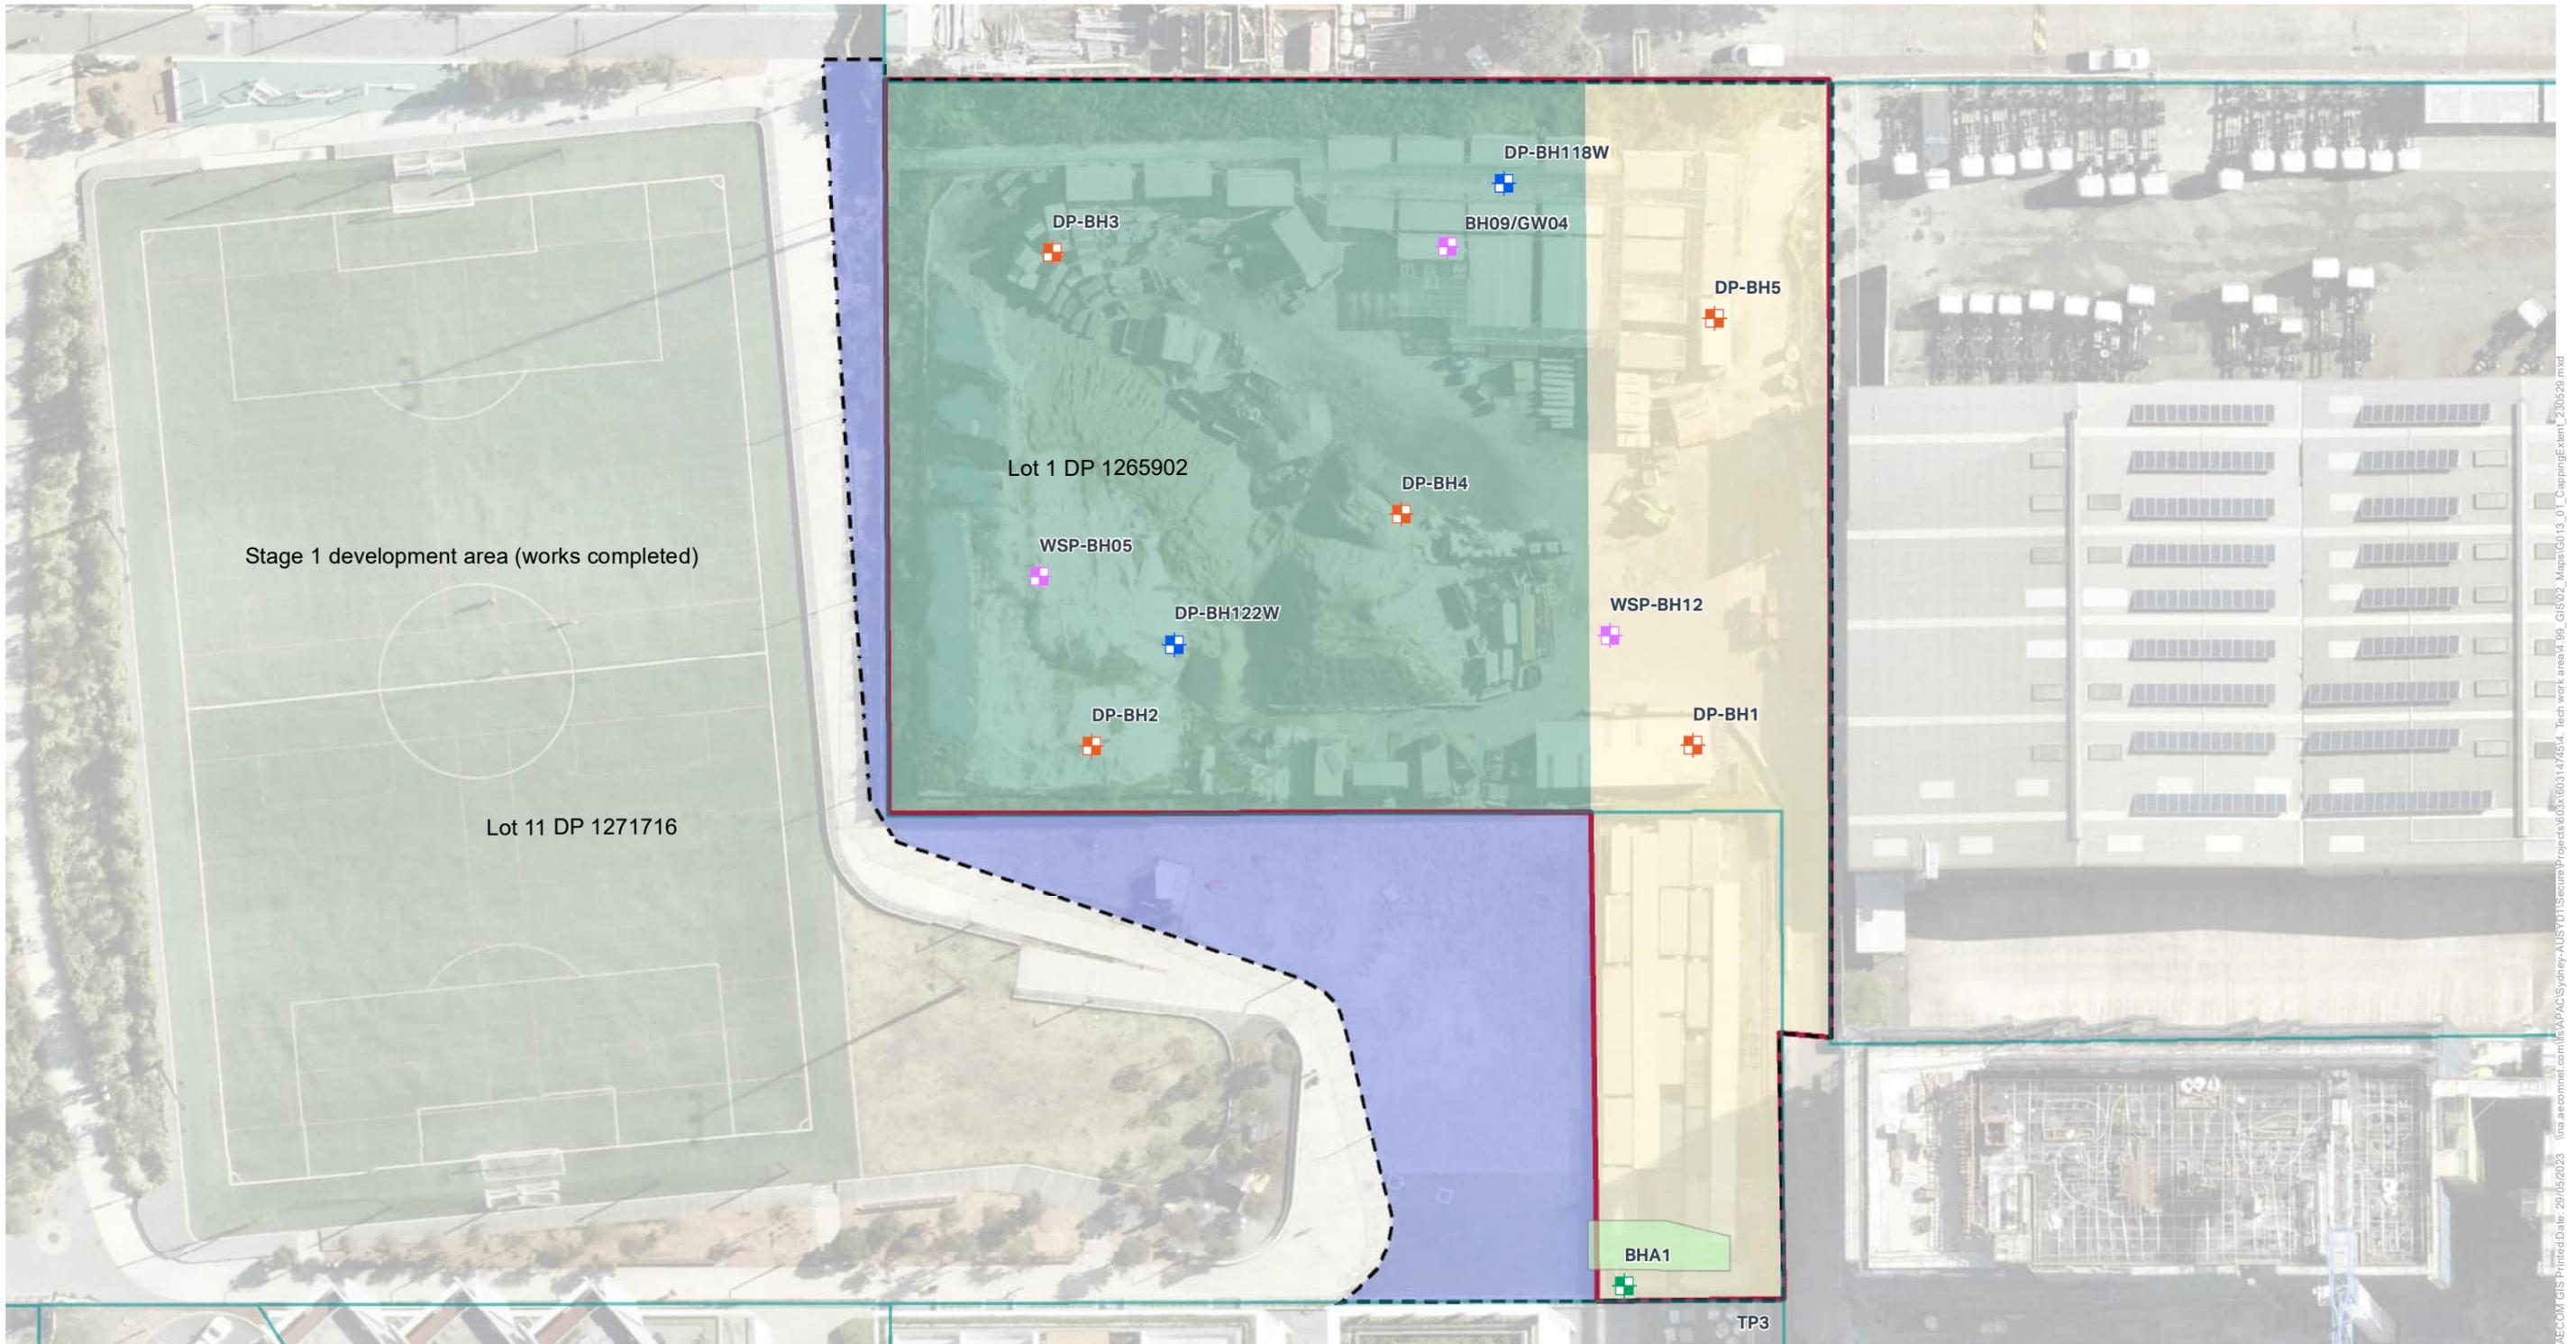
SCALE	1:600		SIZE	A3
SHEET	1 of 1		COORDINATE SYSTEM	GDA 1994 MGA Zone 56
TITLE	FIGURE 6 - Gunyama Park and George Julius Avenue North Capping Extent			
PROJECT	GREEN SQUARE TOWN CENTRE			
CLIENT	CITY OF SYDNEY			
DRAWN	DATE	MAP #	REV	Project
	29/05/2023			
CHECK	DATE	G002 07 60477507

- KEY**
- Site Boundary
 - Stage 2 boundary
 - Cadastral boundary
 - UST excavation (removed and validated during Stage 1 (JBS&G 2020))
 - Remediated and validated during Stage 1 (JBS&G 2020)
 - Extent of capping within the park
 - Extent of capping within the road reserve
 - ⊕ AECOM (2015) borehole locations
 - ⊕ Previous borehole location (DP, 2009)
 - ⊕ Previous borehole/well location (WSP, 2012)
 - ⊕ Previous borehole location (DP, 2016)
 - ⊕ Previous borehole location (JBS&G 2020)

The above capping material requirements are broadly in line with that being undertaken within the Green Square Town Centre infrastructure corridors. The typical cross-sections of the capping and marker layers are shown in **Appendix D**. The extent of the capping layer to be installed as part of the Stage 2 works is shown on **Figure 6** in **Appendix A**.

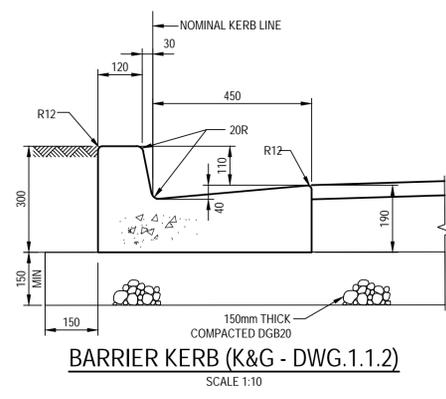
NOTE:
 1. 40MPA CONCRETE.
 2. FOOTING SHALL SIT ON UNDISTURBED SOIL OR WELL COMPACT.
 3. THE SOIL AROUND THE FOOTING SHALL BE COMPACTED AFTER FOOTING IS CONSTRUCTED.
 4. COVER: 50mm
