Report on
Geotechnical Investigation

Gunyama Park Stage 2 and George Julius Avenue
North
17 Zetland Avenue and 13 George Julius Avenue,
Zetland

Prepared for
Place Design Group Pty Ltd

Project 73743.06
September 2023

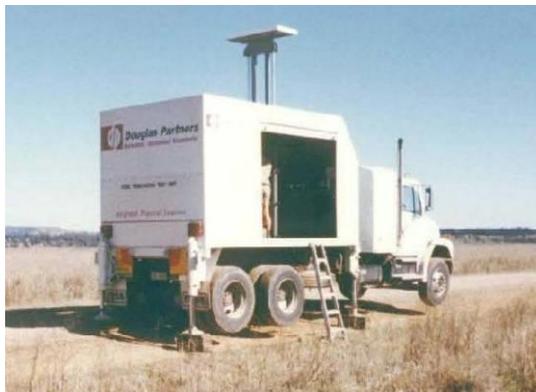
Figure 2: Purpose built CPT rig

The cone is thrust into the ground at a steady rate of about 20 mm/sec, usually using the hydraulic rams of a purpose built CPT rig, or a drilling rig. The testing is carried out in accordance with the Australian Standard AS1289 Test 6.5.1.
