Capitol Theatre Condition Assessment

11 March 2019

Mott MacDonald has been commissioned by Urbis to carry out a condition assessment of the Capitol Theatre in Haymarket, Sydney for inclusion in a new CMP being written for the building.

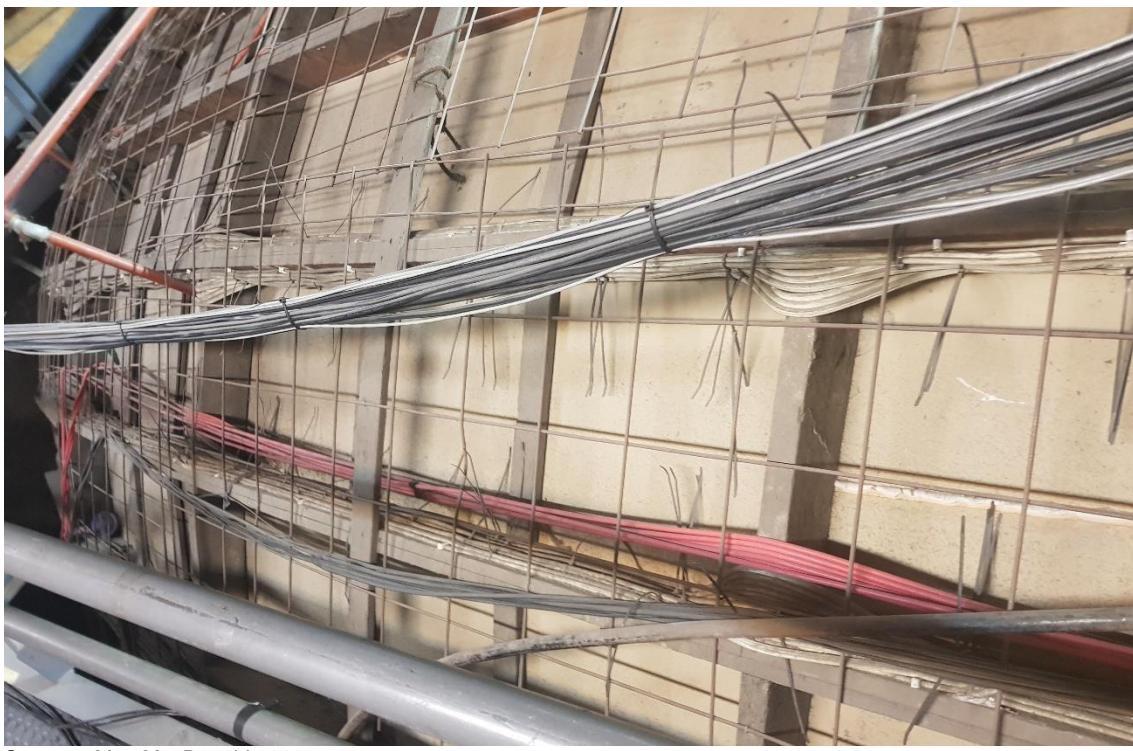
- Timber purlin damage (Figure 1, Figure 2). These defects are low risk as the timber roofing is only supporting weight of the corrugated sheeting and services above, however, should be monitored periodically for any further deterioration.
- Buckled flat truss chord members (Figure 7 and Figure 9). It is uncertain when this
 failure occurred and could be caused by the cutting and rewelding of the truss
 members. These members should be assessed when performing the desktop study and
 the structural check recommended above.

Figure 2: Original Theatre Roof – Timber Purlin Damage

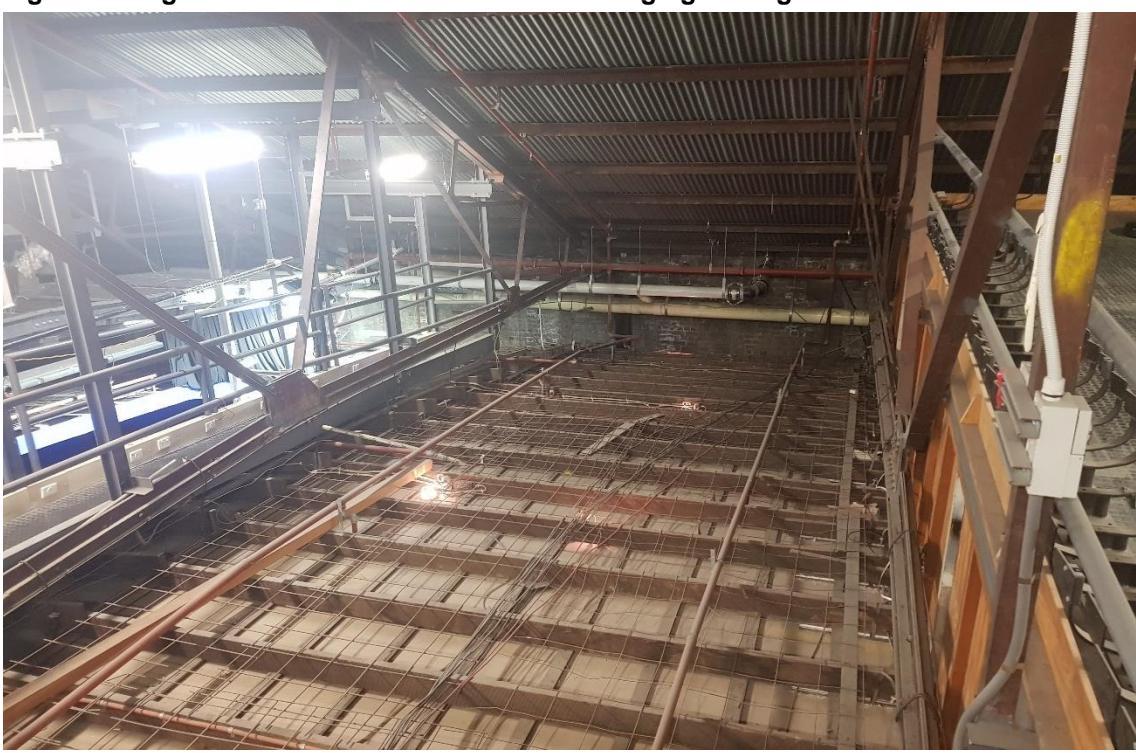
Figure 7: Original Theatre Roof – Buckled Truss Chord

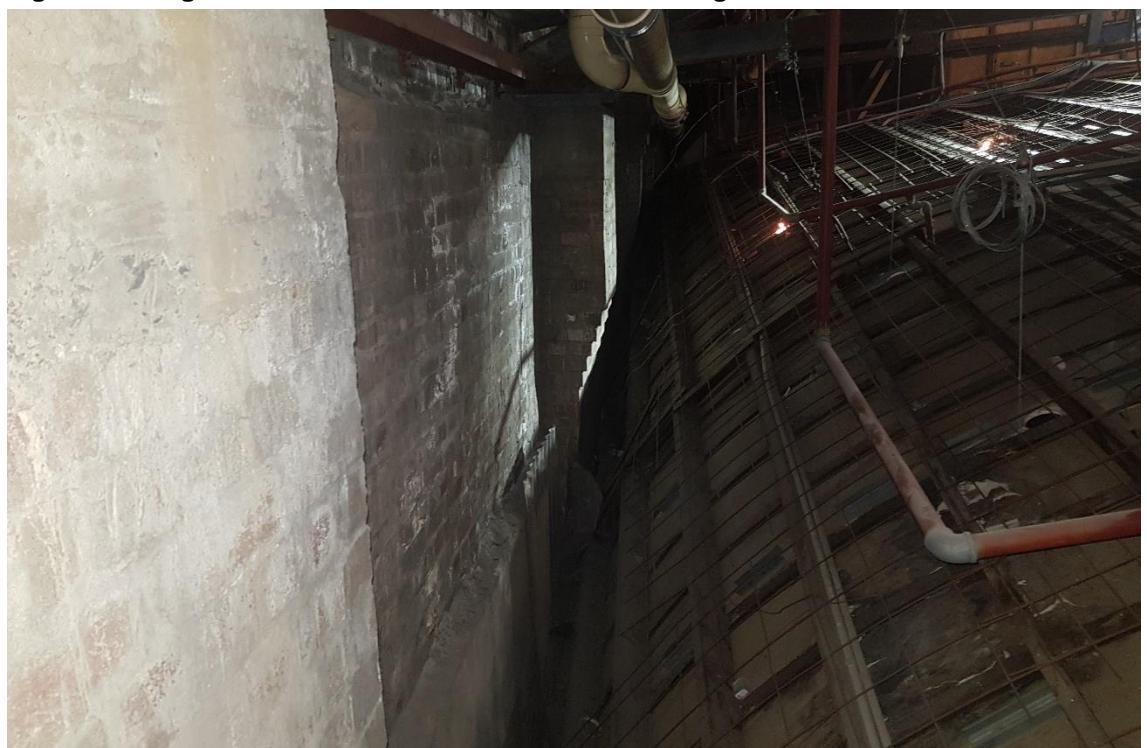
Figure 9: Original Theatre Roof – Bucked Truss Chord

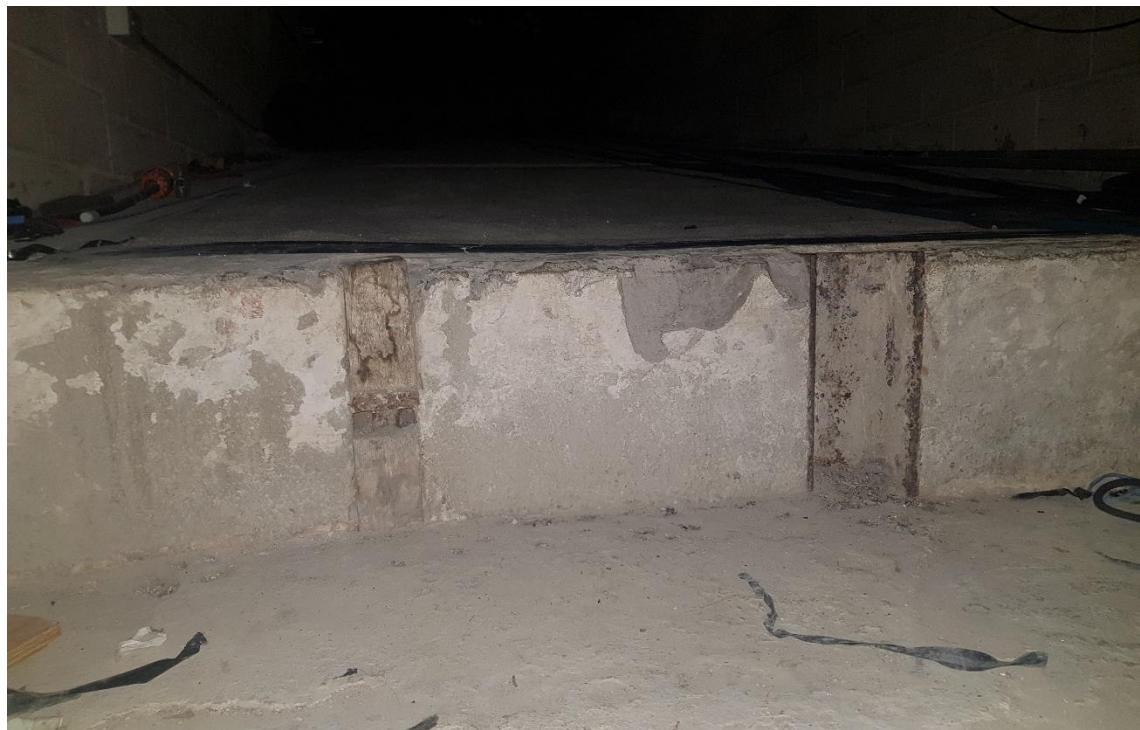
Although the majority of the tank walls was painted (Figure 13), the top of the tank was visible through an access hatch (Figure 14). No major defects were visible at the time of inspection and the elements are not in a particularly exposed location, however, due to its historic significance the walls should be monitored periodically for signs of cracking or spalling.

Figure 14: Original Walls – Top of Tank Wall

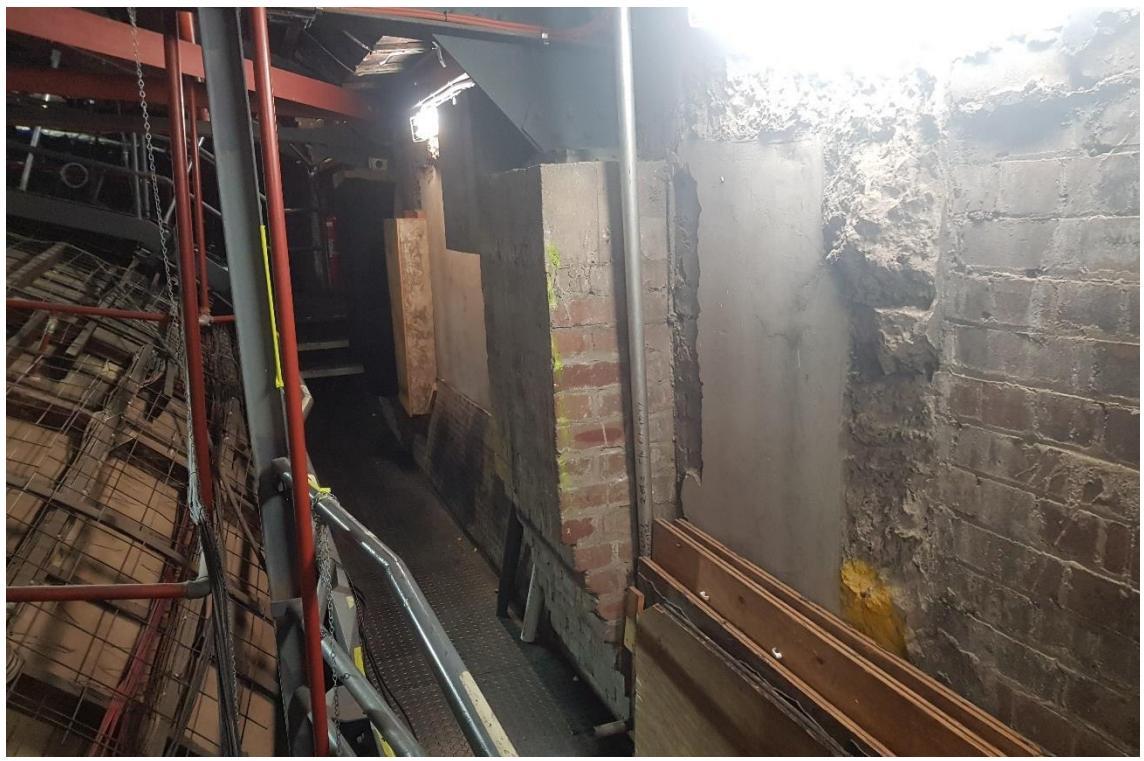
The southern wall (Figure 17), which divides the back-stage area from the theatre seats appears to be a single skin masonry wall that s has long spans between supports in both the vertical and horizontal directions. Due to the size and age of this wall, it is suggested that an engineer be engaged to carry out a desktop analysis to check its structural stability.

Figure 17: Original Walls – Large Wall Dividing Back Stage and the Theatre

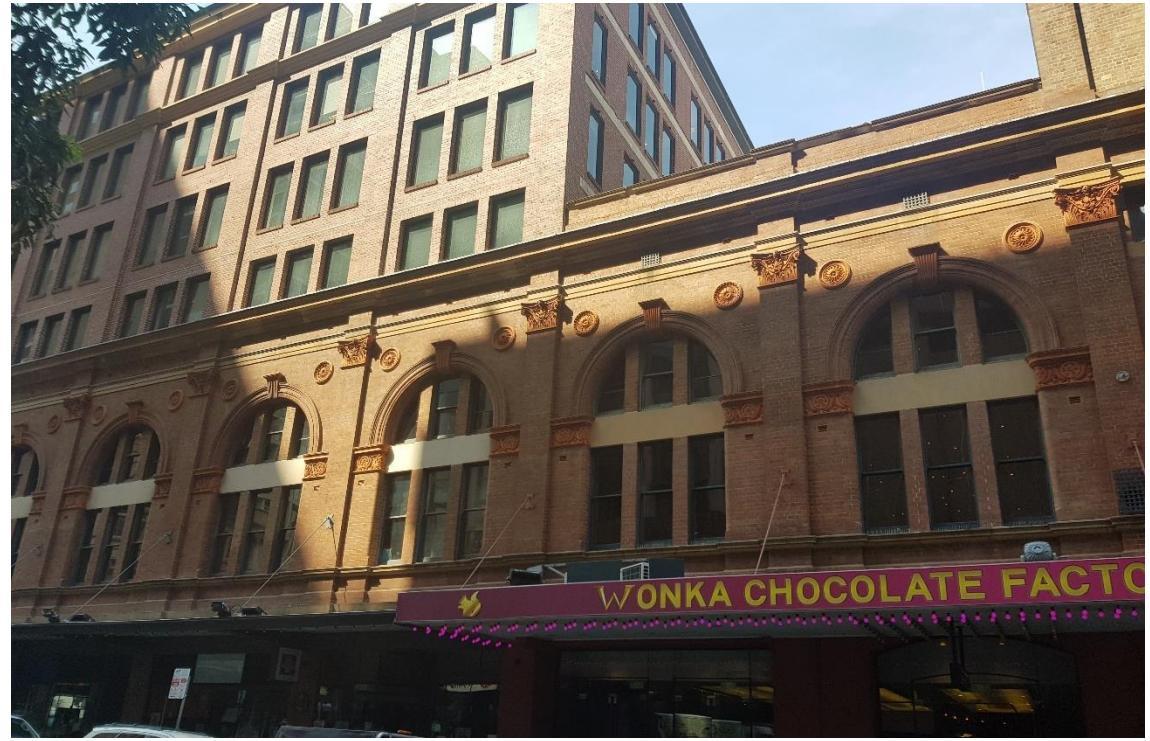
Large awnings cover the footpaths around the outer perimeter of the Capitol Theatre (Figure 38 - Figure 39). Awning structures are typically an area of high risk to public safety. This is largely due to the susceptibility to wind forces and vibrations, their public location and that they are often not visible or are difficult to access for maintenance.

Figure 38: Perimeter Awning

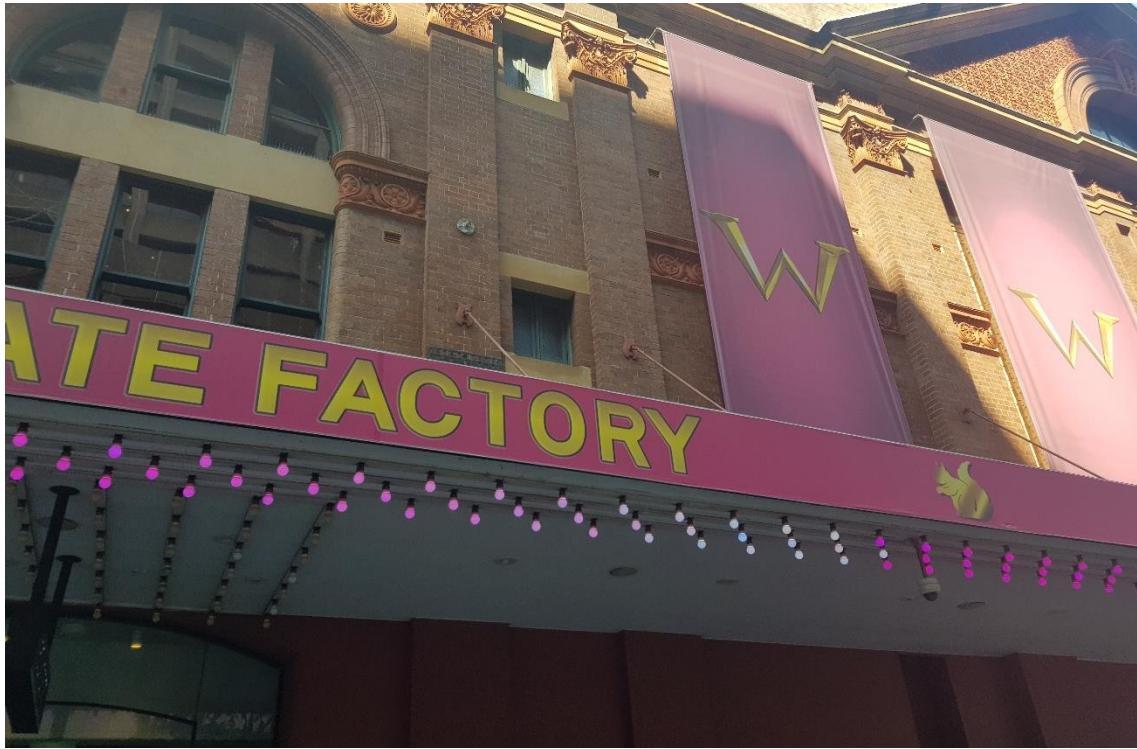
Figure 39: Perimeter Awning
