Queen Victoria Building Condition Assessment

23 July 2018

Document reference: 399302 | 1 | A

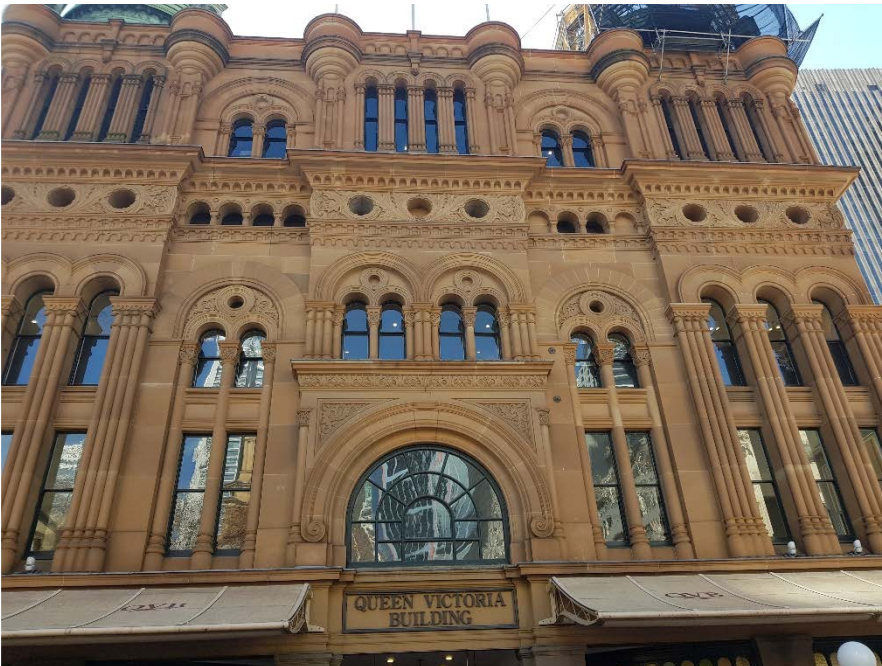
Figure 48: West Façade

Between 2006 and 2009, the sandstone façade of the QVB underwent restoration. Typically, visible sandstone was in very good condition at the time of inspection. No major deterioration or cracking was visible.

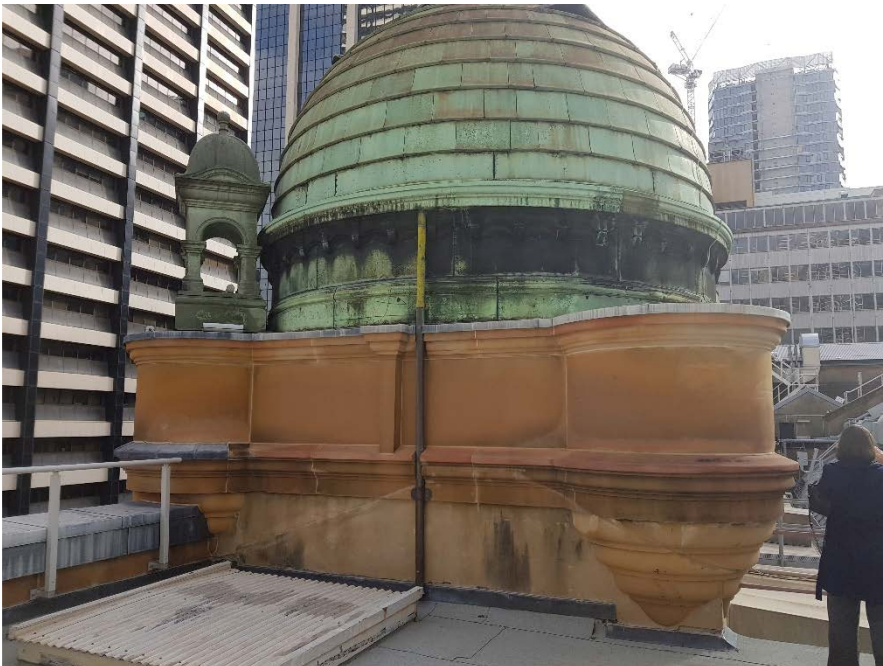
Figure 50: Bowing Gutter Above North West Flat Roof
