Hyde Park Tree Management Plan

The Hyde Park Tree Management Plan was proposed by the Council of the City of Sydney in October 2004, following the failure and consequent removal of several large trees from Hyde Park North and Hyde Park South.

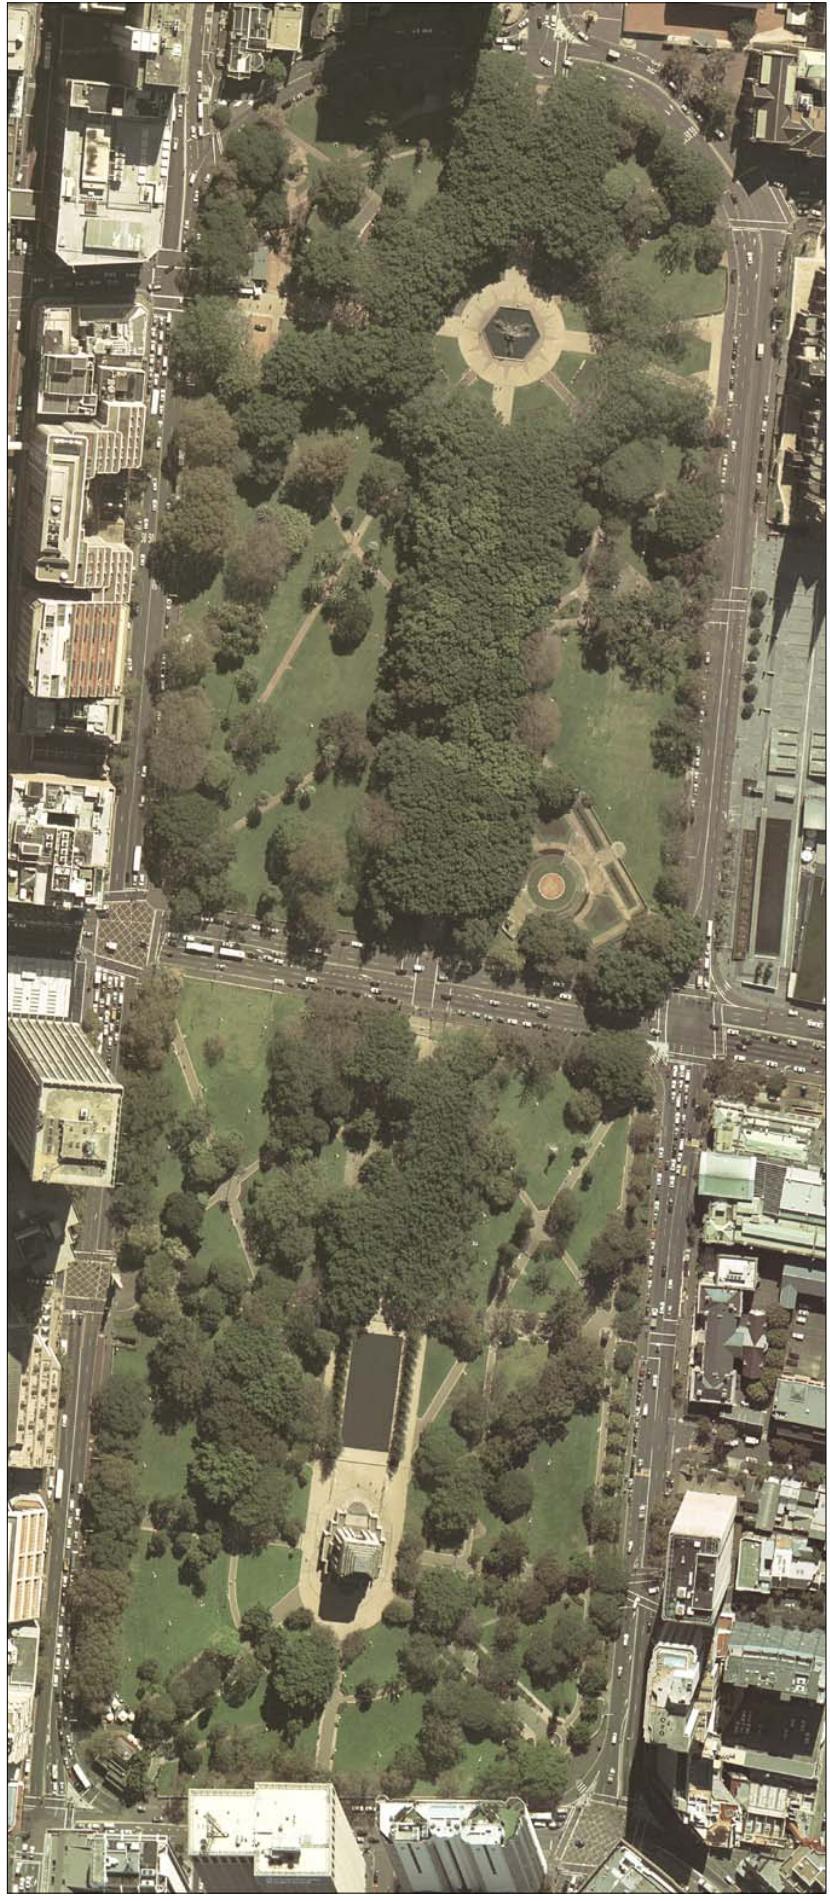
Figure 5

In the last several years, the formality of the original design has been compromised by the *ad hoc* planting of trees (Figure 5). This has occurred partly due to the absence of detailed planting plans. From the appearance of the Park today, it appears that the placement and species arrangement of trees has not been guided by any well conceived design concept. A wide variety of trees have been planted in an irregular fashion resulting in many areas of the Park having ambiguous landscape character.

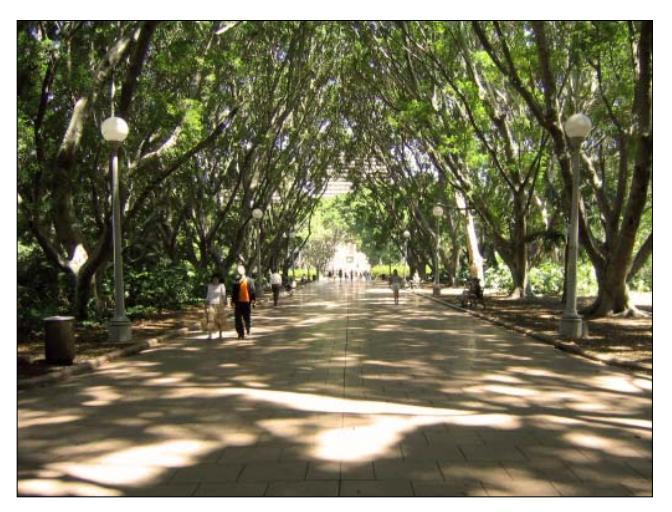
The trees have been planted into compacted impermeable subsoil leading to wet conditions under most of the trees. There is no sub surface drainage.

Tree removals have created gaps in the central avenue detracting from the visual impact of the vista.

A number of large *Eucalyptus sp.* and *Platanus sp.* have been planted along the edges of the central avenue impinging on the avenue planting. *Howea forsteriana* (Kentia Palms), *Strelitzia nicolai* (White Bird-of-Paradise) and *Monstera sp.* have been randomly planted as an understorey throughout the central avenue. Some of the Hill's Figs trees have been wounded by the practice of nailing fairy lights into their trunks.

Figure 8: The central avenue of *Ficus microcarpa* var. *hillii* (Hill's Fig), Hyde Park North.

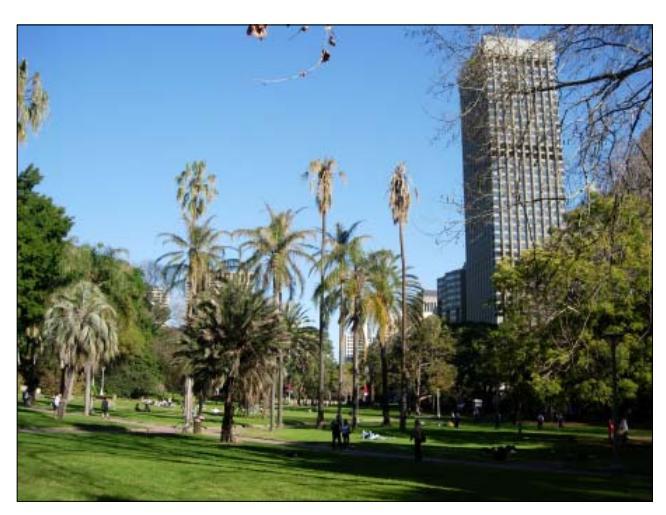
Many of the palms are over-mature and are in decline. (Figure 10)

Figure 11: Palm grove planting at the intersection of the pathways.

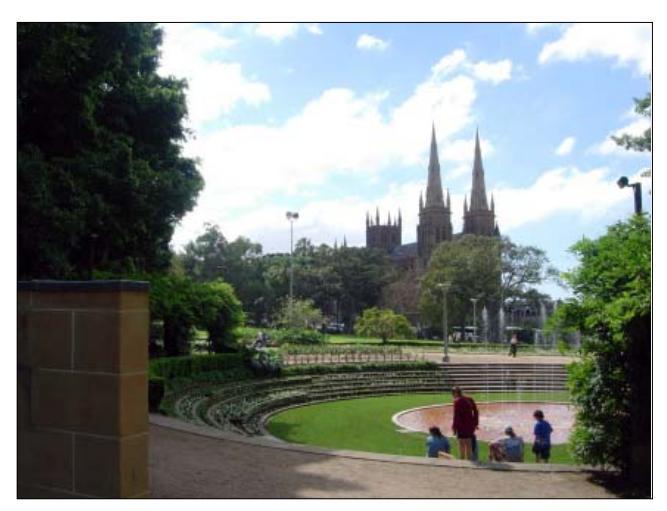
Smaller trees and shrubs are tending to isolate Sandringham Garden from the Central Avenue.

Figure 15: Sandringham Garden looking north to the "British Lawn" with St Mary's Cathedral in the background.

The issue of this 'ad hoc' planting is addressed in the 2006 PoM & Masterplan.

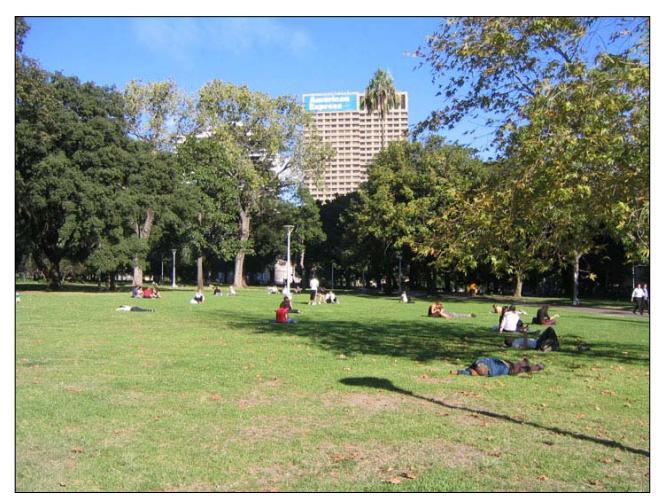
Many of the trees in this section are in poor condition. They suffered major root damage when the pathways were upgraded during the 1990s.

There are a number of *Ficus macrophylla* (Moreton Bay Figs) that were planted prior to 1928, located along the Elizabeth Street boundary. The health of these trees is declining.

Figure 19: The northern section of the western side of Hyde Park South.

The PoM & Masterplan seeks to rationalise the design in this section of the Park and create greater areas of open space.

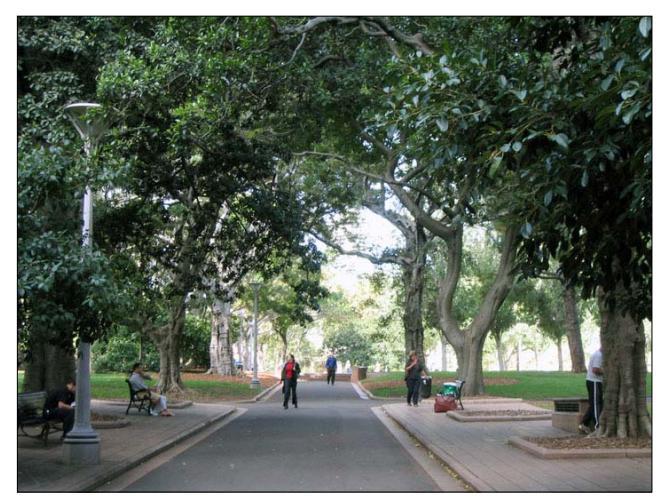
Figure 20: The EW pedestrian axis at the northern end of the Pool of Reflection is predominantly planted with Port Jackson Figs (*Ficus rubiginosa*) following the removal of most of the Oak trees that were previously planted in these locations.

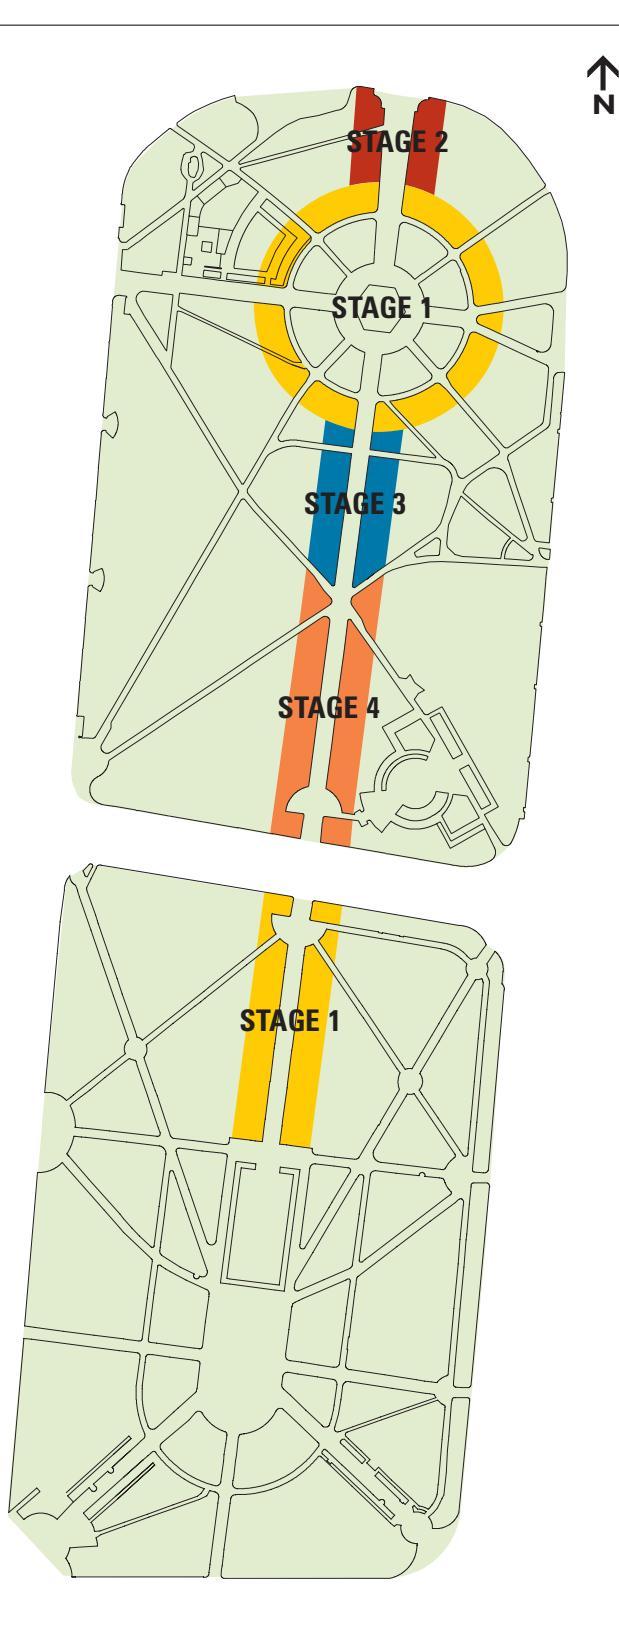
Central Avenue Block Tree Removal Stages 1 - 4

The proposed removal and replacement of the trees in the central avenue of Hyde Park can be flagged now, so that when the time comes, the removals have been largely understood and accepted.

A major capital works project will be required when the trees are replaced, to remove and replace the subsoil and install sub surface drainage and services in the central avenue.

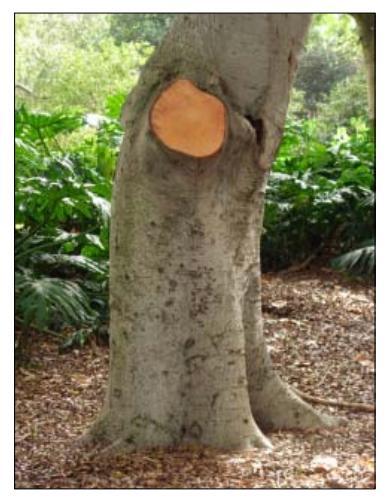
The Hill's Fig trees growing in the central avenue of Hyde Park require constant pruning to maintain the design intent of the cathedral-type vista over the pedestrian walkway. Unfortunately this practice has had an adverse effect on the trees, reducing their ability to manufacture the sugars required for health and growth.

Figure 38: Removal of a large limb from a Hill's Fig located in the central avenue of Hyde Park North.

Removing even a single, large-diameter limb (Figure 38), can create a wound that the tree may not be able to close. The older and larger these trees become, the less energy they have to allocate to defence mechanisms for wound closure and decay or insect attack.

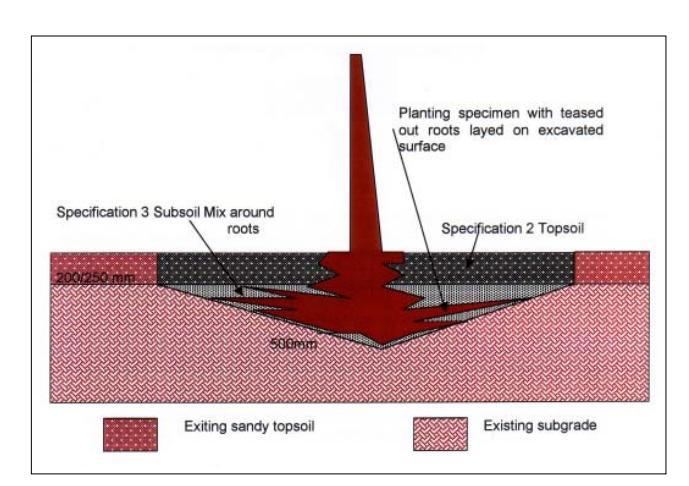
Figure 39: Planting detail for new specimens (Attachment 3: SESL Soil Investigations Vol.1 p.32).

It is imperative that the diameter of the planting hole for all new or replacement trees shall be a minimum of 2-3 times the diameter of the root ball and no deeper than the root crown.

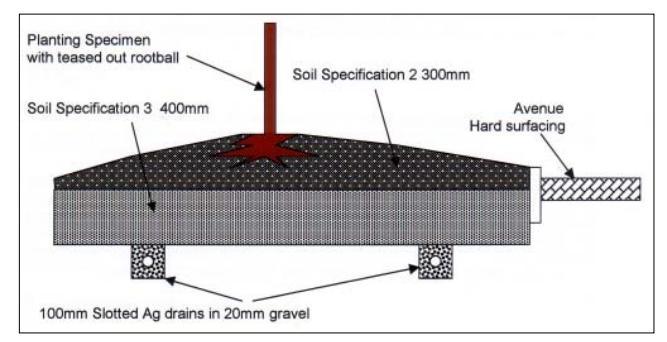
Figure 40: Soil specification for replanting in the central avenue (Attachment 3: SESL Soil Investigations Vol.1 p.35).

Install sub surface drainage in areas identified with drainage problems (Attachment 3: Soil investigations SESL 2005) before planting.

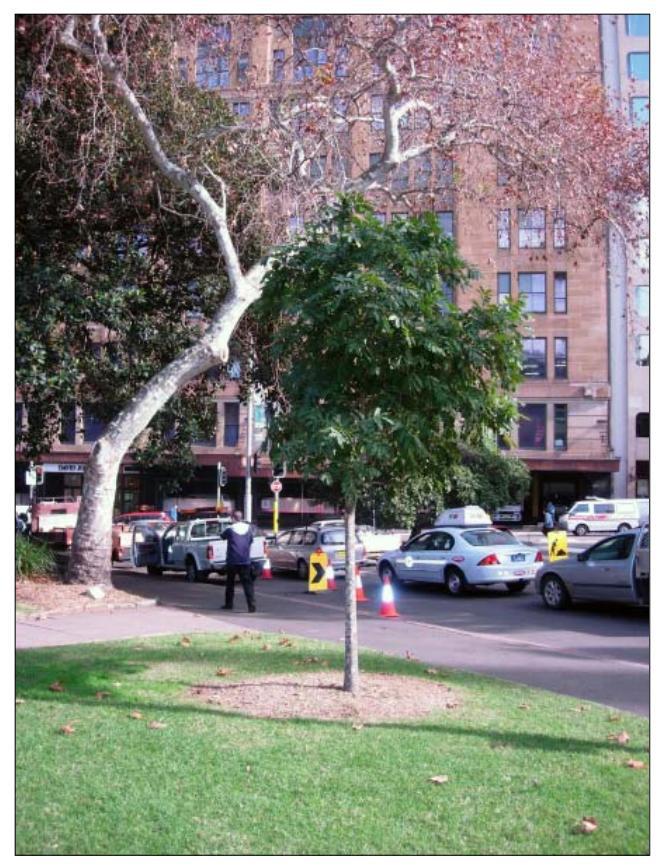
Figure 41: Mulch shall be installed at the base of all newly planted trees, to a radial distance of one (1) metre.

Place an 50mm layer of organic mulch around the base of all newly planted trees to a distance of one (1) radial metre from the trunk.

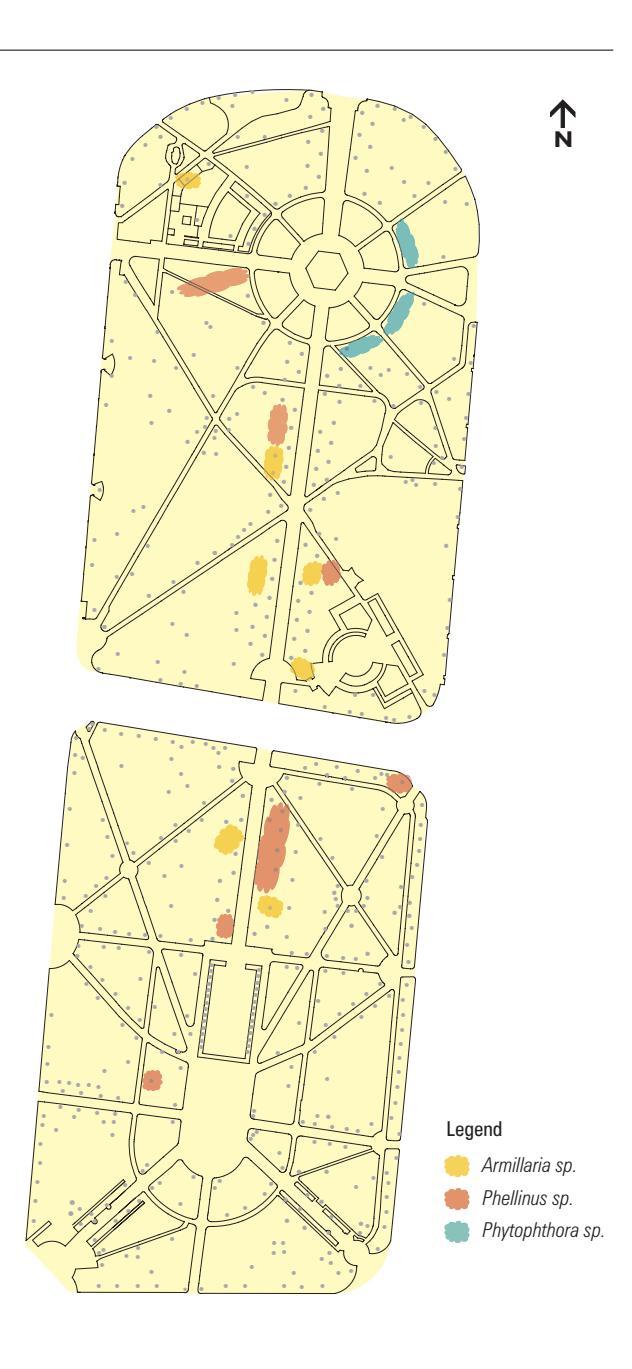
Location of Diseases - August 2005

Treatment for *Armillaria* and *Phytophthora* is limited and as yet little information is known regarding the fungi *Phellinus*.

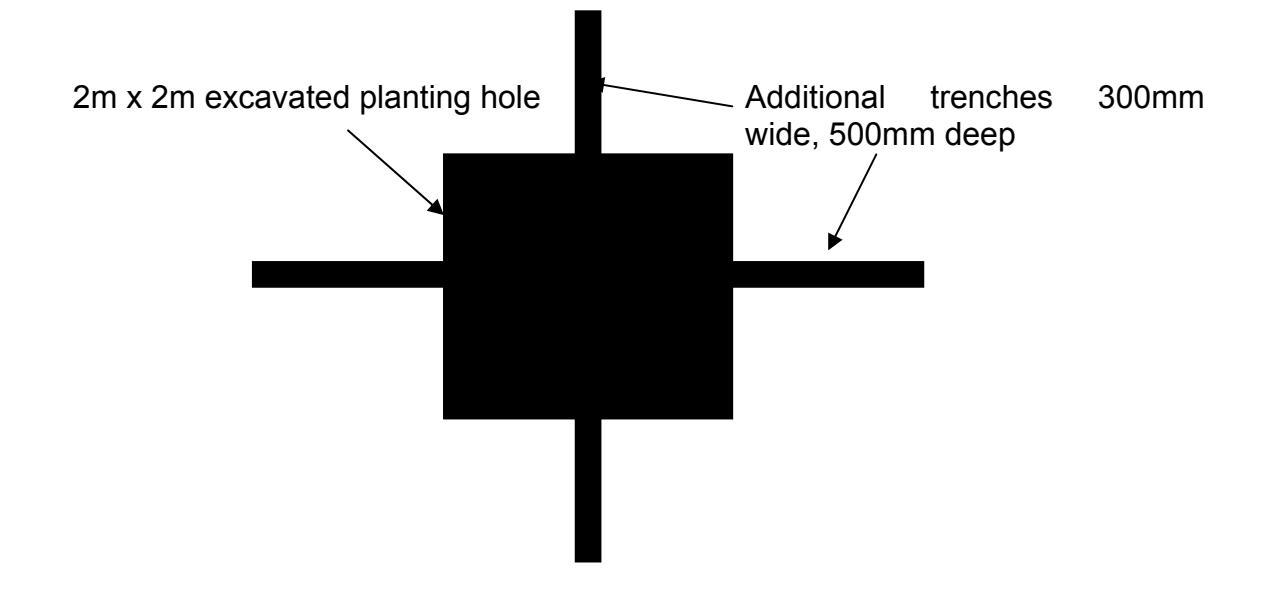
Figure 6. Plan of Planting holes in heavy clay subsoils (Eastern Side)

Where subsoil is very heavy red or mottled grey clay as will be encountered on the North Eastern side of the park both north and south modify the planting hole by trenching using a small backhoe or "ditch witch" type of machine in four cross shaped lines extending a further 2m and 500mm deep away from the opened square hole (see Figure 6). Treat the cut clay surface with lime at 300g/sqm before planting and backfilling. Backfill using the two layered soil mixes as specified in Figure 5.

In the South Eastern quadrant of the park where soils are particularly poorly drained subsoil drainage may be required in addition to the above soil modifications. This presupposes that a stormwater access can be located to shed drainage water.

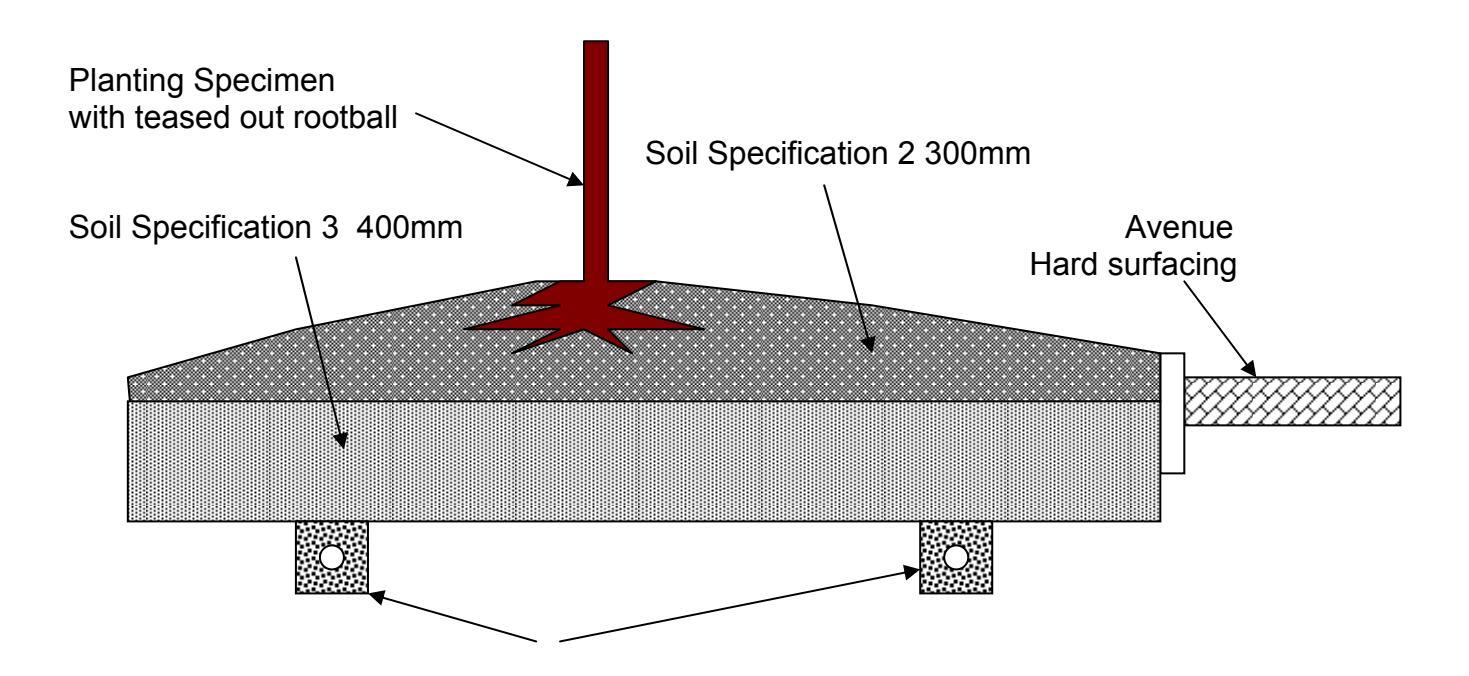
While a range of options is given below to attempt improvement of the existing *F. hillii* avenue soil conditions there is little doubt that complete removal and soil replacement is the only perfectly satisfactory option. The soil replacement detail given here should be used prior to replanting individual failed specimens or blocks of specimens whether they be super advanced, transplants or smaller potted stock. Physical soil conditions under these trees are the worst in the park and will likely deteriorate further with time. There is no point replanting without such soil modification.

Subsoil drainage must be provided. Two main trunk drains are pictured in Fig 6 which need to be connected to a stormwater system. The purpose is to allow all excess ponded water to escape quickly.
