arboricultural impact assessment report

AIA-01

Revision A, Issued for Planning Proposal 13 May, 2020

GLEBE MID-RISE PROJECT

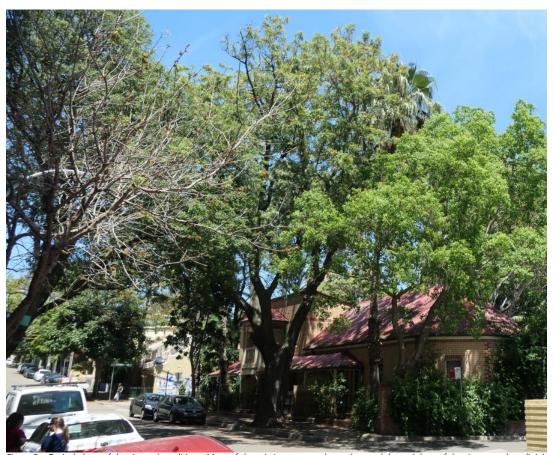
Figure 2 — Typical photo of the site and conditions. Many of the existing trees are located around the periphery of the site or on the adjoining street. There is a small group of trees located in the central courtyard of the southern buildings. View is to the west from Cowper Street with T13 Grevillea robusta to the centre of the frame. (Photo: Arterra 11/11/19)

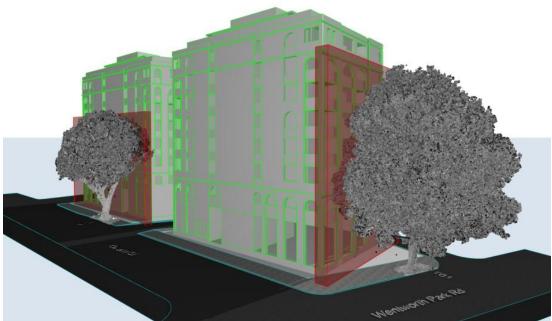
As shown in T-03 Canopy Pruning Plan (Appendix 4.3) the proposed line of the buildings have been set back from the boundaries to facilitate retention of the large adjoining street trees. To facilitate the construction of the building, a scaffold will need to be erected around its perimeter. It is assumed that a 2.0m wide frame will be used. These constraints still result in some impacts to the existing canopy and will result in the removal of some branches and foliage.

Figure 12 — View of 3D computer model of building and point cloud data obtained for trees — T01 to the right and T13 on Cowper Street to the left. Red zone indicates scaffold cut line. (Image Source: Arterra)

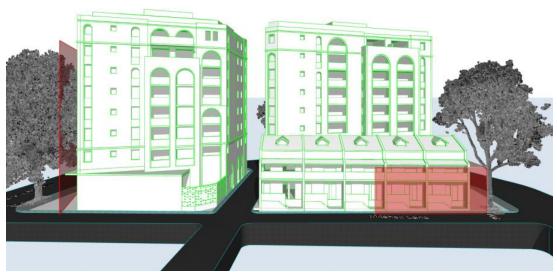
Figure 13 — View of 3D computer model of building and point cloud data obtained for trees — T01 to the left and T06 on the site to the right. Red zone indicates scaffold cut line. Note that the habit and foliage of T06 are well clear of terraces and should not require any pruning. (Image Source: Arterra)

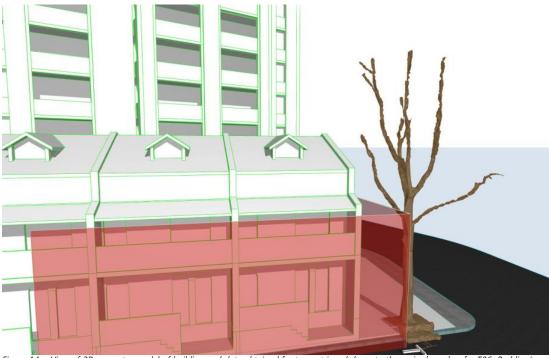
Figure 14 — View of 3D computer model of building and data obtained for trees stripped down to the major branches for T06. Red line/zone indicates scaffold cut line. Note that the majority of main branches are well clear of proposed building and should not require any pruning. (Image Source: Arterra)

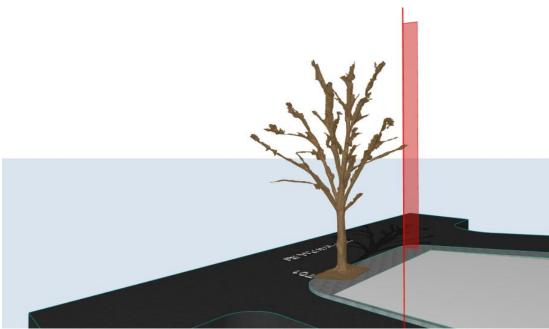
Figure 15 — View of 3D computer model of building and data obtained for trees stripped down to the major branches for T01. Red line/zone indicates scaffold cut line. Note that the majority of main branches are well clear and should not require any major pruning. (Image Source:

Table 2 - Schedule of Proposed Pruning T01

Branch Qty and Size at Cut	Comment / Notes								
1 x 150mm	Lowest branch to southern side of tree taken back to trunk								
1 x 100mm	Mid canopy to southern side of tree taken back to trunk								
1 x 100mm	To south-eastern side of tree taken back to trunk								
1 x 75mm	Lowest branch to south-eastern side of tree taken back to trunk								
3 x <50mm	Various small branchlets in upper canopy taken back to nearest appropriate								
	junction

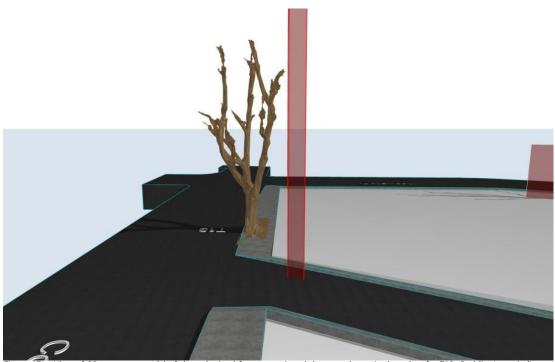
Figure 17 – View of 3D computer model of data obtained for trees stripped down to the major branches for T13. Red line/zone indicates scaffold cut line. Note that all main branches are well clear and should not require any major pruning. (Image Source: Arterra)
