MASTERPLAN AND PLAN OF MANAGEMENT

MACQUARIE PLACE

1990

Lester Tropman & Associates

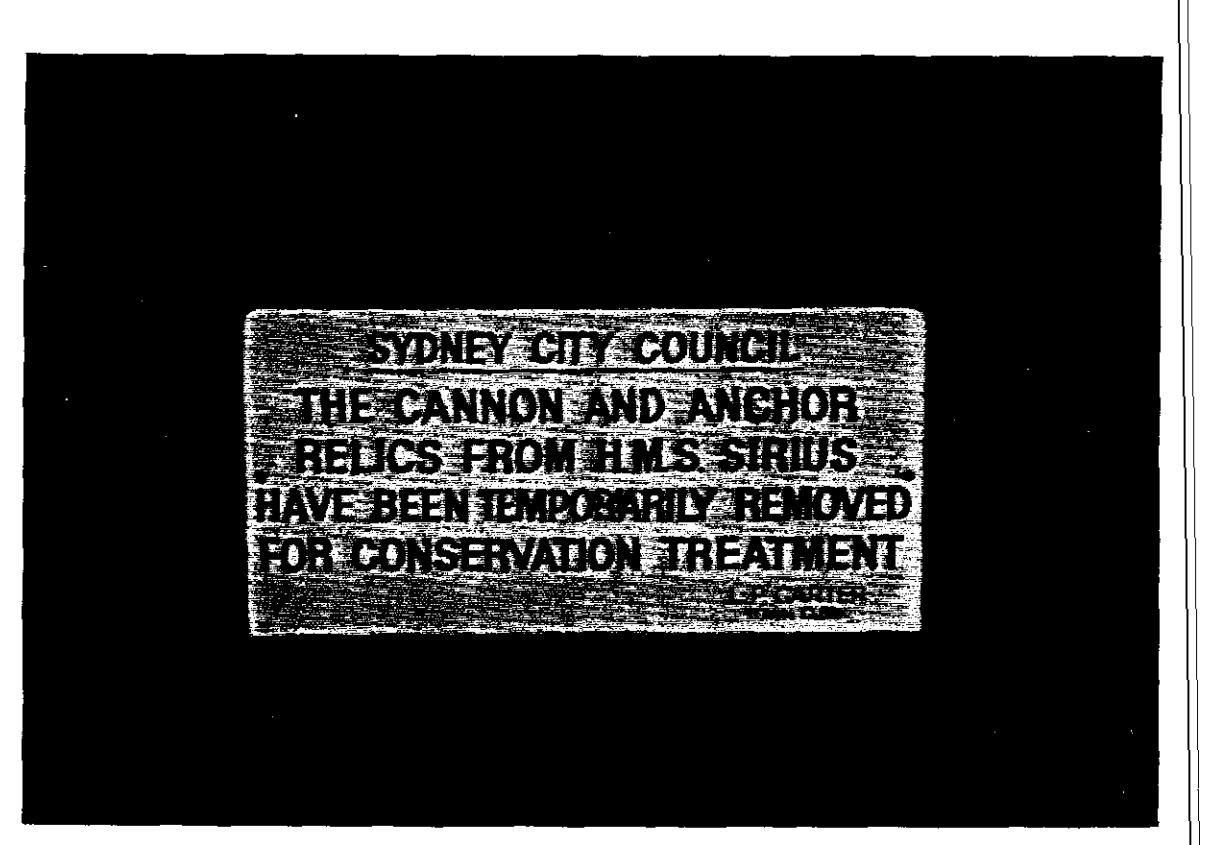
PLATE 4.2

The cannon is itself in good condition, but the replica wooden carriage on which it rests (built in 1907 and rebuilt in the 1970's) has badly deteriorated. The paint is not only lifting off the rotten wood and iron fittings, but is harbouring chloride ions and moisture which will accelerate corrosion of the iron, and perhaps the cannon itself. The anchor has corroded much more heavily than the cannon, especially at points of contact with the concrete base and the replica wooden stock at the end of the shank (which is in a similar condition to the wooden gun carriage). The corrosion process has been aggravated by Sydney's humidity, air pollution and air-borne salt from the harbour.

This notice currently located in the Park, explains the absence of the cannon and anchor, salvaged from HMS Sirius, for conservation purposes.

- The cannon and anchor should be provided with protective coatings.
- A new replica gun carriage for the cannon and new stock for the anchor should be made.
- The anchor and cannon should be redisplayed on special mounts to prevent fresh corrosion.
- A strict maintenance schedule should be drawn up involving regular inspection and maintenance by a qualified person so as to ensure the long term preservation of the relics.

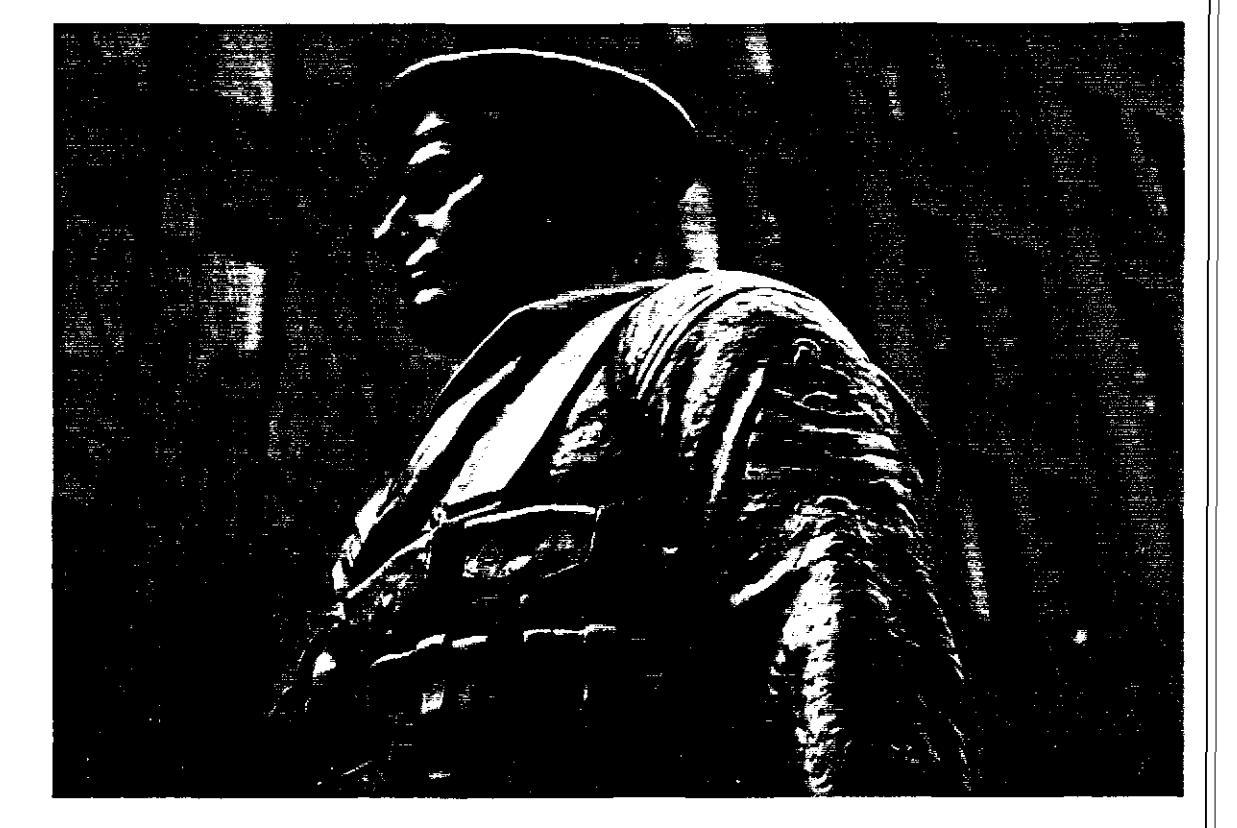
PLATE 4.3

Detail of the Martin Place cenotaph that has recently undergone preservative treatment which has been proposed for the T.S. Mort statue

- The Statue should be reburnished and provided with a wax coating that is to be renewed yearly. (The Martin Place cenotaph has recently undergone this treatment, see plate 4.3)
- Replace the bollards and chain which originally surrounded the statue (see plate 2.10) which will not only prevent the practice of parking bikes around the statue, but the bollards and chain will also help to reinforce the triangular shape of the Park.

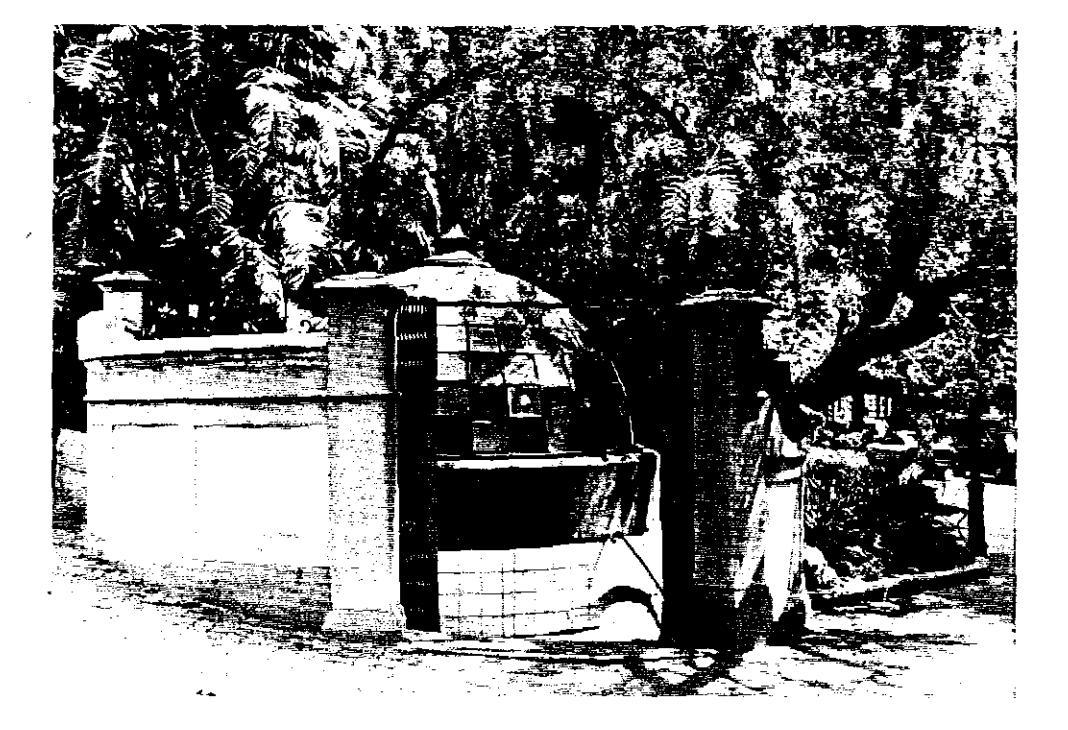
PLATE 4.7

The glazed dome of the Edwardian Lavatory.

This structure should be activly conserved and be subject to the managment recommendations of a separate conservation plan.

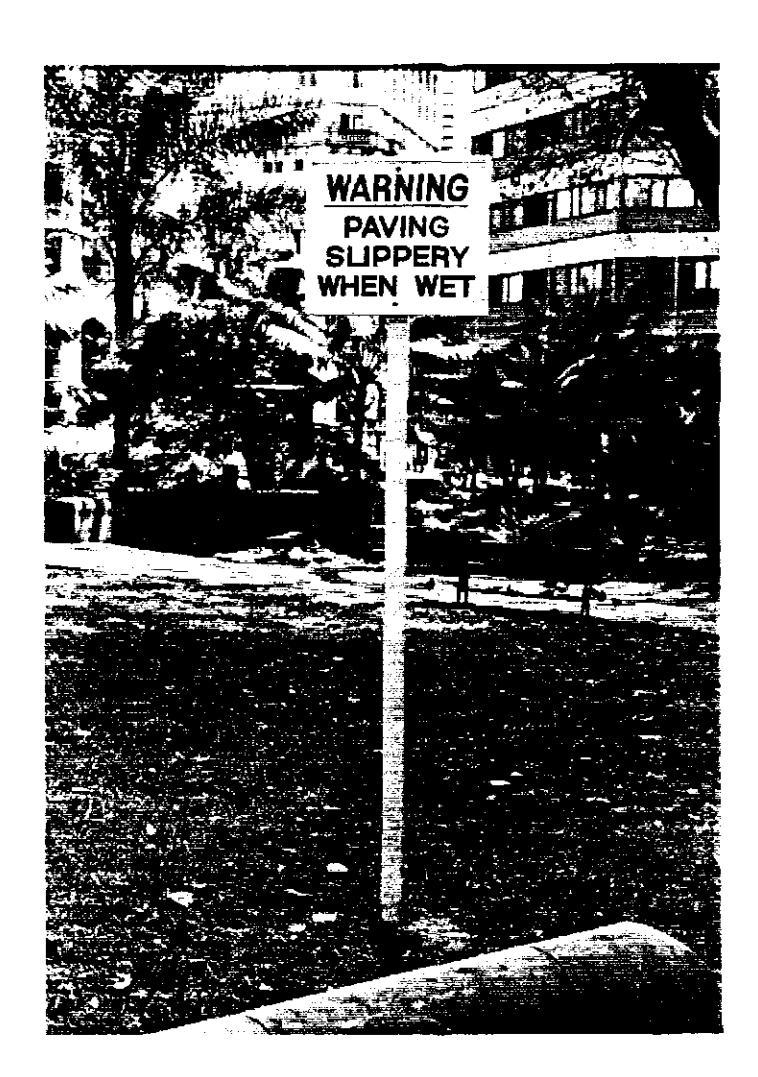
PLATE 4.10

The slate flagstones are generally in good condition but they are slippery when wet making them a hazard to pedestrians. A prominent sign has been erected by Council in the Park warning of the slipperiness of these pavers (see plate 4.10). The sandstone flagging, laid in a random ashlar pattern, is not a pedestrian hazard but has become very dirty over the years and some of the flags are broken.

Due to the slipperiness of the slate paving and the poor condition of the sandstone, it is recommended that this unit paving be replaced by decomposed granite gravel. Gravel paving in Macquarie Place would not only respect the history of the Park, but would also have numerous practical advantages:

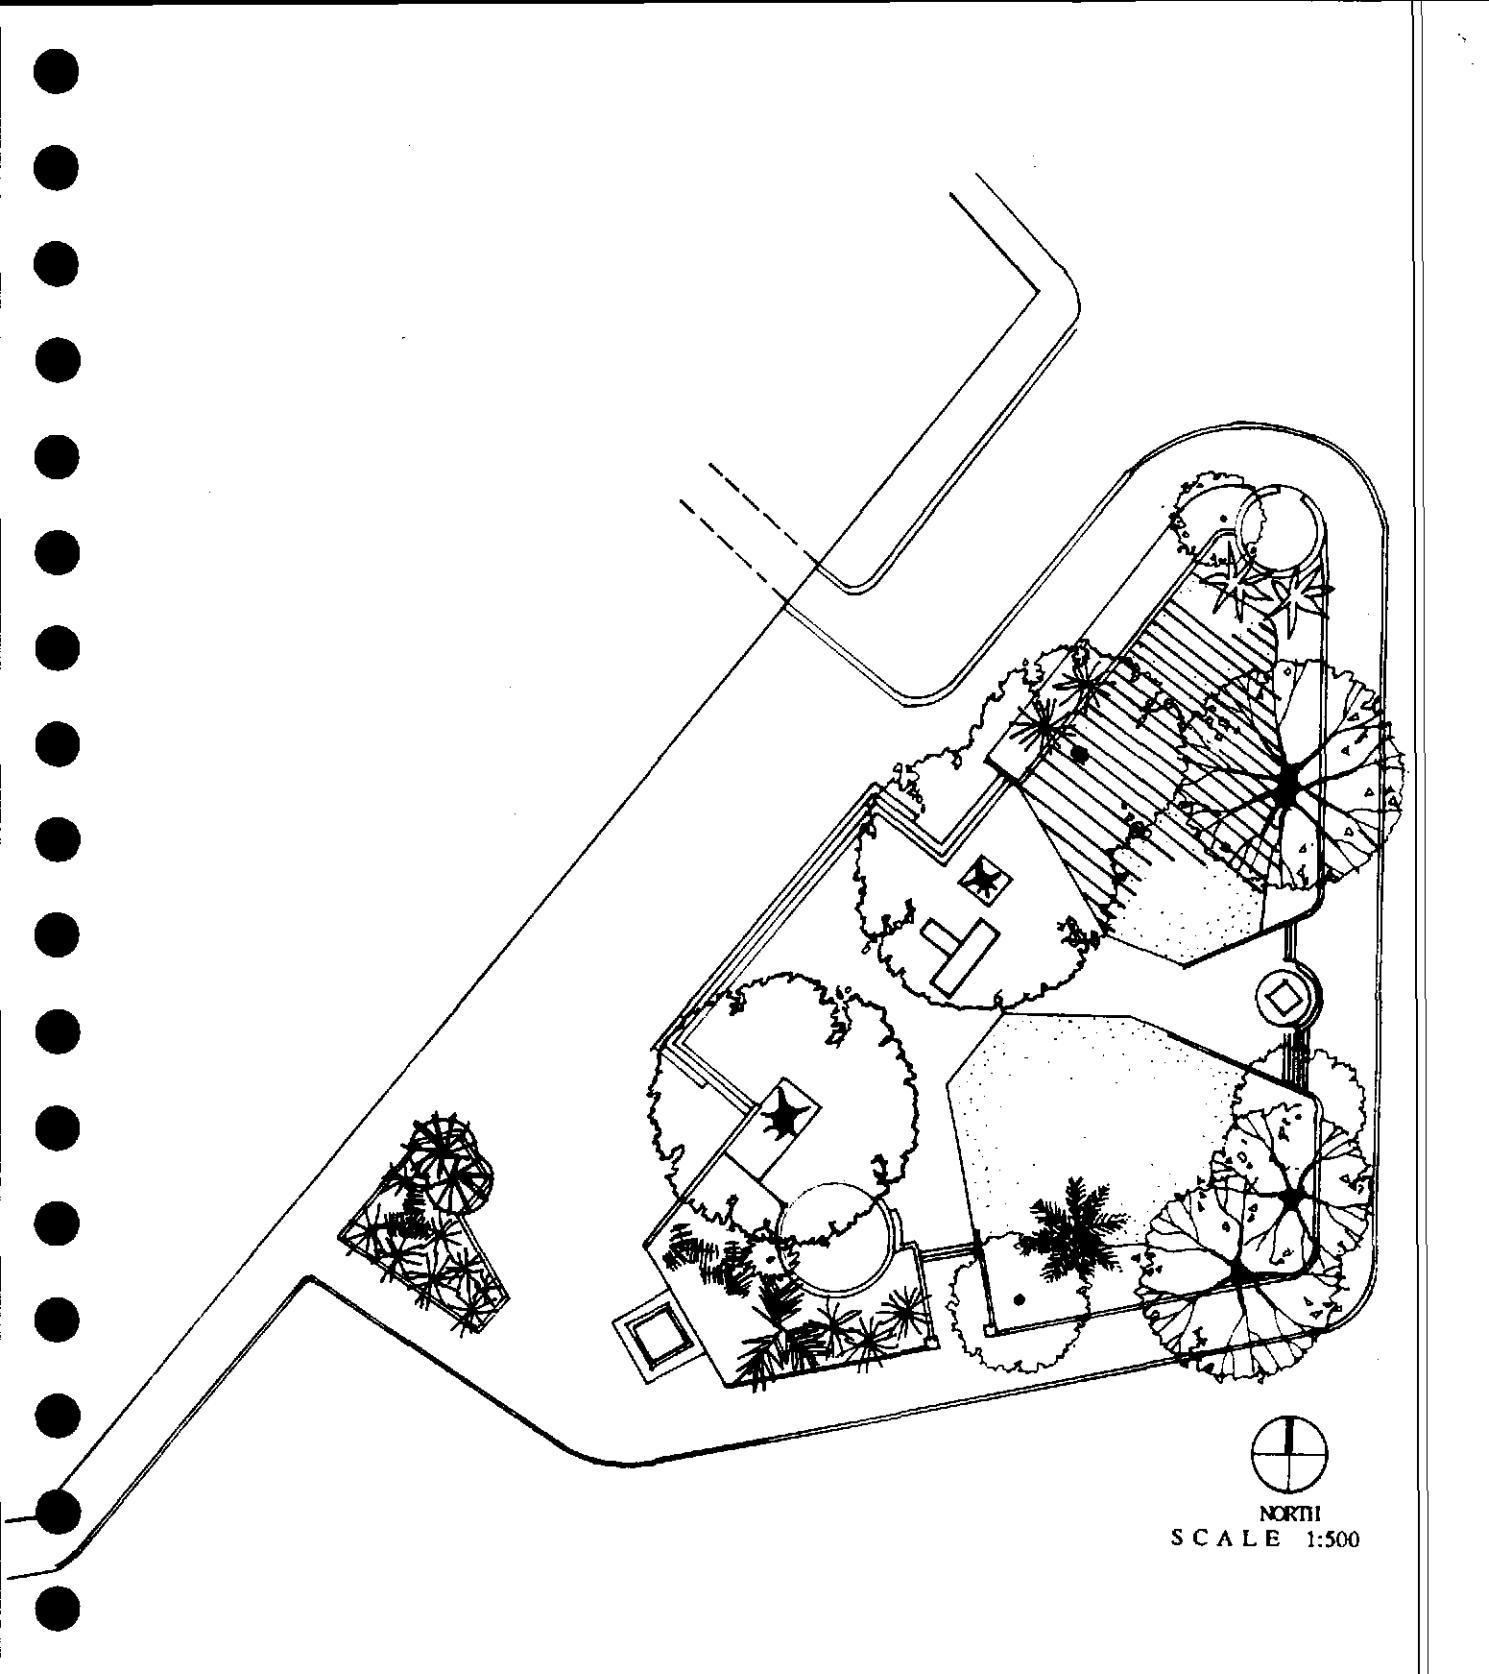
MAP 11

There are large areas of bare earth in Macquarie Place Park due to a combination of soil compaction and overshadowing from tree canopies and buildings (see Map 10). The grass is also being worn by people who take a short cut through the Park from Macquarie Place to Loftus Street. The areas of good grass cover are well used by office workers during lunch time.

Areas within the Park where the grass is not growing successfully.

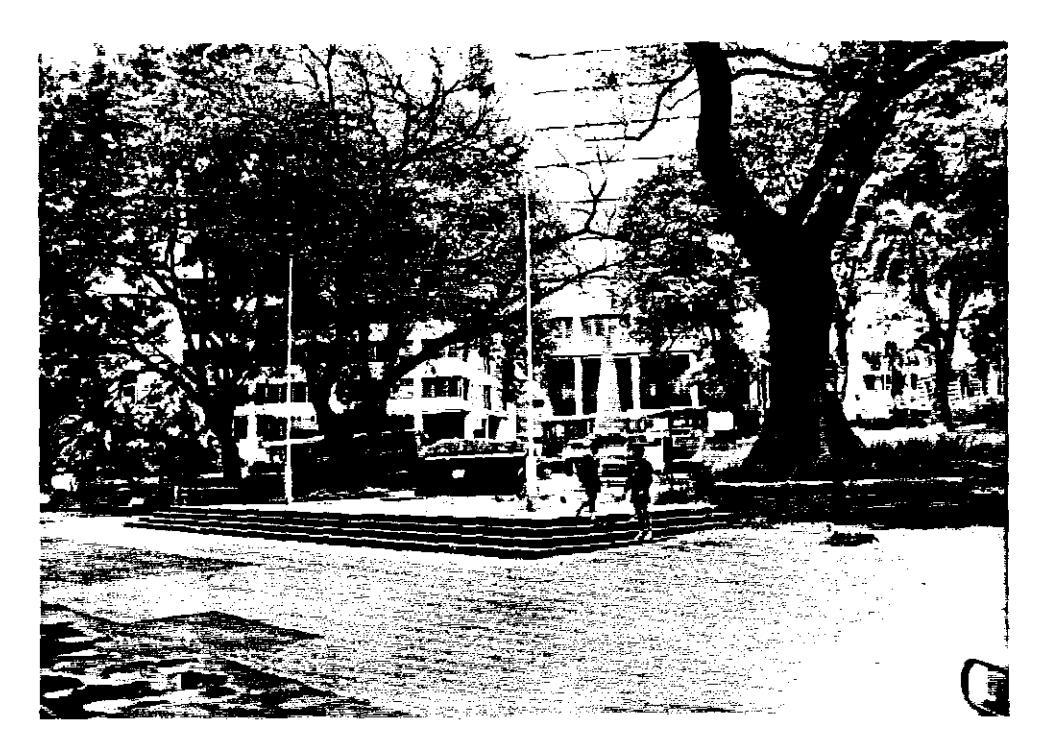
PLATE 4.14

Macquarie Place streetscape is currently in poor condition due to a number of factors. These include:

- The deterioration of recent landscape elements, such as the podium steps and interlocking payers.
- Recent building works along Macquarie Place have necessitated the removal of much of the paving and three street trees. Temporary bitumen pavement is now in place along most of the building frontages.

The orignal character of Macquarie Place has diminished with the inappropriate use of materials and structures (such as the podium).

- The footpaths surrounding the Park that are currently paved with interlocking bricks should be removed and replaced with sandstone flagging or another paving material appropriate to the historic character of the precinct, such as an old style bitumen mix.

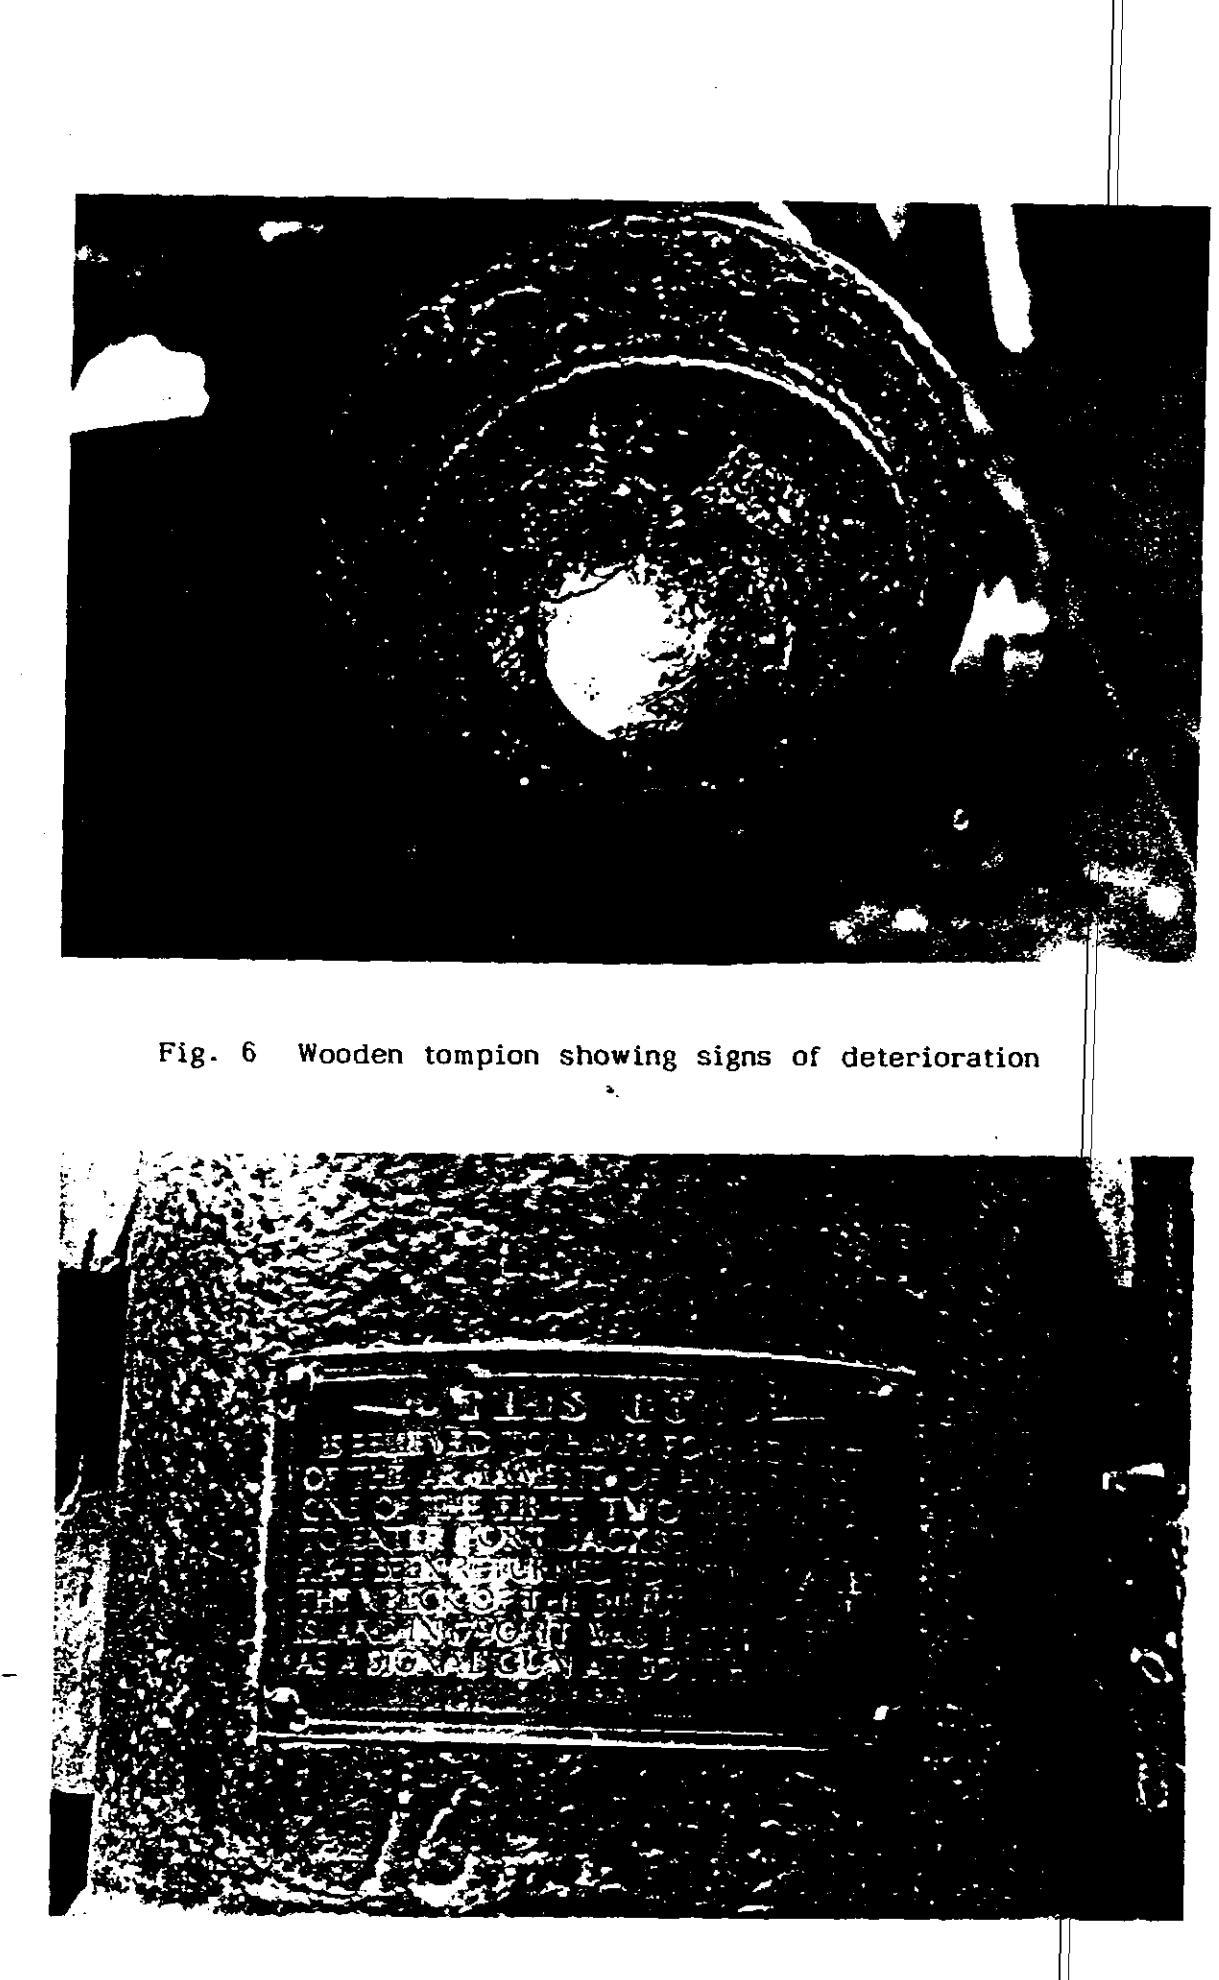
The cannon is of cast iron and has been painted at some stage with a protective coating. The coating system, discussed later, appears to have been very effective in protecting the cannon. There are only a few spots where the top paint layer has lifted. This is seen in Fig. 5. - the red spots near the vent hole are the undercoat. It was not possible to examine inside the barrel without Due to recent heavy rains removing the wooden tompion. this had swollen and would not have been possible to remove without destroying it, necessitating a new replacement (Fig. 6). A brass plaque fixed to the top of the barrel does not appear to have caused any corrosion problems, and although tarnished, is stable from a corrosion point of view (Fig. 7).

Fig. 5 Near the vent hole spots of the black micaceous iron oxide top coat are missing revealing the red oxide under-coat.
