CONSERVATION MANAGEMENT PLAN

171-173 VICTORIA STREET, POTTS POINT

2 JUNE 2020
P0005011
PREPARED FOR OAKSTAND

URBIS

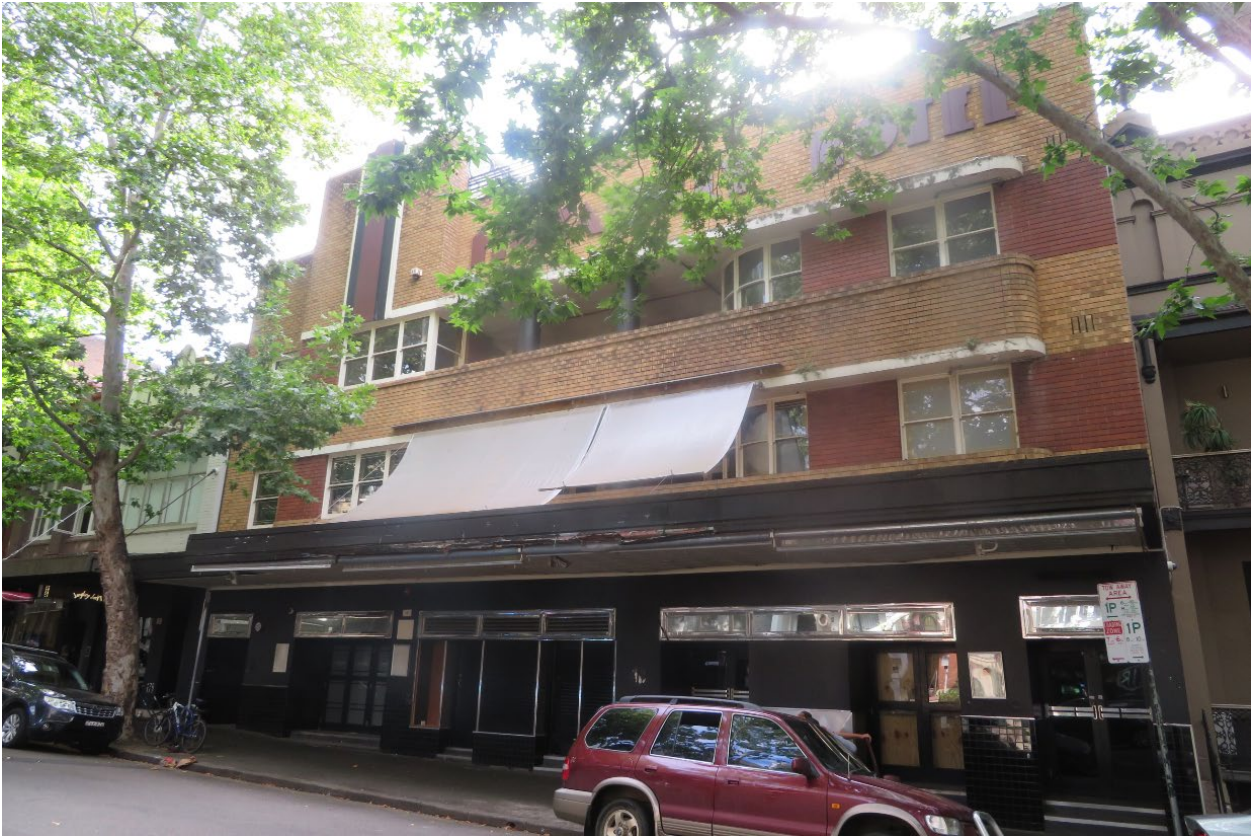
Figure 7 – The eastern façade of the Piccadilly Hotel.

The windows on the first and second floor are all original double-hung, painted timber windows with stripe margins on the glazing. Secondary windows have been installed on the interior. Both the first and second floor balconies have curved windows on the northern end. This is partly obscured from public view by the brick balustrade and minor setback of the curve. This curved feature is also present at either ends of the balustrades and second floor detail. Two fabric awnings have been added above the first-floor balcony that

extend down to the ground floor awning and obscures much of the first floor façade. The ground floor awning has corrugated metal cladding.

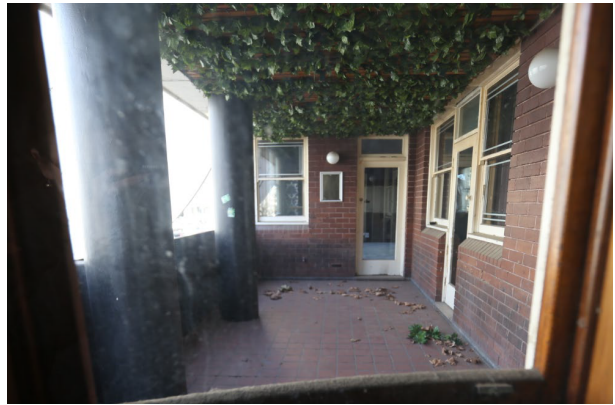
Figure 13 –View of the first-floor balcony (view south).

The balconies both have three doorways (access), concrete support columns, concrete ceilings and floor tiles. The balcony on level one has had a floating ceiling with applied artificial plants. The painted timber doorway and window details are consistent with all other timber windows on the façade.

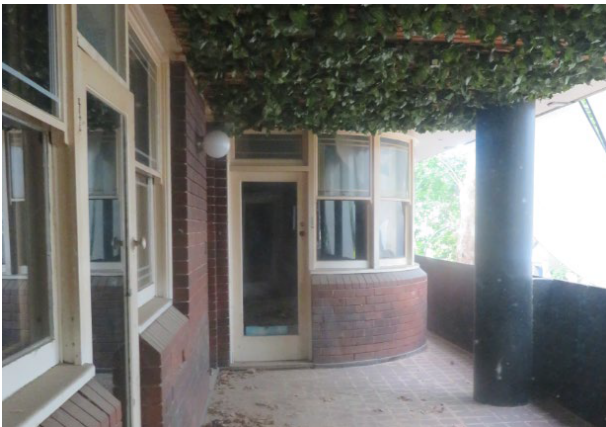
Figure 14 – First-floor balcony (view north)

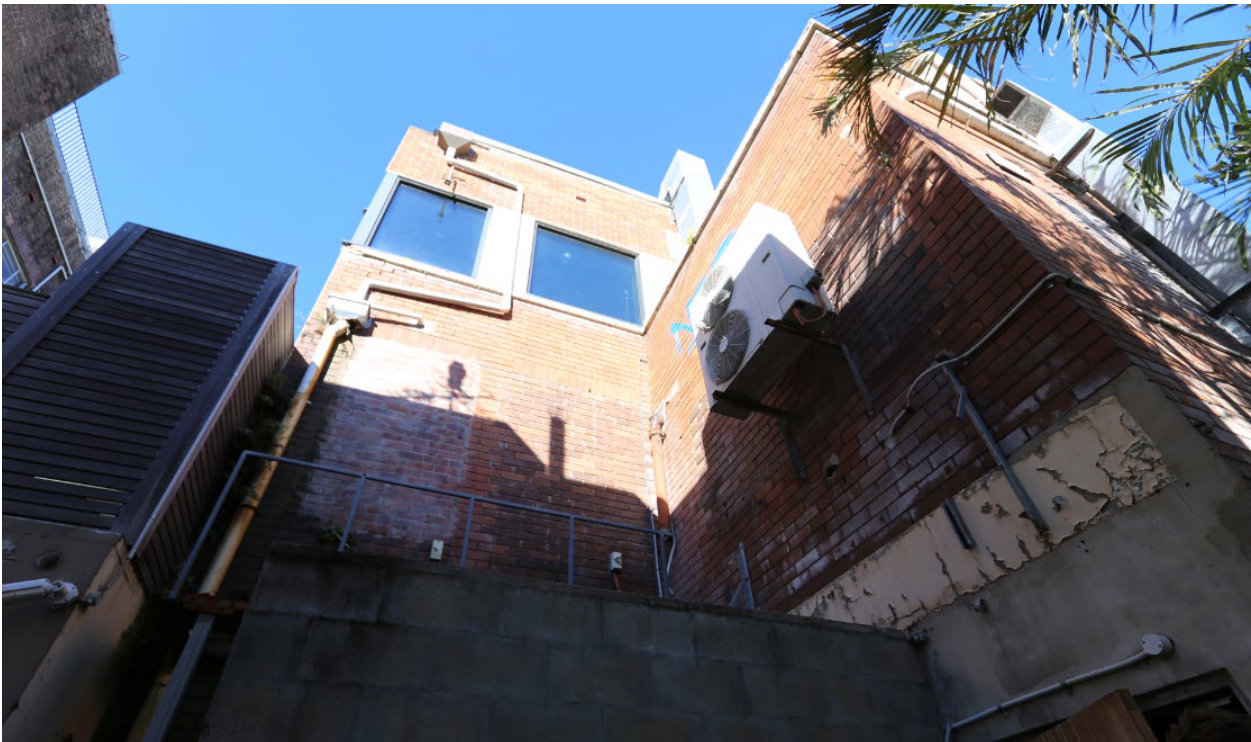
Figure 21 – View of the rear (western) façade of the subject Hotel. View from within the subject site. Note areas of infilled windows on the ground floor. Windows on the second floor were constructed in 1997 as part of the balcony infill.

The rear of the building has been heavily modified with the enclosure of the second-storey, corner balcony and brick-infilled windows which were both undertaken in 1997. There are numerous services attached to the rear, including air conditioner vents and units. Some remnants of “Piccadilly Hotel” bas relief signage, in a characteristic Art Deco style font, is visible at the top, right corner of the western façade. This signage however is only visible from the carpark at No. 100 Brougham Street and is visually obstructed by the dwellings located directly in front.

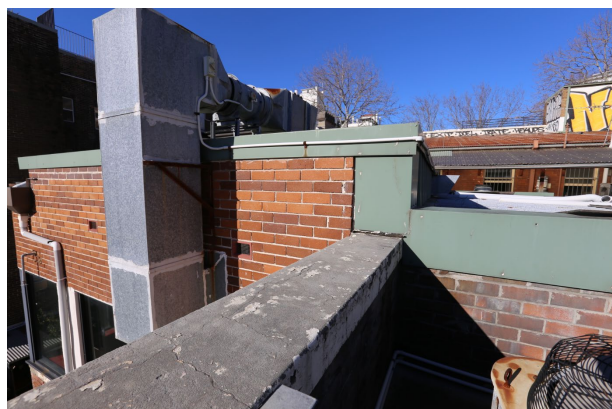
Figure 24 – View of the later infill (former rear balcony) on the first floor in 1997.

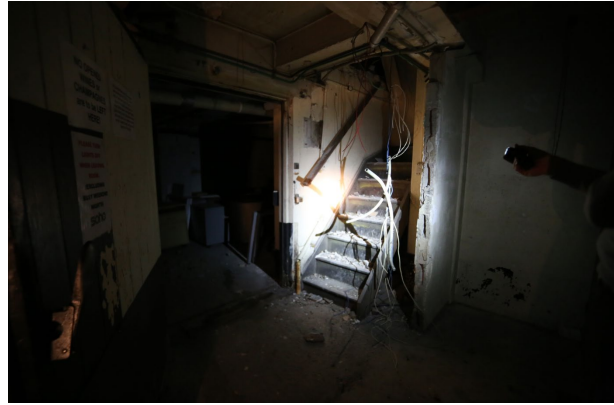
Figure 30 – Original stairs located in the centre of the basement. Leading to the ground floor bar (staff access).

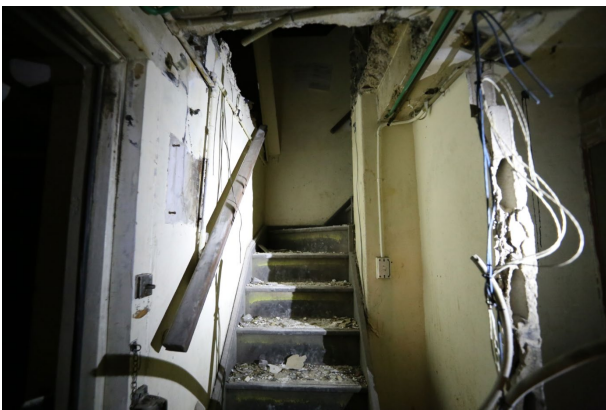
Figure 31 – Original staircase providing access to ground floor.

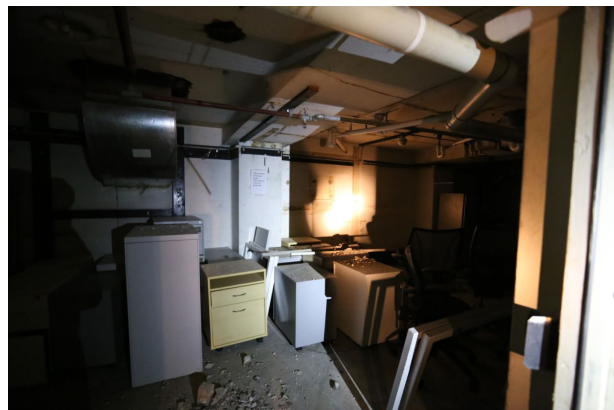
Figure 32 – Non original cool room located on the northern side of the basement.

Like most of the hotel, the basement has been stripped of most fabric, however core features, such as the cool room doors and keg shoot have been retained. The cool rooms are not original and were installed later in 1953. Other areas of fabric that have been retained include some floor tiles (in the south-west corner of the basement) from an original men's bathroom and timber, double hung windows on the western wall. These windows however (located on the western wall) have been blocked. Remnants of a stair well and stairs are also present in the south-west corner and adjacent to the cool room in the north-east corner. Overall, the basement has been altered significantly over time to accommodate various uses, including car parking, storage, cool room, bathroom, cloakroom and office spaces.

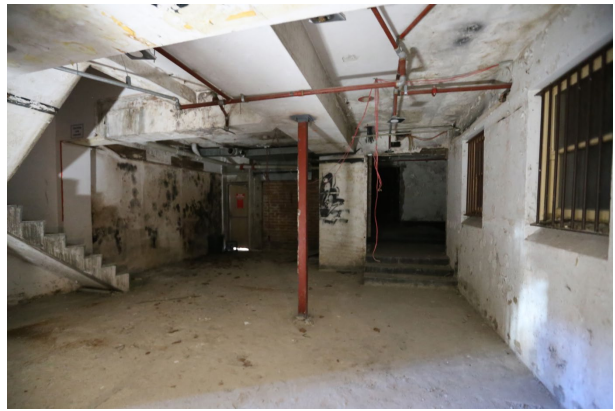
Figure 43 – Former stairwell to ground floor (former bathrooms).

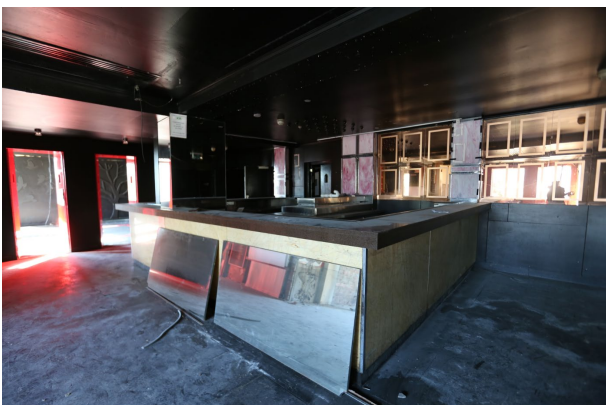
Figure 80 – Remnant cornice, painted recently.

Other original features on the first floor include small sections of architraves, timber paint rails, brackets skirting boards and some areas of floorboards (in the rooms and hallways on the eastern side). The bar in the centre of the floor is located in the original location, however it is likely to have been replaced. Contemporary wall and floor finishes (paint and wallpaper), bathroom, bar and kitchen fitouts were also installed (likely during the 1990s refurbishment).

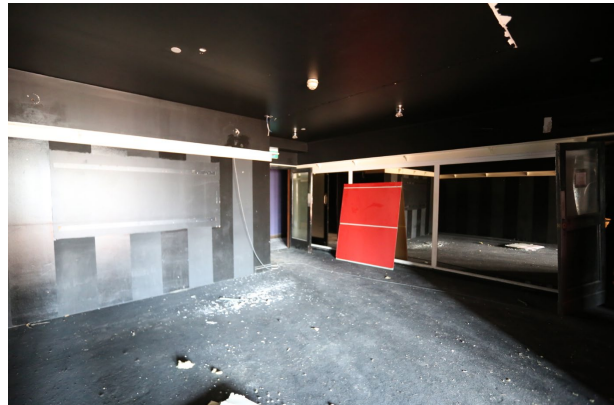
Figure 85 – Bar area., contemporary fitout and finishes.

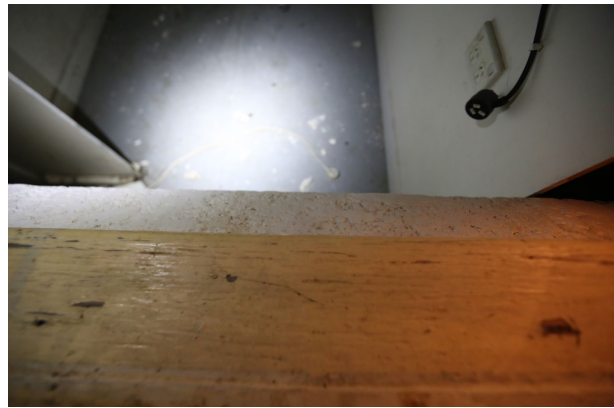
Figure 97 – Infilled lightwell on the first floor.

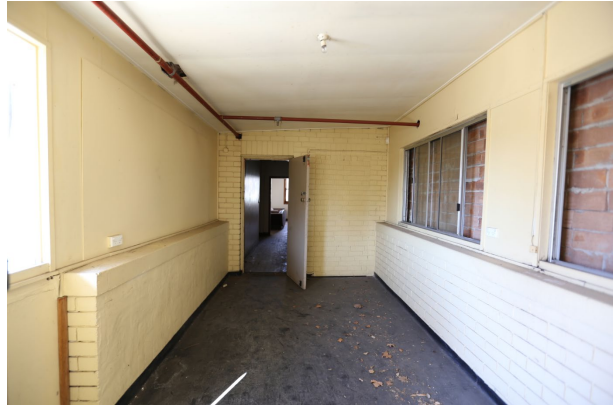
Figure 114 – View west into a later infill between an original small laundry room. The original external brick walls can be seen with lightweight walls placed above.

In the south-west corner of level two, an area of later infill connects the former laundry room with the main building. This provides access to the open roof top.

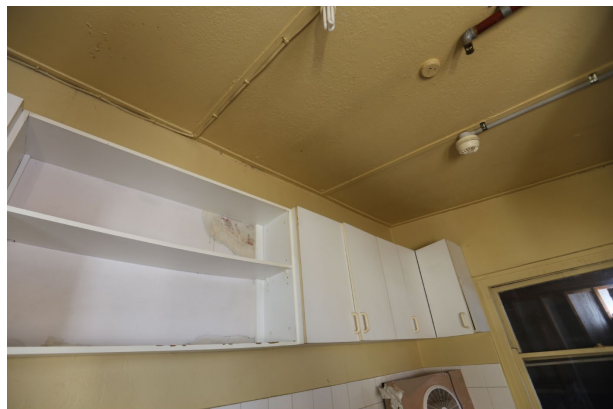
Figure 116 – Recent kitchen, believed to have originally been a laundry room.

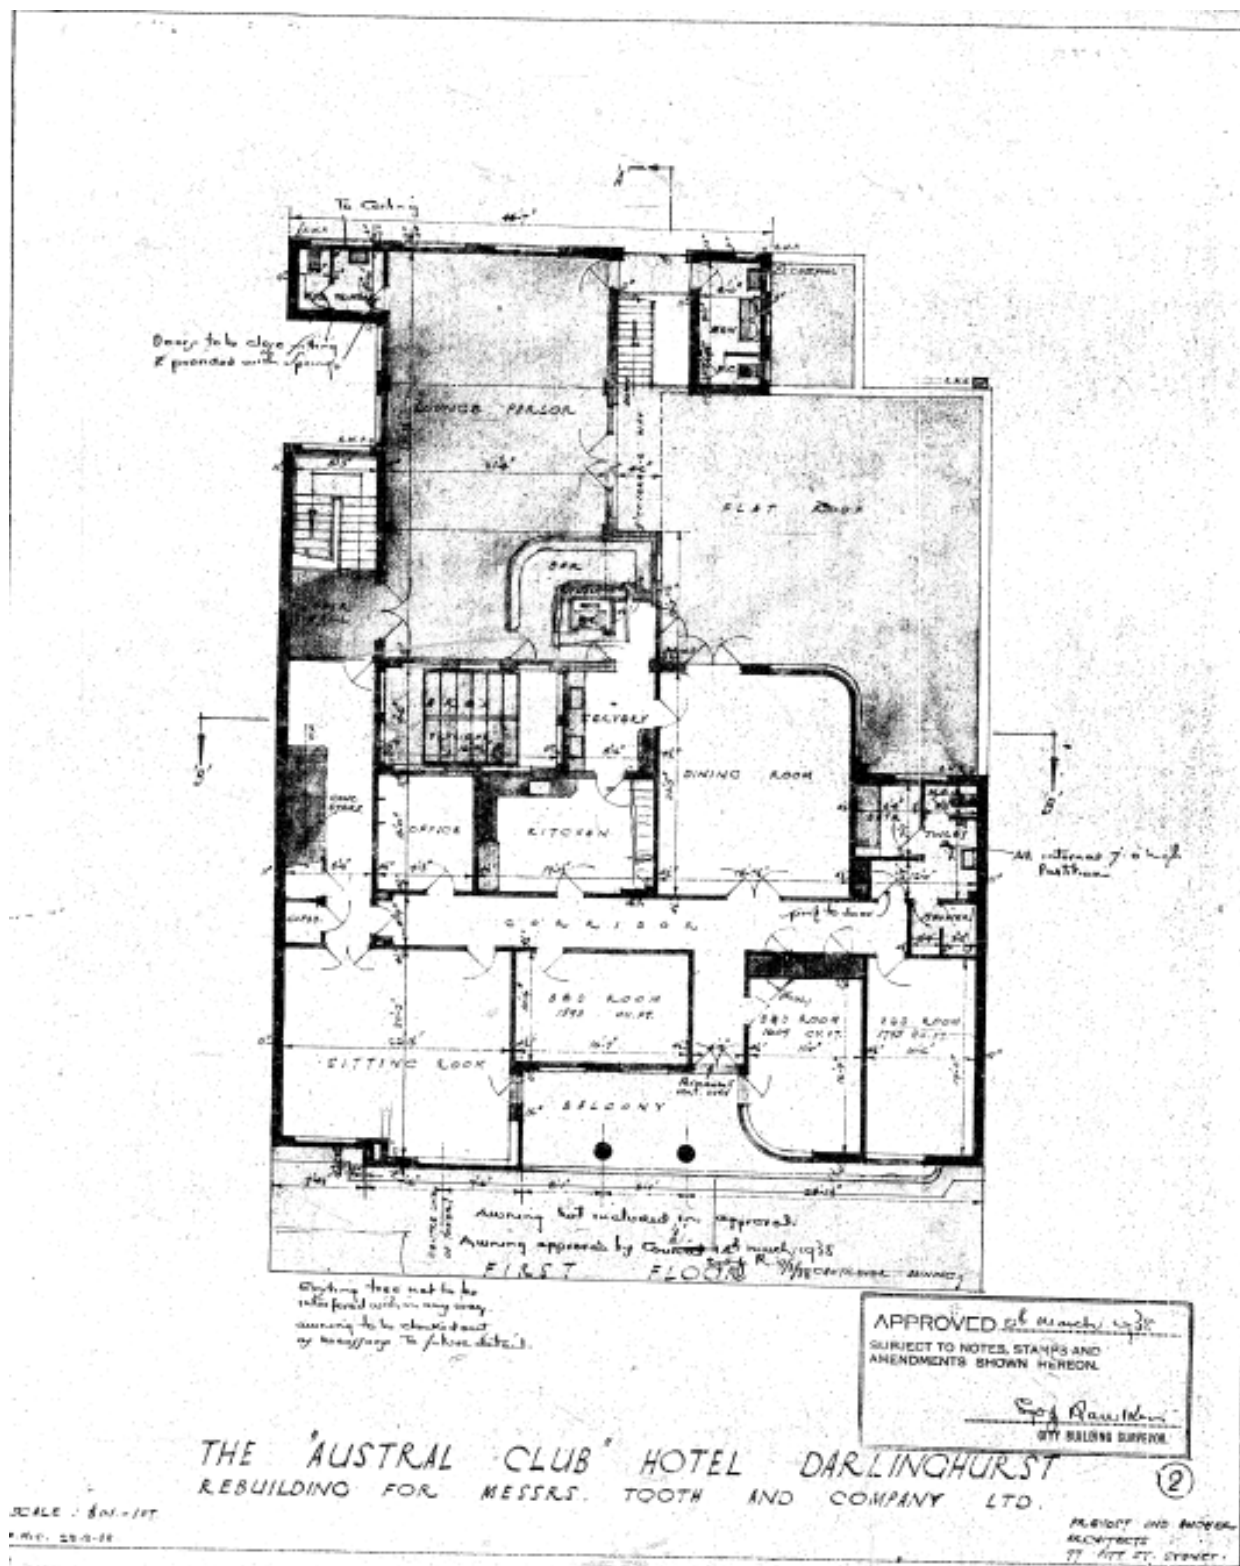
Figure 124 – Original first floor plan. Approved in 1938.

The subject hotel was designed in the Inter War Functionalist Style by the prominent architects Prevost and Anchor. The Yellow Card records indicate that Tooths purchased the property in July 1936. The original plans were approved in 1938 by the City of Sydney. At this time, it was intended to retain the name, "The Austral Hotel" for the site. However, at the time of opening, the Hotel had been renamed the Piccadilly Hotel. The upper levels of the hotel were used for residential accommodation. The yellow cards indicate that the hotel provided accommodation for 6 single rooms however the plans included below show 12.

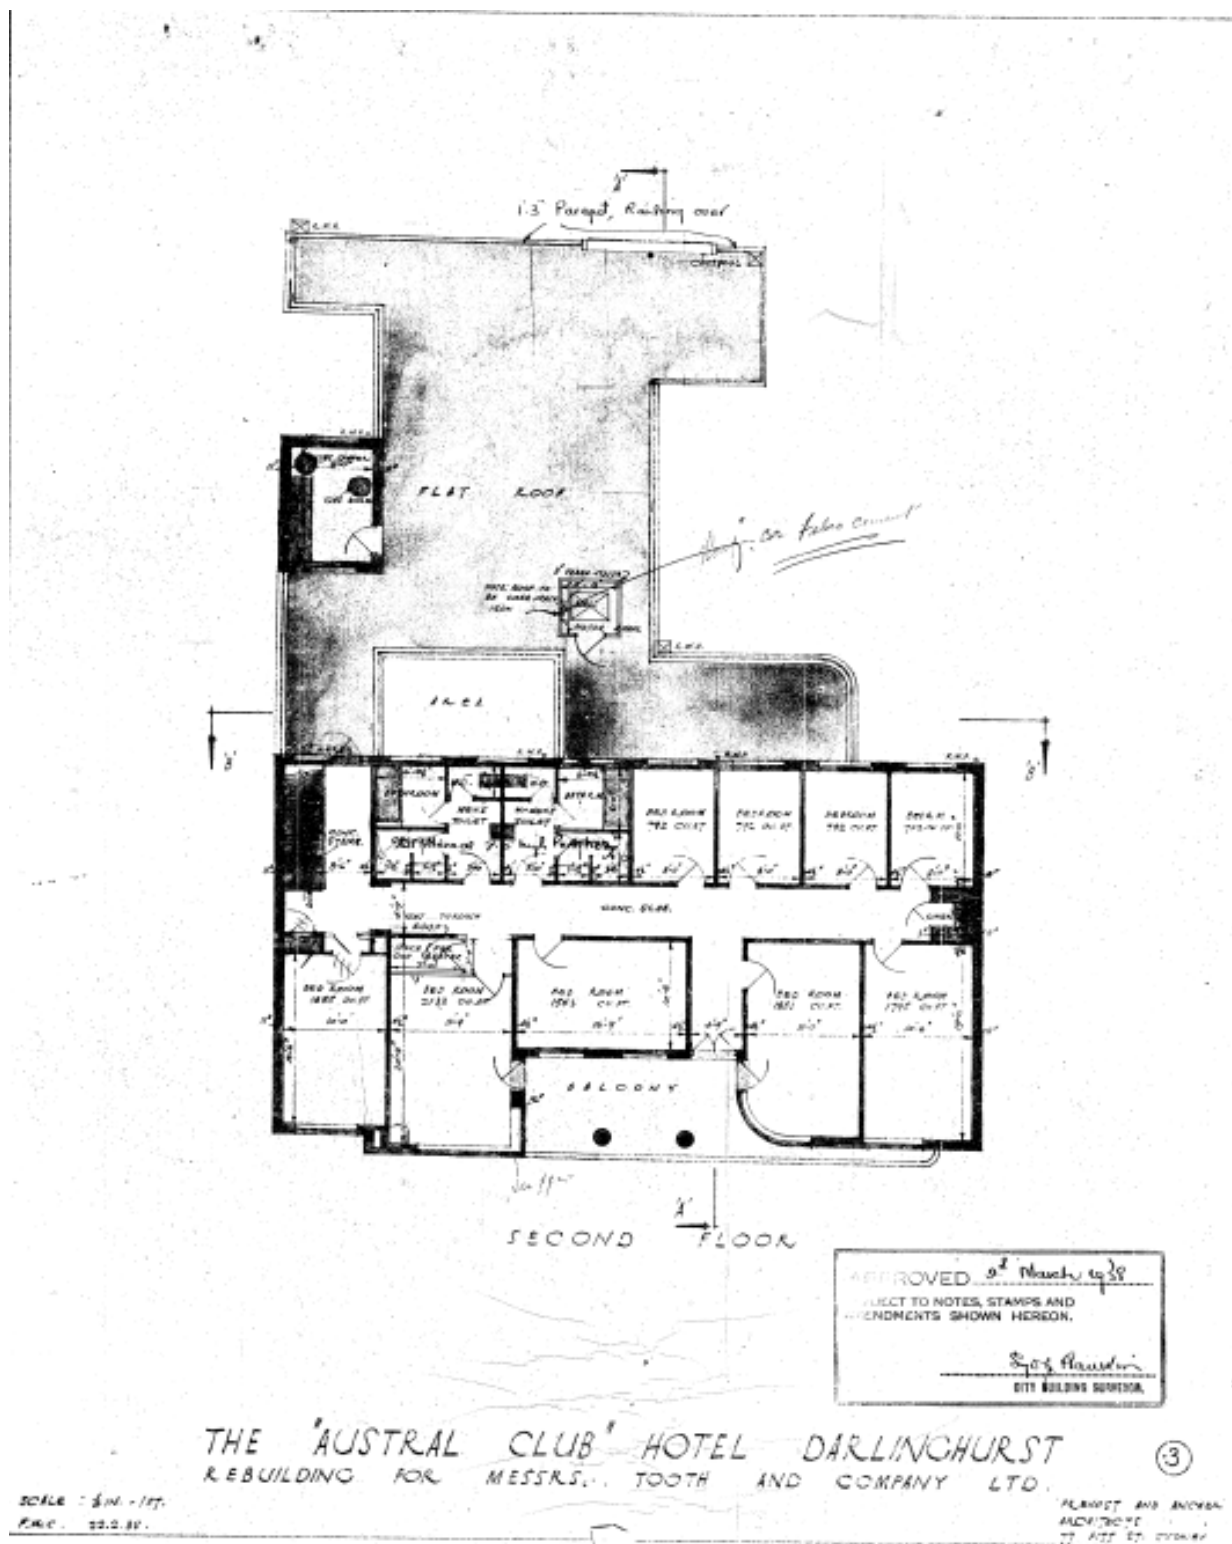
Figure 125 – Original second floor plan. Approved in 1938.

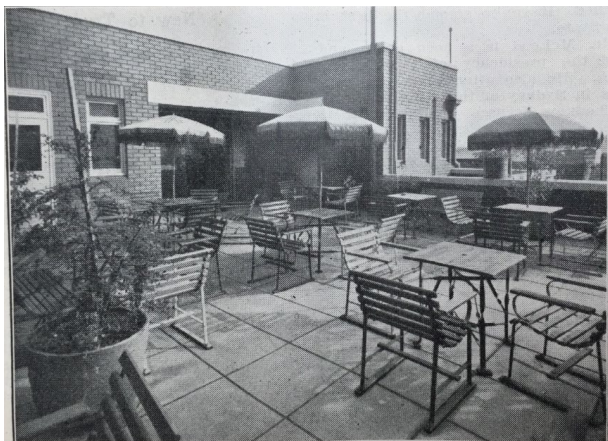
A popular feature of the Piccadilly Hotel, in Victoria Street, Darlinghurst, is the accommodation provided for having a drink in the open on the roof, as shown in the picture above. Provision was made for this activity when the hotel was rebuilt.

Figure 127 – Original outdoor balcony.

These photographs show two areas that have largely changed since 1940, including the complete infill of the outdoor balcony (Figure 127) during the 1990s. The other photograph shows the original design intent of the first-floor bar/restaurant with booth seating and curved bar in the top left corner. Neither of these features have been retained.

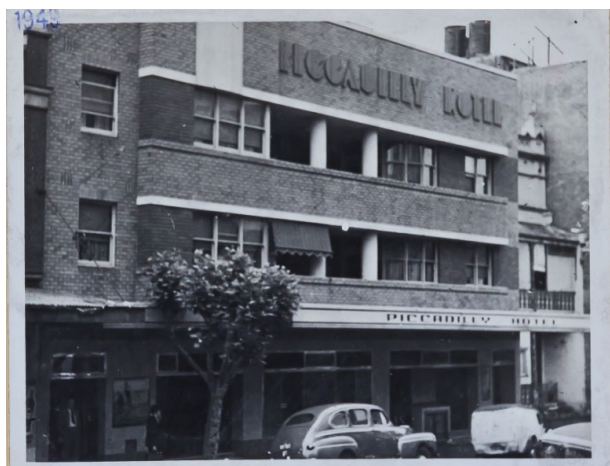
The following photographs of the exterior are from the Tooth & Co. yellow cards from 1949 and 1960. They both represent the original appearance of the ground floor façade with lighter colours (tiles) and what is likely to be a Tooth & Co. poster.

Figure 129 – Piccadilly Hotel, 1949.

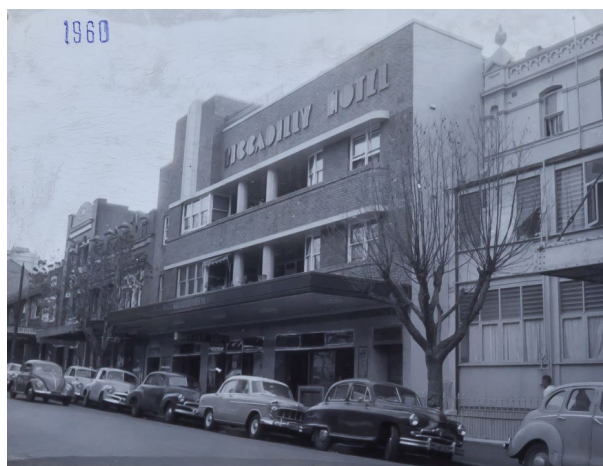
Figure 130 – Piccadilly Hotel, 1960.

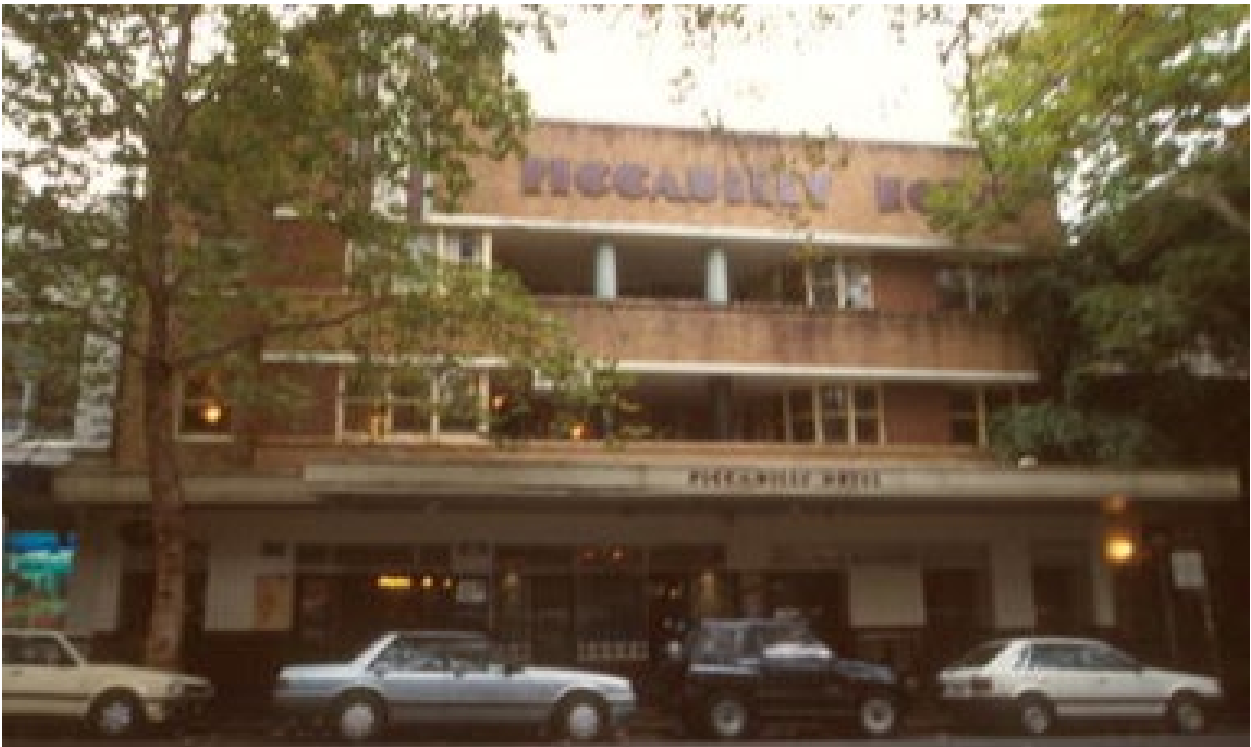
Figure 133 – The eastern façade of the Piccadilly Hotel in 2000. Prior to the ground floor façade works.

- Alterations to the design and finishes to both the interiors, on the ground and first floor and to the eastern façade on the ground floor.
- Removal of original details and fixtures, including the ground floor and first floor bar. While a bar has been retained on the first floor in the same location, the detail and overall design differs from the existing.
- Construction of a roof over existing balcony first floor (enclosure of existing beer garden on first floor) and new bar to the proposed.

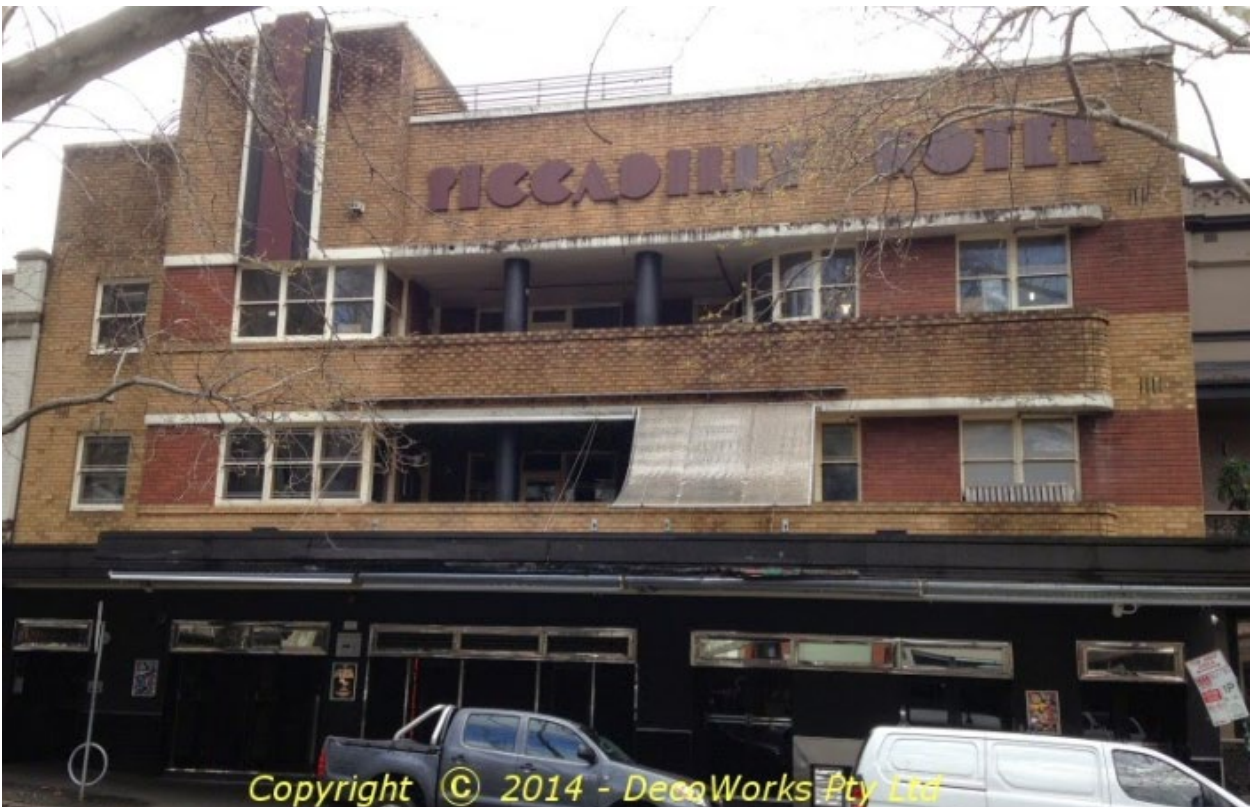
Figure 134 – The eastern façade of the Piccadilly Hotel in 2014. After the ground floor façade had been altered and awnings installed above the first-floor balcony.

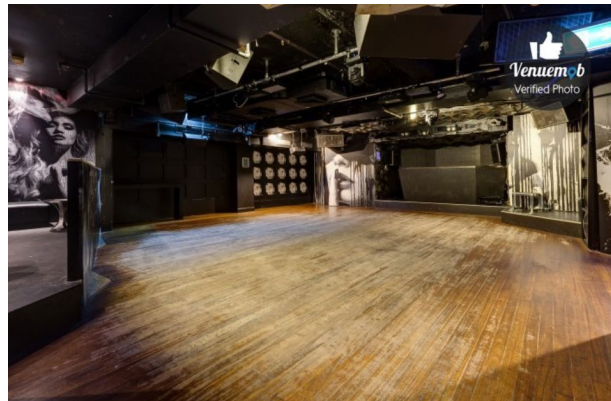
Figure 136 – Northern side of the ground floor, dance room/area with a DJ booth at the rear. These floorboards have been removed.

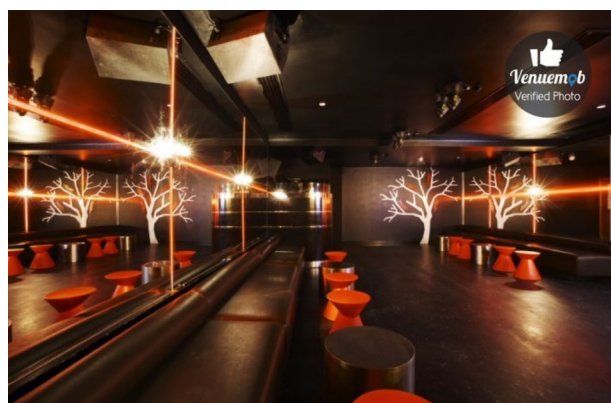
Figure 138 – View across bar area showing contemporary fitout.

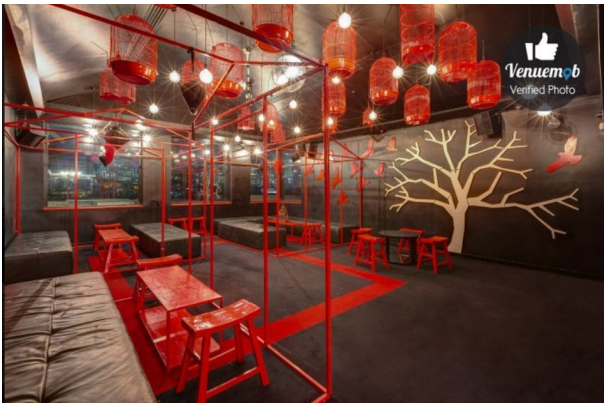
Figure 139 – View across bar area showing contemporary fitout.

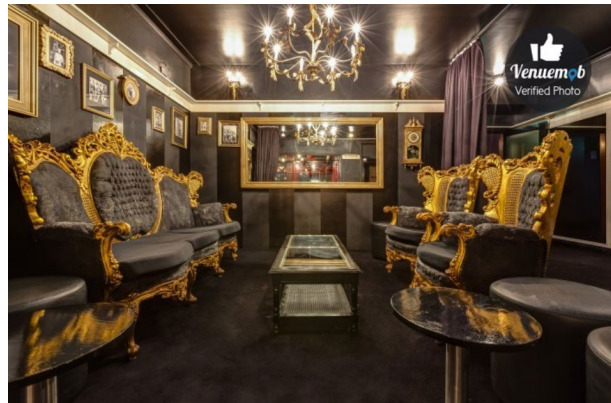
Figure 140 – View east within, room off the infilled area (former terrace) with original paint rail painted white and other new finishes.

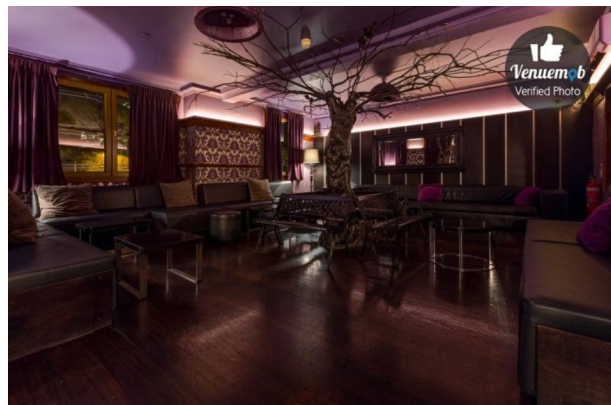
Figure 142 – View south-east on the first floor. Remnants of the wall paper and paint have been retained but other fixtures and features have been removed.
