BELMORE PARK

DRAFT PLAN OF MANAGEMENT

NOVEMBER 1993

EDAW (Aust) Pty Ltd 551 Pacific Highway ST LEONARDS NSW 2065

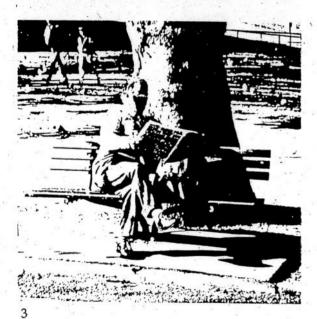
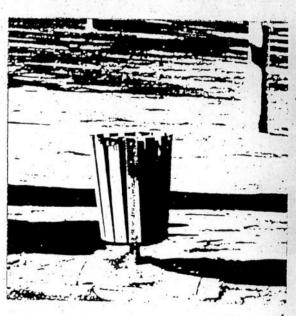
- 1 Bandstand
- 2 Lighting in 1920, and in 1990
- 3 Seating
- 4 Rubbish Bins
