Policy for the Management of Warehouse/Courtyard Complexes in Central Sydney

CITY
OF SYDNEY

Adopted by the Council of the City of Sydney on 12 November 2001 and the Central Sydney Planning Committee on 8 November 2001.

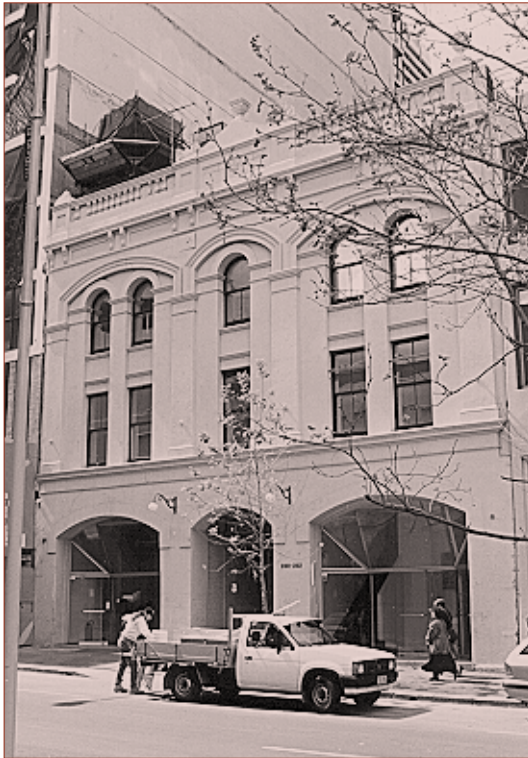
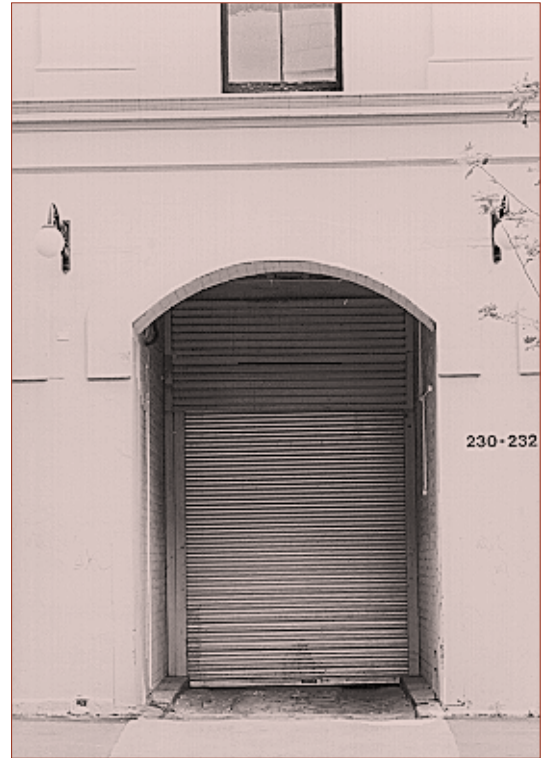
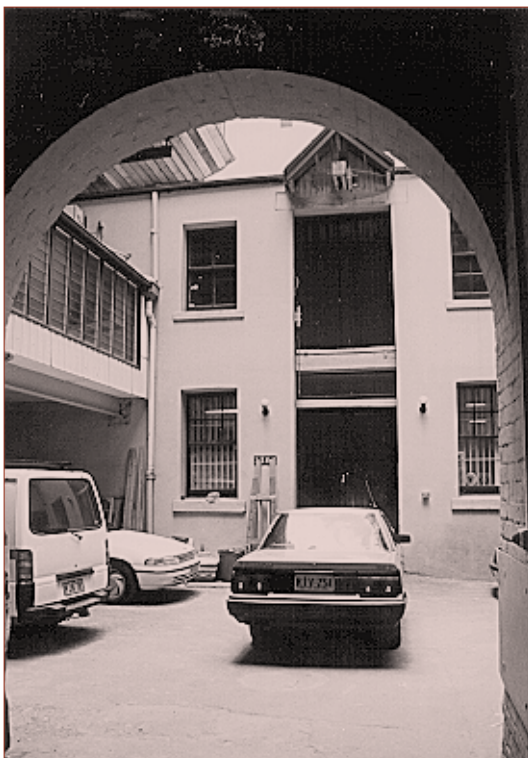
Inventory N°: 8107
Name: Former Foley Brothers Warehouse
Address: 230-232 Sussex Street

Former Warehouses retaining intact Cartways/Courtyards

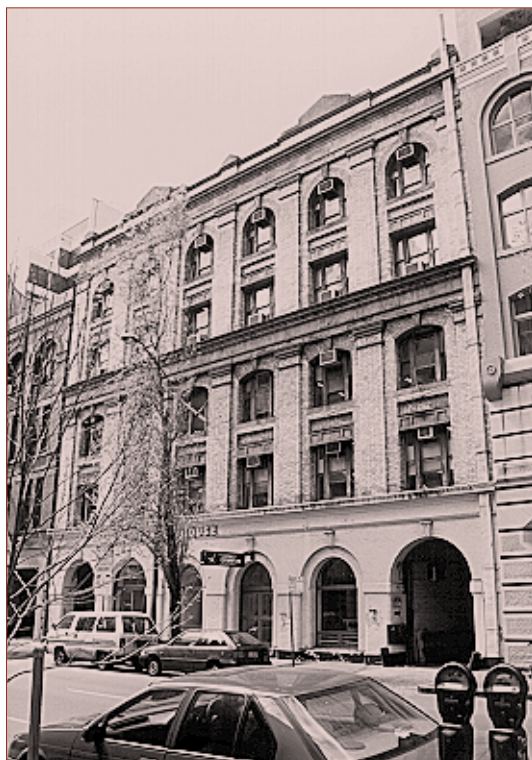
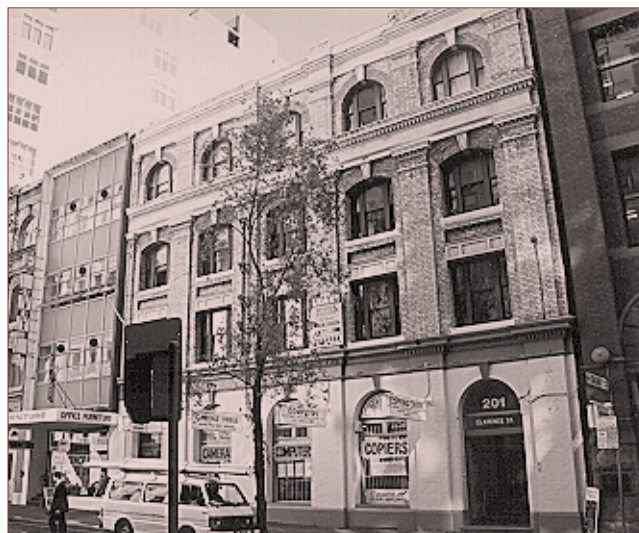
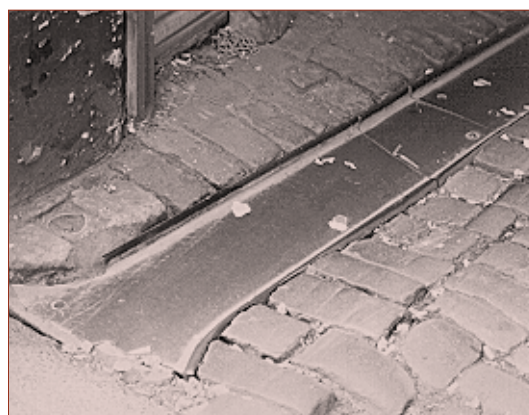
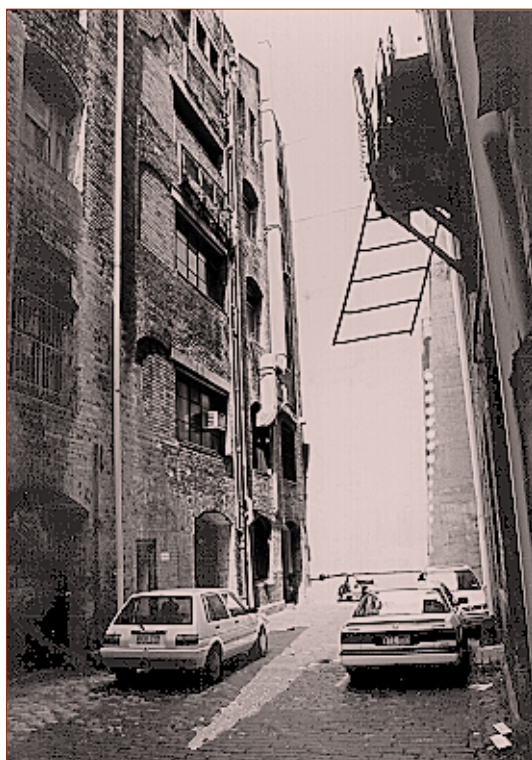
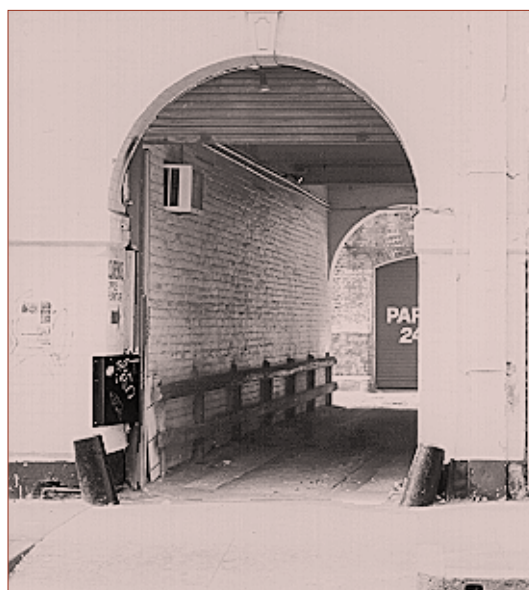
Inventory N°: 4045/4010/4011
 Name: Letraset House/Guide House
 Address: 346-348 Kent Street/201-207 Clarence Street

Former Warehouses retaining intact Cartways/Courtyards

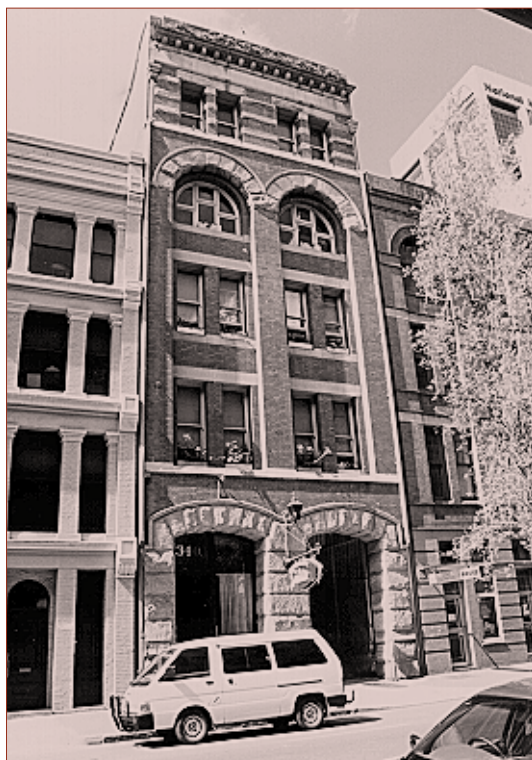
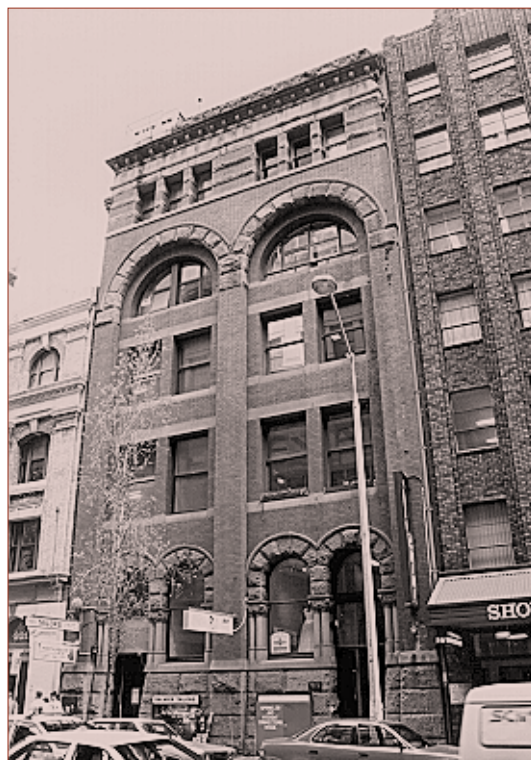
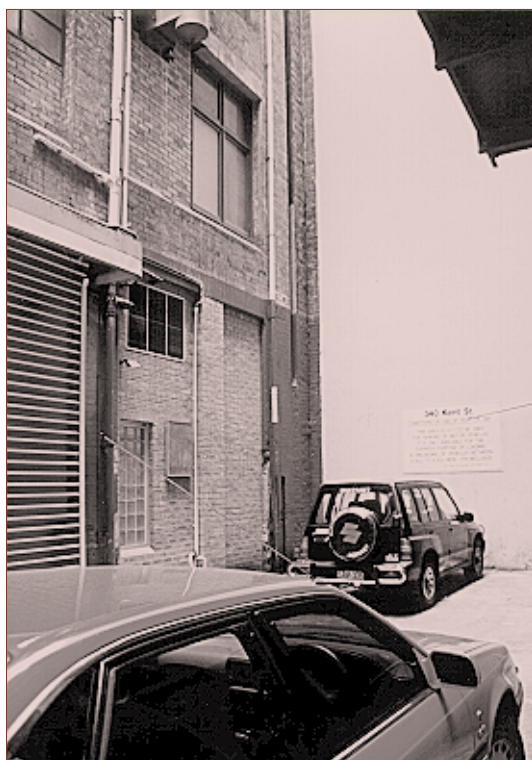
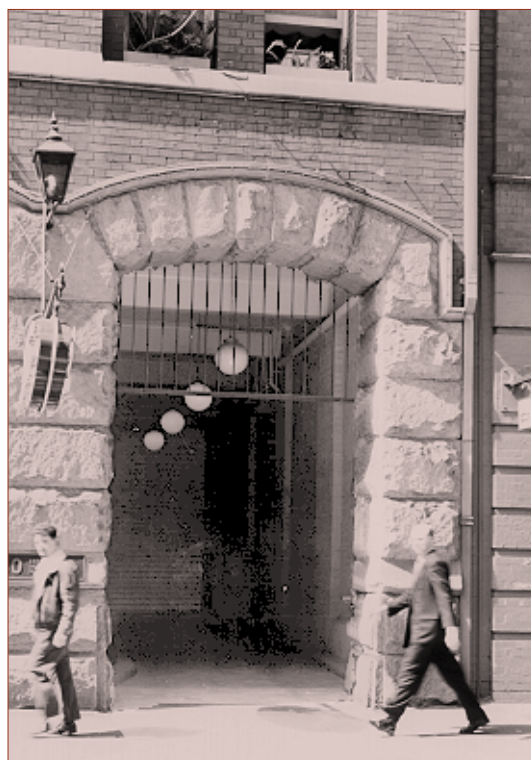
Inventory N°: 4043/4008
Name: Subito/Guild House
Address: 340 Kent Street/ 1 97- 1 99 Clarence Street

Former Warehouses retaining intact Cartways/Courtyards

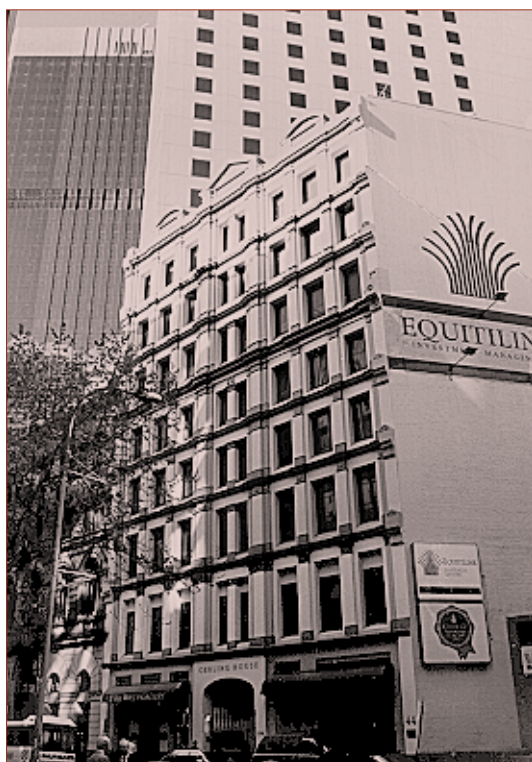
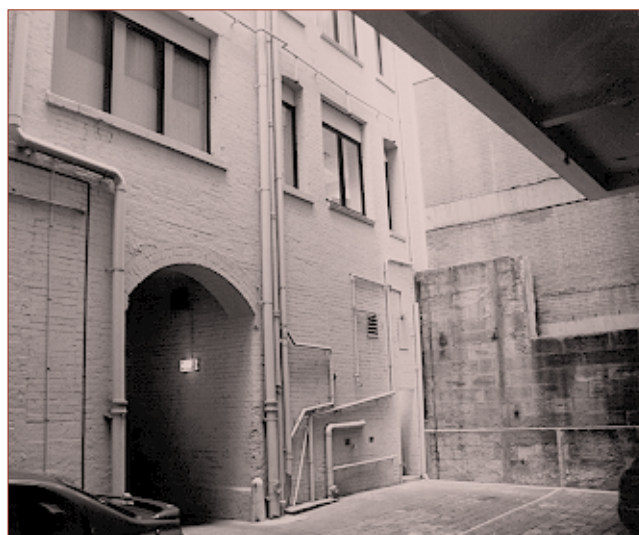
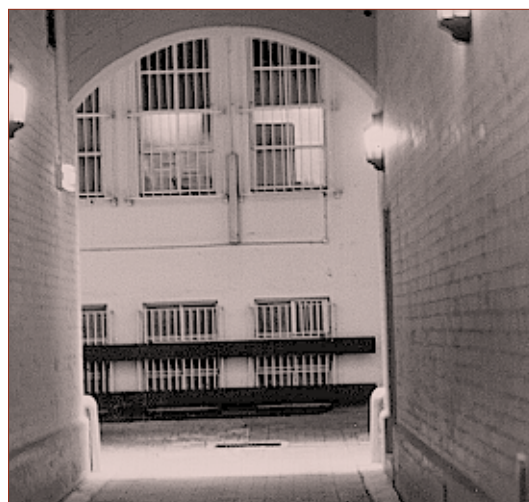
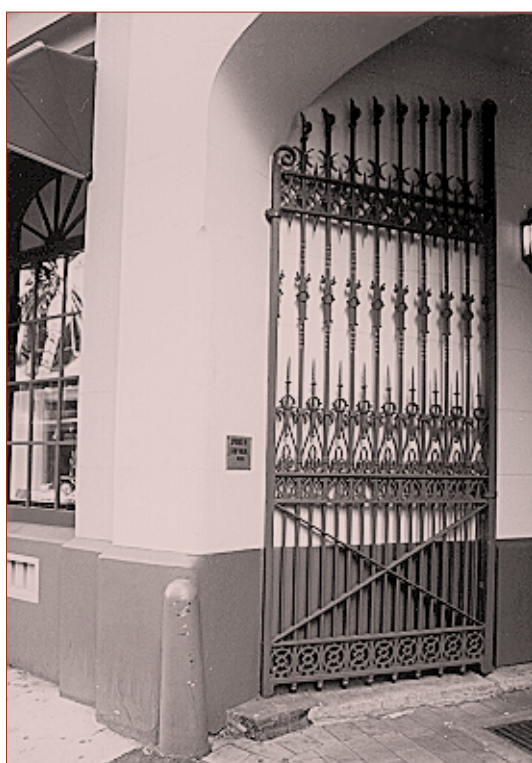
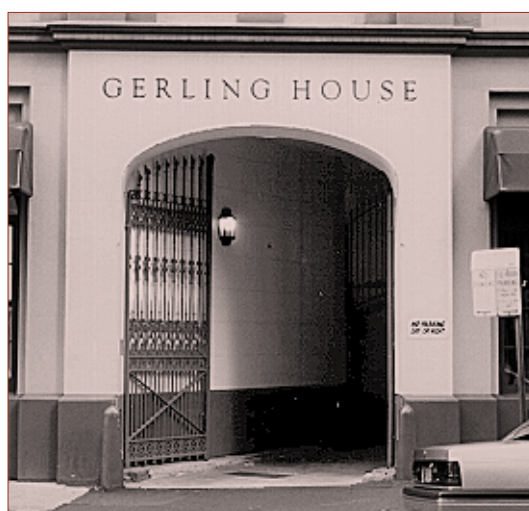
InventoryNº 2139
 Name: Gerling House
 Address: 42-44 Pitt Street

Former Warehouses retaining intact Cartways/Courtyards

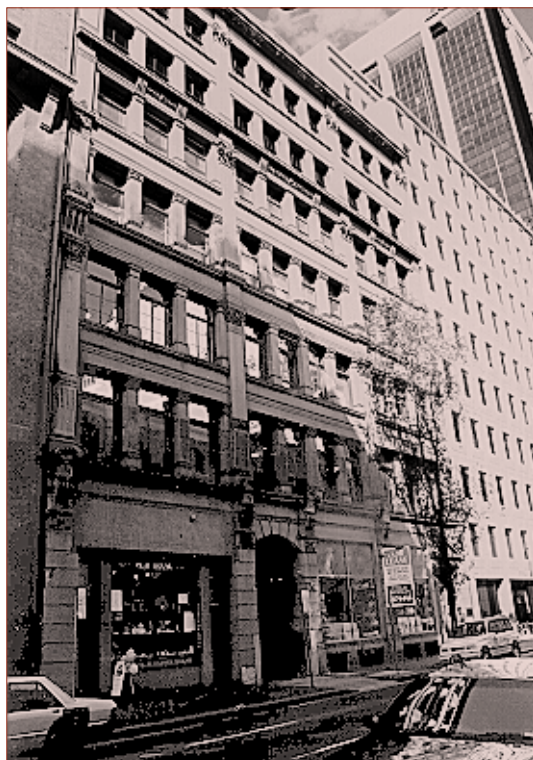
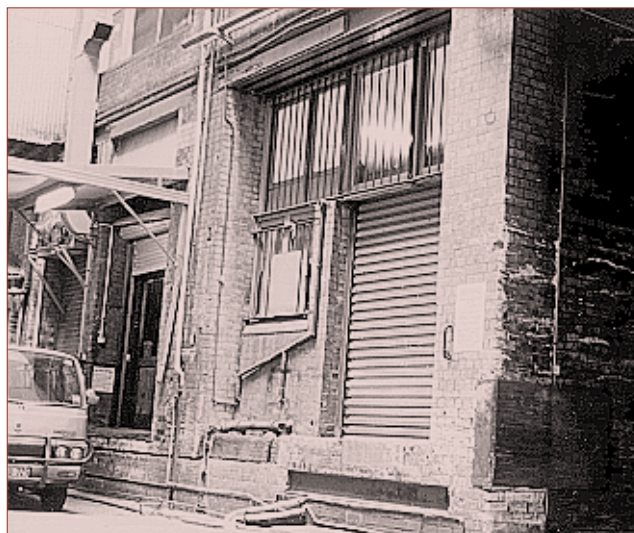
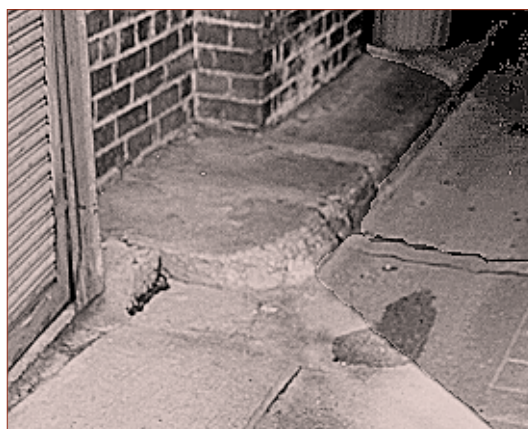
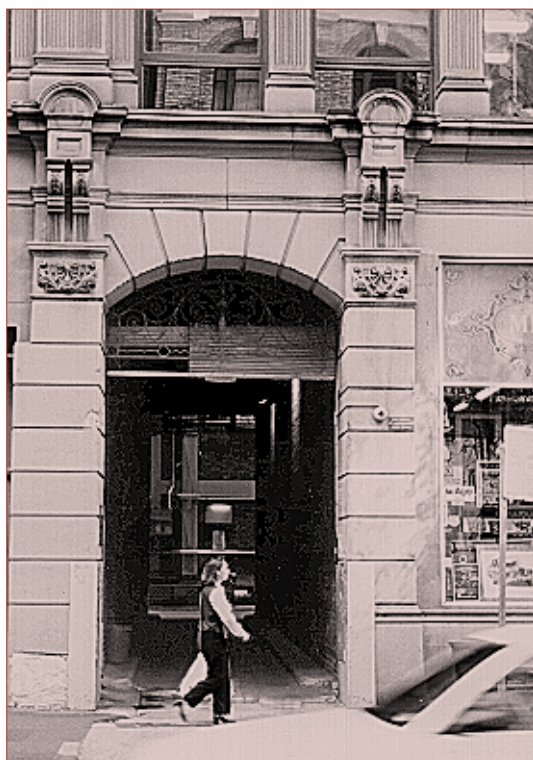
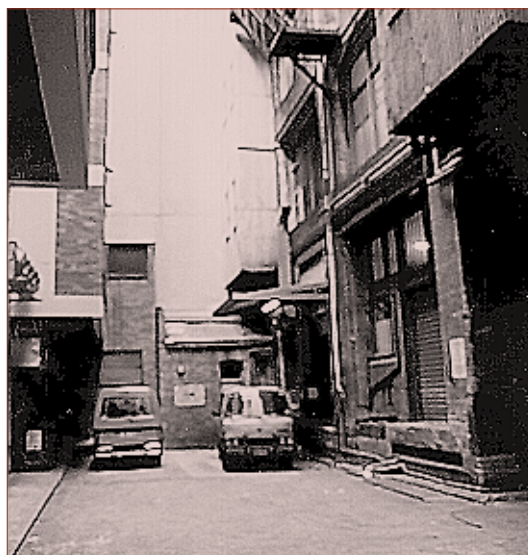
Inventory N°: 4005
Name: Clue Clothing Company
Address: 152-156 Clarence Street

Former Warehouses retaining intact Cartways/Courtyards

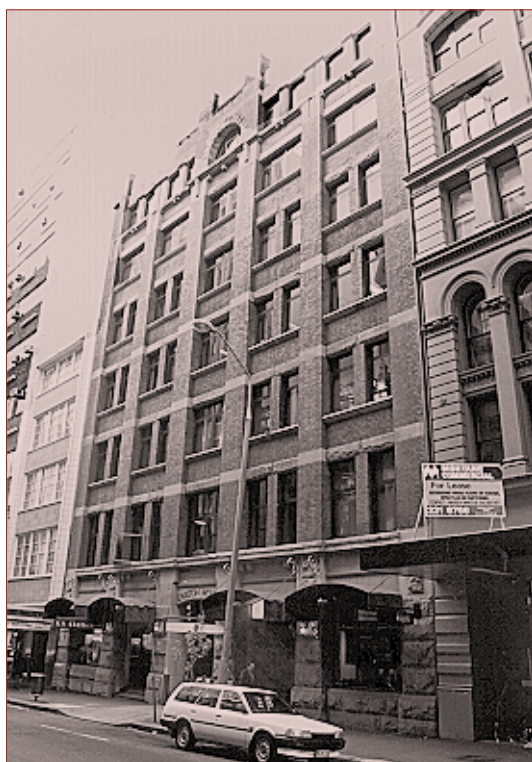
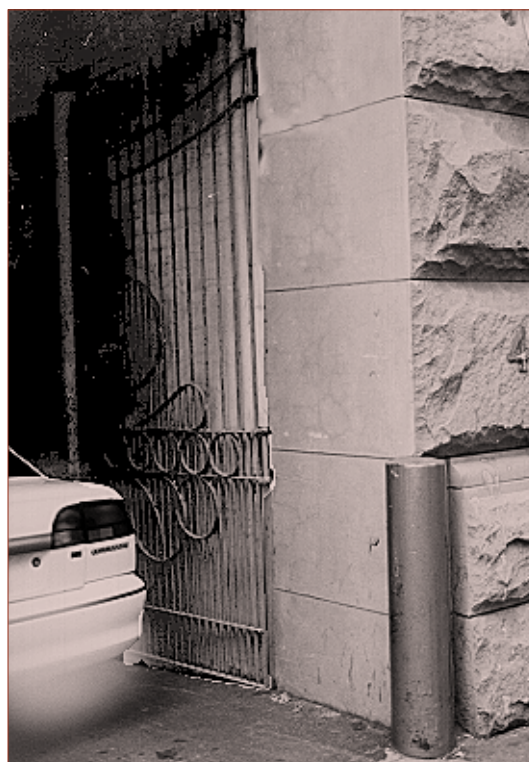
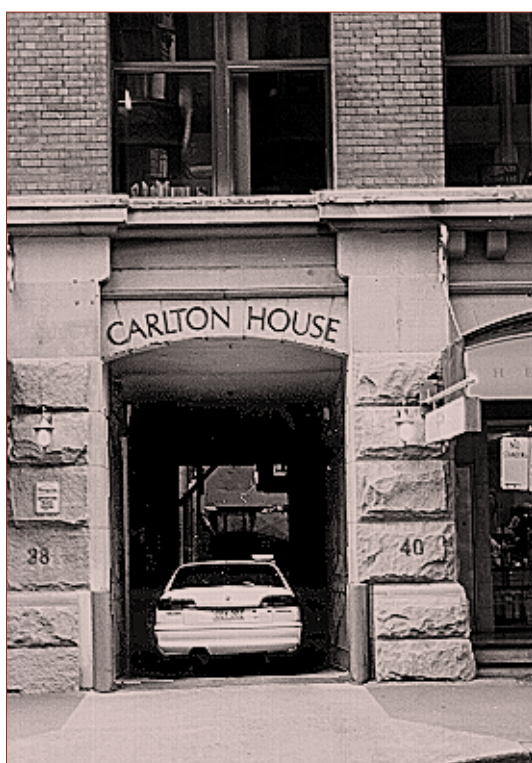
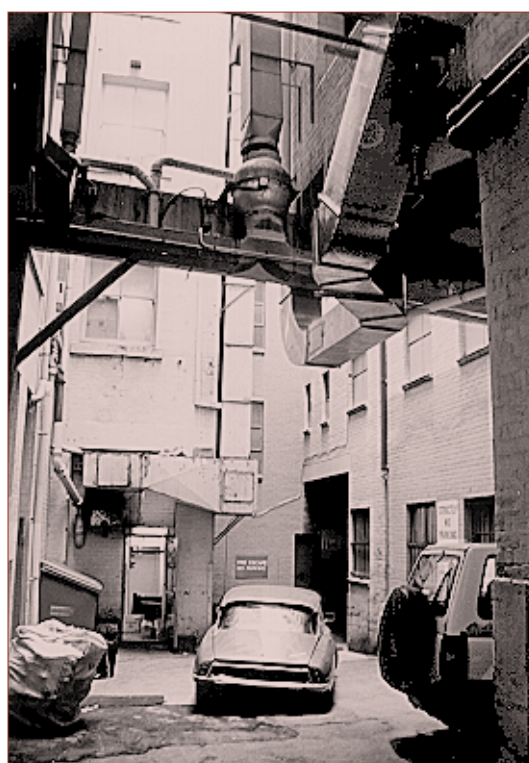
Inventory N°: 4083
Name: Carlton House
Address: 38-44 York Street

Former Warehouses retaining intact Cartways/Courtyards

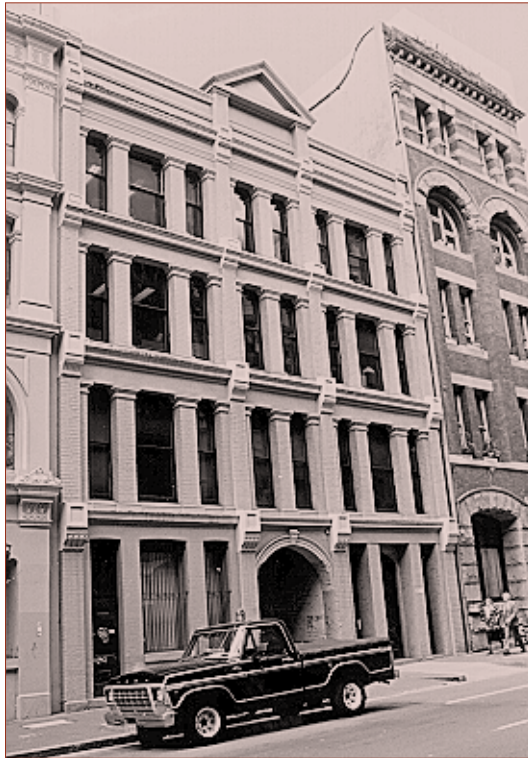
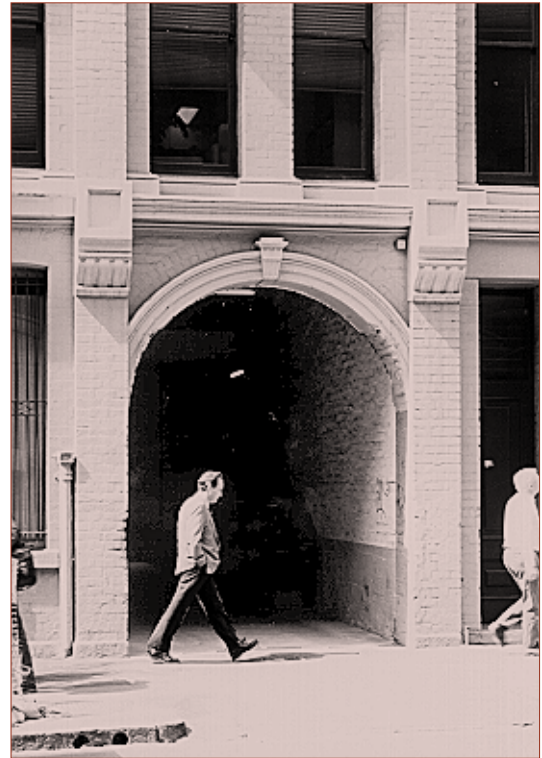
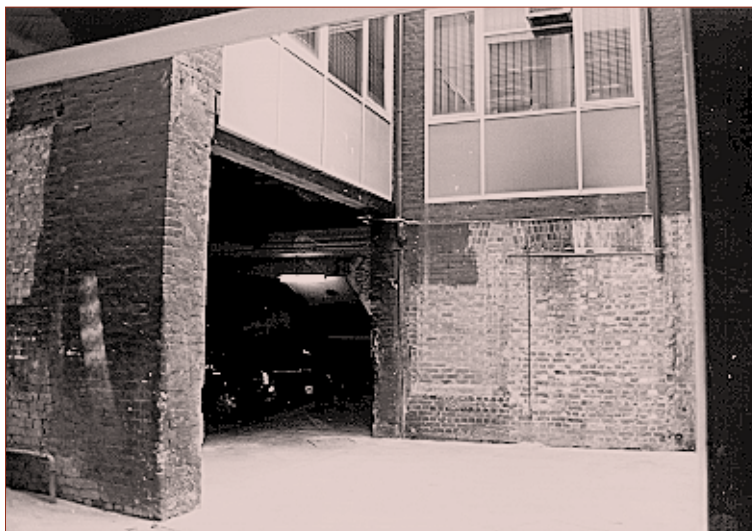
Inventory N°: 4042 0''
Name: Former Warehouse
Address: 336-338 Kent Street

Former Warehouses retaining intact Cartways/Courtyards

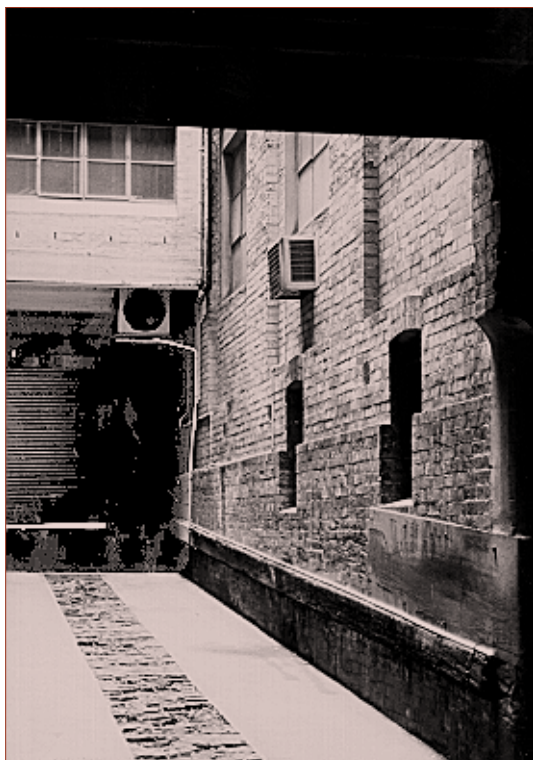
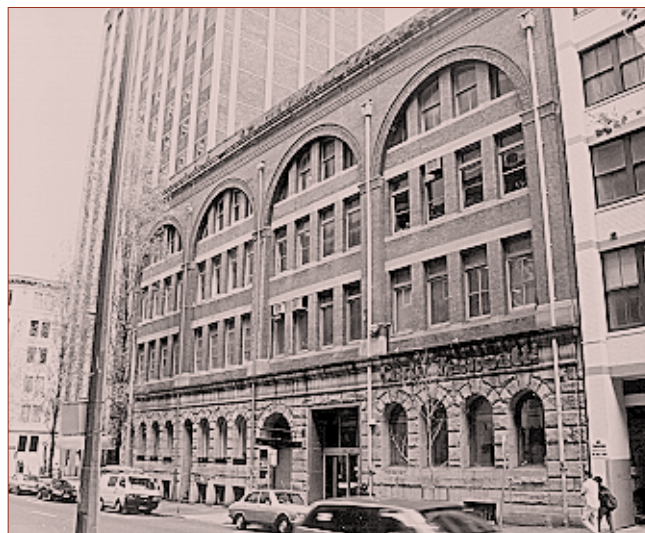
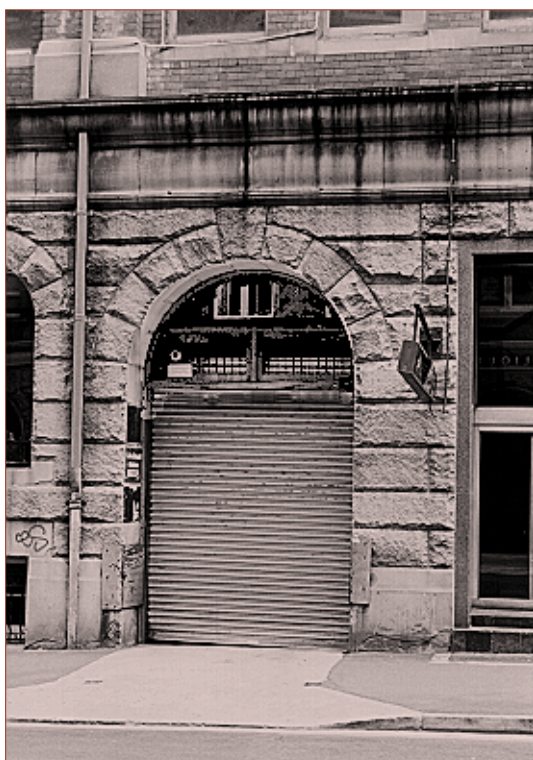
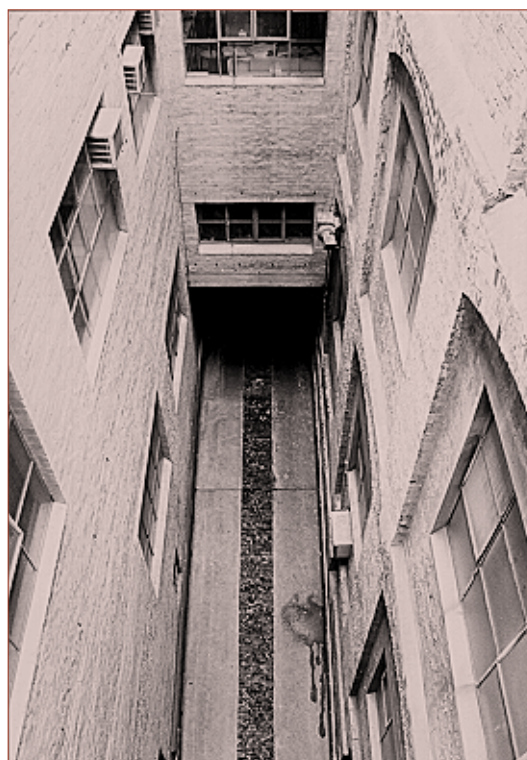
Inventory N°: 4053
Name: Caria Zampatti
Address: 435-441 Kent Street

Former Warehouses retaining intact Cartways/Courtyards

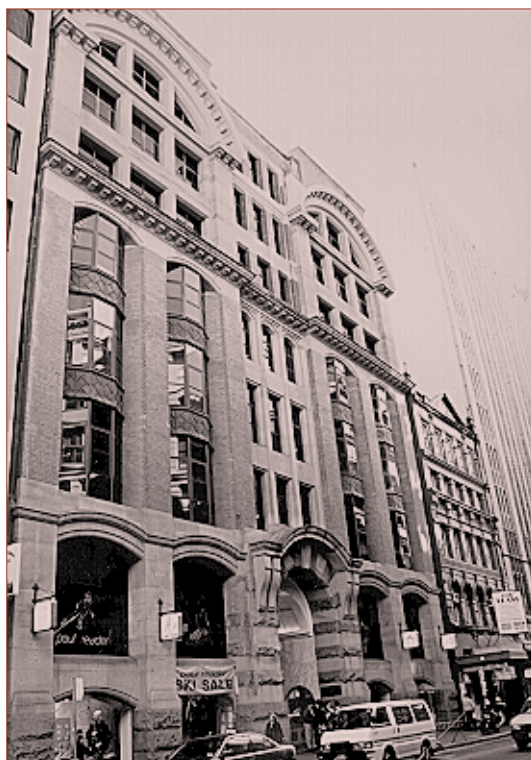
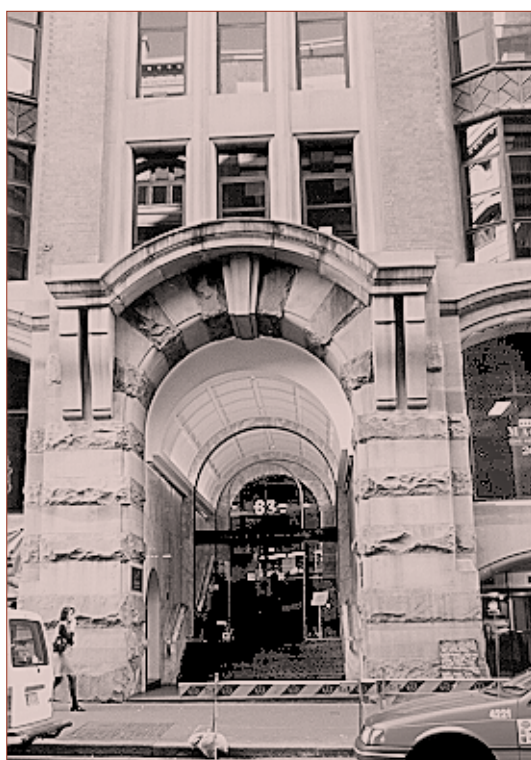
Inventory N°: 4090
Name: NEM House
Address: 83-87 York Street

Former Warehouses retaining infilled Cartways

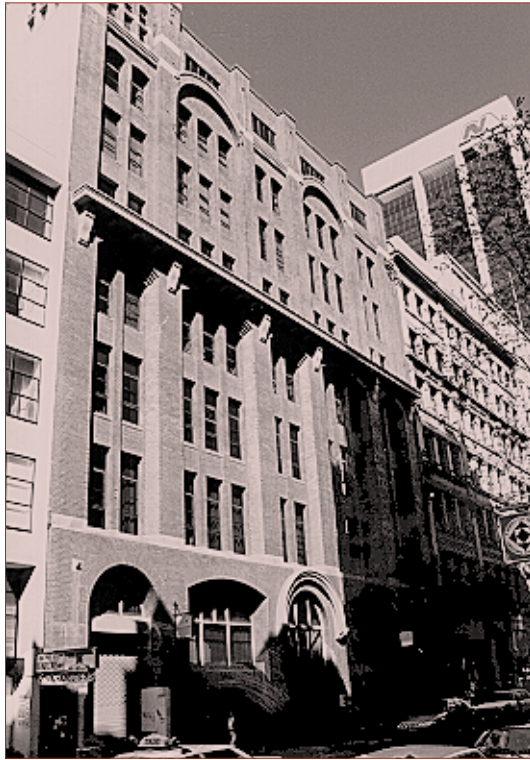
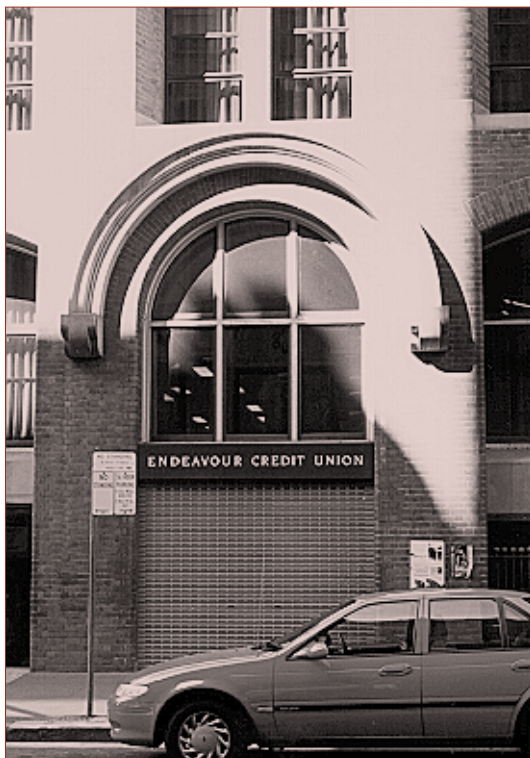
Inventory N°: 4003
Name: Endeavour Credit Union House
Address: 144 Clarence Street

Former Warehouses retaining infilled Cartways

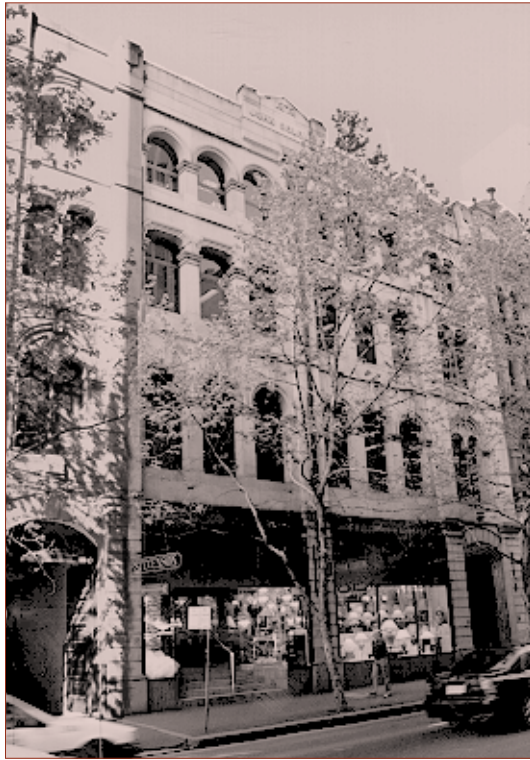
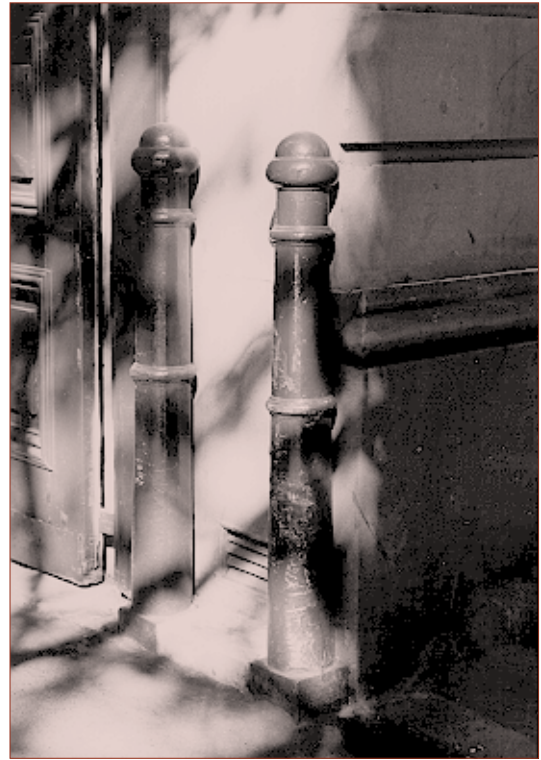
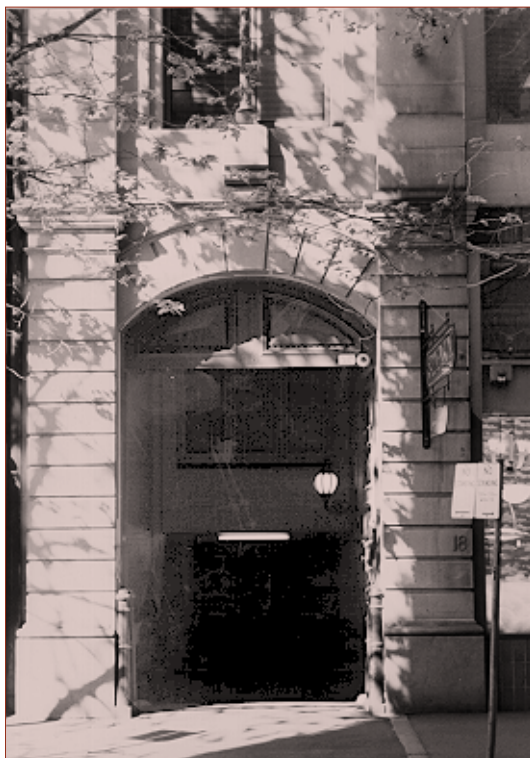
Inventory N°: 2160
Name: John Solomon Building
Address: 1 8-20 York Street

Former Warehouses retaining open Cartways

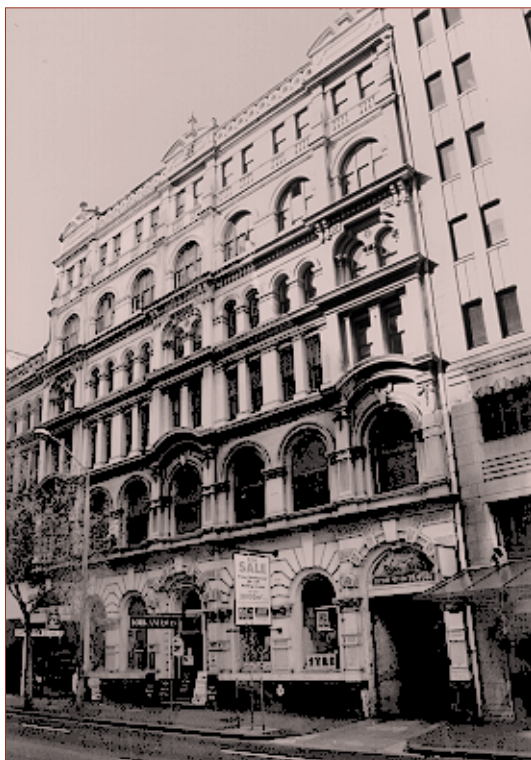
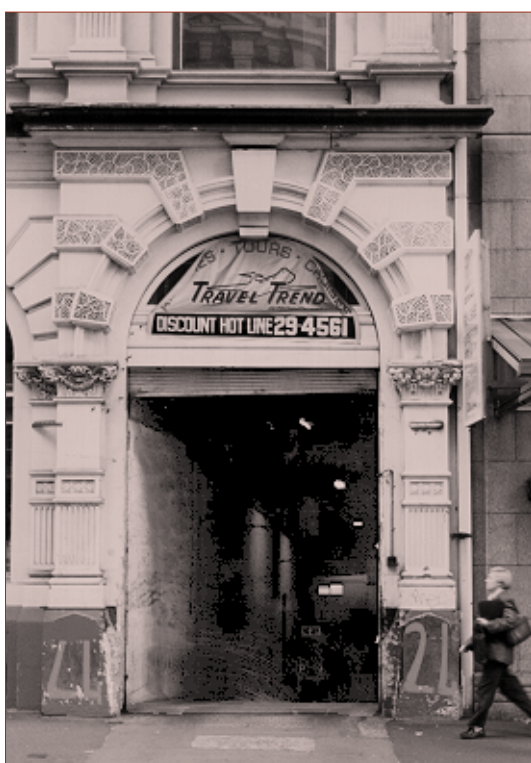
Inventory N°: 2162
Name: The Landmark (No.22)
Address: 22-26 York Street

Former Warehouses retaining open Cartways
