Your ref 187 Thomas St  
Our ref 270416-02  
File ref 270416-RPT-001

## **187 Thomas Street Planning Proposal - Reference Scheme Option 5E - Geotechnical Desktop Assessment**

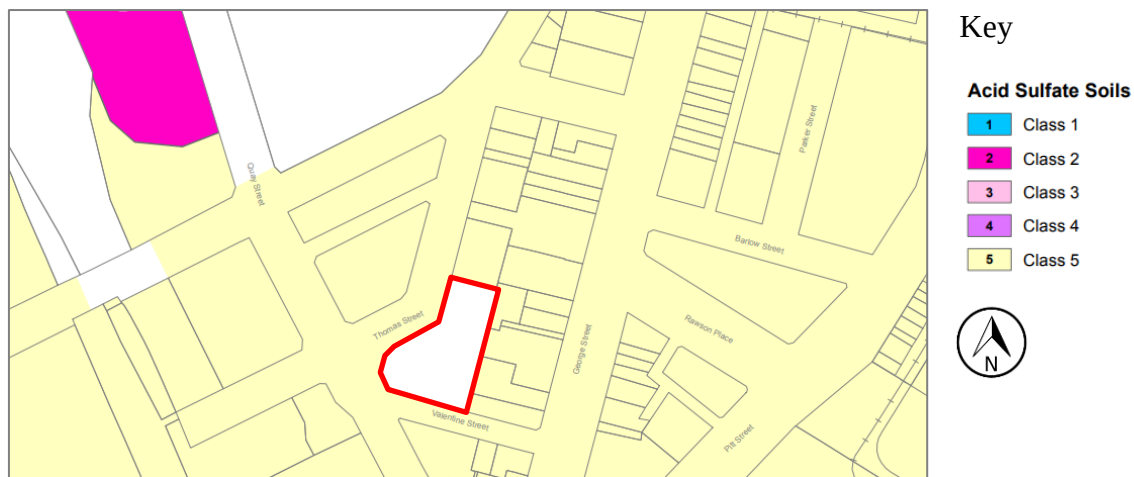
A Phase 1 (Preliminary Site Investigation) Assessment has not been undertaken at this stage of works. A review of the Sydney Local Environmental Plan Acid Sulfate Soil (ASS) Risk Map (Ref [4]) for the Sydney Region indicates that the risk of ASS on the site is Class 5. An ASS Assessment would be required where works within 500m of adjacent Class 1, 2, 3 or 4 land that is below 5mAHD, and where the water table is likely to be lowered below 1mAHD on the adjacent Class 1, 2, 3 or 4 lands. A Class 2 site is located within 500m of the site, as shown in Figure 7 below.

Figure 7: Extract from Sydney Local Environmental Plan ASS Map - Sheet ASS\_015, with the project highlighted in red.
