Report on  
Geotechnical Desktop Investigation

Proposed Commercial Building  
232-240 Elizabeth Street, Surry Hills

Prepared for  
Stasia Holdings Pty. Limited

Project 218198.00  
November 2022

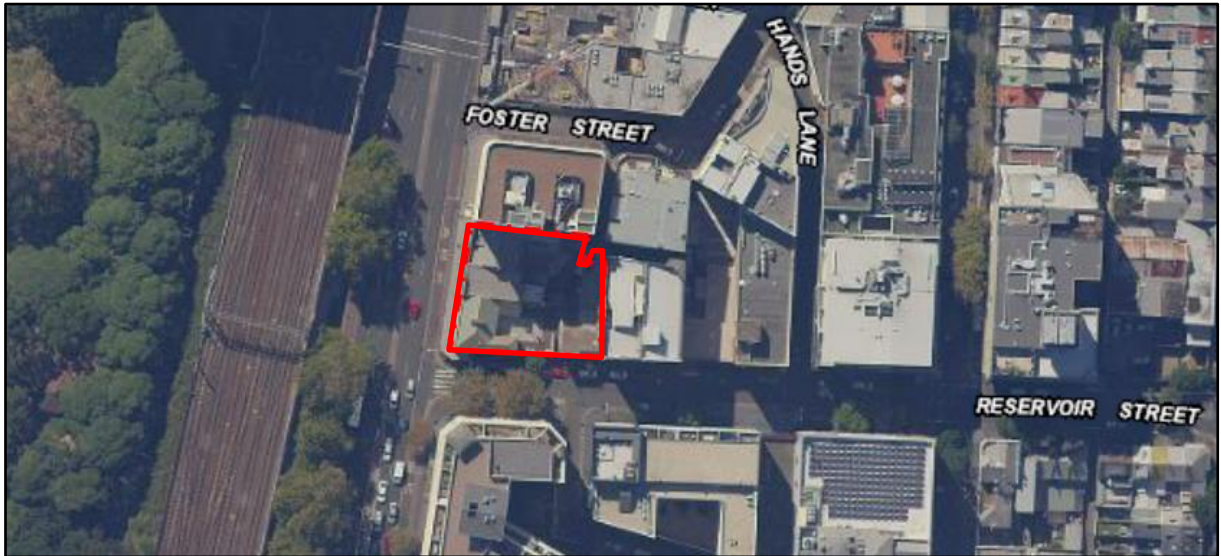
**Figure 1: Aerial photograph of the site (outlined in red).**

The roughly square site comprises three Lots and a strata plan encompassing 232 to 240 Elizabeth Street, Surry Hills (see Figure 1). The approximately 900 m<sup>2</sup> site has Elizabeth and Reservoir Streets on its western and southern sides and is bound to the north by a nine storey brick building and on the east by a six storey brick building. Foster Lane provides access to the northeast corner of the site. The site gently slopes to the southwest with a surface elevation on Elizabeth Street at about RL 10.9 m and RL 11.6 m at the southern end of Foster Lane.
